# Survey on PV Modules' Common Faults After an O&M Flight Extensive Campaign Over Different Plants in Italy

**Index Terms**—PV module faults, PV monitoring and control, unmanned aerial vehicle (UAV).

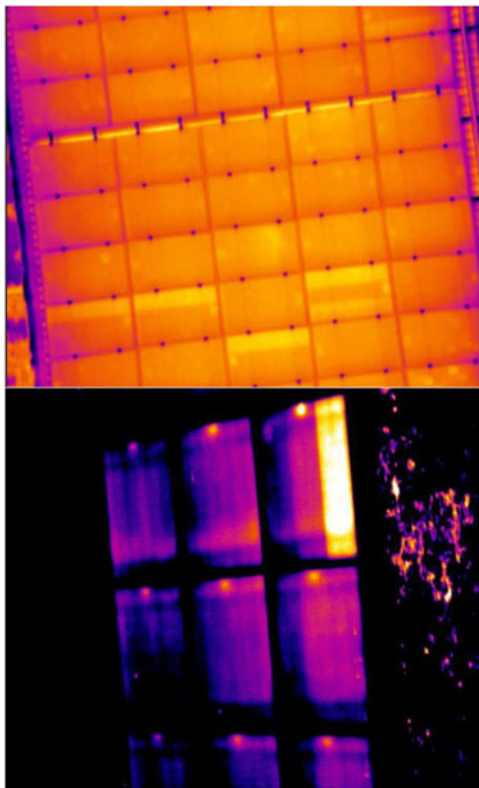
A very common occurrence is when 1/3 or 2/3 of a module is hotter than the other parts (see Fig. 3). Since all the modules here analyzed are Si-crystalline with three by-pass diodes, this problem can be due to by-pass diode failure or to soldering defects in the junction box. In any case, we always classify this failure as *by-pass failure*. Even modules or string disconnections (see Fig. 4) are quite popular and they cause loss in efficiency of PV plant. They represent one of the three most common defects among the observed plant in Italy and they can be easily recognized just using IR sensors mounted onboard.

Fig. 3. Multiple (up) and single (down) by-pass failures observed with IR sensor in plant B and plant D.

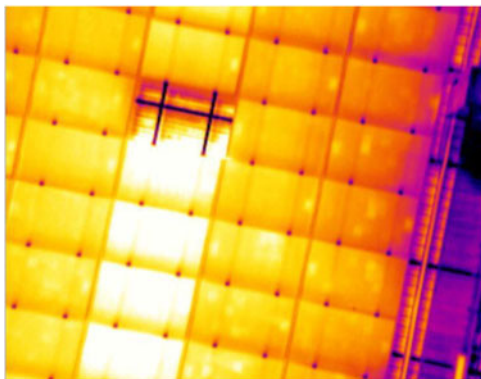
Fig. 4. Complete disconnected string with an empty module observed by the IR sensor in plant B.

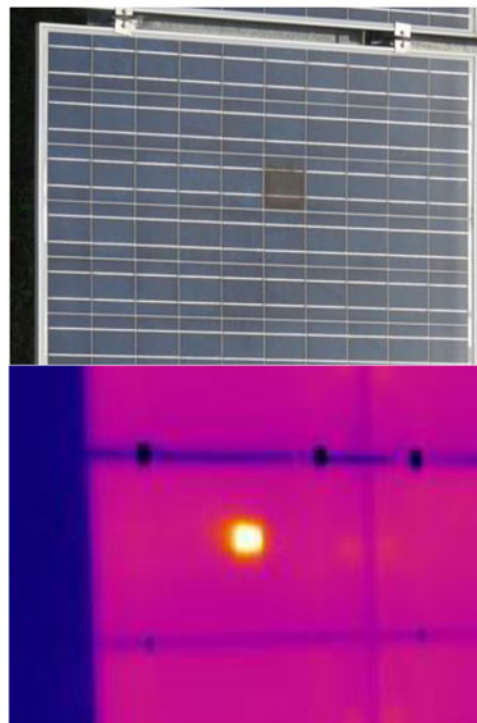
Fig. 5. Cell corrosion detected both in visible and IR in plant C.

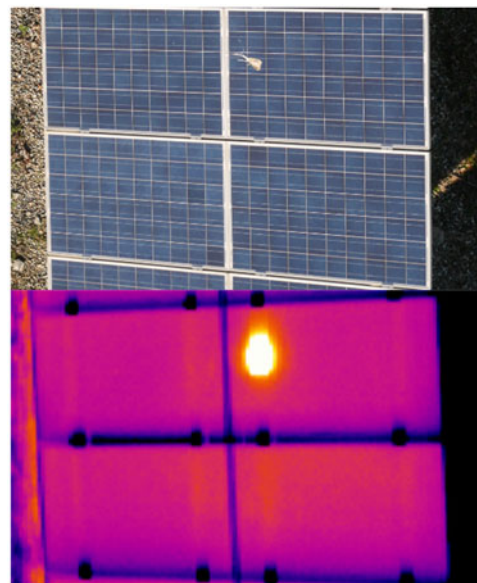
Fig. 6. Dirty module detection both in visible and IR in plant A.

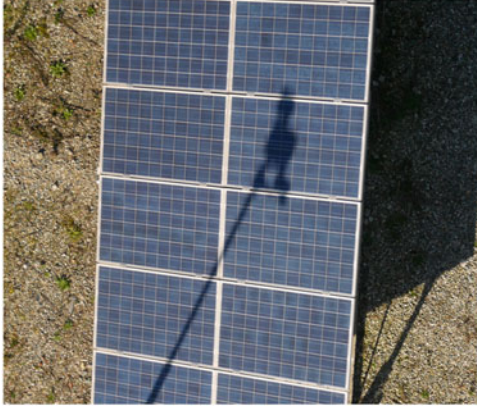
Fig. 7. Shading detection by a visual sensor in plant A.

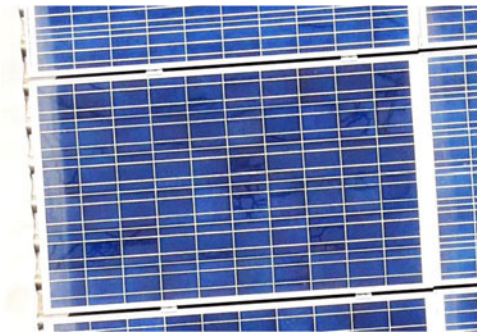
Snail trail phenomenon, due to production causes linked to a particular manufacturer, appears as dark and irregular small lines (see Fig. 8). It is not so common according to our inspections, even if plant B was dramatically affected by this failure (92.2% over only the found defected modules) while in plant E (12.5% over only the found defected modules). It is important to notice that once again the correlation with visual pictures has made possible to classify as *severe* the snail trail in plant B while as *incipient* (with no thermal effect) in the case of plant E. Snail trail can be detected by visual inspection: in this case we

Fig. 8. Snail trail detection by a visual sensor in plant B.

need high-resolution sensors or to flight as close as possible to the module [17]. In some cases, snail trails are associated with cracks and then to hot spots [18].

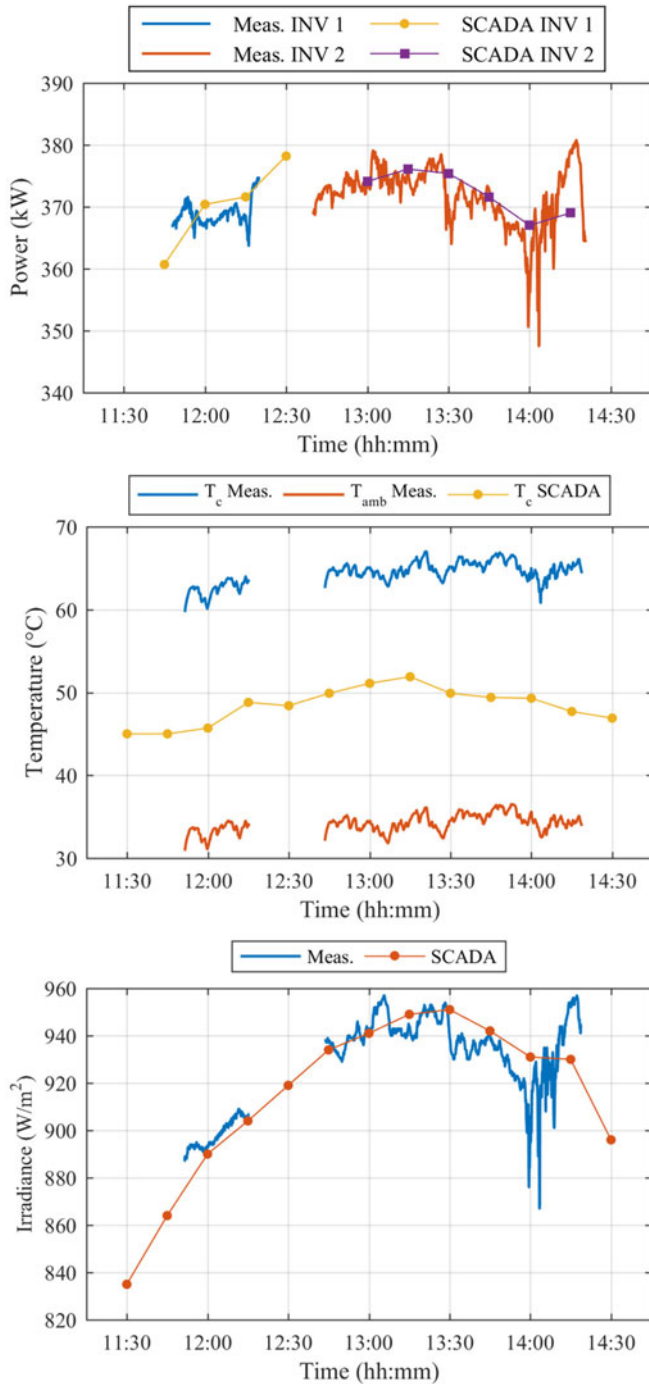
By the analysis of Fig. 9, it is possible to notice the incorrect calibration of the temperature plant sensor ( $T_c$  SCADA). Instead there is a good match between irradiance and power data recorded by SCADA and that measured in field (*Meas.*). Furthermore, a very strong correlation has been found between the final modules' defect map and the performance measured in each of the two separate parts of the plant with relative computed

Fig. 9. Temperature, irradiance, and power comparison between data recorded by SCADA and measurement (Meas.) in plant D.

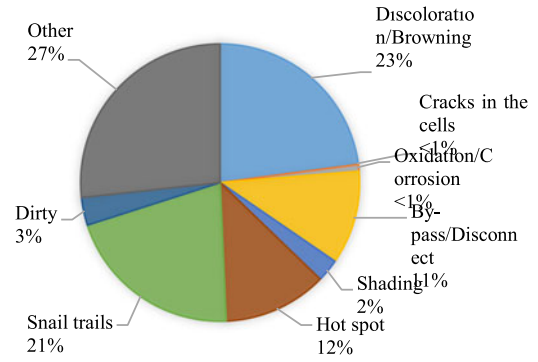
Fig. 10. Circle chart related to the module defects in the 5 plants (over the total number of failures).

With respect to the percentage of failures at module level found in this flight campaign (see Fig. 10), it is quite valuable comparing our findings with the recent literature even if not trivial and made on heterogeneous samples. In [19], both failure rates due to customer complaints in the first two years after delivery and based on a field study of many manufacturers in the midlife are reported. The rates are given relative to the total number of failures such as in our study, and show a wide range of occurrences, often with different classification criteria: for example, defect cell interconnects are around 10%, j-box and cables around 10–20%, glass failures 10–30% depending on the plant age and means of detection. In [20], a physical model for degradation and reliability is validated on a large statistical data set, confirming that some studies do not distinguish for example corrosion damage from fatigue damage; however, more than 60% of returns is attributed in this case to cell-interconnection issues, considering modules that are aged less than 10 years. Kurtz *et al.* [21] discuss the degradation mechanisms depending on both technology and climate zones, as well as how they generally affect differently current and voltage giving average rates in terms of %/year with no distinction based on the nature of defects. Finally, [22] reports a project report on PV plant risk assessment, finding that among the overall common failures, glass breakage, ethylene-vinyl acetate discoloration, and defective backsheets bear a higher level of economic impact on O&M.
