Evaluation of the masonry and timber structures of San Francisco Church in Santiago de Cuba through nondestructive diagnostic methods

Riccardo D. De Ponti¹ | Lorenzo Cantini² | Laura Bolondi¹

Summary

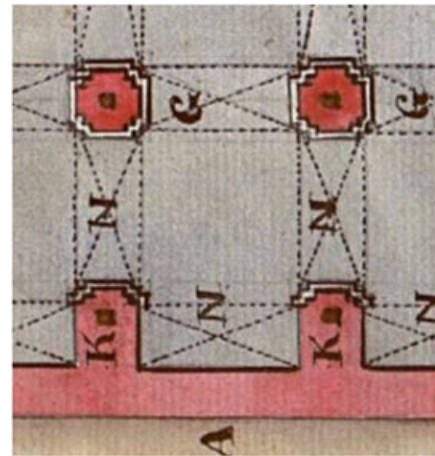
FIGURE 2 A detail of the pillars with the dark rectangular shape inside the structures

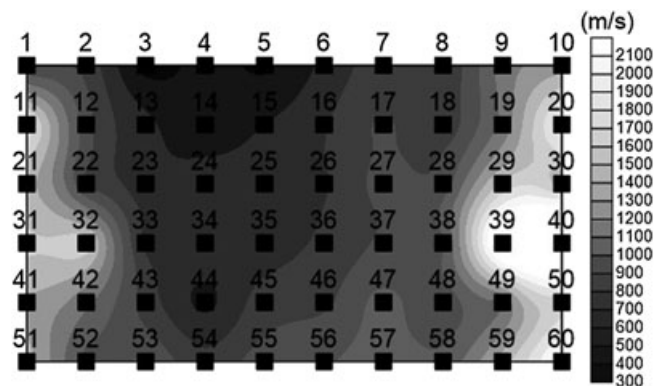
As shown in Figure 14 and Figure 15, higher velocities (around 2,000 m/s) are concentrated along the edges of the

FIGURE 14 Velocity map indicating the distribution of the velocities obtained on pillar P3b. Path direction: north-south

pillar, composed by a sequence of compact materials, and the central columns of the grid of points present lower values (between 400 and 900 m/s). These quality results offer limited information: in this case, the low velocities can be associated with the supposed organization of the masonry section, presenting a brickwork with several mortar joints that can mitigate the sonic waves velocity.

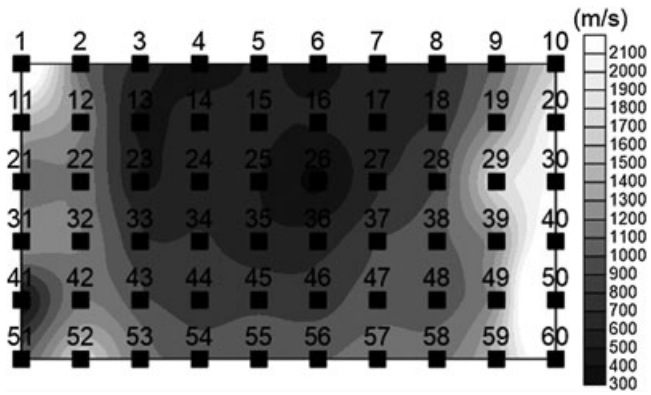
FIGURE 15 Velocity map indicating the distribution of the velocities obtained on pillar P3b. Path direction: east–west

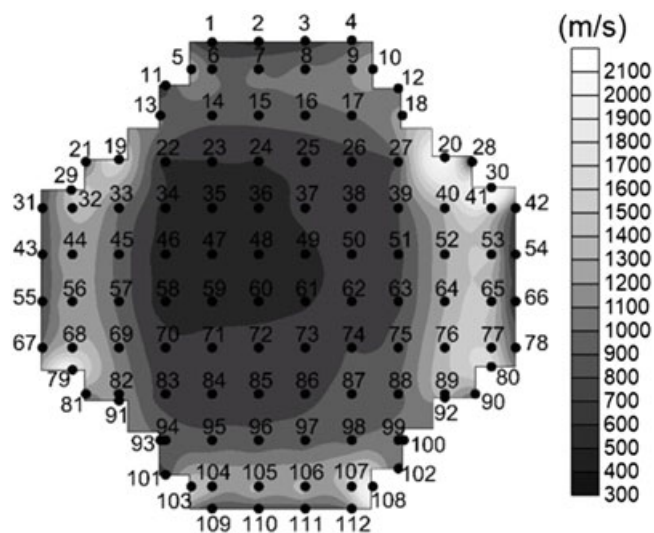
FIGURE 17 Distribution of the velocities obtained by the cross-path computation on the horizontal section of the pillar at 110 cm from the floor

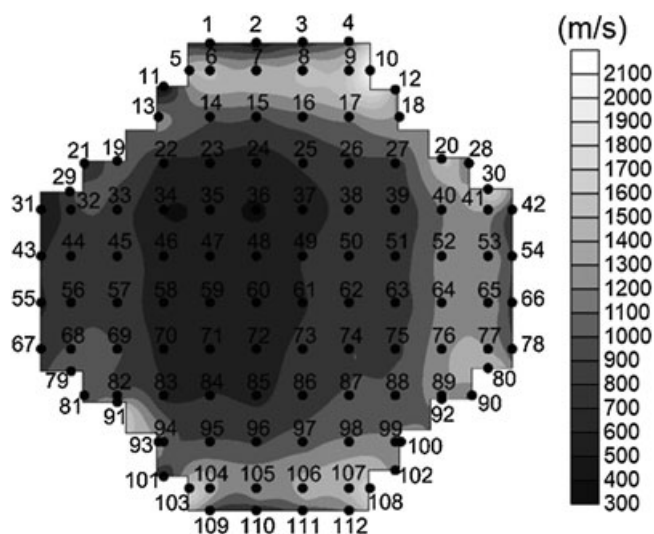
FIGURE 18 Distribution of the velocities obtained by the cross path computation on the horizontal section of the pillar at 154 cm from the floor

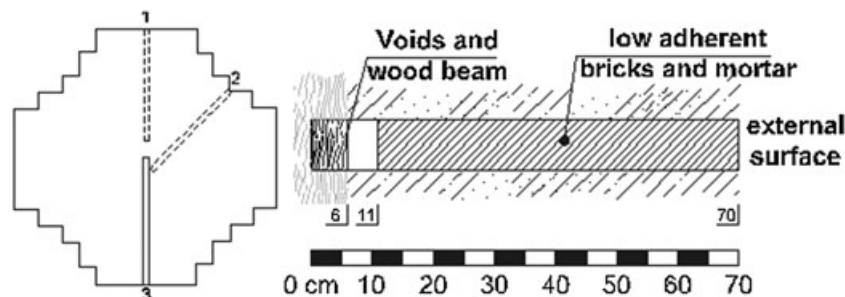
FIGURE 19 Stratigraphic analysis of the pillar section

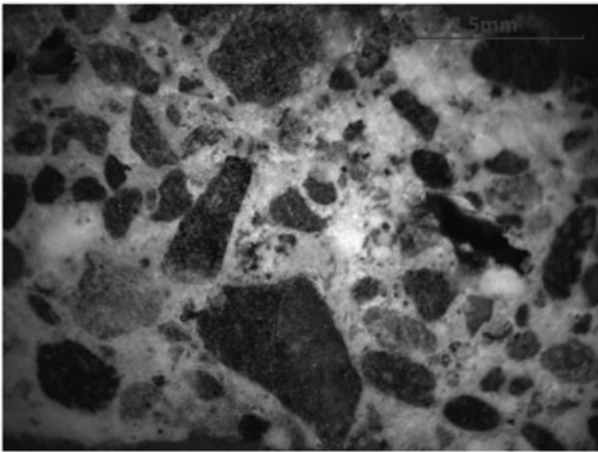
Sample SF_b is a single layer fragment of lime-based bedding mortar, homogeneous in binder and aggregate (Figure 22). At the stereomicroscope analysis, a very good adhesion between aggregate and binder is detected. In the binder, a few lime lumps are visible, max diameter: 1 mm. Aggregate has a fluvial origin; fragments are rounded and homogeneous in characters and shape, average diameter: 1 mm, max diameter: 4 mm. Pores are mainly present in the binder, not numerous and with a max diameter of 1.5 mm. No fibers or inclusions were detected.

PFM analysis shows Sample SF_b to be air-lime based, with a high binder-aggregate ratio (about 1:2.5). Binder is coarse grained and not homogeneous in distribution. Aggregates are mainly quartz, volcanic, and meta-

FIGURE 22 Stereomicroscope analysis of sample SF_b (bedding mortar)

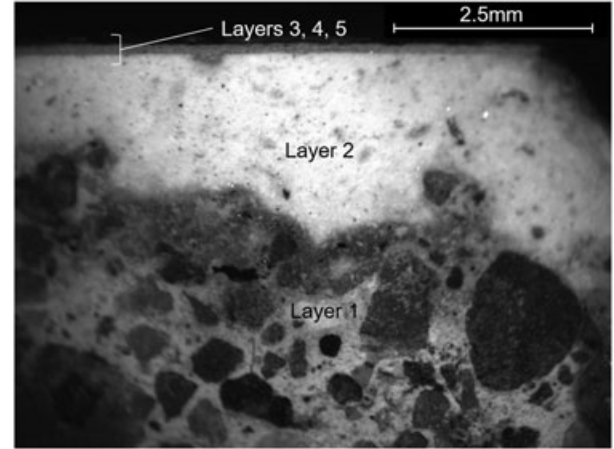
Sample SF_r is a 5-layer fragment (Figure 23), constituted by a 20-mm thick fragment of render (layer 1), a 3- to 5-mm-thick lime wash (layer 2), and three layers of color (layers 3–5). Layers 1 and 2 seem to have a good adhesion. Aggregates of layer 1 are similar to sample SF_b (but a bit more angular), average diameter: 2 mm, max diameter: 7 mm. Compared to SF_b, sample SF_r has a lower binder-aggregate ratio (about 1:3).

PFM analysis shows a partial disconnection between layers 1 and 2, separated by a thin and continuous crack. They are also different in binder: layer 1 has an air-lime based binder, very dense and coarse grained. Layer 2 is characterized by a fine-grained air-lime binder, with several pores and no aggregate. Layers 3, 4, and 5 are modern, synthetic materials. Aggregates are, in layer 1, homogeneous in shape and nature: metamorphic and volcanic rocks and a few quartz are present. In the binders, no hydraulic reaction was observed.

FIGURE 23 Stereomicroscope analysis of sample SF_r (render)

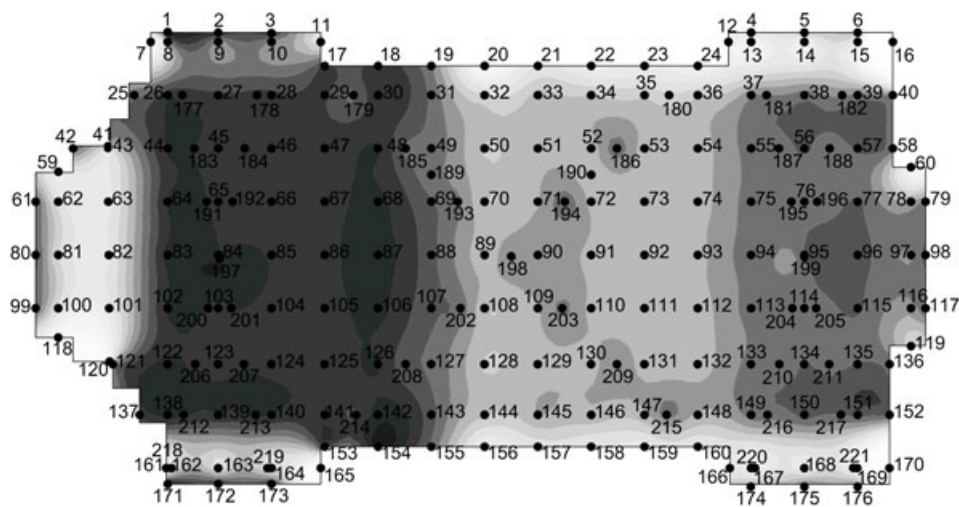
FIGURE 25 Velocity map on the horizontal section of the large pillar

a more refined interpretation of the presence of discontinuities in the masonry structure. The distribution velocity map (Figure 25) reveals the influence of the cavities hosting the timber columns in two separate areas of the horizontal section. The large area characterized by a sonic average velocity of about 700 m/s indicates a relevant part of the supposed load-bearing structure that is subjected to low density in the section morphology. Thanks to historical analysis, the low velocity range can be associated to the presence of the vertical timber elements and the result suggests the utility of an in-depth study of this area through MD tests.
