Damage survey, simplified assessment and advanced seismic analyses of two masonry churches after the 2012 Emilia earthquake

by
Marco VALENTE⁽¹⁾, Gabriele MILANI^{*(1)}

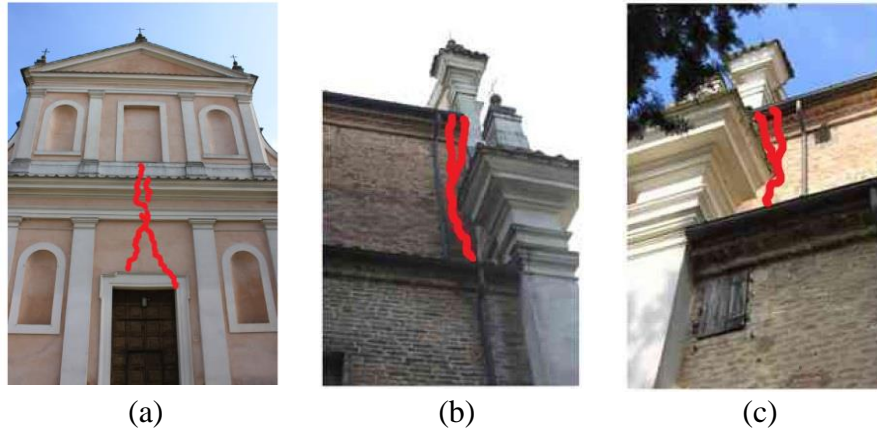
The façade presents severe vertical cracks that propagate from the entablature to the main door, Figure 3 (photo a); an important crack on the façade is also visible inside the church, in correspondence with the arch above the organ. Significant vertical cracks can be observed in the upper part of the nave walls in correspondence with the façade, Figure 3 (photos b-c). Internal and external cracks patterns observed suggest the activation of a partial failure mechanism involving the façade. As a matter of fact, it should be also pointed out that the presence of a meaningful vertical crack near the main opening of the façade is probably an indication of a relatively good interlocking between façade and nave lateral walls, which is also expected to be associated to a higher load carrying capacity. Since the most vulnerable part of the structure seems to be the façade under out-of-plane actions, it appears reasonable to conclude that the main direction of the shake might be roughly parallel to the longitudinal direction of the structure. To corroborate such a conclusion, façade cracks pattern should be always read cross-checking information with surveys conducted on the rest of the church, especially on longitudinal walls of the nave and near the triumphal arch.

Figure 3. San Paolo church. (a) Vertical cracks in the façade; (b)-(c) vertical cracks in the connection region between the façade and the upper part of the nave walls.

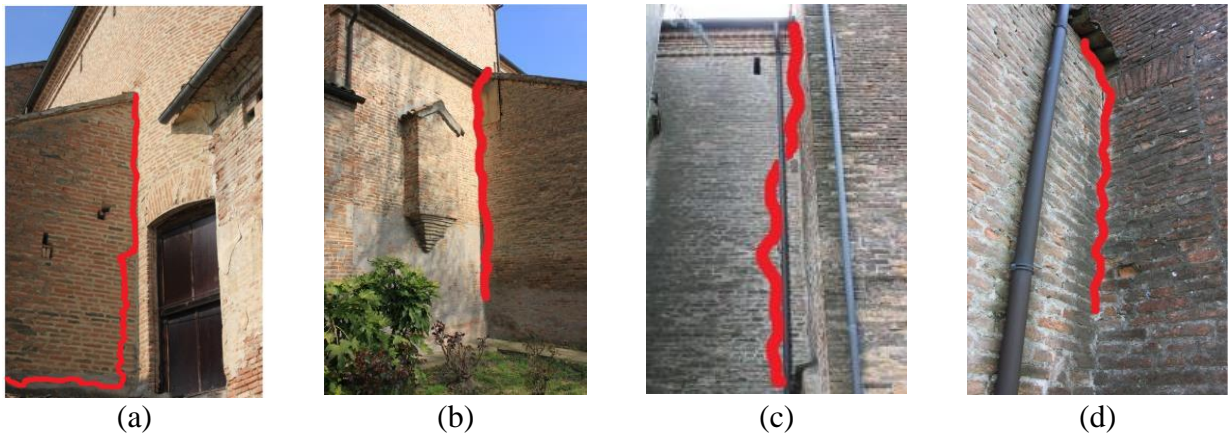
Figure 4 collects the results of such a cross-checking and synoptically shows severe vertical cracks in the connection regions between the side chapels and the nave walls (photos a-b) and between the church and the annexes (photos c-d). Such cracks suggest a differential deformation of the structure along the longitudinal direction, particularly among the central nave, the lateral annexes and the triumphal arch, which is obviously a consequence of an earthquake shake directed longitudinally. Inside the church, many cracks are visible in the upper part of the building, mainly near the arches and openings, Figure 5 (photos a-b). The vertical cracks along the connection regions between the nave walls and the adjacent buildings (side chapel and sacristy) are considerable also inside the church, Figure 5 (photos c-d), an information which once again confirms the idea of a shake acting along the main direction of the nave.

Figure 4. San Paolo church. (a)-(b) Vertical cracks between the side chapels and the nave walls; (c)-(d) vertical cracks between the church and the annexes.

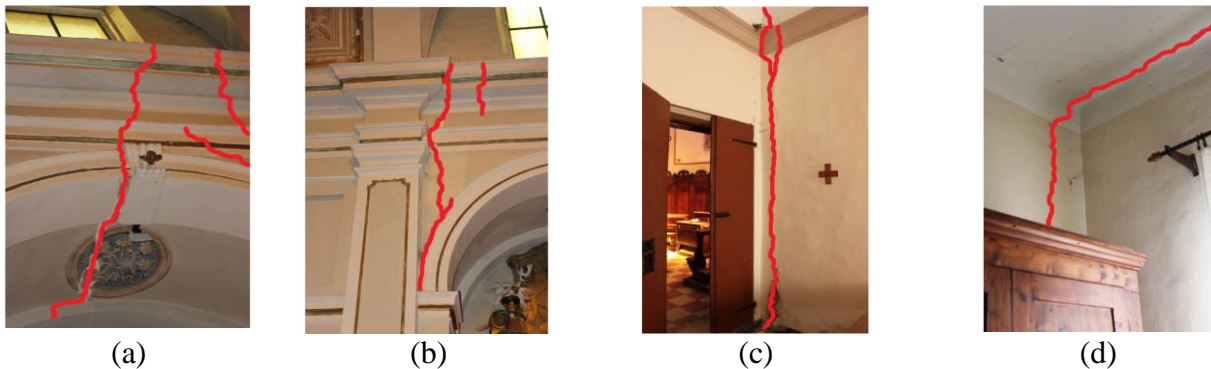
Figure 5. San Paolo church. (a)-(b) Cracks in correspondence with the side chapels; (c)-(d) vertical cracks between the nave walls and the side chapels and sacristy.

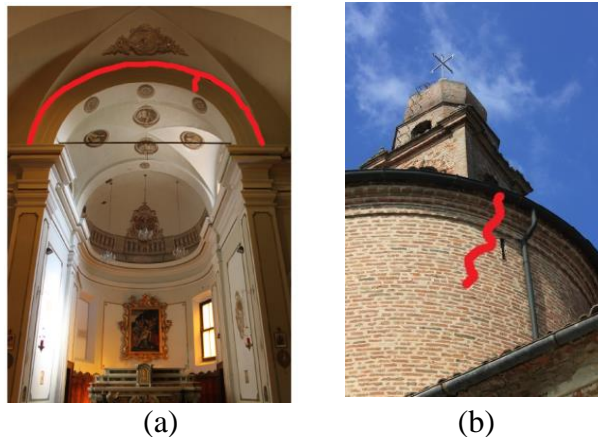
Again in agreement with the conclusions already raised, significant cracks are observed in the triumphal arch, where the effective contribution of the steel tie-rod is also evident, Figure 6 (photo a). The apse presents clear vertical and diagonal cracks in the upper part of the right wall, Figure 6 (photo b), and in correspondence with a small door. Such a crack pattern indicates an overturning mechanism not yet fully developed; it is again consistent with what has already been discussed, i.e. that partial collapses experienced are associated to a shake directed mainly along the longitudinal

direction, but also suggests that the load carrying capacity of the apse seems still slightly higher than that of the façade, despite the good interlocking of the façade with the nave lateral walls.

Figure 6. San Paolo church. (a) Cracks in the triumphal arch; (b) crack in the apse

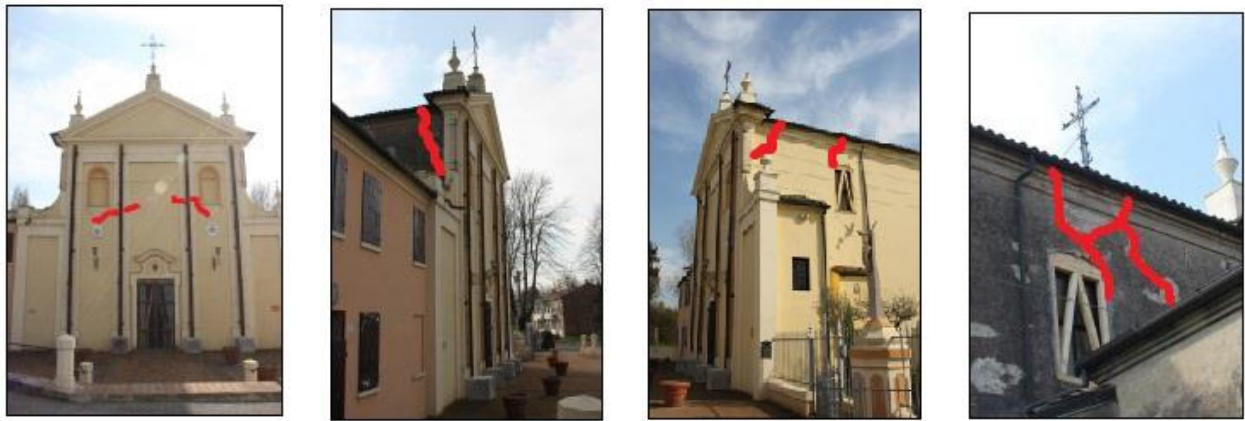
Figure 7. San Pietro Apostolo church. (a) Main cracks in the façade and collapse of the pinnacles; (b)-(c) cracks in the connection region between the façade and the nave walls; (d) cracks in the nave wall near the opening.

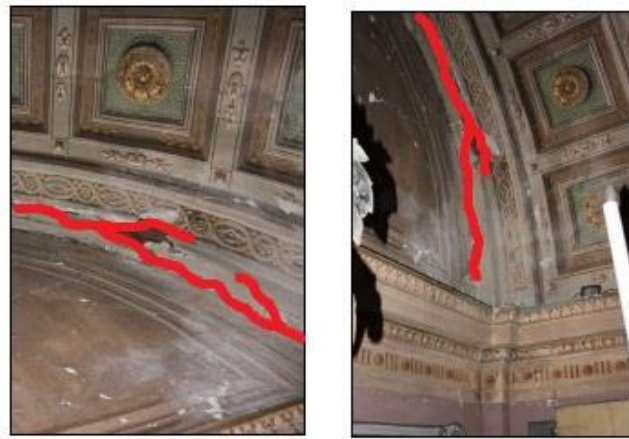
Figure 8. San Pietro Apostolo church. (a)-(b) Cracks along the arch of the façade (inner view).

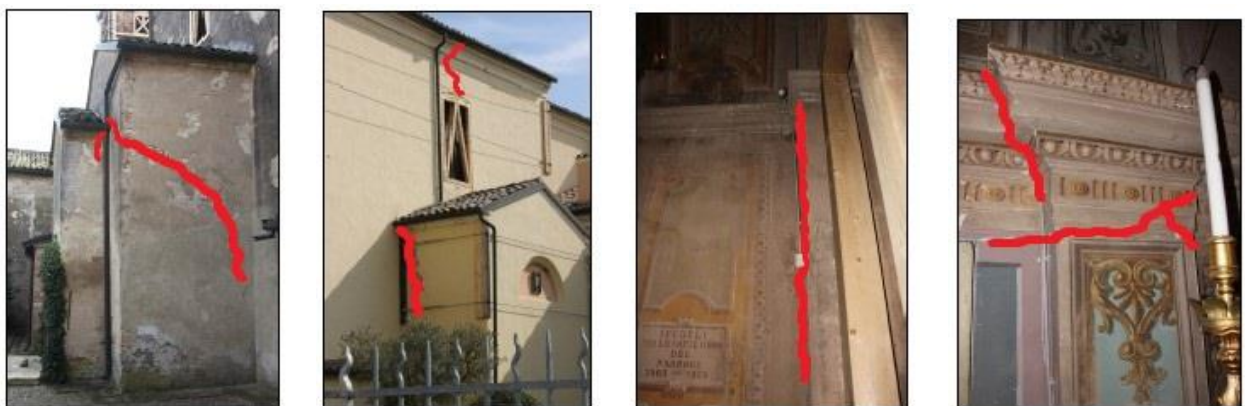
Figure 9. San Pietro Apostolo church. (a)-(b) Cracks of the side chapels and nave walls (external view); (c)-(d) cracks of the side chapels (inner view).

Consistently with such a deduction, important cracks are indeed observed in the side chapels and near the connection region between the side chapels and the nave walls, promoted also by the quite

ineffective interlocking between perpendicular walls observed. Figure 9 (photos a-d) shows the signs of detachment of the side chapels (outer and inner views), creating a possible overturning mechanism. Severe cracks are detected at the impost of the triumphal arch, Figure 10 (photos a-b), due to the probably poor interlocking with the supporting nave walls and the longitudinal motion of the nave. Damage is more significant on the left side, probably influenced by the presence of the bell tower overloading the arch during the earthquake. Other cracks can be observed in the arch and in the recesses starting from the openings, as shown in Figure 10 (photos c-d). The apse does not present widespread damage or overturning mechanisms, meaning that the collapse activation acceleration was higher than that of the façade. Some typical diagonal cracks are observed near the openings, Figure 10 (photo e), which however can be justified by an in-plane shear stress concentration induced by the presence of the transept, which interconnects with the presbytery roughly in that location.

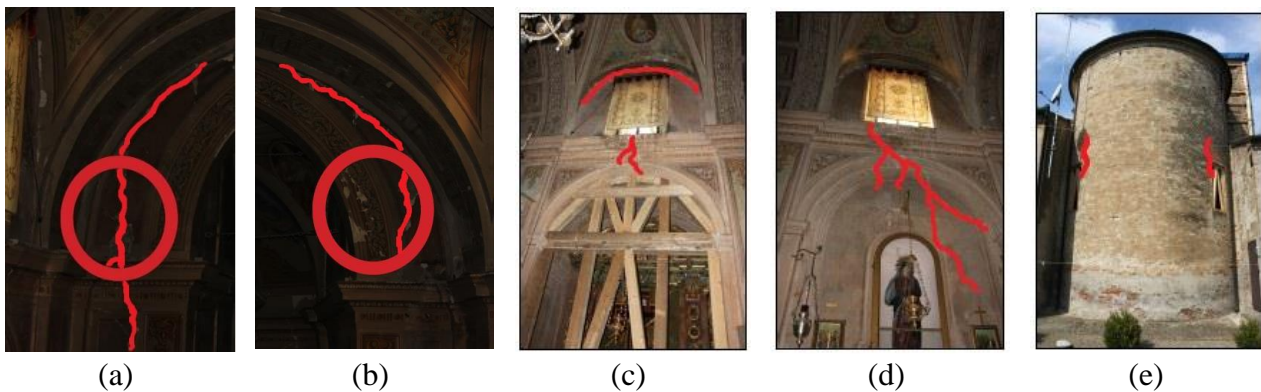
Figure 10. San Pietro Apostolo church. (a)-(b) Cracks at the impost of the triumphal arch; (c)-(d) cracks starting from the openings and involving the arches and recesses; (e) cracks in the apse near the openings.

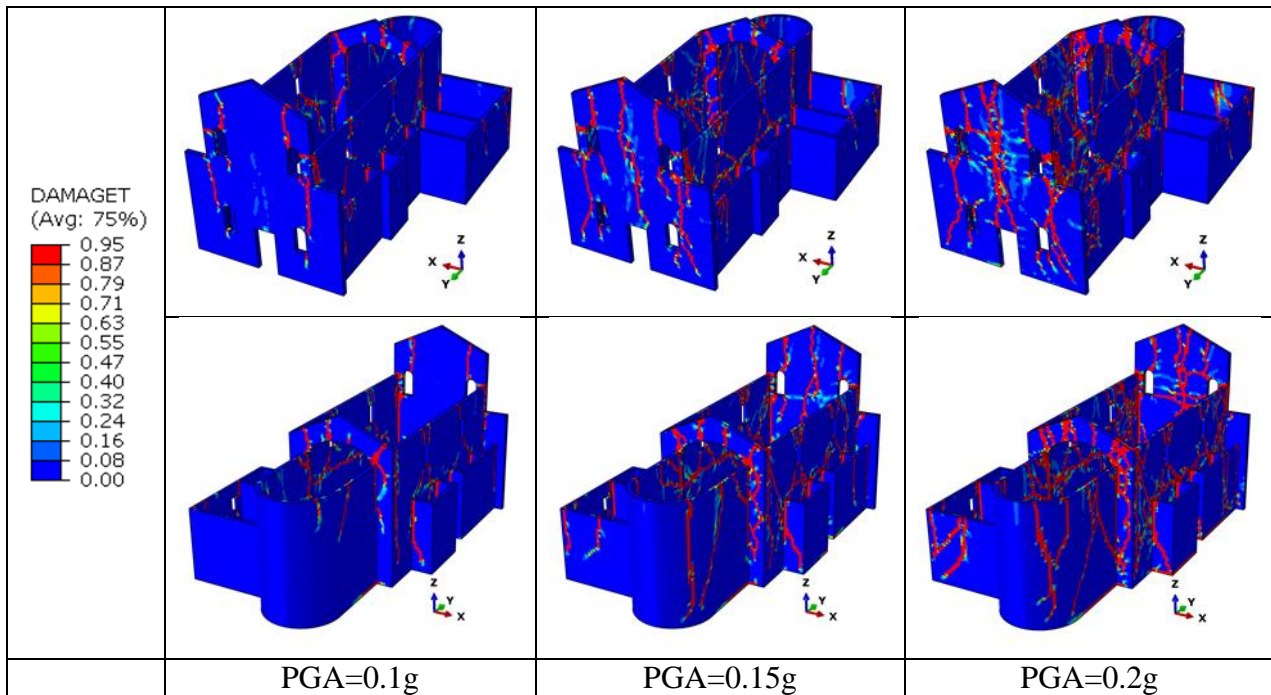
Figure 22 shows the tensile damage contour plots of San Paolo church at the end of the non-linear dynamic analyses for three different PGA values. It is worth noting that a significant increase of damage can be observed when the seismic intensity level varies from $\text{PGA}=0.1\text{g}$ to $\text{PGA}=0.2\text{g}$.

-Under $\text{PGA}=0.1\text{g}$ the façade exhibits some vertical cracks involving the four openings. The analysis under $\text{PGA}=0.15\text{g}$ shows the formation of a large vertical crack in the central part (from the top of the tympanum to the door) and two lateral cracks in the edge parts. Under $\text{PGA}=0.2\text{g}$ damage increases and extends considerably all over the façade. It is important to highlight that the façade of the church is rather slender and there is a significant height difference (17.4 m vs 12.1 m) between the top of the tympanum and the nave walls. Moreover, it can be noted that the numerical model shows a more widespread damage than the real case, particularly with regard to the edge parts.

-The nave walls exhibit diagonal and vertical cracks near the openings, even under $\text{PGA}=0.1\text{g}$, in agreement with the on-site survey; evident horizontal damage is present along the walls at the height of the side chapels. Severe vertical cracks can be observed in the connection regions between the nave walls and the façade, even under $\text{PGA}=0.1\text{g}$, as emerged from the on-site survey.

-A considerable damage is registered in the triumphal arch, which exhibits vertical cracks in the central part and diagonal cracks at the edges: moreover, the vertical elements are significantly damaged. These results are reflected in the main outcomes derived from the on-site survey.

-The side chapels exhibit clear vertical cracks close to the connection regions with the nave walls, even under $\text{PGA}=0.1\text{g}$: it is pretty similar to what has been described in Section 3.1.

-The apse presents negligible damage under $\text{PGA}=0.1\text{g}$: on the contrary, several vertical cracks starting from the top of the walls can be observed for higher PGA. These results are consistent with what has been highlighted in the direct damage survey.

Figure 22. San Paolo church. Tensile damage contour plots at the end of the non-linear dynamic analyses with three different PGA.

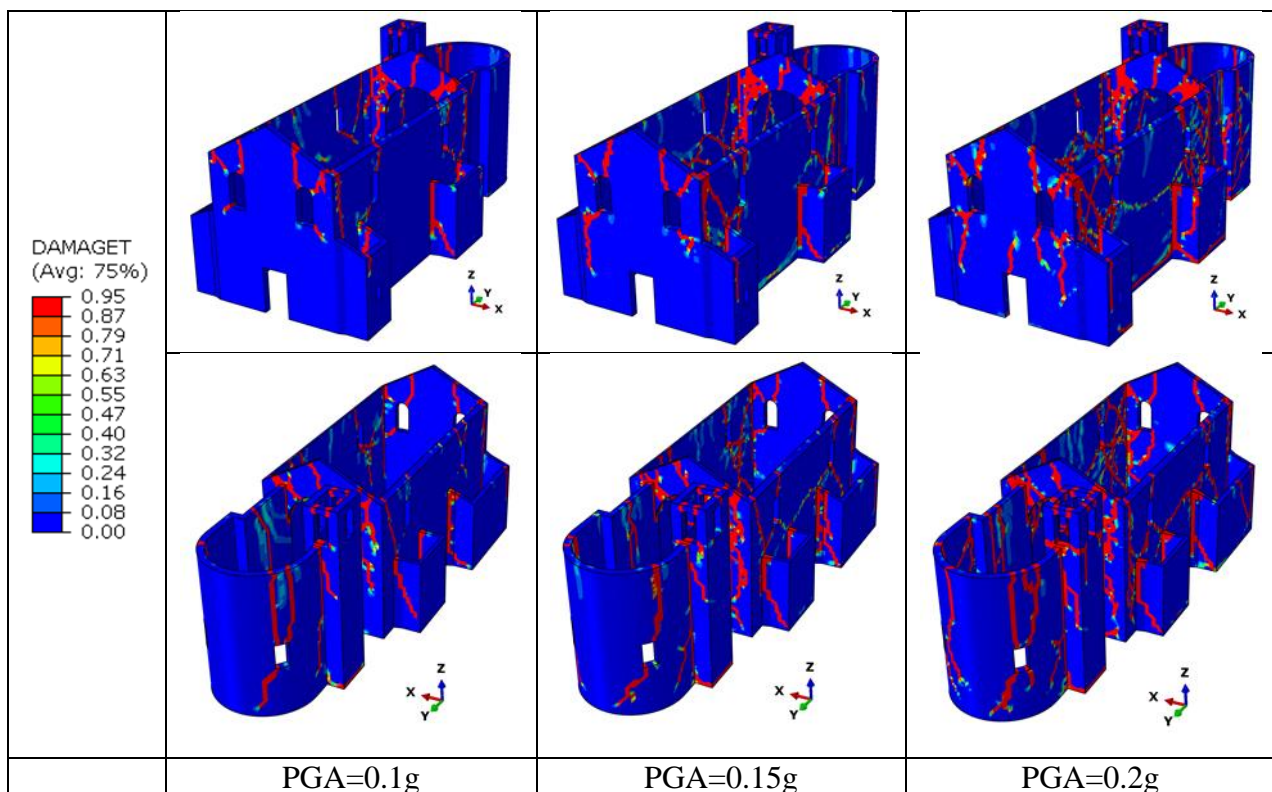
Figure 25 shows the tensile damage contour plots of San Pietro Apostolo church at the end of the non-linear dynamic analyses for three different PGA levels. It is worth noting that widespread damage can be observed even for PGA=0.1g.

-Under $PGA=0.1g$, the façade presents some important cracks in the upper part, near the two openings. For higher PGA , damage increases and extends to the bottom part, showing two main cracks in correspondence with the nave walls; moreover, an evident crack can be observed above the main door under $PGA=0.2g$. It can be noted that damage is more evident than that observed during the on-site survey.

-The nave walls exhibit significant damage under $PGA=0.2g$. A horizontal crack is visible mainly in the left wall at the height of the side chapel: it may be probably due to the out-of-plane deflection of the upper part of the wall. Severe vertical cracks, which are consistent with the real damage, can be observed in the connection regions with the façade, even under $PGA=0.1g$,

-The triumphal arch shows extensive damage with a distribution that is comparable with the crack pattern observed during the field survey: vertical cracks can be observed in the central part and diagonal cracks are registered at the edges.

-The apse exhibits marked vertical cracks near the openings and at the edges, near the bell tower, even under $PGA=0.1g$, as confirmed by the field survey.

-It can be noted that the bell tower presents damage in the upper part, near the openings, and along the body, even under $PGA=0.1g$: important vertical cracks can be observed near the connection regions with the walls of the apse and the presbytery.

-Severe vertical cracks, which are in a good agreement with the surveyed damage, are registered in the connection regions between the side chapels and the nave walls, even under $PGA=0.1g$.

Figure 25. San Pietro Apostolo church. Tensile damage contour plots at the end of the non-linear dynamic analyses with three different PGA .
