**A MULTIDISCIPLINARY STRATEGY FOR THE
INSPECTION OF HISTORICAL METALLIC TIE-RODS:
THE MILAN CATHEDRAL CASE STUDY**

Bellanova Mariagrazia¹

Felicetti Roberto¹

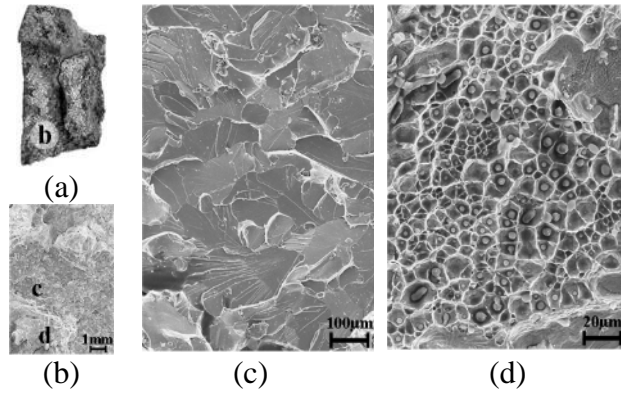
The fracture surfaces of the failed tie-rod were thoroughly studied by SEM. Since results are completely repeatable, in this paper only those pertaining to one of them (sample A, Figure 2) are shown. Typical images are displayed in Figure 3. In the picture at lowest magnification (Figure 3b), areas with different features can be recognized. Figure 3c reveals a transgranular brittle failure through a clear identification of both cleavage planes and river patterns. Figure 3d clearly shows dimples, indicating micro void coalescence around an inclusion. The latter has a silicates-rich chemical composition, as highlighted by EDXS analysis. This observation suggests a low reducing iron-smelting atmosphere. Often brittle and ductile failure modes were identified very close one to each other all over the fracture surfaces, indicating a heterogeneous microstructure.

Figure 3. SEM analyses on failure surface (sample A), (a) fracture surface, (b) general picture enlargement, (c) transgranular brittle failure area, (d) ductile failure area

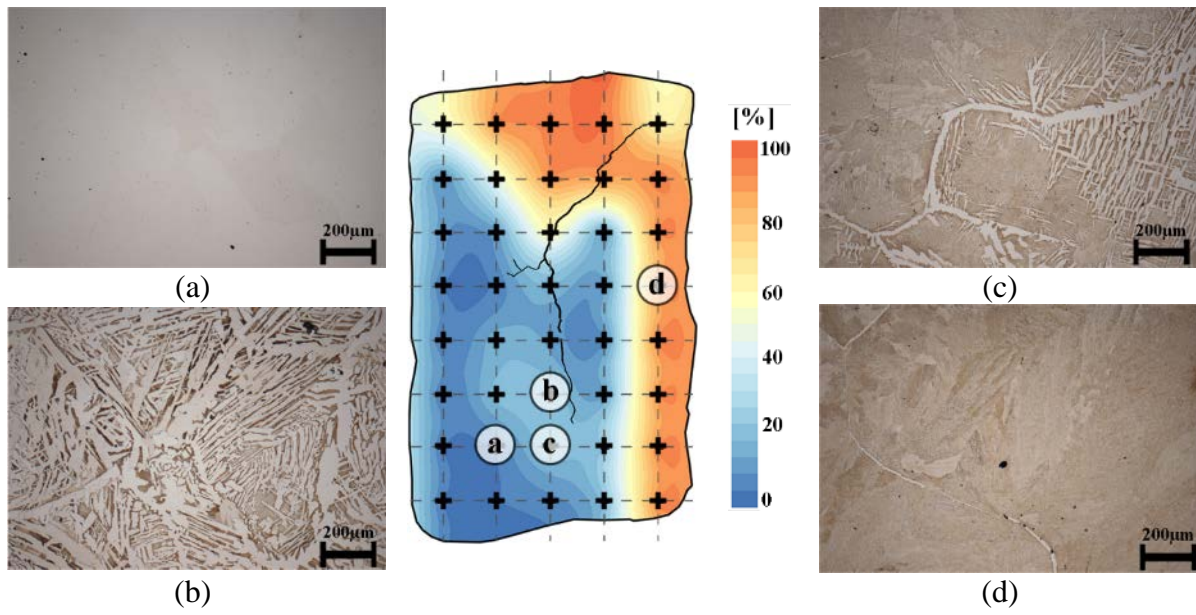
microstructural compounds were determined according to ASTM E 562-02. The discrete data system was transformed into a continuous distribution by interpolating the nodal values. Ferrite and pearlite are the most recurring microstructures but their percentage over the cross-section is extremely variable as can be observed in Figure 4. Two distinct more homogenous areas can be identified. At the interface between them, the amount of the two microstructural compounds is comparable. Only along this latter line, grains exhibit large and different dimensions. Often Widmanstätten plates can be observed, suggesting a direct production process (Ashkenazi et al. 2012). Mostly ferritic structure is prevalent and characterizes the 78% of the examined grid nodes. Increasing the percentage of pearlite, the amount of carbon raises and hence also strength and brittleness.

Figure 4. Pearlite distribution over the investigated cross-section (sample B) and typical micrographies at 100X, (a) pearlite 0%, (b) pearlite 20%, (c) pearlite 21%, (d) pearlite 97%

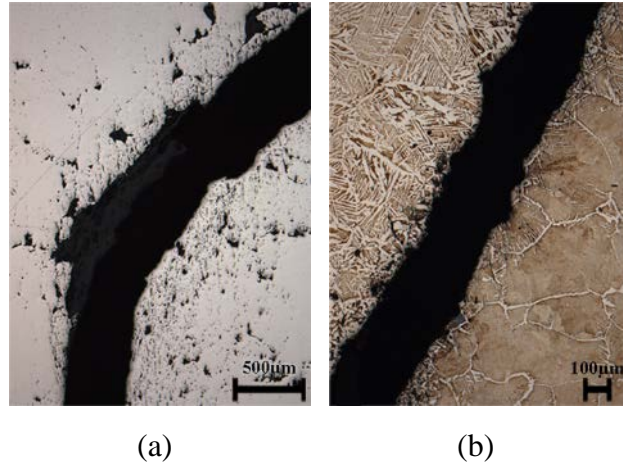
Very interesting features were detected by LOM on the fractured area across the crack. Before etching, concentrated discontinuities were locally identified (Figure 5a). After etching, sudden change of both microstructure and grains size was highlighted as well. As can be seen in Figure 5b, the crack seems to be propagated at the boundary between these two patterns. In the literature, these features are often associated to a forged weld between two pieces characterized by dissimilar compositions (L' Hèritier et al. 2013, Menzemer et al. 2016).

Figure 5. LOM analyses close to crack on the investigated cross-section (sample B), (a) concentrated discontinuities, (b) sudden microstructure change

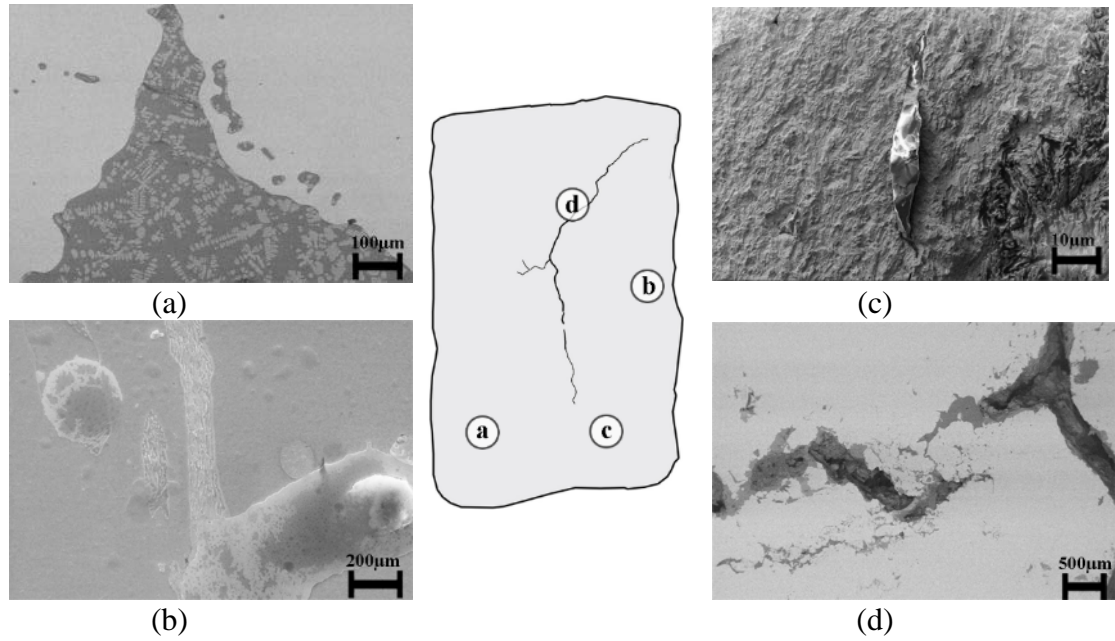
Many types of defects were recognized by using SM, such as micro-cracks, micro-porosities, voids, slag inclusions. SEM coupled with EDXS allowed their characterization. A strong correlation was found between metal matrix and type of discontinuities. Iron-rich dendritic slag inclusions (typically wüstite) characterize the mostly ferritic matrix (Figure 6a). Spheroidal graphitic carbon is often identified as well. Fine pearlite nucleates around carbon nodules (Figure 6b). These features cannot be recognized in the mostly pearlitic microstructure, where smaller glassy slag (Figure 6c) and microcracks were detected. Crack propagated toward the mostly pearlitic structure. Usually iron oxides inclusions are located inside the crack (Figure 6d).

Figure 6. Micro discontinuities detected by SEM on the investigated cross-section (sample B) (a) iron-rich dendritic slag inclusion, (b) carbon-rich glassy inclusion, (c) spheroidal graphitic carbon, (d) iron-oxide inclusion inside crack

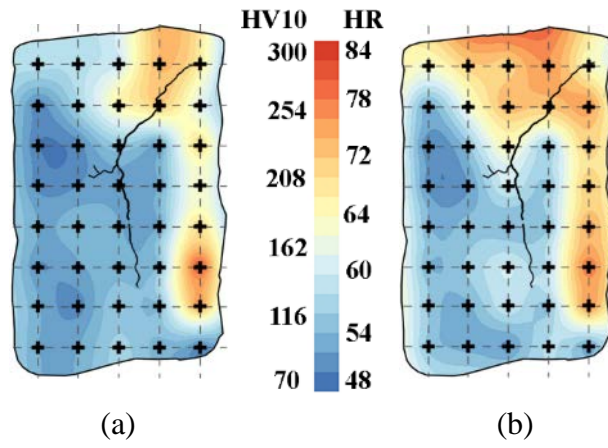
Vickers and Rockwell hardness tests were performed as well at the same location of LOM analyses by shifting the two measurements by 4mm in order to avoid any interaction. In Figure 7 the two corresponding contour plots are compared. Large standard deviations (55 HV10 and 9.2 HR) confirm the heterogeneity detected by the previous inspections. The Vickers data fall in the interval of 79 - 284 HV10 and have a mean value of 132 HV10. The Rockwell values span over a maximum of 79 HR and a minimum of 50 HR and have a mean value of 61 HR. The results show a good agreement with the microstructural findings: higher hardness values correspond to mostly pearlitic microstructure, while the lowest ones to mostly ferritic microstructure. Further details on the material characterization of tie-rods of Milan cathedral can be found in (Bellanova et al. 2015).

Figure 7. Contour plots of hardness tests on the investigated cross-section (sample B)
 (a) Vickers method, (b) Rockwell method

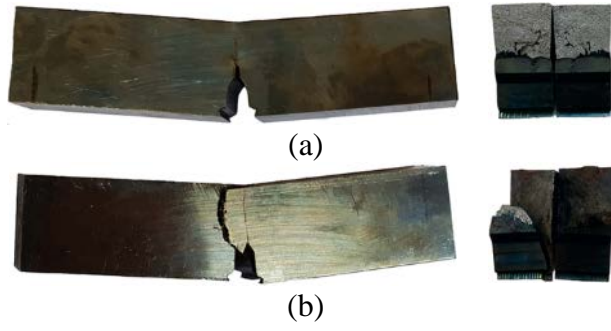
The observation of specimens after testing clearly confirms the experimental data. Samples including forged weld are nearly broken in two parts and crack propagation pattern is not straight but follows an inclined path, probably corresponding to the welding line (Figure 10a). On the contrary, in samples machined from base material crack propagated through a very limited portion of the thickness (Figure 10b).

Figure 10. SEB specimens and their fracture surface after toughness test,
(a) specimen of base material, (b) specimen including forged weld

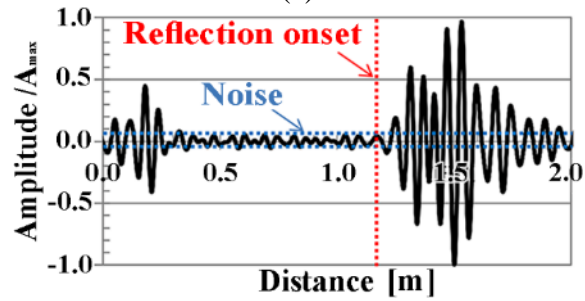
Nevertheless, the effectiveness of the method was evaluated by performing measurements at a known distance (i.e. 1.2 m) from the macroscopic defect of T02, which is a deep crack characterized by a maximum opening of about 1.5 mm. The achieved amplitude-distance plot is shown in Figure 13. A peak can be easily recognized at the distance corresponding to crack location and noise is fairly low (about the 5% of the peak amplitude). Despite of the not optimal test configuration, the results are promising.

Figure 13. Laboratory experimental investigations on guided waves method
(a) crack details, (b) wave amplitude-distance plot

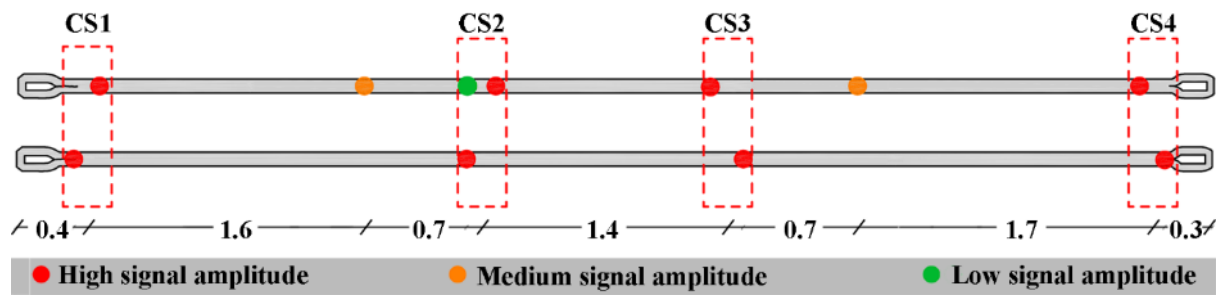
Figure 14. Discontinuities survey by using off-the-shelf spot probe

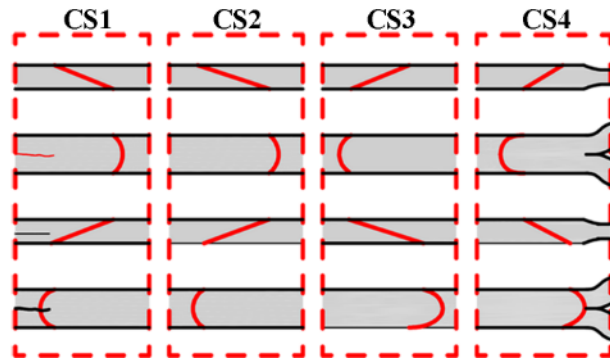
detecting dominant cracks in the tie-rods at issue. A penetration depth of about 15 mm was estimated experimentally (without considering the effect of the surface oxidation layer). The tie-rod T02 was inspected by scanning all its four sides. The achieved indications survey is shown in Figure 14. The results do not completely fulfill the test requirements because many indications were detected and the dominant defects cannot be recognized unambiguously. However in four regions, indicated as Critical Section (CS) in Figure 14, the recorded indications showed very interesting features: sharp and strong variation of impedance were identified along the whole width of at least three tie-rod sides. One of them is the region with the macroscopic crack leading to the tie-rod replacement. In order to validate the results of eddy current testing, Magnetic Particles Inspection (MPI) was carried out according to ISO 3059. It revealed at each CS position a continuous discontinuity over the whole perimeter having the typical forged weld shape, i.e. inclined at about 27° on the smaller sides and rather rounded on the larger ones (Figure 15).

Figure 15. Discontinuities pattern survey by using magnetic particles inspection

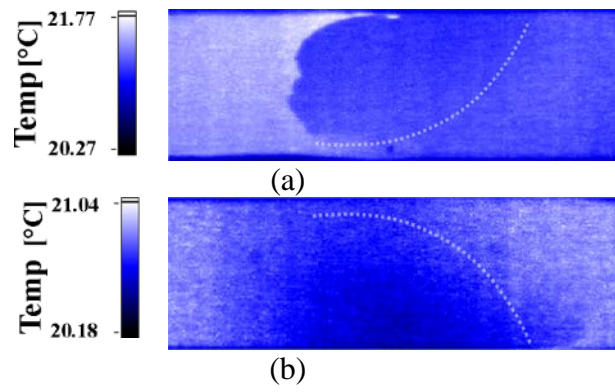
Figure 18. Experimental results of pulsed thermography, distribution of the maximum temperature T_{max} at the unexposed face of the tie-rod (a) emerging crack, (b) non-emerging crack

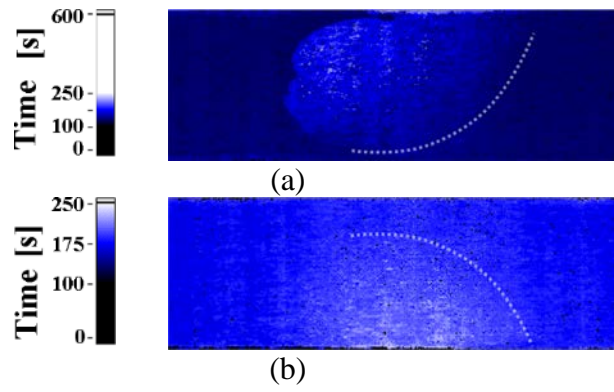
Figure 19. Experimental results of pulsed thermography, distribution of time $t_{T_{max}}$ corresponding to the maximum temperature T_{max} at the unexposed face of the tie-rod
(a) emerging crack, (b) non-emerging crack

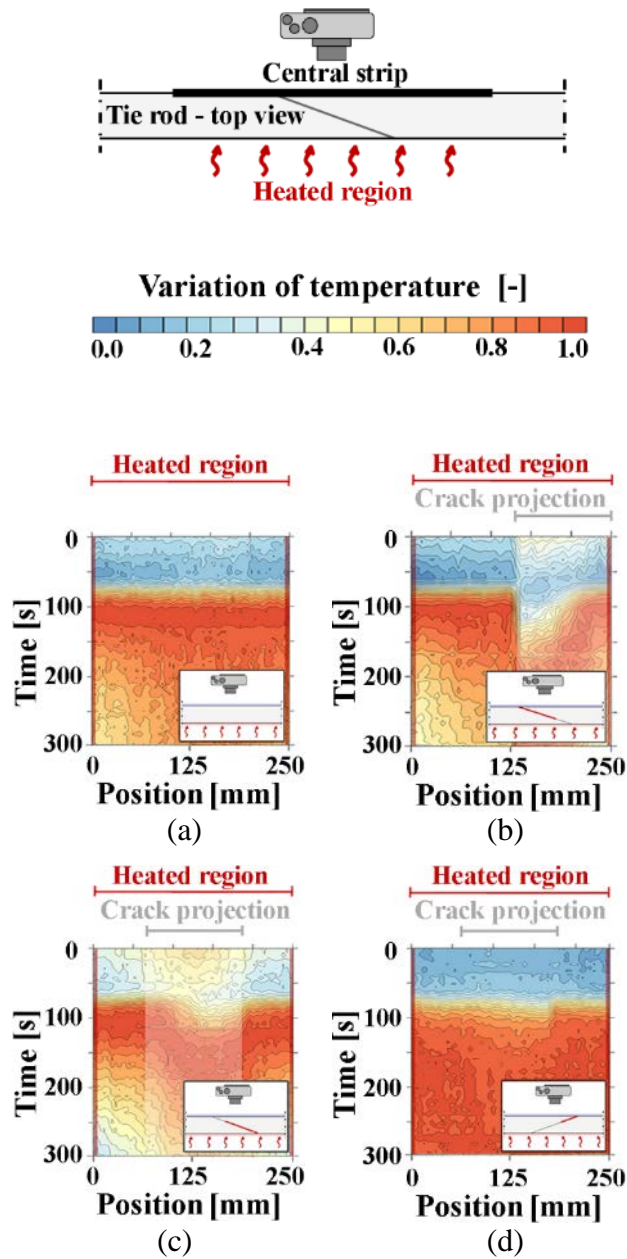
Numerical analyses were validated by performing experimental tests on the tie-rod T02 characterized by the visible crack. Along this element, four different conditions can be recognized after magnetic particle inspection: region without discontinuity, emerging macroscopic crack at forged weld, non-emerging macroscopic crack at forged weld, minor emerging crack at forged weld detected by eddy current testing. With the objective of avoiding the heat losses through the upper and lower sides of the tie-rod and to promote a planar heat flow, the setup shown in Figure 17 was arranged. The distributions of the maximum temperature reached at each point on the unexposed surface and of the corresponding time were used as indicators for the time analysis of thermograms. The plots pertaining to the region characterized by the macroscopic crack are shown in Figure 18 and Figure 19. As can be observed, the results are very effective both in emerging and non-emerging conditions. However, in the other examined regions, the same representation does not provide equally compelling outcomes. Clearer indications were obtained by plotting the evolution of the temperature variation along a central strip, as shown in Figure 20. Despite of the noise effects, the experimental results are in full agreement with the numerical analyses. A sharp discontinuity can be recognized in the plots corresponding to the emerging cracks. A stronger perturbation is associated to the macroscopic emerging crack (Figure 20b) whereas the isotherms slope at the welding joint including a minor crack is smaller (Figure 20c). On the contrary, a smoother variation is identified by taking thermal pictures over the surface where the crack does not emerge (Figure 20d).

Figure 20. Experimental results of pulsed thermography, variation of temperature along a central strip, (a) region without discontinuity, (b) emerging macroscopic crack at forged weld, (c) minor non-emerging crack at the forged weld, (d) minor emerging crack at the forged weld detected by ET

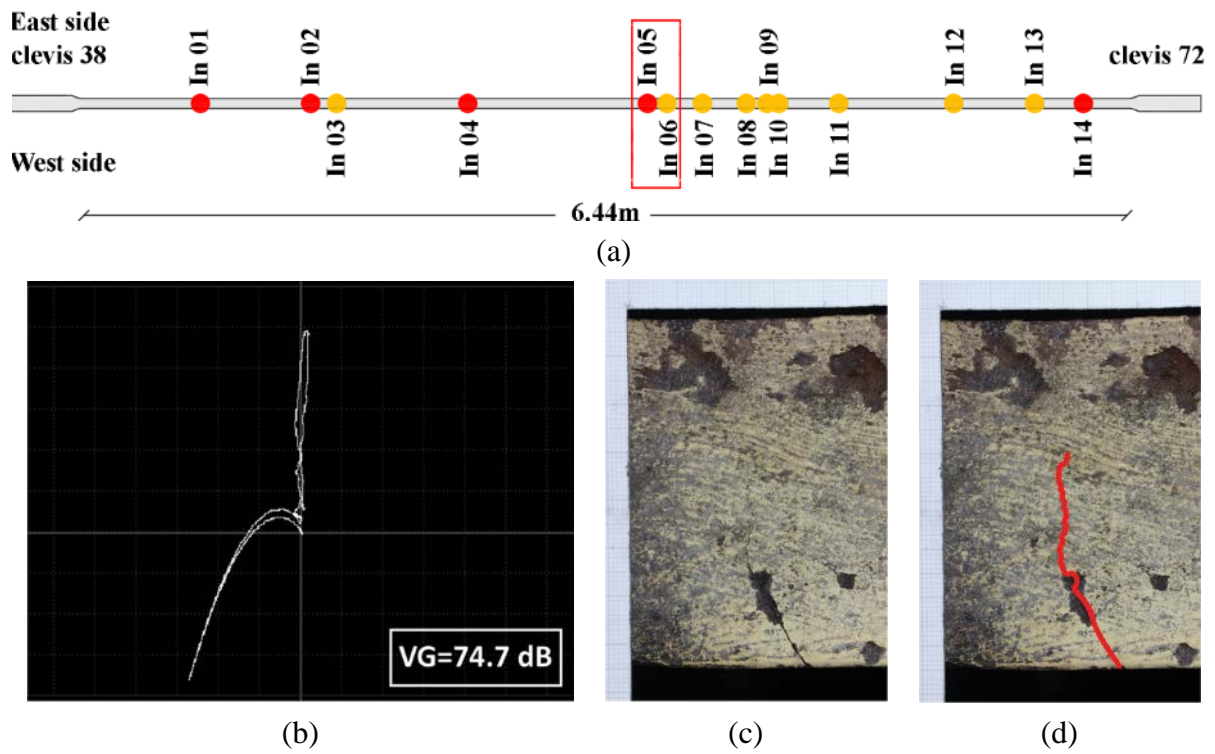
Among the examined elements, the most critical condition was recognized on the tie-rod T04 Figure 1. On this element, eddy current testing allowed the identification of 14 indications, whose amplitude was either medium or strong (Figure 22a). Based on geometrical requirements, three couple of indications could be associated to forged welds. The most critical region is defined by indications In05 - In06. Indeed, in both cases the signal amplitude is rather high and a distance of about 120 mm separates the two peaks. The latter is exactly the length

between the two ends of a forged weld inclined about 27°. As can be observed in the high resolution pictures (Figure 22b), the eddy currents signals correspond to a continuous crack over three sides, with a maximum opening of 0.25 mm (15 pixels), which has never been identified before. The results of the guided waves in the same area are shown in Figure 23. Despite of the quite high noise amplitude (about the 25% of the maximum peak amplitude), a clear peak can be identified at location corresponding to crack. However, it is worth noting that crack detectability is strongly influenced by crack dimensions, due to a quite dispersive behaviour of the diagnostic wave allowed by the adopted device.

Figure 22. Results on tie-rod showing the most severe condition (a) detected ET indication, (b) impedance plane at In05, (c) detailed picture at In05, (d) crack highlighting

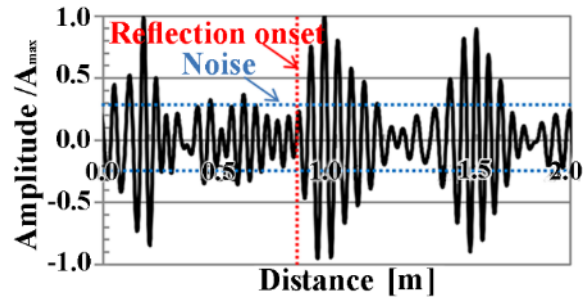
Figure 23. In-situ investigations on guided waves method (a) crack details, (b) wave amplitude-distance plot
