# The San Carlo Colossus: An Insight into the Mild Galvanic Coupling between Wrought Iron and Copper

**Abstract:** The San Carlo Colossus, known as *San Carlone*, is a monument constituted by an internal stone pillar support to which a wrought iron structure is attached. Embossed copper sheets are fixed to the iron structure to give the final shape to the monument. After more than 300 years of outdoor exposure, this statue represents an opportunity for an in-depth investigation of long-term galvanic coupling between wrought iron and copper. Most iron elements of the *San Carlone* appeared in good conservation conditions with scarce evidence of galvanic corrosion. In some cases, the same iron bars presented some portions in good conservation conditions and other nearby portions with active corrosion. The aim of the present study was to investigate the possible factors correlated with such mild galvanic corrosion of wrought iron elements despite the widespread direct contact with copper for more than 300 years. Optical and electronic microscopy and compositional analyses were carried out on representative samples. Furthermore, polarisation resistance measurements were performed both

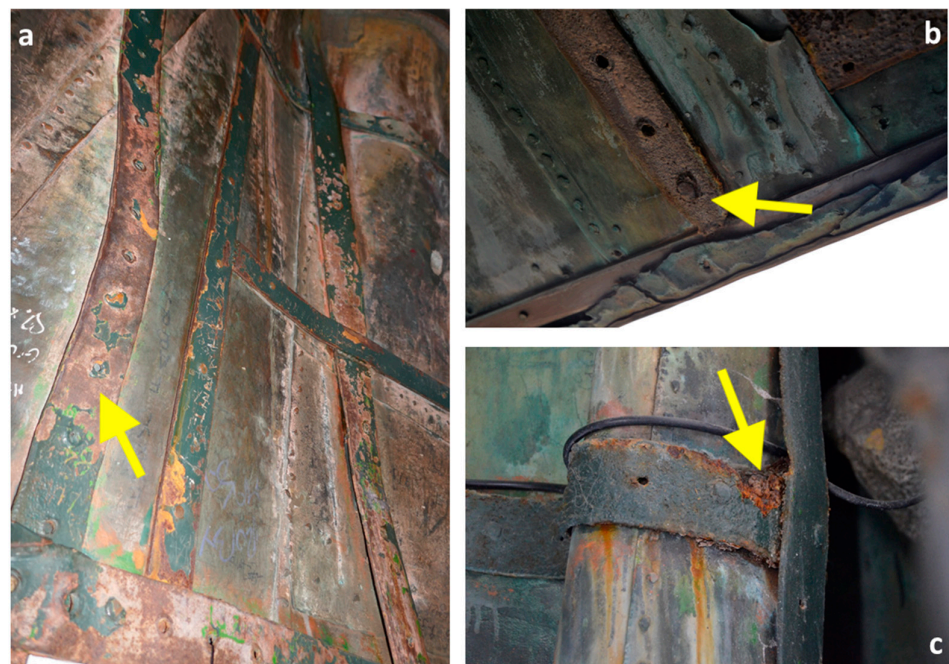
It has been reported that in a previous restoration, a protective coating was applied [1–3]. However, this coating is nowadays heavily deteriorated with large portions of the iron surfaces directly exposed to the atmosphere. The *San Carlone* statue, therefore, should be prone to galvanic corrosion. However, upon visual inspection of the monument, most iron elements of the Colossus appeared in quite good conservation condition despite the general degradation of the protective coating (Figure 2a) with scarce evidence of galvanic corrosion. In contrast, active corrosion of the iron elements was observed regardless of their direct contact with the copper sheets. In some cases, the same iron bars presented some portions in good conservation conditions and other nearby portions with active corrosion (Figure 2b,c).

**Figure 2.** Examples of degradation patterns on iron elements. (a) Iron bars in good conservation conditions despite the degradation of the protective coating; (b,c) small areas characterised by severe corrosion surrounded by almost intact zones.

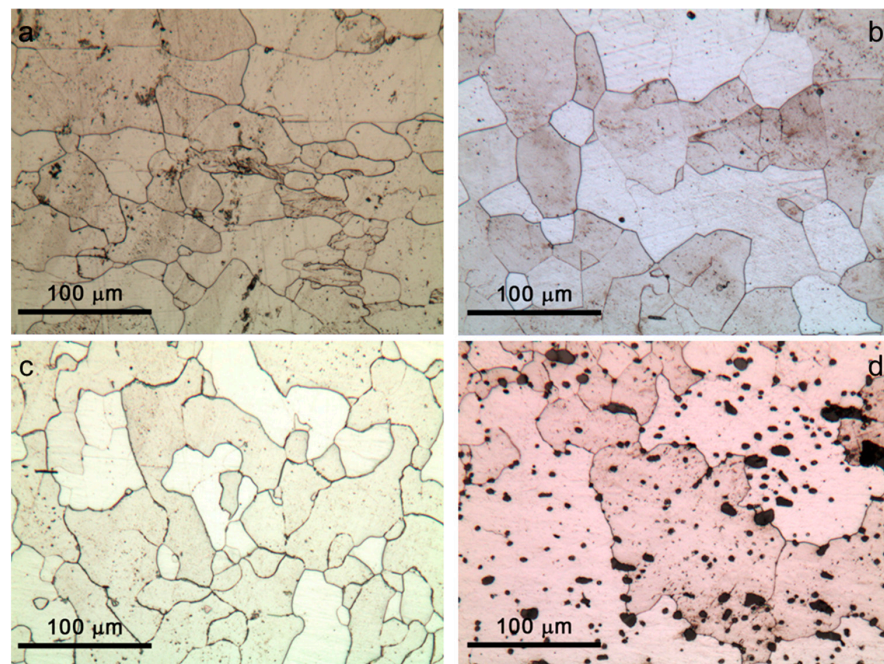
In Figures 4 and 5, images of the microstructures observed in a cross-section of iron samples from the Colossus are reported (bulk in Figure 4, outermost zones in Figure 5). It has been observed that different areas of the samples presented slightly different carbon content and different microstructures, as could be expected for historical iron samples [13,40,41]. Moreover, the predominance of ferritic structure can be observed. In general, the core of the samples from the Colossus showed a ferritic microstructure with coarse grains ranging between about 10 and 100  $\mu\text{m}$  (Figure 4a–c). However, the microstructure of wrought iron samples was not homogeneous. Ferritic–pearlitic microstructures were observed (Figure 5) in discontinuous areas near the surface or at the outer edge of the samples. Moreover, other microstructural heterogeneities were observed across the surface of the polished samples. In Samples 44 and 87 (Figure 5a,c), the ferrite grains showed a rounded shape, and their dimensions became smaller (up to 10  $\mu\text{m}$ ) on going from the bulk towards the surface. In Sample 46, the ferrite grains in ferritic–pearlitic areas just below the surface showed a Widmanstätten structure (Figure 5b) [42] with the exception of the most superficial area (about a couple of  $\mu\text{m}$  thick) where ferrite with small and round-shaped grains became predominant again. In hypoeutectoid steels such as those investigated here, Widmanstätten structures may form mainly through rapid cooling combined with coarse prior austenitic grain size (leading to an insufficient number of nuclei for conventional proeutectoid ferrite crystallization) [42–44]. The abovedescribed microstructural heterogeneity in these samples can be ascribed to surface carburization/decarburization cycles during the hot forging process, typical of wrought iron produced in the reference period for this statue [40]. The Widmanstätten structures detected in bands parallel to the outer surface are probably due to localised fast cooling during the forging cycles. Moreover, the puddled iron reference sample showed a banded structure with the alternation of ferritic areas with grain size ranging from  $\sim 100$   $\mu\text{m}$  (Figure 4d) to  $\sim 10$   $\mu\text{m}$  or lower (Figure 5d). In particular, such a

**Figure 4.** Microstructure observed by optical microscopy in the cross-sections of iron samples from the *San Carlone* and on the reference sample of puddled iron after etching with Nital2. Images of the Sample core: (a) Sample 44—slightly corroded sample in contact with copper; (b) Sample 46—slightly corroded sample not in contact with copper; (c) Sample 87—heavily corroded sample in contact with copper; and (d) Sample A—reference sample of puddled iron.

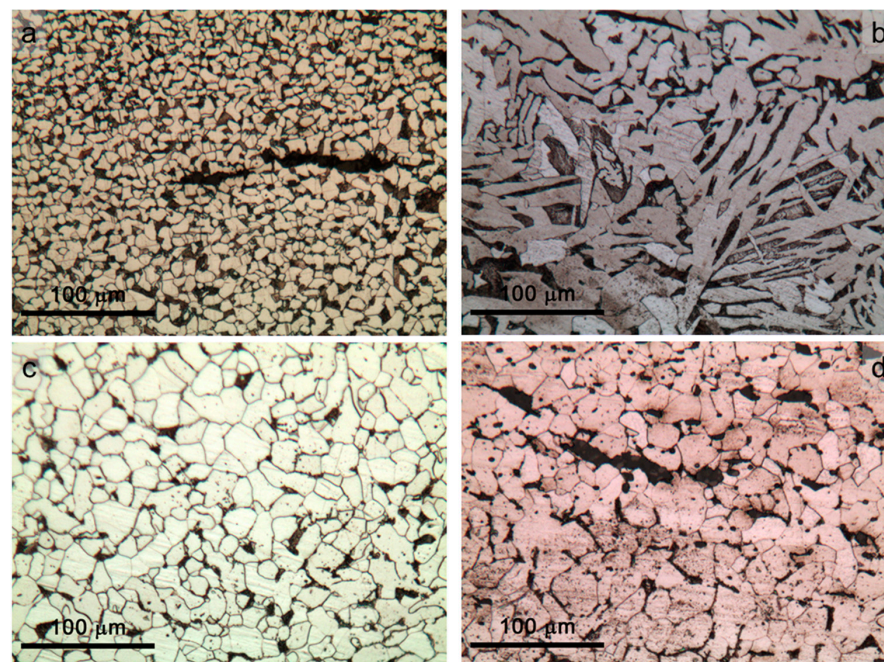
**Figure 5.** Microstructure observed by optical microscopy in the cross-sections of the iron samples from the *San Carlone* and on the reference sample of puddled iron after etching with Nital2. Outermost areas of the samples: (a) Sample 44—slightly corroded sample in contact with copper; (b) Sample 46—slightly corroded sample not in contact with copper; (c) Sample 87—heavily corroded sample in contact with copper; and (d) Sample A—reference sample of puddled iron.

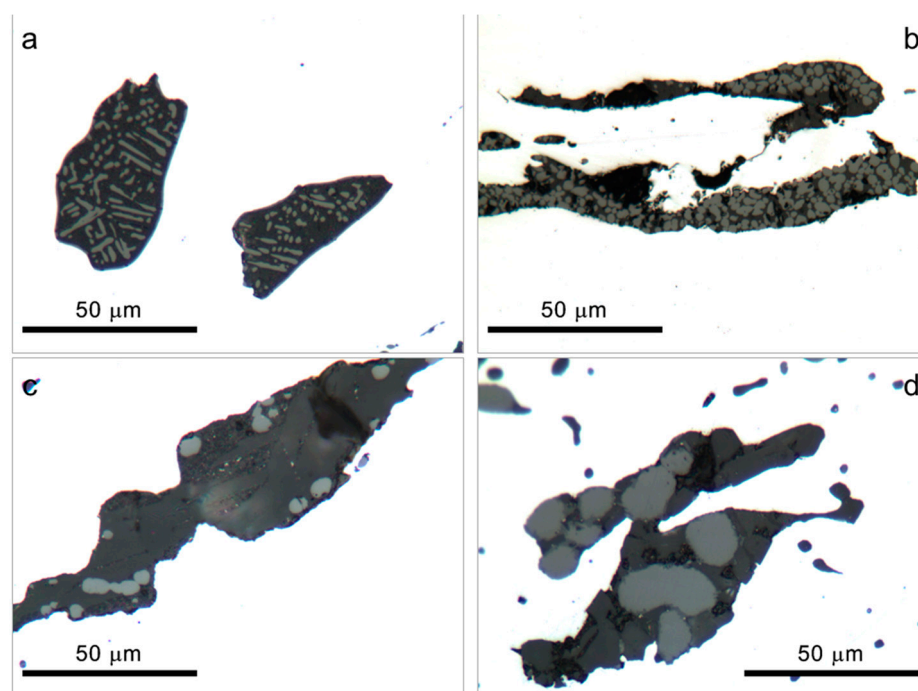
For historical wrought iron, the corrosion and mechanical behaviour of the metal is strongly influenced by the amount, dimensions, orientation, and composition of the slag inclusions [13,23,39,45,46]. In general, for historical irons, the presence of a high number of inclusions with strongly variable dimensions is expected [13,40,45]. Inclusions are typically constituted by a glass matrix of fayalite ( $\text{Fe}_2\text{SiO}_4$ ) with wüstite ( $\text{FeO}$ ) crystals [13,39] and are usually arranged in parallel bands due to forging [39]. Both in samples of *San Carlone* and on the reference A sample (puddled iron), slag inclusions with dimensions ranging from about 50  $\mu\text{m}$  to millimetric dimensions (Figure 6) were present. Moreover, in Sample A, smaller etching pits, typical of phosphorus-rich irons [39], could be observed (Figure 6d). In all the samples, small crystals (light areas) are visible in a glass matrix (darker areas in Figure 6) with the typical fayalite-wüstite structure confirmed by micro-Raman spectroscopy.

**Figure 6.** Inclusions observed by optical microscopy on nonetched cross-sections of the *San Carlone* iron samples and the reference sample of puddled iron. (a) Sample 44—slightly corroded sample in contact with copper; (b) Sample 46—slightly corroded sample not in contact with copper; (c) Sample 87—heavily corroded sample in contact with copper; and (d) Sample A—reference sample of puddled iron.

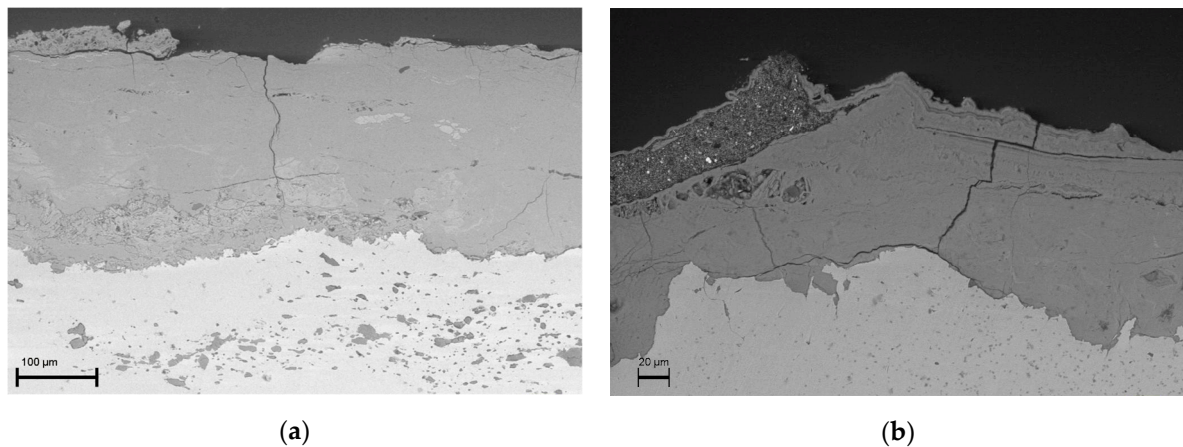
Corrosion products of the areas adjacent to Samples 44 and 46 looked compact and highly adherent to the surface. They were characterised by a dark brown-blackish colour. Sample 87 was a small lamina of iron surrounded by a thick layer (>1 cm) of reddish-brown corrosion products that peel off and disintegrate easily and that detached during sampling. When investigated by SEM/EDX, all samples presented a compact and adherent corrosion layer (Figures 7 and 8). EDS X-ray maps in Figure 8d also revealed some remnants of a Pb-containing antirust paint layer (the so-called “red lead paint” which was frequently used a few decades ago) above the corrosion products on the surface of Sample 87.

**Figure 7.** SEM images of Samples 44 (a) and 87 (b).

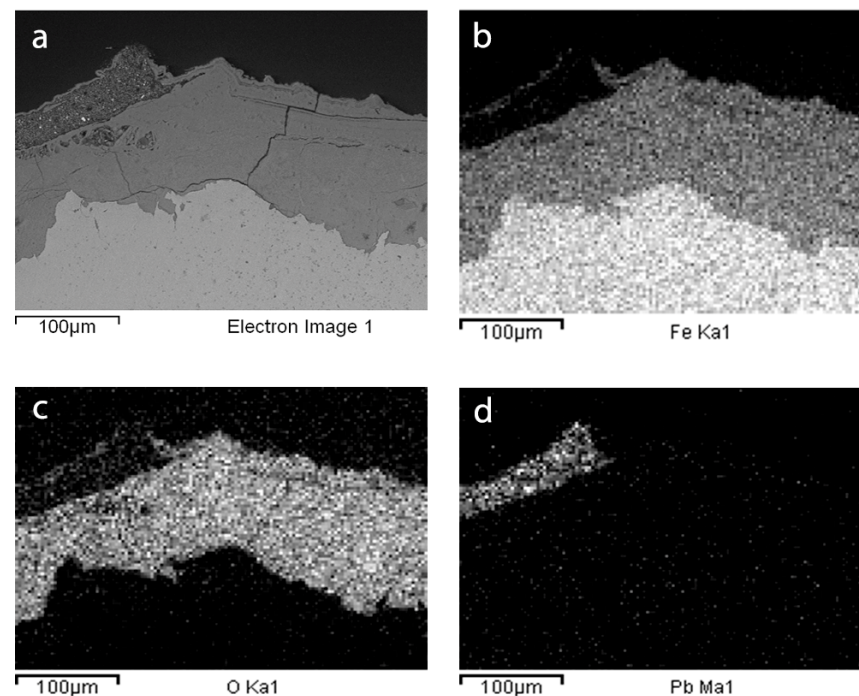
**Figure 8.** EDX maps of Sample 87 (a) Electron Image, (b) Iron Ka1, (c) Oxygen Ka1, and (d) Lead Ma1.

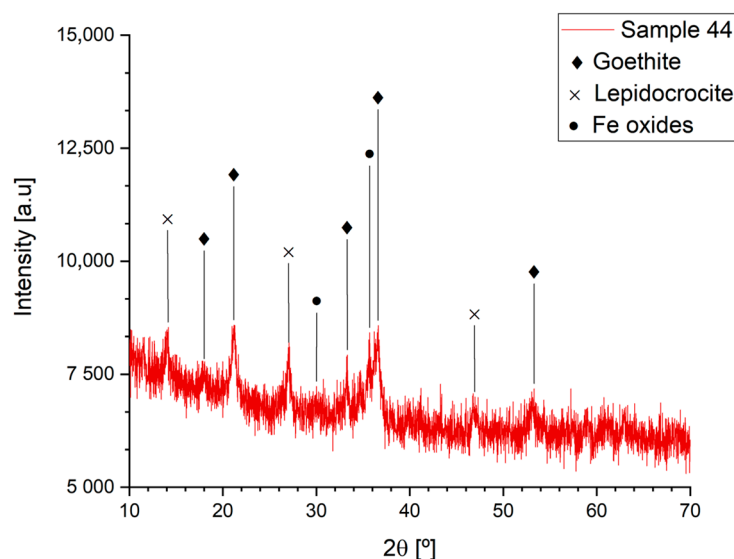
**Figure 9.** XRD analysis of sample 44.

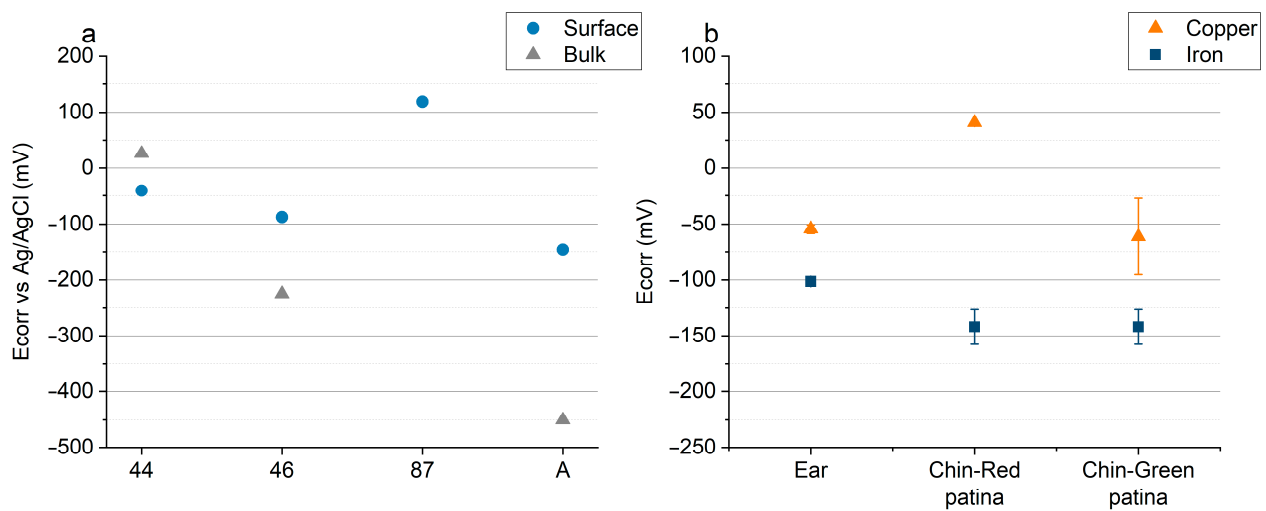
Figure 10a shows the  $E_{\text{corr}}$  values measured in the laboratory on the surfaces and polished cross-sections of the iron samples from the Colossus and on the reference sample A. On Sample 87, only surface measurements could be performed due to its very small dimensions. The bulk of Samples 44 and 46 show a more noble potential (25 mV and −225 mV vs. Ag/AgCl) with a  $E$  of +475 mV and +225 mV, respectively, with respect to the puddled iron ( $E_{\text{corr}} = -450$  mV vs. Ag/AgCl). Moreover, the corrosion potentials measured on the surfaces of such samples are quite noble. Surprisingly, the highest value (+120 mV vs. Ag/AgCl) has been measured on the surface of the most corroded sample (87). Interestingly, the difference in corrosion potential between the surface and bulk alloy of Samples 44 and 46 is very low and significantly lower than the one measured on the reference sample A. Figure 10b shows the results of on-site  $E_{\text{corr}}$  measurements in the statue on adjacent copper and iron surfaces. In this case, all the iron bars appeared slightly corroded but were covered by compact corrosion layers adherent to the surface. The potential difference between the two surfaces never exceeded 200 mV, and in two cases out of three, it was lower than 100 mV. The three iron fragments from the Colossus and the reference sample A were electrochemically characterized by measuring the polarization resistance of their surfaces with LPR and EIS. Nyquist plots of Sample A (surface) and Sample 44 (section) are reported in Figure 11a,b, respectively. Average  $R_p$  values (Figure 12) were higher than  $30 \Omega \cdot \text{m}^2$ . The surfaces of Samples 44 and 87 resulted in the least resistance to corrosion. Sample 46 and the reference sample A showed  $R_p$  values higher than  $150 \Omega \cdot \text{m}^2$ , suggesting a good corrosion resistance.

**Figure 10.** Corrosion potential ( $E_{corr}$ ) measured on surfaces of the *San Carlone* with a Ag/AgCl reference electrode. (a)  $E_{corr}$  measurements on the surfaces and the polished cross-sections of iron fragments; (b) on-site  $E_{corr}$  measurements on adjacent copper and iron surfaces.

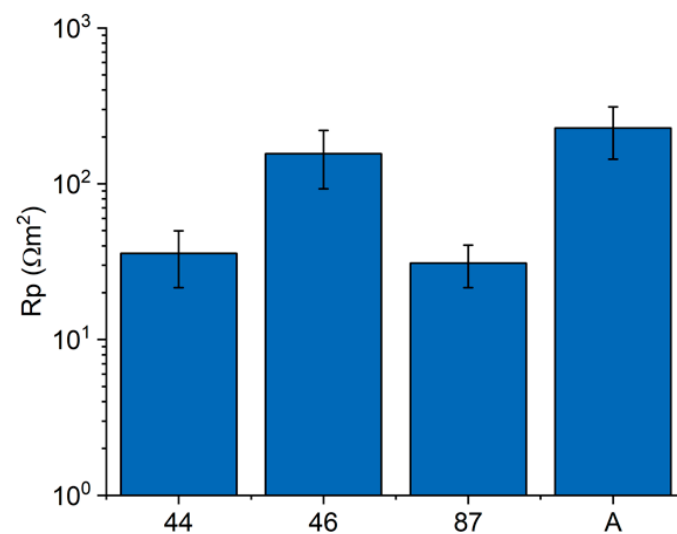
**Figure 12.** Polarization resistance measurements on iron fragments from the *San Carlone* of Arona.

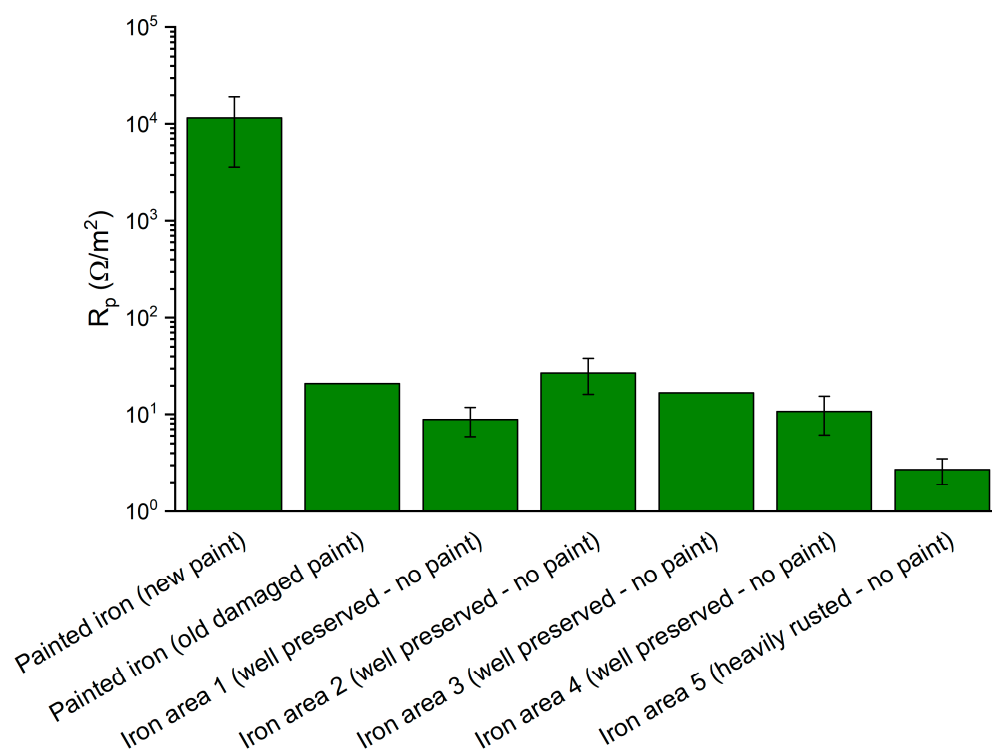
The  $R_p$  measurements, performed in situ, of different iron elements of the *San Carlone*, characterised by different conservation conditions are displayed in Figure 13. Only a few areas were characterised by the presence of a protective coating (“painted iron-new paint”), while most areas were characterised by a fairly good conservation condition despite the lack of paint (“well preserved”). These “well preserved” areas showed  $R_p$  measurements similar to the ones obtained from the fragments analysed in the laboratory, suggesting a relatively low corrosion rate. Rusted areas (“heavily rusted”) were those showing the lowest polarisation resistance.

**Figure 13.** In situ polarization resistance measurements on iron elements of the *San Carlone* of Arona.
