XIX ANIDIS Conference, Seismic Engineering in Italy

Seismic Assessment of Typical Historical Masonry Churches in Banat region, Romania - Part I

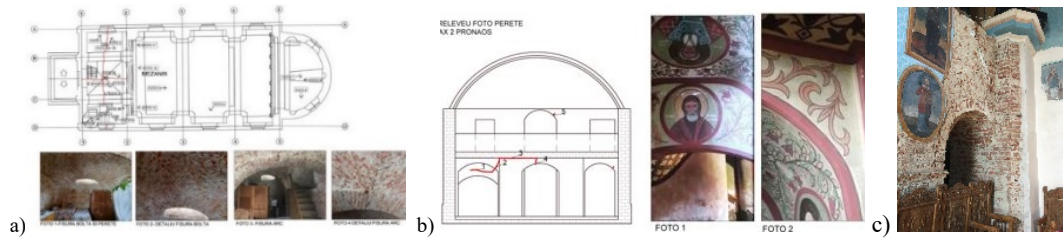
As for the current state of the churches the description of each structural part will be treated separately. For the foundations in all cases, they are continuous under the masonry walls, one made from stone masonry and the other of brick masonry, with mortar. All buildings present vertical cracks near the windows on the outside of the façade as presented in Fig. 5a for Beregsau Mare, Fig. 5b for Chizatau church and Fig. 5c for Birda church.

Fig. 5. Structural damages identified on interior walls for: a) Berégsau Mare church; b) Chizatau church; c) Birda church

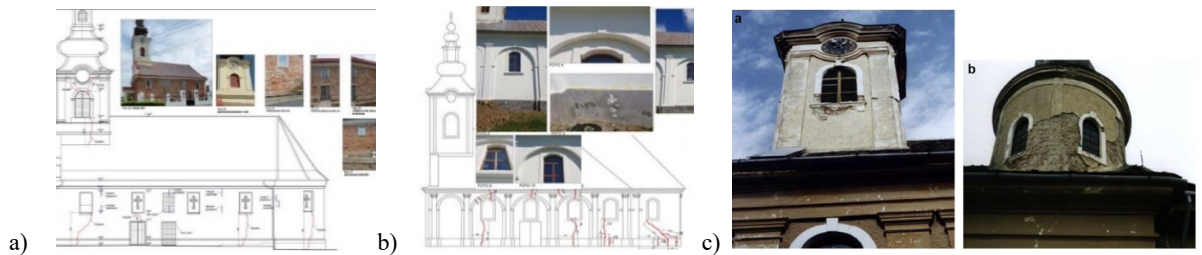
Inside the Beregsau Mare church, cracks were identified between the longitudinal walls and the altar wall, at the arches of the narthex balcony and cracks in the narthex vault have been identified (Fig. 6a). For Chizatau church cracks were identified between the tower walls and the longitudinal walls as presented in Fig 6b.

For Birda church, which was close to the epicenter, by examining the positions of the cracks after the earthquake in 1991, the followings damages were found: the East tower has the upper closure in a vault made of bricks and has no significant cracks, the West and East towers present diagonal cracks characteristic to seismic actions and horizontal cracks due to torsion at the level of the windows (Fig. 6c). The largest cracks are developed in the eastern wall next to the altar because it is situated furthest away from the center of rigidity. (Mosoarca M., 2013)

Fig. 6. Structural decay: a) in Berégsau Mare; b) in Chizatau; c) diagonal cracks and horizontal cracks in Birda (Mosoarca M., 2013)

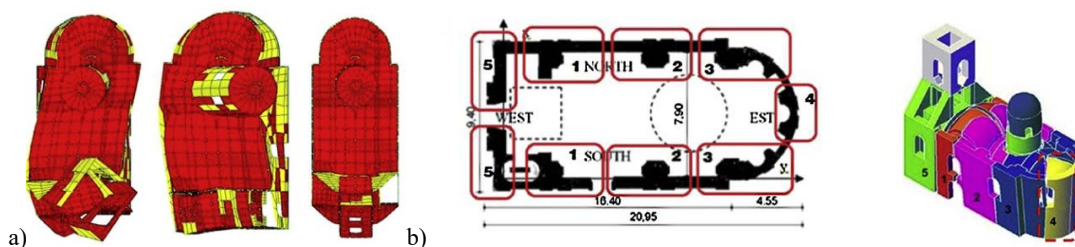
The main vibration periods are presented in Fig. 9a for translation in transversal and longitudinal direction and for torsion. In the analyses of seismic behavior of Church of St. Gheorghe Birda, Timis County, Romania, based on the theory of transfer mechanisms, the church was divided into five rigid blocks according to the observations of cracks recorded after 1991 earthquake in the Banat area. Transfer blocks are shown in Fig. 9b.

Fig. 9. a) Main vibration periods; b) Rigid blocks division for analysis.

Because the greatest damages were recorded in the nave and apse altar, a special attention was given to these areas. The analysis predicts that the ultimate limit state will be achieved by the collapse of block 4, which will collapse before blocks 2 and 3. This damage is confirmed by the biggest masonry rupture of the apse area after the 1991 earthquake. The torsion appears due to the large distance between the mass center (MC) and the rigidity center (RC) and the big difference between the rigidity in the nave and narthex. The main vibration periods are presented in Table 2. for translation in transversal and longitudinal direction and for torsion for all three churches.
