MODELLING AND EFFECTS OF SEISMIC IMPROVEMENT INTERVENTIONS ON CHURCH ROOFS

3. The Centro-Italia earthquake of 2016 and the church of S. Martino dei Gualdesi

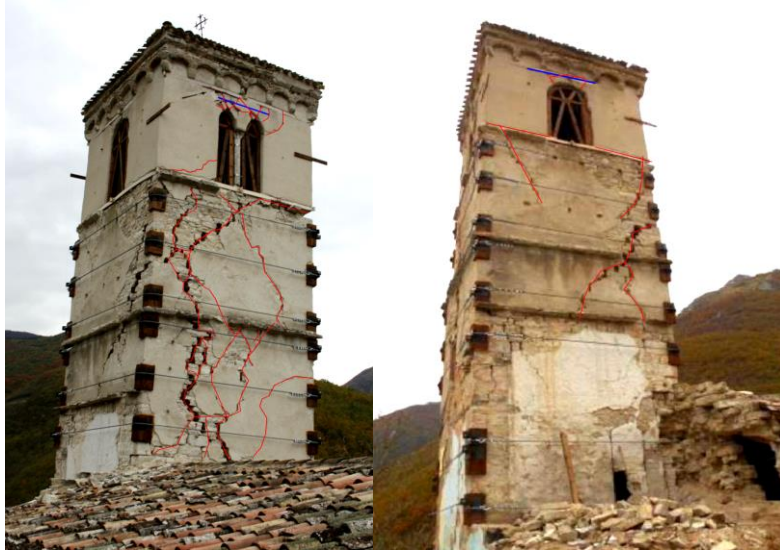
The arrival of the 2016 sequence, thus, found the presence of several different interventions on masonry walls, on arches and on the bell tower. Damage occurred during the 2016 sequence, consequent to the high level of acceleration reached, extended to different parts of the church, primarily the internal arches, the perimeter walls and the bell tower. Cracks were deep, but without loss of stability, contained by the interventions previously performed. The bell tower was cracked as in figure 7.

Figure 7. Damage to the bell tower: west and east side (Da Porto & Modena, 2020).

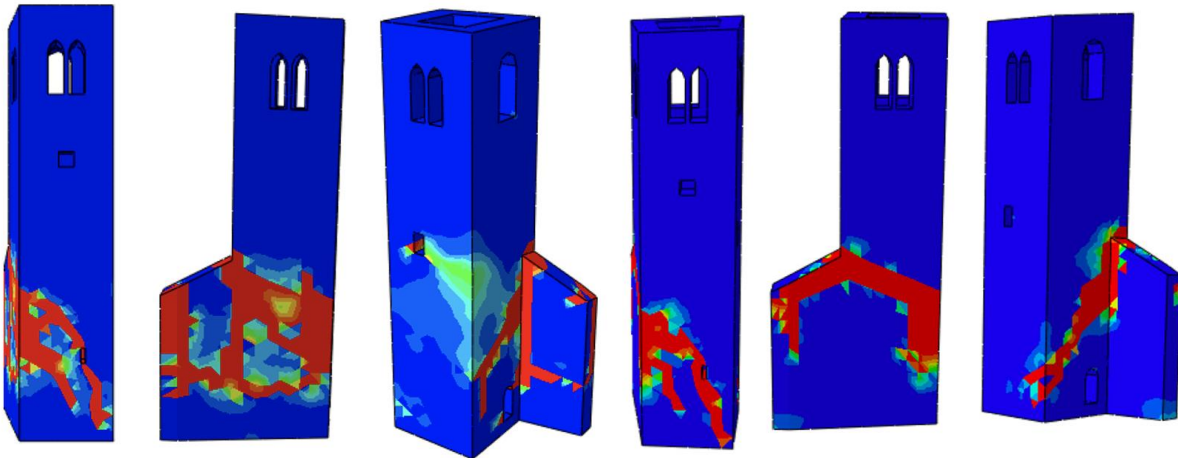
Results may be seen in the damage maps in figure 11. For the lighter roof system, model 1, damage has spread on most of the connecting wall between church and bell tower, in correspondence of the apse and at the intersection with the nave walls. Cracks propagate on the south side diagonally, reaching the opening in the wall, while on the north side a vertical crack runs along the wall separating the church and the bell tower from the presbytery. On the same side a diagonal crack extends from the base to the opening in the east wall. Results for model 2 indicate diffused damage at the connection areas between roof cover and west wall and again at the junction with the nave. In both cases, no damage appears at the bell tower top, whereas it has occurred during the earthquake. This may derive from the situation of the masonry in the bell tower, previously damaged, repaired and strengthened with reinforcement bars, which could not be detailed in this model.

The crack pattern obtained numerically and that observed for the present roof case are compatible. Yet, for a more precise assessment of effects, a quantitative measure of damage has been developed making reference to the displacement of the tower top relative to the base during motion and to the residual displacement after motion. The amount of residual displacement may be assumed as a measure of plasticization. Figures 13 and 14 report the development of displacements for model 1 (lighter roof), and model 2 (heavier roof), in the longitudinal and transversal direction. The pictures show an important difference in the two results: the lighter roof develops a milder plasticization in the bell tower, with a particularly low residual displacement in the transversal direction. The heavier roof clearly corresponds to a greater permanent damage of the structure. The result confirms the negative influence of heavy roof solutions observed in several damage situations. A similar analysis performed on the previously mentioned church of S. Salvatore, which had undergone the same history of earthquakes and a comparable series of interventions, yielded corresponding results.

Figure 11. Damage development and distribution in model 1 (timber roof), first three images from left and model 2 (concrete slab) second three from left; for each case, South, West and North-East views are shown.
