Investigation of failure and damages on a continuous casting copper mould

Silvia Barella ^{*}, Andrea Gruttadauria, Carlo Mapelli, Davide Mombelli

Politecnico di Milano, Dipartimento di Meccanica, Via La Masa 1, 20156 Milano, Italy

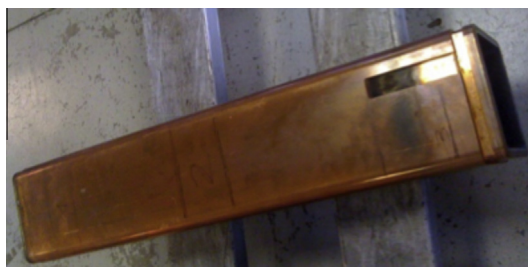
The examined mould showed significant damage approximately 110 mm from the mould top, at the meniscus level. This damage was even detectable from the external mould side, where the copper mould assumed a colour typical of high

Fig. 2. Failed square mould.

temperature exposure. The visual examination suggested that the temperature had reached 350 °C (Fig. 2). Furthermore, the inner portion of the mould (coated with chromium) had a non-homogeneous surface.

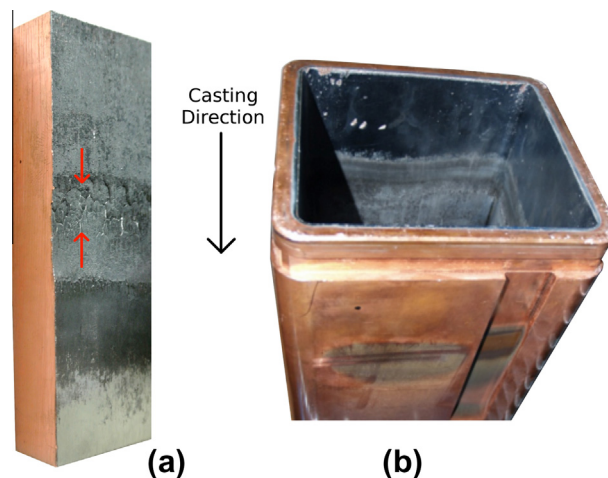
For the in-depth examination along the width of the mould wall, samples were cut from the mould. On the hot face of the mould, a black strip was detected. Many cracks were also visible in this zone: these cracks were aligned along the mould axis (red arrows in Fig. 3). The black area seemed to be constituted by a layer of iron oxide, obtained at a high temperature. In the sample section, a 20 mm eroded region was detectable on the entire surface. The groove was deeper than the chromium plate and this indicated that it was not only due to the chromium wear but also due to the copper erosion as a result of steel percolation through the crack.

Fig. 3. Damaged mould, the external side assumed a characteristic colour different from its original featuring the entire mould (a) and damaged inner mould side featured by chromium plate removal and cracks (b). (For interpretation of the references to colour in this figure legend, the reader is referred to the web version of this article.)

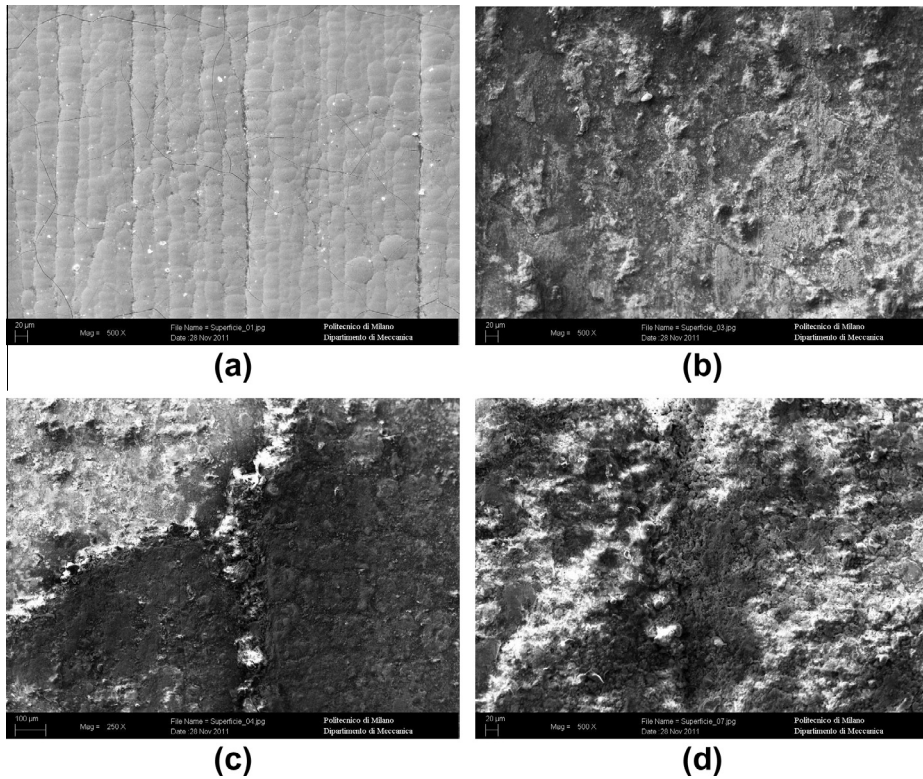
The SEM analysis was performed on the damaged surface to detect its chemical composition. Investigations were performed on both the damaged surface and the undamaged zone. At high magnification, the undamaged zone aspect (Fig. 5a) was typical of a chromium plate, but some cracks were detectable. These cracks were typical of the chromium deposition process and had been exaggerated by the thermal stress created by the steel casting working conditions [12,13]. In particular the hardness and, as a result, resistance to erosion were decreased. This erosion could potentially cause the complete depletion of the coating. Fig. 5b–d show the damaged area, where the chromium plating is completely removed and the surface aspect is rough.

According to the chemical composition analysis (Table 1) the chromium plating was intact in the upper part of the mould (undamaged zone), because it contained a chromium concentration near 100%. The damaged areas were found to be contaminated by many elements contained in the liquid steel, i.e. silicon, manganese and sulphur; moreover, the EDS revealed a significant concentration of zinc in these zones. Zinc is introduced into liquid steel by scrap but it eventually evaporates during melting and secondary steelmaking operations. However, when zinc is dissolved in liquid steel during casting, and plate damage occurs, this element tends to form a brass-type alloy (γ type) within the copper mould. This brass formation reduces the mould toughness along with its physical (thermal and electrical conductivity) and chemical properties (liquid metal corrosion resistance) [14–20].

Fig. 5. SEM investigation on undamaged (a) and damaged zones (b-d).

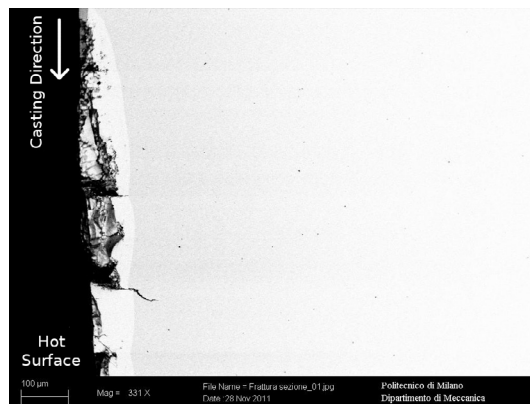
The SEM analysis performed on the cross section showed a brass layer on the hot face of the mould (Fig. 6 and Table 2). Many cracks were detected but two of these appeared more pronounced. The first was 2.2 mm long (Fig. 7a) and the

Fig. 6. SEM investigation on the section of the damaged zone.

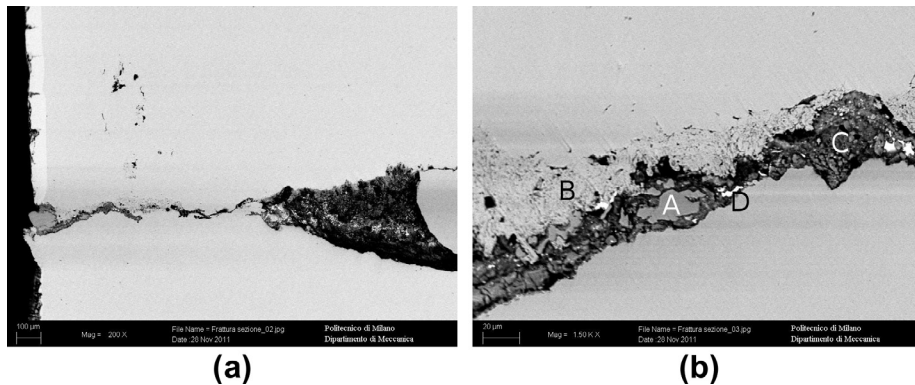
**Fig. 7.** SEM investigation on the section of the damaged zone, crack detail.

surrounding areas seemed recrystallized (Fig. 7b). In addition to zinc, many other residual impurities (i.e. Fe, S, and Pb) were detected in the crack due to the liquid steel infiltration (Table 2).

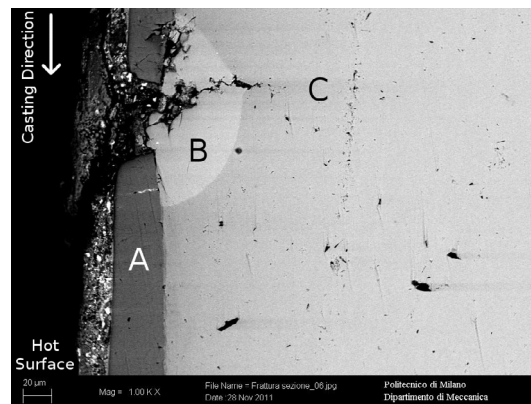
**Fig. 8.** SEM investigation on the section of the damaged zone, crack detail.

The crack shown in Fig. 8 displayed an interesting brass layer formation due to chromium plating damage, which was a consequence of the zinc diffusion in the copper matrix. The variation of the concentration profile (Fig. 9) provided for good identification of the layer's chemical composition in the undamaged (a) and damaged zones (b).

The observed damage is very dangerous because it can cause the continuous casting machines to breakdown. For this reason, Zn concentration of the cast steels must be reduced in order to avoid this detrimental phenomenon, given that intrinsic chromium cracking, thermal stresses and the related coating erosion could not be avoided.

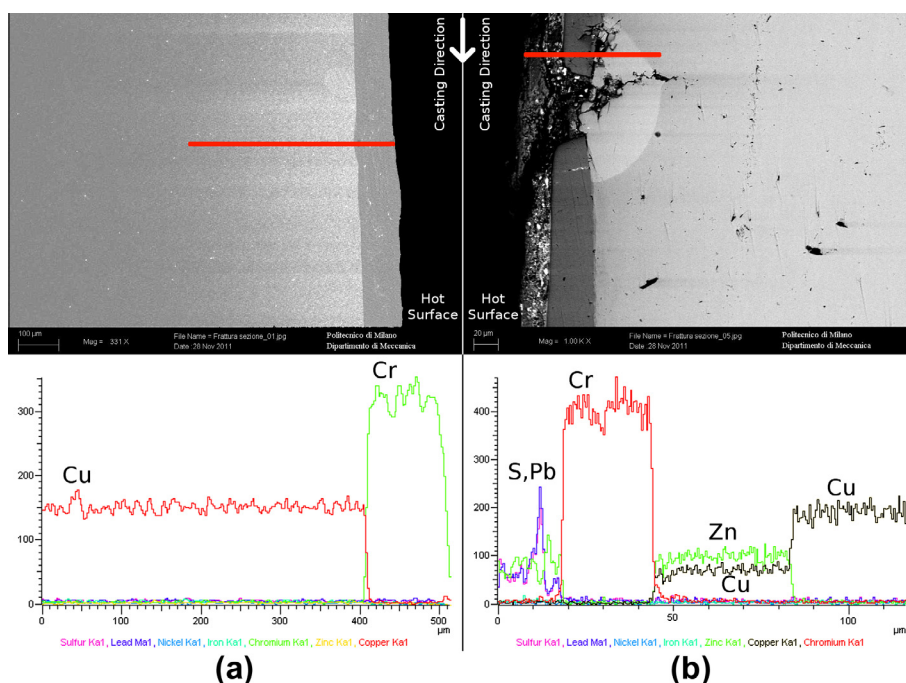
Fig. 9. Elements concentration profiles (a) on the undamaged and (b) the damaged zones (linescan were performed on the red line). (For interpretation of the references to colour in this figure legend, the reader is referred to the web version of this article.)

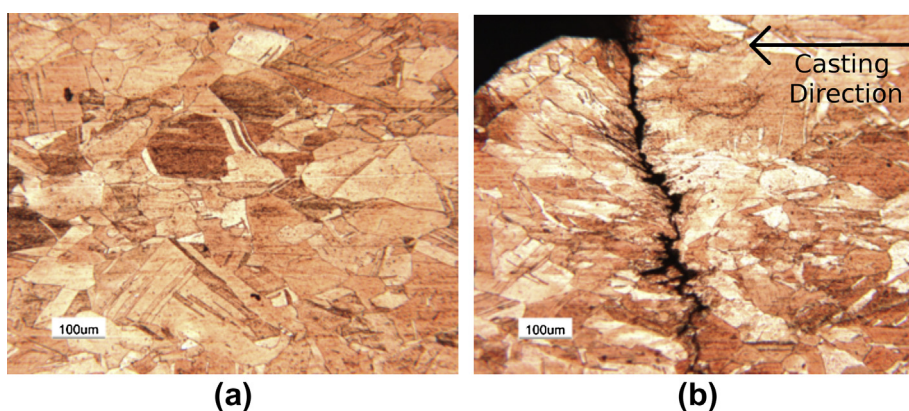
Fig. 10a displays the microstructure of a sample taken far from the damaged zone: the average size of the grain is roughly 100 µm. Many other observations were performed on the sample obtained from the damaged zone (Fig. 10b). The grains were finer than in the undamaged zone and the cracks propagated along the grain boundaries (intergranular fracture).

Fig. 10. Microstructure on (a) the mould central zone and (b) on the damaged zone.

The microstructure seemed to have undergone a recrystallization process near the crack because of the small grain size [21]. Moreover, in some areas, the copper appeared melted due its contact with the liquid steel.

The grain size measurement (ASTM E112-96 (2004)) confirmed the recrystallization hypothesis: the G number was approximately 5.2 in the undamaged zones and roughly 7.1 in the damaged areas.

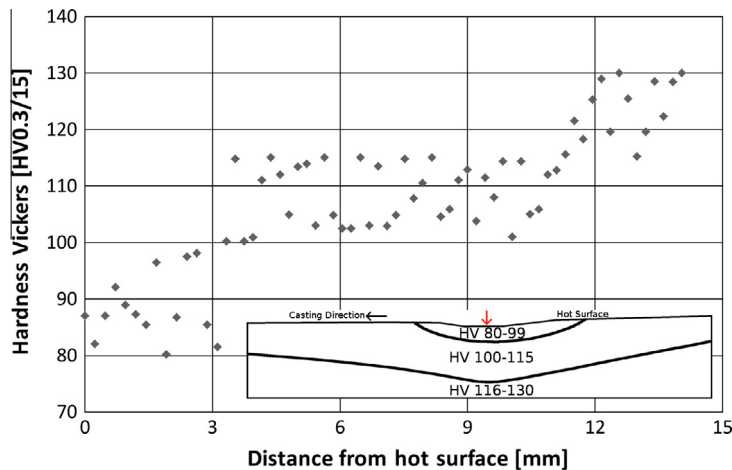
Finally, micro-hardness tests allowed for a better understanding of the extension of the thermal-affected mould zone due to the liquid steel infiltration (Fig. 11). The area near the damage showed the lowest hardness number (80–90-HV) due to a static recrystallization phenomenon followed by the grain growth. Instead, the outer part of the mould showed the typical hardness value for this kind of work-hardened copper (115–130 HV) [17,19]. Between these two regions the heat-affected zone could be identified as the zone characterized by intermediate hardness numbers (100–115 HV). This indicated that the recrystallization phenomena had taken place. The work hardened material retained energy in the form of lattice defects and the driving force for recrystallization was this stored energy. The heat given off from the high temperatures of the liquid phase provided the thermal activation energy needed to transform the material to a lower energy state, through a diffusion process. As the internal lattice strains were relieved during annealing, the hardness decreased [22].

Fig. 11. Micro-hardness profile along the cross section of the mould near the damaged zone and schematic representation of the micro-hardness trend. Red arrows indicate the initial site of the profile.
