Article

Between Safety and Conservation—Procedure for the Assessment of Heritage Buildings Based on Historic Research

The procedure is implemented on the Arengario (Figures 1 and 2), the 13th-century Town Hall of Monza, representing the main symbol of the Commune Age of the city. Over the centuries, the building has been transformed several times due to the changes in its

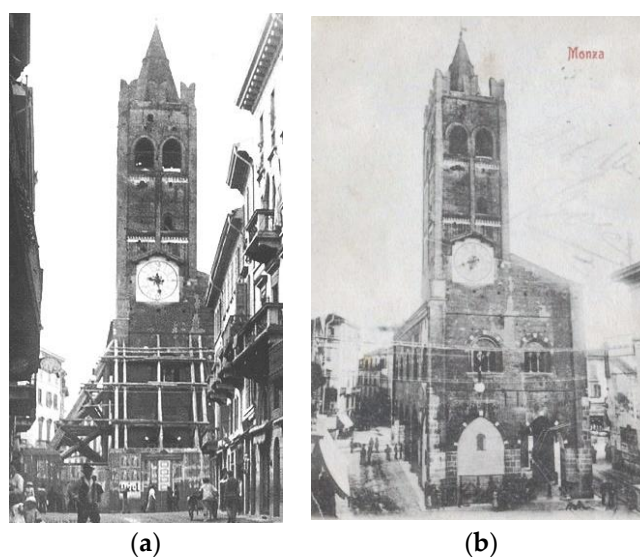
In December 1881 [48], serious damages to the columns supporting the tower—particularly on the north and east sides—raised concerns (Figures 5 and 6). A technical committee was appointed and composed of Archimede Sacchi—one of the first professors of the Politecnico di Milano—and Giovanni Ceruti. Due to the extensive historical documentation analyzed, the monograph by Sacchi and Ceruti [48] remains today the foremost source for studying the Arengario.

The committee promptly installed a shoring structure (Figure 5a) to support the four arches supporting the tower, the arch between column E (the most damaged) and column D, and the wall on the east side, preventing the out-of-plumb of the façade. The conventional names of the columns (A, B, C, ...) are summarized in Figure 7. During the operations, it was observed that: (i) the tower had a regular tapering of walls, without any out-of-plumb, and (ii) the wall built over the arch between column E and column L (Figure 7) was separated from the rest of the structure by some cracks on the corners. Consequently, the cause of the column damage was identified being caused by excessive stress (estimated at about 2.1–2.4 MPa) rather than the soil settlement.

Figure 5. In 1881, serious damages to the north and east sides raised concerns and a temporary structure was built (a); a wide repair intervention was carried out to repair the damaged walls (b).

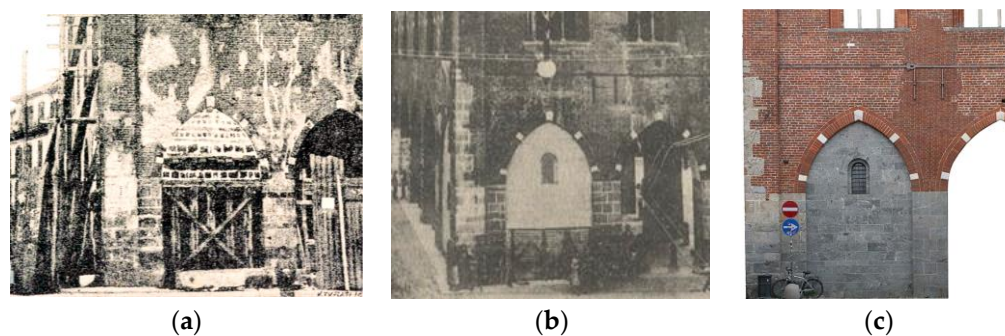
Figure 6. Details of the north front during the repair works (a,b) and of the current state (c).

The works started in 1881 showed that the columns were previously partially reconstructed: the core built was from a local soft and porous sandstone called “Ceppo”, coated with a 20 cm thick layer of “Saltrio’s Stone” (i.e., a compact limestone). The E and L columns (Figure 7) were then rebuilt with squared blocks of a local high-strength Gneiss, called “Serizzo”, respectively, in 1882 and 1884. The cracked masonry was locally dismantled and re-built, as it is easily readable through the changes of the masonry texture (Figure 6c).

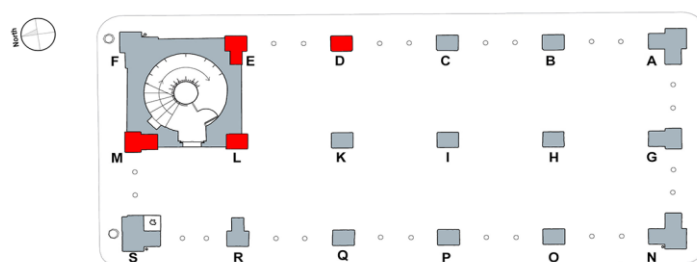
Figure 7. Plan of the ground floor. In order to strengthen the tower, the supporting arches at the ground floor were infilled and columns D, E, L and M were rebuilt.

Notwithstanding the several strengthening works, in 1902, new cracks were identified on column E (Figure 7), and new interventions were planned. At the same time, it was decided to move the courthouse from the area of the Arengario and demolish the Palazzo del Pretorio. Consequently, it was necessary to find new access to the Arengario's first floor; until that time, it was indeed provided by the overpass from the Palazzo del Pretorio.

iron tie-rods on the tower and the conical roof; (iv) in 1896, the rebuilding of column M (Figure 7); and (v) the installation of a wooden staircase in the tower.

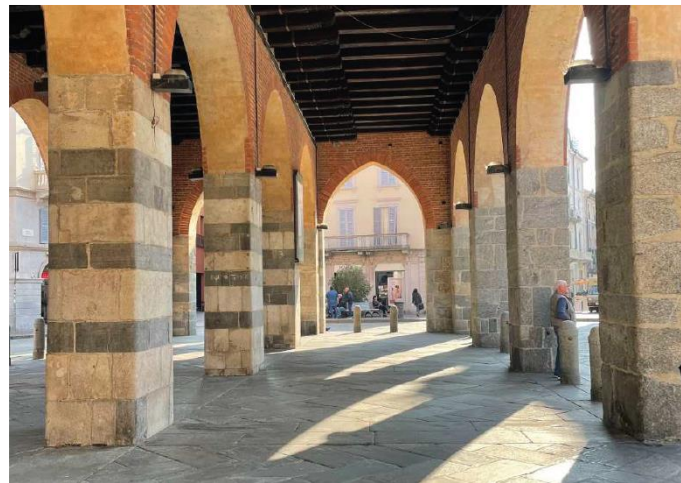
The structure is composed of brick masonry supported by stone masonry columns on the ground floor (Figure 9). The mortars are presumably composed of lime, despite several instances of joint repointing and local repairs occurring over time.

Figure 9. View of the columns NOPQ (on right) and GHIK (on left) (See Figure 7). The GHIK columns are built with alternate white and grey stone blocks, similar to the façade of the Monza Cathedral.

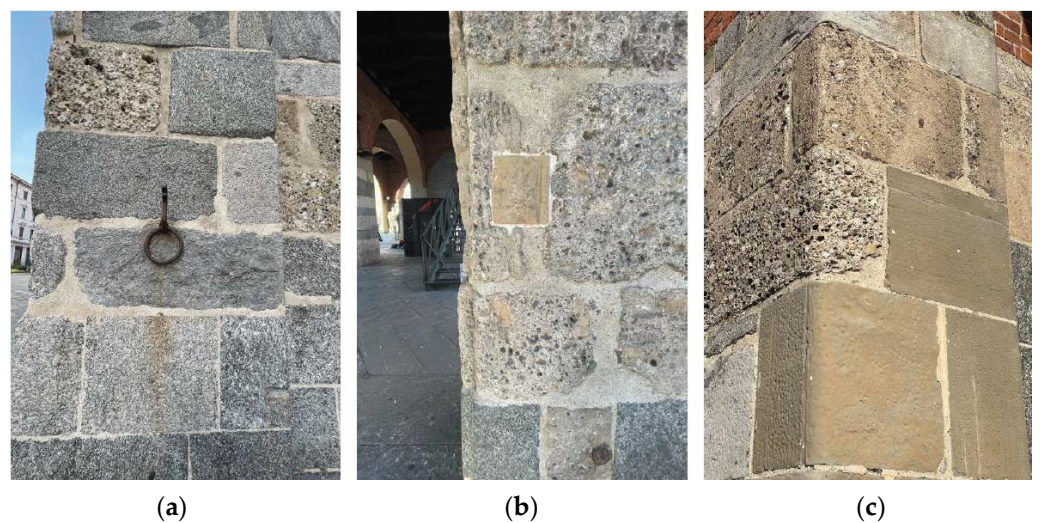
The masonry of the perimetrical columns appears to be composed of different stone blocks, such as soft sandstone, Ceppo, and high-strength Serizzo (Figure 10). The Serizzo masonry was used to infill the arch and the ground floor and for the local repair of some columns.

Figure 10. The masonry of the perimetrical columns appears to be composed of different stone blocks, such as Gneiss, Ceppo (i.e., a local soft and porous sandstone), and soft sandstone. (a) Detail of stone masonry column mainly composed of Serizzo; (b) mainly in Ceppo and (c) column mainly in Ceppo and sandstone.

More accurate investigation concerning the stone columns is necessary [50–53]. The procedure does not consider the possible complexity of the section layout, which can produce unexpected structural behavior and specific vulnerability. Pulse sonic tests or radar surveys can explore the section morphology. The external texture appears to be composed of large stone blocks. However, the internal organization is unknown, as is the presence of a rubble masonry core.

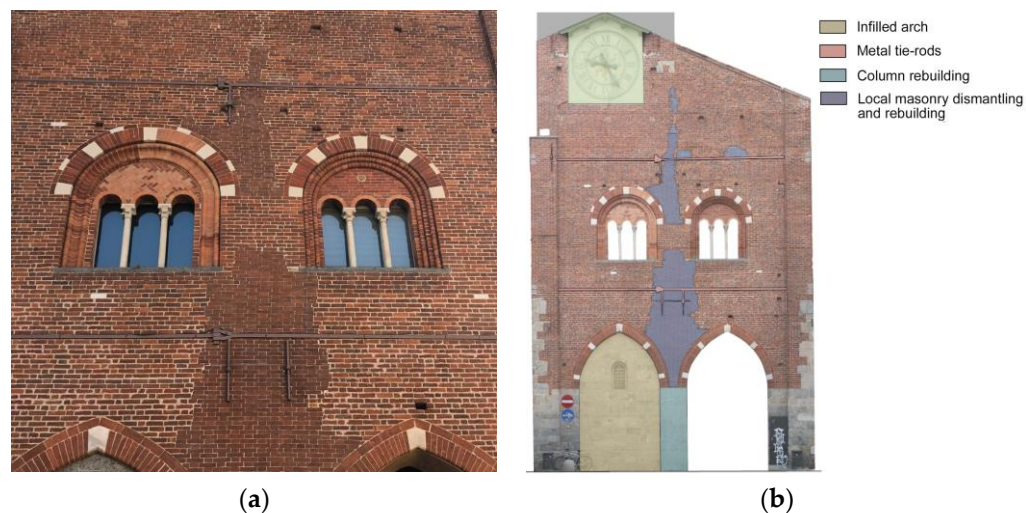
The brick masonry shows several irregularities due to the past repairs and window redistribution (Figures 8 and 11). The stratigraphic survey of all the fronts enhanced the complex sequence of interventions that were partially confirmed by the historical research (Figure 11).

Figure 11. Detail of the north side (a) and part of the stratigraphic survey with the main interventions on the north façade (b). During the intervention of the late 19th century, the masonry was locally demolished and rebuilt. This is clearly readable by the changes in the masonry texture, the brick color, and the surface compactness.

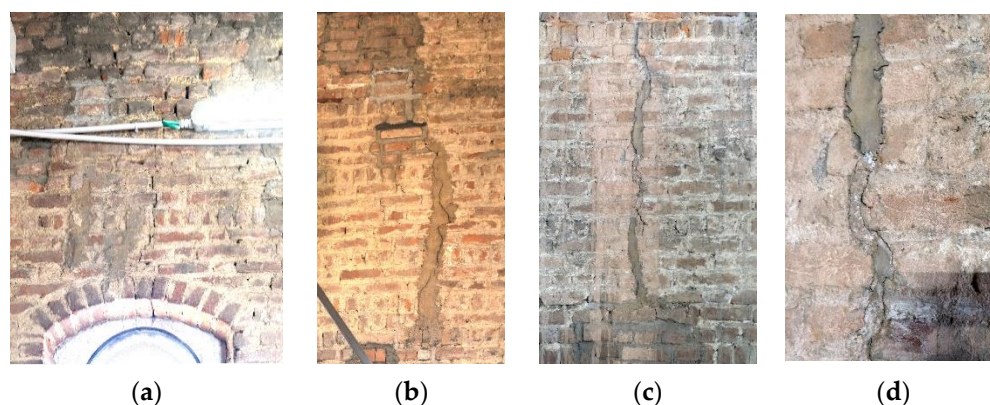
Furthermore, visual inspections of the tower highlighted the presence of several cracks (Figure 12). Some of them were repaired but the cracks are still open. This suggests the necessity of the installation of a static monitoring of the main cracks. In fact, thermal actions can re-open cracks even without the progress, further damage progress. The distinction between thermal effects and damage is a safety priority.

Figure 12. Detail of the cracks surveyed on the tower. Despite the past interventions, several cracks are still present (a). Some of them were repaired but the cracks are still open (b–d).
