Long-term reliability of photovoltaic c-Si modules – A detailed assessment based on the first Italian BIPV project

C. Del Pero^{*}, N. Aste, F. Leonforte, F. Sfolcini

Architecture, Built Environment and Construction Engineering A.B.C., Politecnico di Milano, Via Bonardi 9, 20133 Milano, Italy

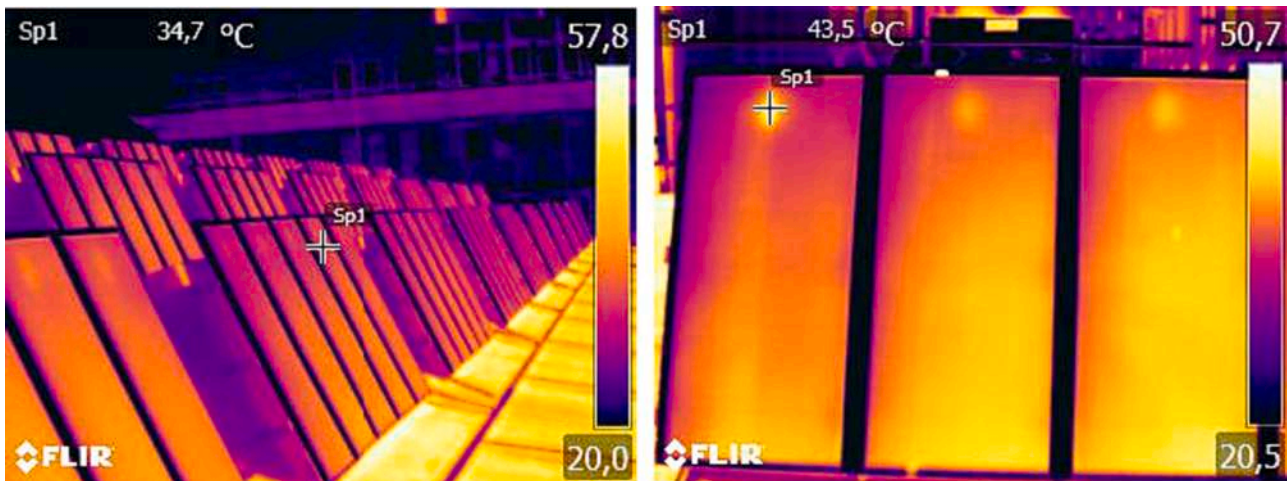
Fig. 4. IR overview of the BIPV array (left) and frontal picture of 3 modules (right).

After the visual inspection, in order to identify possible failures or overheating phenomena due to cells defects, also an infrared (IR) analysis was carried out with a Flir T640b IR camera (Fig. 4).

More in detail, the entire array was examined, checking the possibility of hot spots or other thermal anomalies. The images were taken from the front side, setting the emissivity of the module to 0.85, which is a typical value for the glass.

On one module (Module 140) a slight hotspot was found during the IR analysis, with a local increase of the surface temperature of about 10 °C compared to other cells (i.e., around 40 °C versus an average of 30 °C). It's important to note that the same phenomenon was observed during the 2014 assessment and no changes can be highlighted.

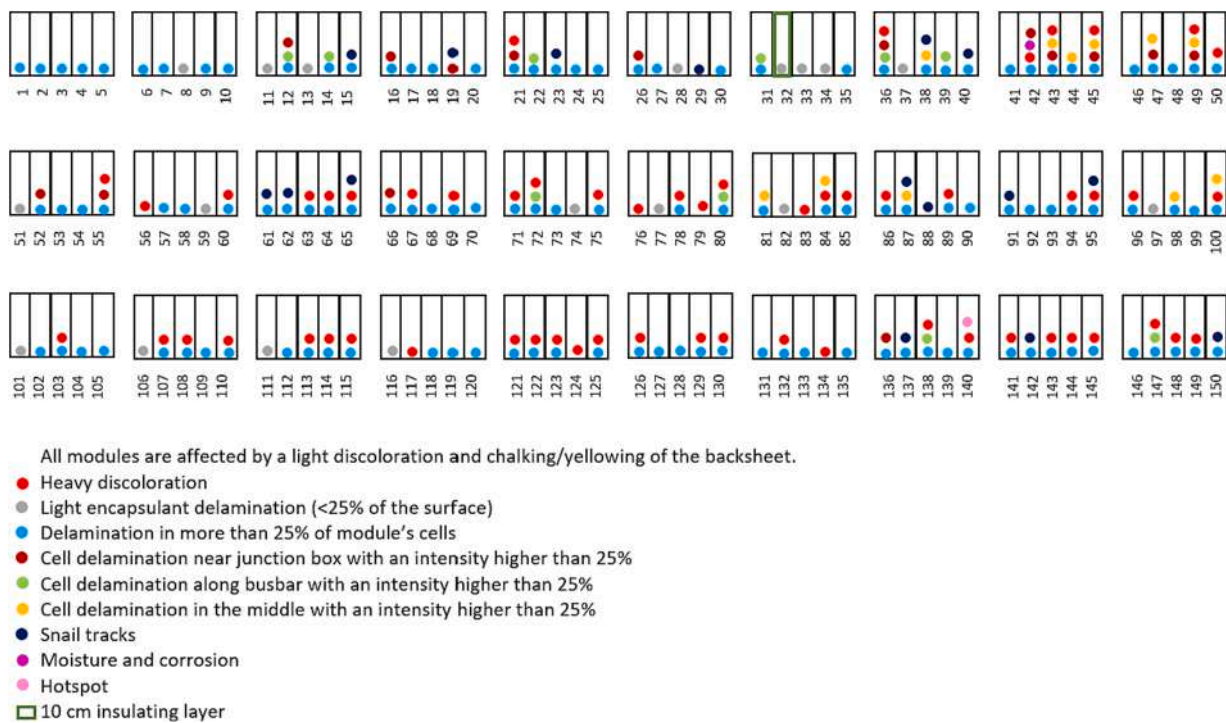
Fig. 5. Main alterations identified in the visual inspection on Politecnico di Milano BIPV Plant.

The main alterations detected by the visual/IR inspection are summarized in the scheme reported below, which also represent the displacement and numbering of the 150 modules within the array (Fig. 5).

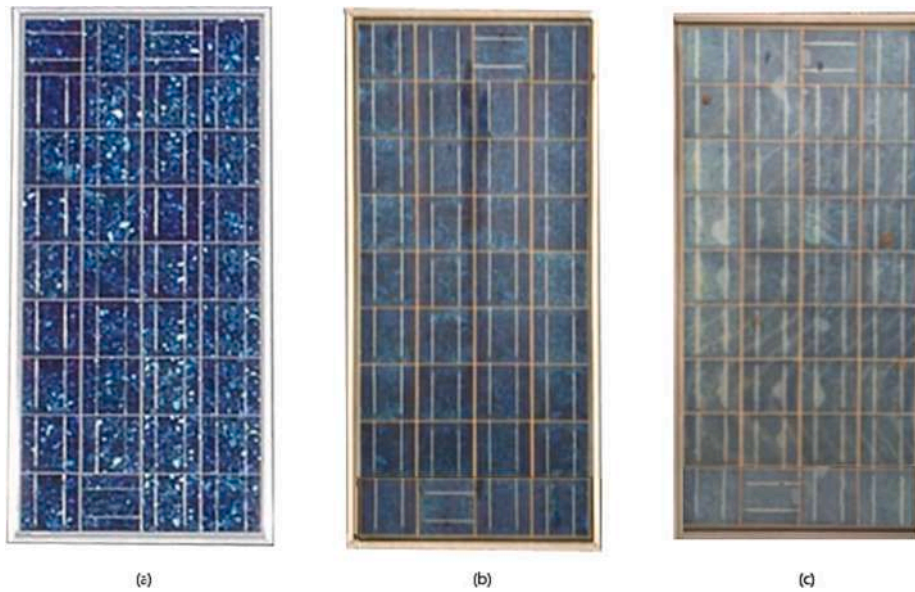
Fig. 6. A new RSM75 PV module (a), one affected by light (b) and heavy (b) discoloration.

As, already observed in previous works [8], all the modules are interested by a discoloration of the encapsulant. It has been decided to distinguish discoloration phenomenon between light and heavy discoloration, depending on its intensity compared to the module's color when it was new (Fig. 6).

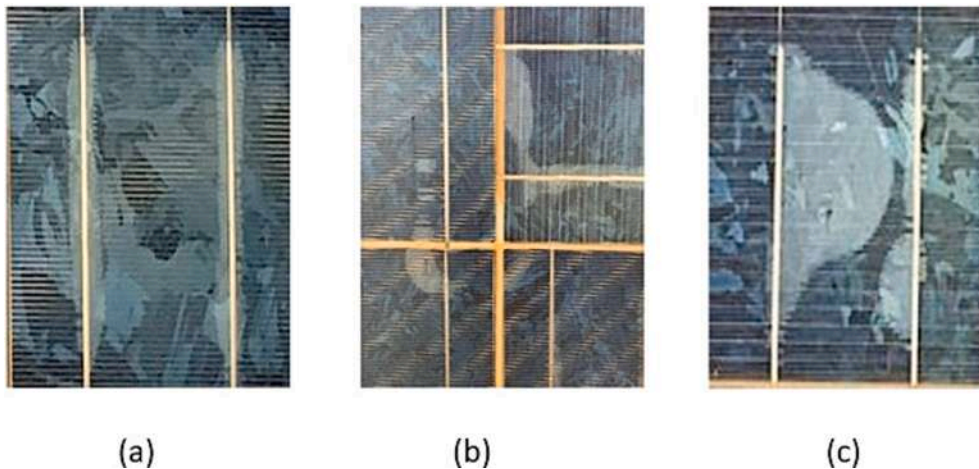
Fig. 7. Examples of delamination along busbars (a), near junction box area (b) and in the middle of the cell (c).

The other frequent alteration is the delamination: it appears in all modules, but its intensity and extension are heterogeneous. In particular, considering all modules affected by delamination, 81 % of them present a potentially critical situation, since they are characterized by delamination in more than one quarter of the total surface, while in the remaining 19 % the phenomenon interests just very limited parts (Fig. 7).

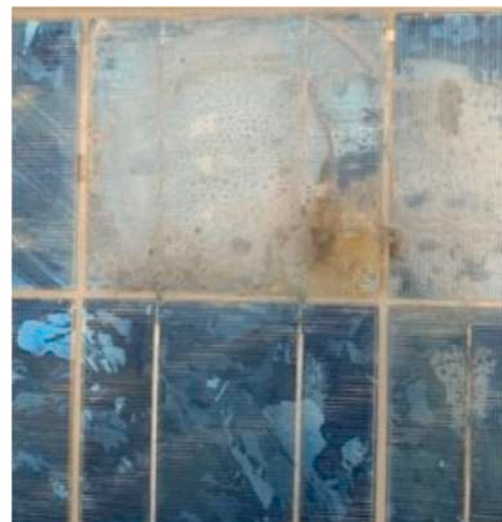
Fig. 8. Moisture infiltration and corrosion in module 42.

Just one module (Module 42) presented a fault during the visual inspection; more in detail, it was characterized by moisture/rainwater infiltration in the junction box and subsequent corrosion of electric contacts. The phenomenon was clearly detectable from the presence of moisture in the laminate, which probably caused hydrolysis within EVA with the consequent production of acetic acid; the latter acts as a catalyst

in the corrosion of finger electrodes and solder ribbon, causing the formation of dark areas in solar cells, as shown in the following picture (Fig. 8).

In Module 42, the junction box presented a so dreadful state, caused by corrosion, which precluded the possibility to carry out both flash and electroluminescence tests, since connection was impossible and power supply in that conditions would be dangerous.

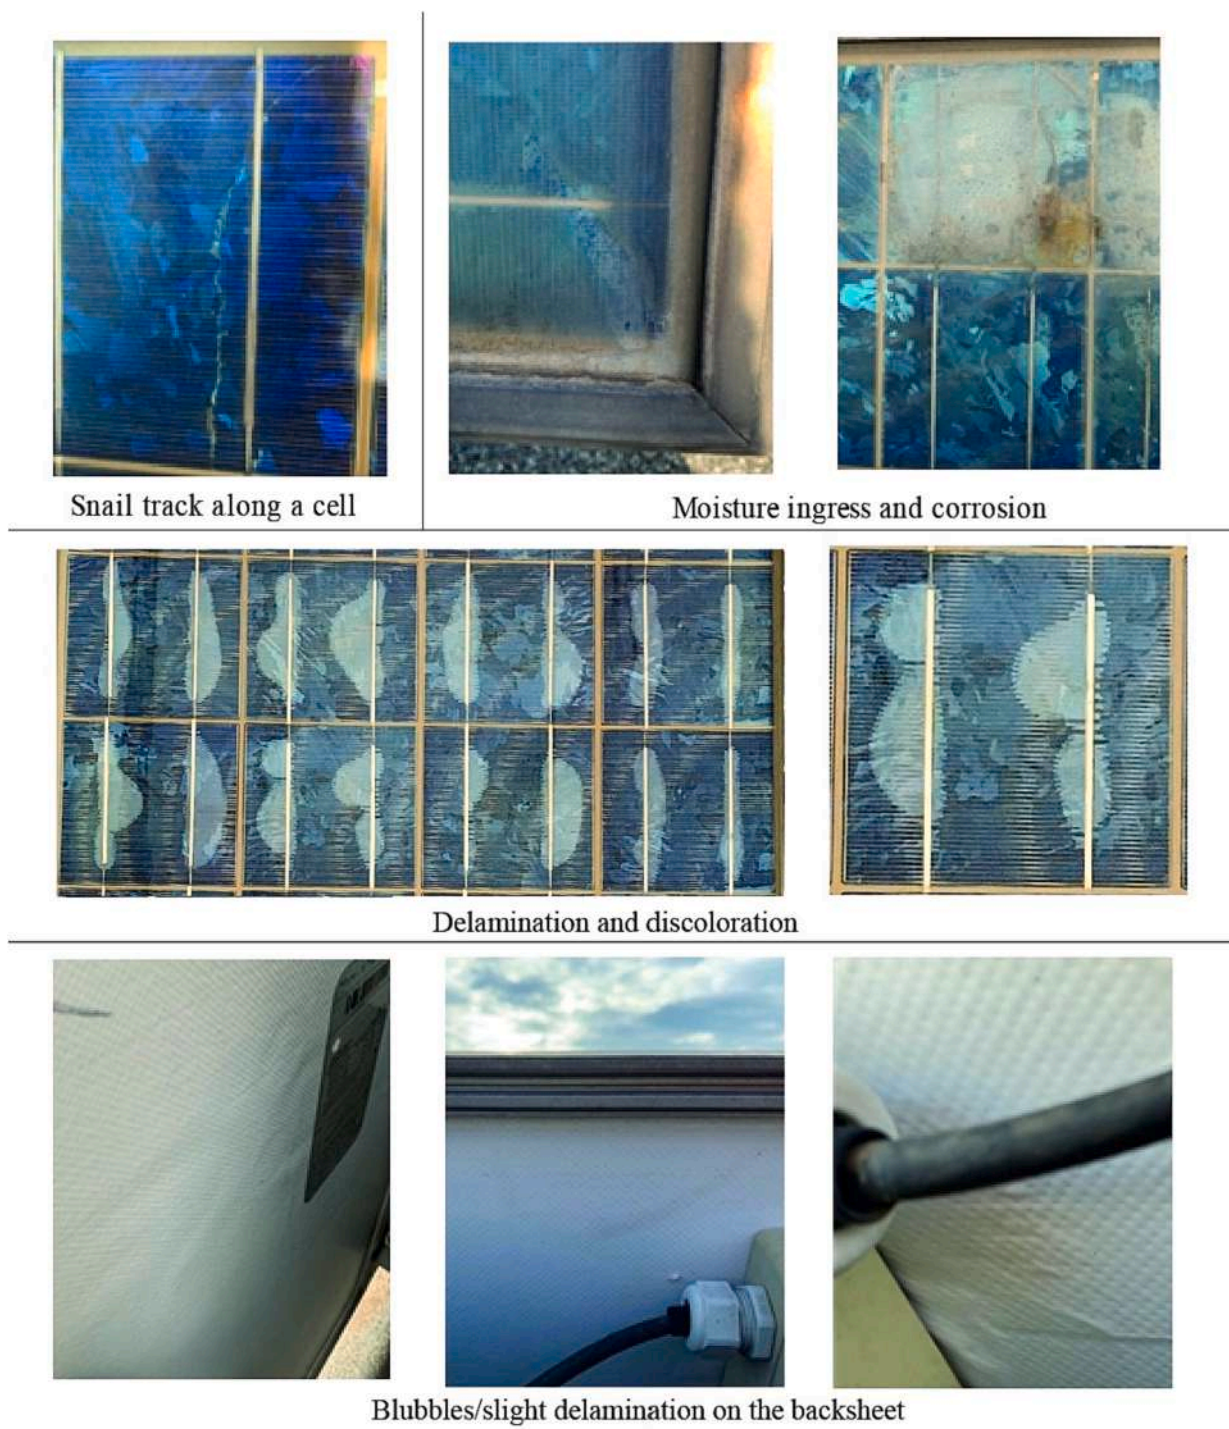
Fig. 9. Overview of the main detected alterations.

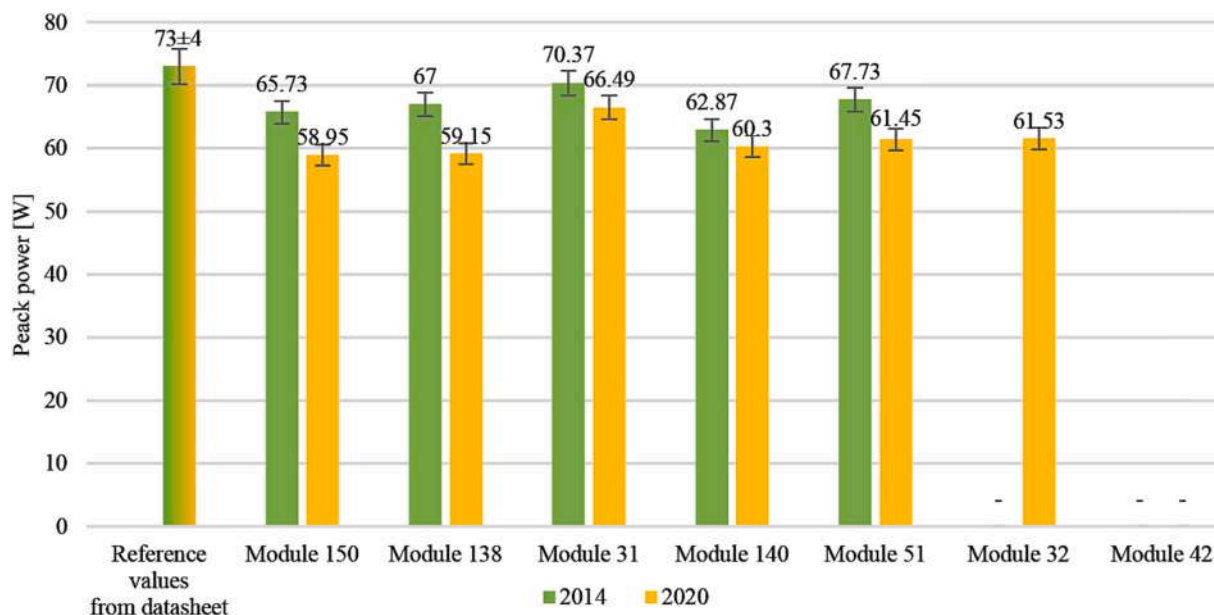
Fig. 10. Power variation after 13 and 20 years compared to reference power from datasheet.

from datasheet and the I-V characterization evaluated in 2014 after 13 years, as reported below. It must be noted that all values are referred to cleaned PV modules (Fig. 10).

Among other modules, it is evidently noticeable that Module 150 presents the worst power degradation respect to datasheet values, and this is probably due to the presence of snail trails identified along two cells. Module 138 instead, was characterized by a strong delamination along busbar and near junction box and by a strong discoloration

especially along cell's edges, which probably have worsened during the last five years, since it presents the highest degradation respect to 2014 values. Regarding module 140, slight hotspots could explain the quite high power-degradation respect to 73 W. For this reason, module's power was already low in 2014 and therefore the variation respect to previous I-V characterization is the lowest. Module 51 instead, didn't present any visual defects to naked eyes, but it presents higher degradation rates compared to module 31 characterized by spot delamination along busbar and near junction box. Module 32, instead, characterized by a 10 cm insulation layer arranged in 2014, although it is within the reasonable range for expected degradation, it is close to the 0.8 %/y threshold, so a probable slight negative influence due to the higher operating temperature is conceivable.

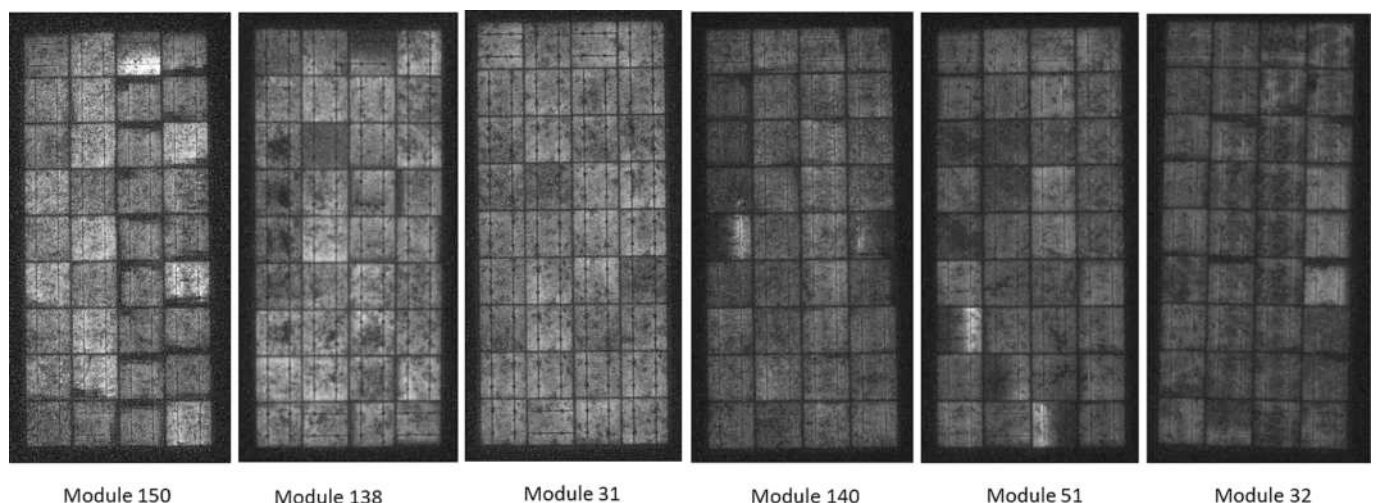
**Fig. 11.** Electroluminescence image of tested PV modules.

Module ID	EL outcomes	Comments
150	EL confirmed the existence of a cross crack line nearby snail tracks, already detected in 2014 assessment. Moreover, darker sections attributable to a mismatch of the cells, probably caused by a factory defect or poor assembly during wafer construction, are present along the lower edges of all the cells belonging to the right two columns.	The presence of the crack justifies the highest overall degradation rate among tested modules.
138	EL reports darker spots along cells belonging to the first column, which probably correspond to slight moisture ingress, since there the delamination is more intensive. Moreover, along the right edges of two cells and along the upper edge of one cell, we have identified darker sections similar to the ones previously explained, which could be attributed to a mismatch of the cells.	The extended delamination with slight moisture ingress and the heavy discoloration explains the significantly increased degradation rate in the 2015–2021 period.

31	EL image doesn't highlight relevant problems, except for some darker spots near delamination zones	The module is an optimal conservation status, just some spot delamination appeared in the 2015–2021 period. This justifies the lowest degradation rate among tested modules.
140	EL shows the existence of a light hotspot (i.e. brighter sections along busbars' joints), which were not visible by the IR images.	The problem is the same highlighted in 2014 and no changes are recorded. Thus, it could be related to a manufacturing imperfection which didn't change during operation.
51	EL revealed two brighter sections along cells' joints, which could be classified as hot spots	The problem was not present in 2014, thus it could be caused by the disconnection of cells electrical contacts occurred in the 2015–2021 period. This justifies the increased degradation rate.
32	EL image didn't highlight relevant issues, except for a few darker sections along the lower edges of the cells, attributable to a mismatch of the cells	The degradation rate, although it is within the reasonable range for expected degradation, it is close to the 0.8 %/y threshold, so a probable slight negative influence due to the higher operating temperature is conceivable. Additional tests will be performed in the future on the same module.
