ANIDIS 2007

On site and laboratory investigation to assess material and structural damage on some churches hit by an earthquake

Anna Anzani, Luigia Binda, Lorenzo Cantini, Giuliana Cardani, Antonella Saisi, Cristina Tedeschi
Dipartimento di Ingegneria Strutturale, Politecnico di Milano, P.za Leonardo da Vinci, 32 – 20133 Milano, Italia

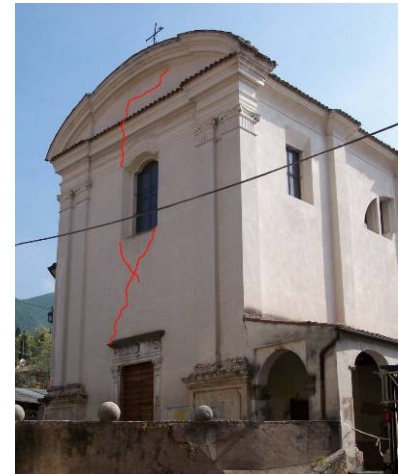
Figure 3. S. Antonio at Morgnaga.

This mechanism has been observed in six cases; it is the most frequent one and always involves simple façades, i.e. plane front only connected to the lateral bearing walls. In all the studied cases, the crack pattern has developed along few well defined lines, indicating a good quality of the masonry 8, 9. The crack position is obviously influenced by the openings too. In figure 3 the church of S. Antonio Abate at Morgnaga is presented: on the central part of the façade a series of cracks are visible corresponding to the windows.

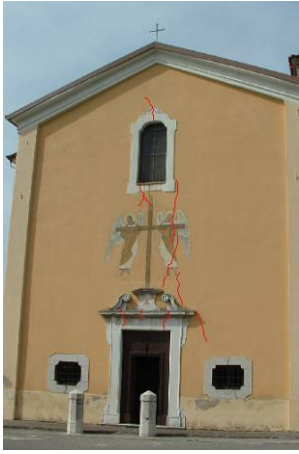
Figure 4. SS. Crocifisso at Bogliaco.

In figure 4 the Church of SS. Crocifisso at Bogliaco di Gargnano can be seen: from the photograph a failure line basically vertical and in central position can be noticed. The cracks are probably generated by the out of plane displacement of the lateral walls and are exacerbated by the presence of the openings.

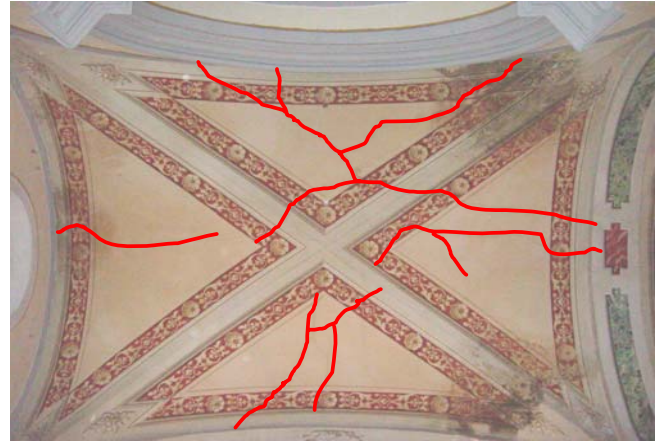
Figure 7. S. Pier d'Agrino, Bogliaco di Gargnano.

In four cases the vaults of the central nave looked cracked, often due to the heavy load of the re-built roof (Figure 7).

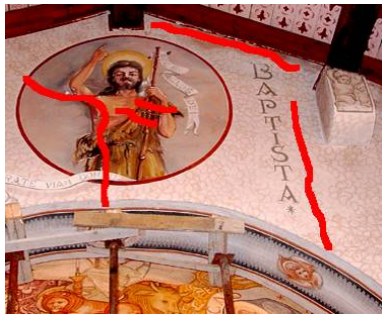
Figure 5. S. Giovanni Pavone, Sabbio Chiese; triumphal arch.

Because of the out of plane confinement on both sides, the triumphal arches only showed in plane failure that has been detected in four cases. In Figure 5 the triumphal arch of the church of S. Giovanni Pavone at Sabbio Chiese shows a particularly evident crack pattern that required supporting structures. A similar problem is evident in Figure 6 at the arch of the apse, where the movement of the key-stone also required the use of props.

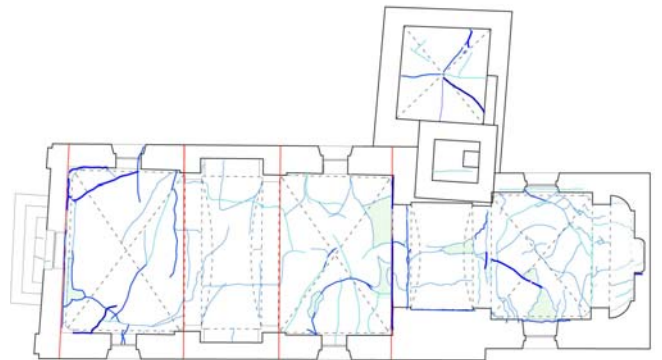
Figure 8. S. Benedetto at Pompegnino di Vobarno.

In the case of S. Benedetto da Norcia at Pompegnino di Vobarno (Figure 8) the central nave looks severely cracked, probably because of the presence of a rigid plaster that makes the cracks more evident. The structure has been completely propped to guarantee safety.

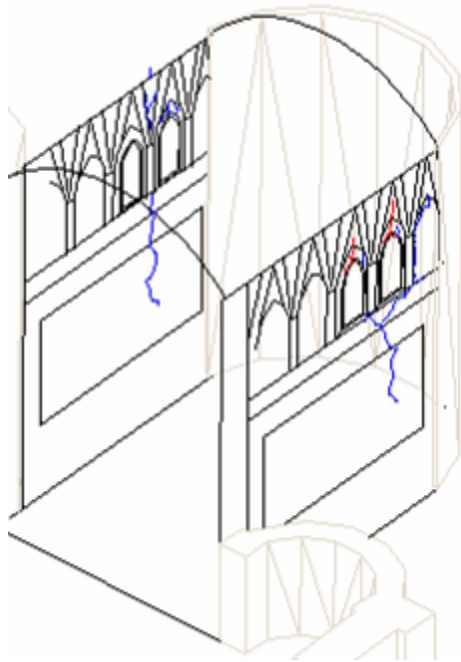
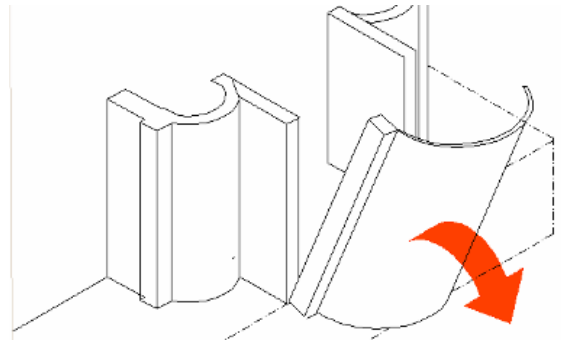
Figure 9. S. Michele Arcangelo at Sabbio Chiese.

Four churches are affected by the rotation mechanism of the ending part of the apse. In Figures 9, 10 the church of S. Michele Arcangelo at Sabbio Chiese is illustrated. Two long cracks can be seen in symmetrical position, sometimes cutting the whole wall thickness, indicating a detachment of the ending part of the apse due to out of plane rotation.

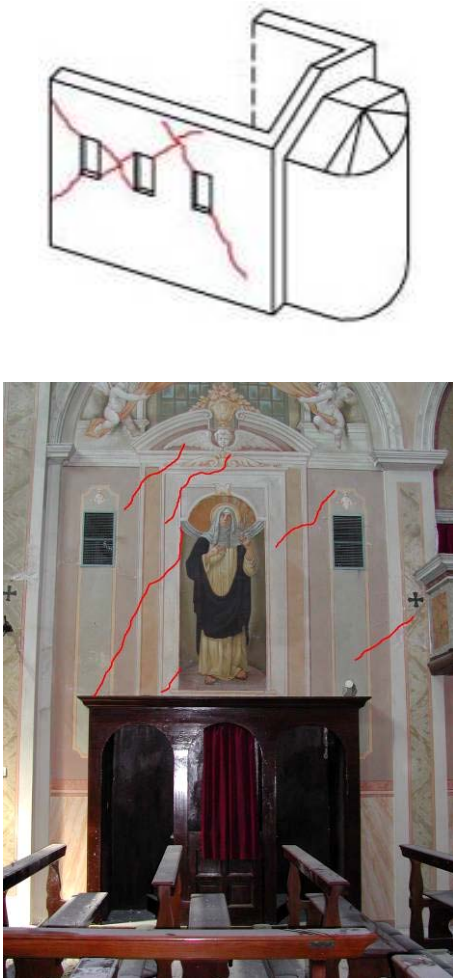
Figure 11. S. Antonio Abate at Morgnaga.

Because of the good transversal connection offered by the roofs and by the lateral chapels when present, no out of plane rotation of the lateral bearing walls has been observed, except that in the case of the central plane church of SS. Crocifisso, where the vertical cracks in the façade is presumably due to a rotation of the lateral walls. On the contrary, shear cracks showed in the case of three churches. The phenomenon is less frequent than the in-plane mechanism of the façade, probably because of the higher in-plane flexural stiffness of the lateral walls and to the higher slenderness of the façade. In Figure 11 the crack patterns appeared on the north and south walls of the church of S. Antonio Abate at Morgnaga are shown.

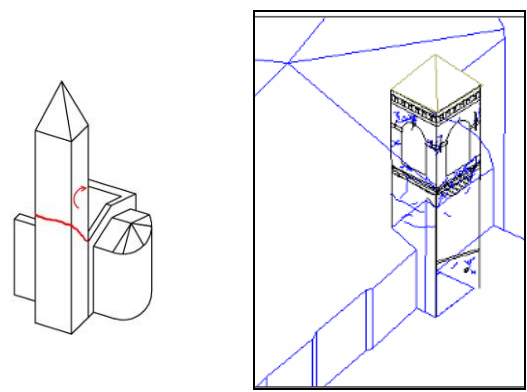
Figure 12. Bell-tower of S. Michele Arcangelo, Sabbio Chiese.

The bell-tower was not present in all the case studies. In general its failure mechanisms are influenced by its position with respect to the church and by the kind of connections, considering that it may be particularly vulnerable because of its slenderness. In Figures 12, 13 the bell-tower of S. Michele Arcangelo, at Sabbio Chiese is shown, which is affected by severe crack patterns. In particular, the cracks on the east and west fronts indicate a movement of the tower in the north-south direction. In fact, the upper part of the tower can freely move whereas the lower part is well constrained by the church and the rectory. East and west faces of the belfry show a crack corresponding to the keystone, probably due to an out of plane rotation of north and south walls.
