Evaluation of Fukushima Daiichi Unit 1 Ex-Vessel Phenomenon Leveraging on Primary Containment Vessel Robotic Inspections

Michal Cibula, Marco Pellegrini, Masato Mizokami & Shinya Mizokami

^a*Tokyo Electric Power Company Holdings, Inc., Tokyo, Japan*

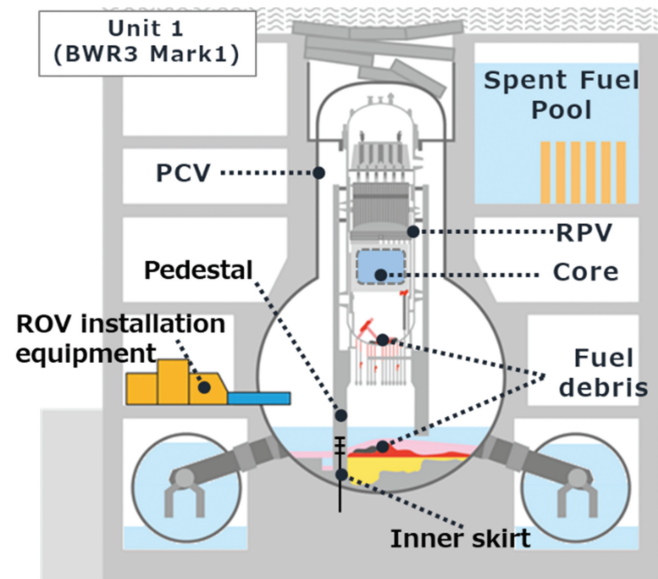
Figure 1 depicts the estimated state and fuel debris distribution within the PCV of Unit 1 based on the information acquired before 2022 (Ref. 6). With the purpose of collecting crucial information to grasp the state in the containment to efficiently proceed with the decommissioning work, as well as to further decrease the uncertainties related to the accident progression and severe accident phenomena understanding, a wide range of investigations inside the PCV utilizing submersible remotely operated vehicles (ROVs) was conducted between December 2022 and March 2023.

Fig. 1. Estimation of status inside RPV and PCV (as of 2022).

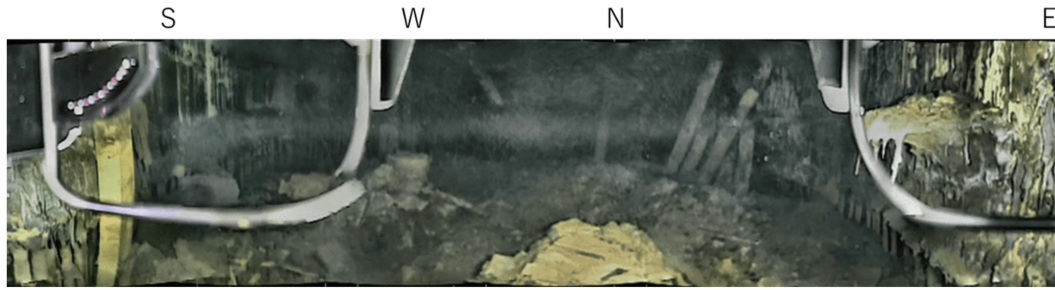
Fig. 3. Panoramic view of the pedestal area (taken from the pedestal opening).

Figure 3 shows the panoramic view of the pedestal area taken from the pedestal worker access opening (herein referred to as pedestal opening). Erosion of concrete along the entire inner circumference of the pedestal wall was confirmed up to the height of approximately 1 m. This left the vertical reinforcing steel rebars exposed, but surprisingly, no significant damage to the rebar itself was confirmed. In multiple locations where the extent of the concrete erosion and state of the rebars could be investigated in detail, the inner skirt could be observed as well. The inner skirt is a cylindrical reinforcing structure in the center of the pedestal wall reaching from the basemat up to the height of 1 m from the D/W floor (Figs. 1 and 2). No significant

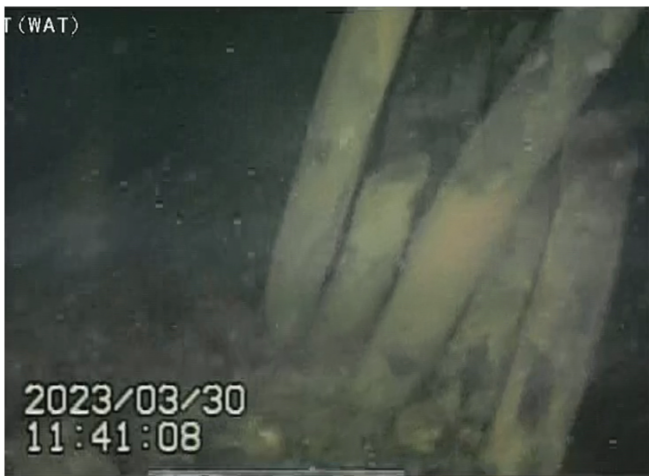
Fig. 4. Fallen CRD housings leaning on the pedestal wall, severed on top and partially buried in deposits below (N-3).

In the recent investigation, one ICM housing apparently detached from the LH was found suspended above the water level in the outer periphery of the pedestal area (Fig. 5). Because the observed ICM housing is clearly lower than its original position yet it is not supported from below, it is assumed that some of its upper part is stuck in the dense array of other structures and/or solidified debris retained in the areas that could not be directly observed at this time. The fact that multiple CRD housings are found on top of the deposits in the pedestal area or partially buried in them might suggest their relocation in the later stage of the ex-vessel phase (Fig. 4). It is also

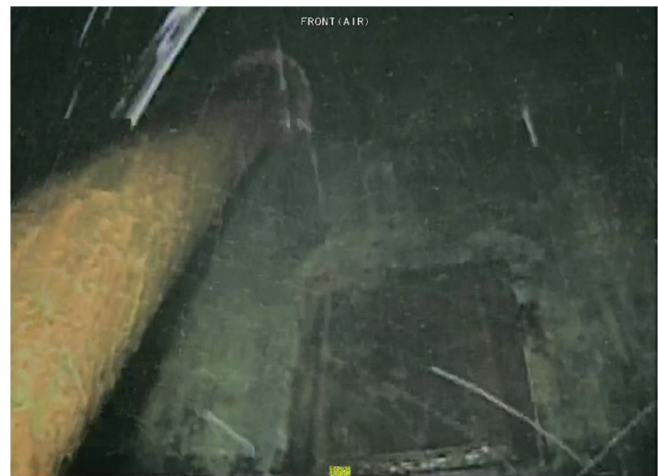
Fig. 6. Fallen CRD housing leaning on the pedestal wall with flange in the upper position above the water level (NW-3).

Global failure under the depressurized RPV condition could take place after dryout and debris bed reheating, long after the penetration failures, but would provide for the largest ex-vessel relocation path of the three considered scenarios. The positional relationship of the CRD housing flanges observed in the upper pedestal region, which seems to be not significantly deviating from their original vertical position but misaligned from their horizontal pitch (Fig. 9), might be a sign of a larger-scale rupture of the LH, i.e., vessel sag or “unzipping.” Moreover, some of the CRD housings (length of ~4 m) were found rotated upside down, which would require a high degree of damage especially in the central area to allow for such movement (Fig. 6).

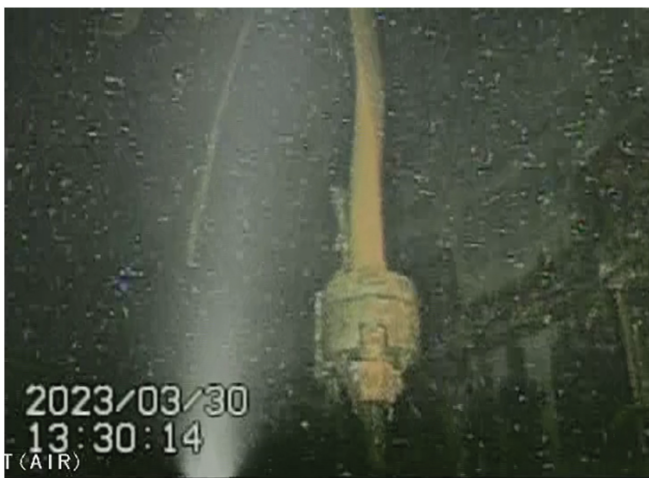
Fig. 5. Detached ICM housing suspended above the water level (SE-3) near the pedestal wall.

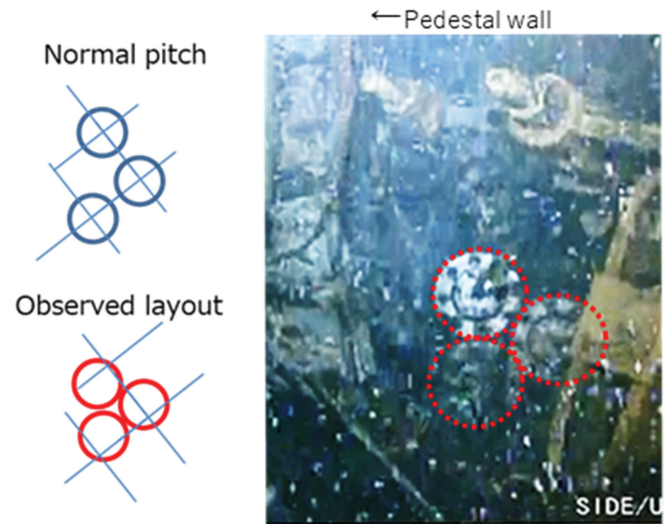
Fig. 9. Deviations of CRD housings from their normal pitch (ESE-3).

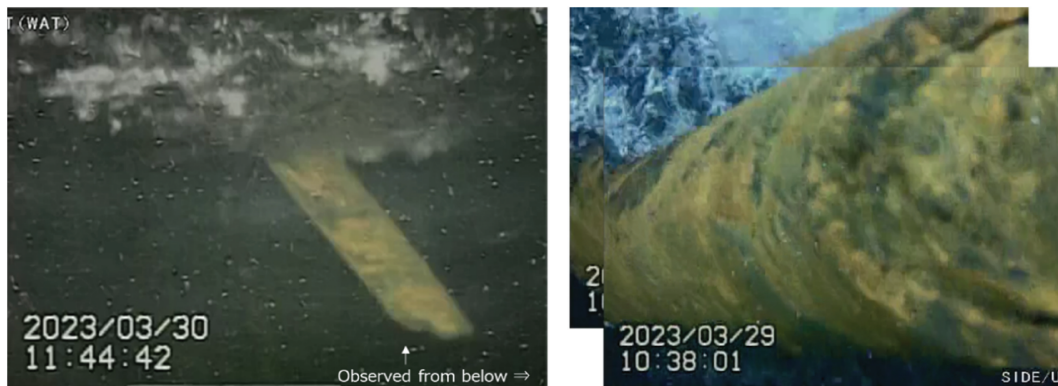
In some instances, the severed sections of the CRD housings could be observed. CRDs consisting of several hollow cylinders inside the housings appear to have the gaps between each cylinder clogged by solidified

materials (Fig. 8). Those completely separated from all the upper support structures have been found partially buried in the deposits, with some deformations and “gouging” on their surfaces, adherence of dark-colored material, and seemingly interfering with the protruding deposits attached to the pedestal wall (referred to as shelves) in the process of relocation, resulting in fracturing of the shelf in some instances.

Fig. 8. Clogging of severed CRD housing (central section of the pedestal area) observed from below the severed section of the suspended CRD housing (right picture).

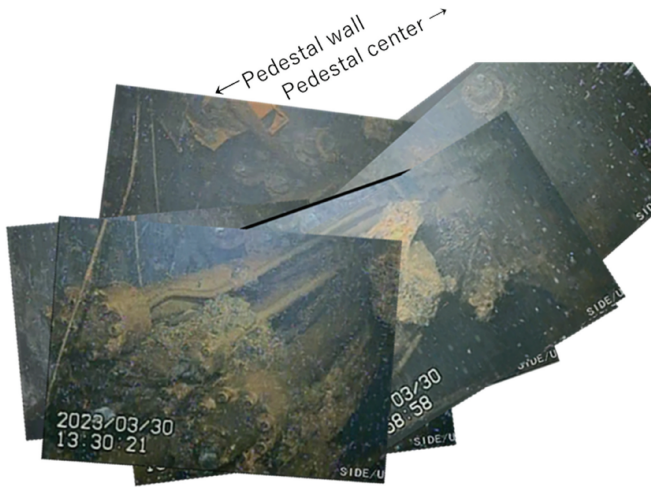
High above the water level, numerous flanges of the CRD and ICM housings considered to be remaining in or near their original height could be observed. While their vertical position does not appear to be significantly changed, their positional relationship in the horizontal plane shows deviation from the original square grid (Fig. 9). A bundle of CRD and ICM housings was confirmed remaining in a slanted position with bulky deposits adhering to their surfaces. At least one of these housings is sticking out of this bundle farther downward and appears to be in contact with the end of the CRD exchange rail inside the opening in the higher part of the pedestal wall near 90 deg (Fig. 10).

Fig. 10. Bulky deposits attached to the relocated CRD housings suspended above the water level (SSE-2 to SSE-3).

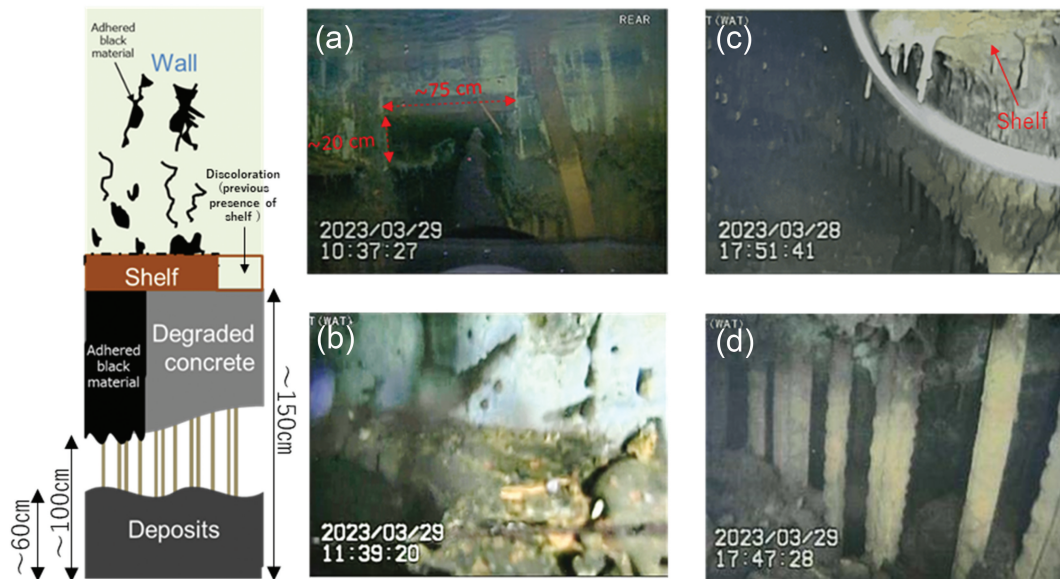
Fig. 11. Left: vertical distribution of wall states. (a) State difference above and below shelf level around the pedestal opening (E-3). (b) Dark materials attached to the wall and accumulated on the shelf (NNE-3). (c) Concrete degradation below the shelf level (E-3 to ENE-3). (d) Exposed rebar and lower deposits bed (NE-3).

As a result of this concrete erosion, the support structures originally embedded in the pedestal wall (i.e., rebars and inner skirt) were exposed, and their current state is largely sound (Figs. 11d and 12). This conflicts with the expectations coming from the MCCI knowledge accumulated up to date, which expects the rebar mesh to be eroded together with the concrete.^[8] Although some experiments were conducted in recent years to investigate the potential effect of rebars on the ablation front progression,^[24] clean separation of concrete without damage to rebars was not deemed realistic. Long-term effects, such as coolant water flow and slow degradation over the period of 12 years (similar to leaching) after the accident, offer themselves as seemingly plausible explanations, but the bending of horizontal rebars welded to the inner skirt (Fig. 12) implies that such long-term degradation was not the main contributor. These rebars are thought to have bent under their own weight as a result of the increased temperature causing the deterioration of their mechanical properties. In the longer term, when the flow of cooling water could cause the degradation of the concrete, the temperature inside the PCV is considered to be too low to significantly affect the mechanical properties of steel. It seems likely that the temperature to which the rebars were exposed was simply not sufficient to cause their melting but was high enough for the concrete matrix to erode and for horizontal rebars to lose their mechanical strength and to bend under their own weight.

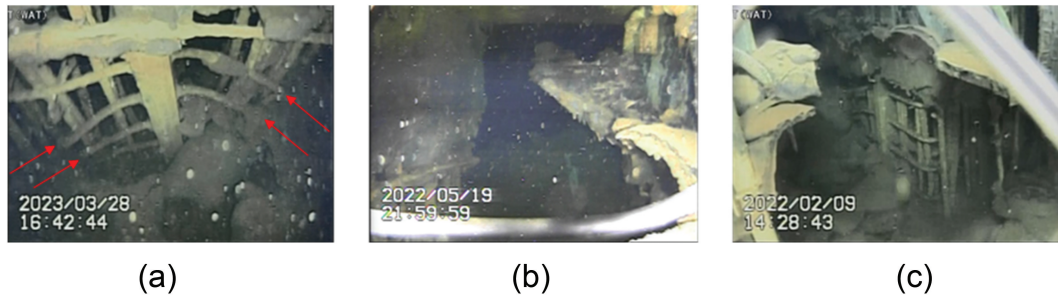
The damage to the pedestal wall concrete could be observed in the closest detail inside the pedestal opening (Fig. 12). The concrete of the pedestal wall was confirmed

to be missing from both side walls of the opening, up to the height slightly exceeding the height of the inner skirt at maximum. No clear deformation of the inner skirt itself could be confirmed; however, the L-shaped rebars that are horizontally welded to the inner skirt to reinforce the corners of the opening were found bent on both inner and outer sides of the wall on both left and right sides of the opening. A slanted shelf is attached to the right side of the wall at the height of ~1.5 m on the pedestal inner corner and ~1.3 m on the outer corner. No shelf is currently attached to the left side of the wall; however, the discoloration and deterioration scale of the wall suggests the possibility of the previous existence of a slanted shelf similar to the one on the right side wall. In general, the distribution of the states along the walls of the pedestal opening is the same as inside the pedestal area, including the presence of dark-colored materials on top of and above the shelf. In addition, the piping of the reactor building closed cooling water system (RCW) serving to cool the equipment drain sump in the pedestal area could not be found in its original position along the left wall.

Fig. 12. State of pedestal opening. (a) Left wall with exposed inner skirt and rebar. (b) Upper part with shelf deposit. (c) Outer right corner with exposed rebar and shelf deposits. Red arrows are pointing to bent rebars.

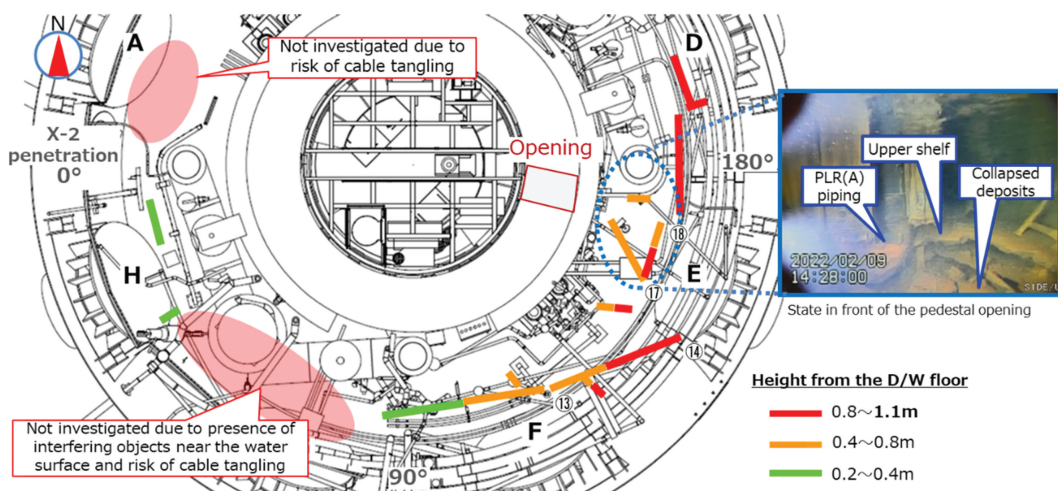
Fig. 13. Height distribution of the deposits.

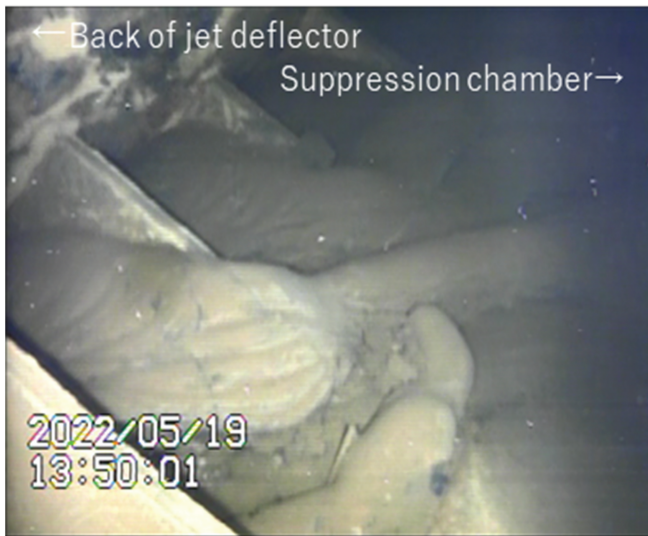
lower edge of the torus downcomer about 20 cm high from the floor level, and a currently unknown volume of materials relocated behind jet deflectors F, E, and D, which are located nearest to the pedestal opening (Fig. 14). The state of the original D/W floor could not be observed at any of the investigated areas.

Fig. 14. Clogging of the bottom openings of vent pipe behind jet deflector E (ENE-6).

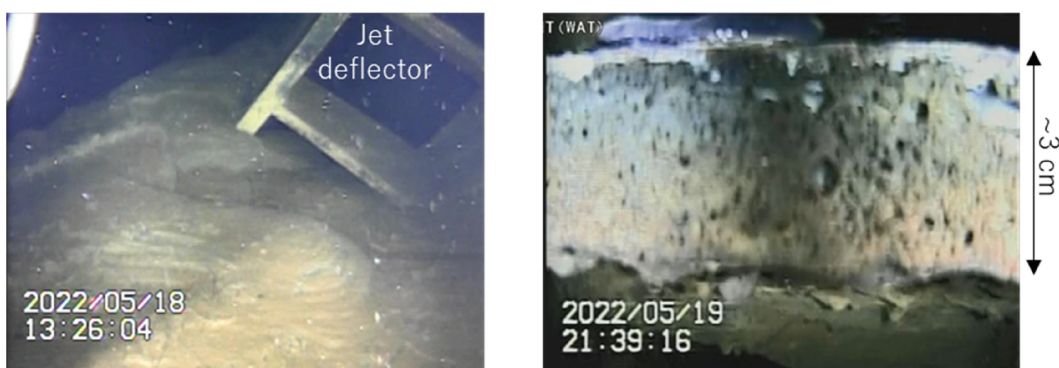
Height gradient and ripplelike patterns can be observed on the upper surface of these shelves (Fig. 15), while the

Fig. 15. Wrinkly shape of the upper surface of shelf deposits (SE-6) and porosity observed on the fragmented side (E-4).

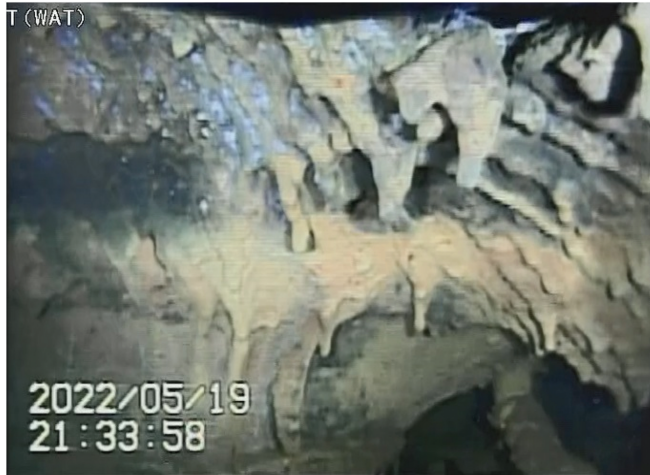
bottom side, especially in and near the pedestal opening, has “lavacicle”-like formations (Fig. 16). The thickness of the shelf was estimated to be 3 to 4 cm both near the pedestal wall (Fig. 15) and near the D/W shell, with similar high porosity observed on the profile in both cases. Between the PLR piping and the D/W shell and jet deflector E, a second layer of shelf was observed, with its surface being relatively flat, in contrast to the wrinkly shape of the upper shelf. These two layers are interconnected along the D/W shell, and some metallic support structures are entrained in between them, without any observable damage or deformation along their length (Fig. 17).

Fig. 16. Lavacicles on the bottom side of the shelf at the corner of pedestal opening.

Regarding the dark black materials adhering to some parts of the walls inside the pedestal and in the pedestal opening above the level of the concrete erosion, their nature and origin are not fully understood at this moment. One plausible explanation could be that these materials are results of “volcanic” eruptions caused by decomposition gases entraining melt droplets.^[7] Similarly, “icicles” found on the bottom side of some shelves (Fig. 16) could

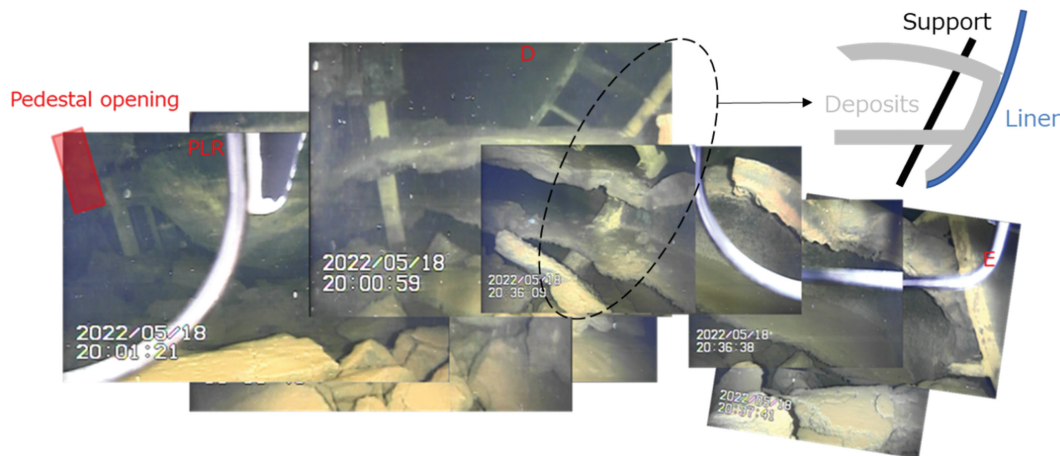
Fig. 17. Shelf deposits reaching from the right corner of the pedestal opening, along PLR piping, toward the D/W shell and jet deflectors D, E (E-4 to 6 to ESE-4 to 6).

Similarly, the state of PLR piping, support structures, and jet deflector plates between the shelves and lower debris bed is fundamentally intact (Fig. 17). In the BWR Mark I, attack of the melt on the D/W shell without any interventions (such as D/W spray, etc.) is expected to result in early failure of the containment, bypass of the S/C, and a catastrophic release of the contaminants into the environment.^[31] Since a high level of water can be maintained in the D/W and most of the metallic structures in the outer circumference of the D/W annulus are relatively intact, failure of the D/W shell seems to be improbable.

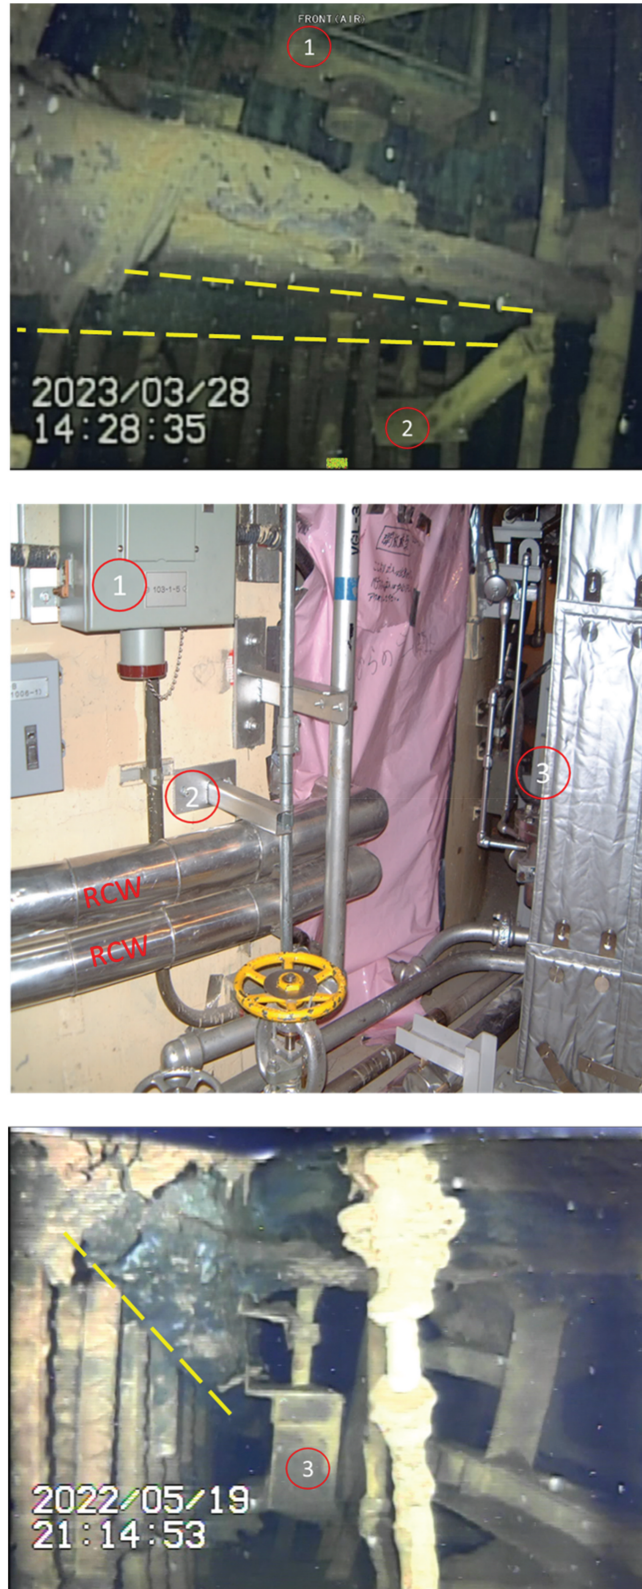
support structures and pipes standing vertically in front of the pedestal wall are only slightly deformed both below and above the height of the shelf deposits (Fig. 18). Similarly, no obvious deformation or melting was confirmed on the PLR piping or shielding block of the equipment drain sump pump or jet deflectors.

Fig. 18. Erosion height gradients and state of the structures on the outer sides of the pedestal opening (covered by a pink sheet in the central picture); yellow lines mark parts considered to be remaining concrete below the shelves; numbers in red circles indicate original structures that could be identified.

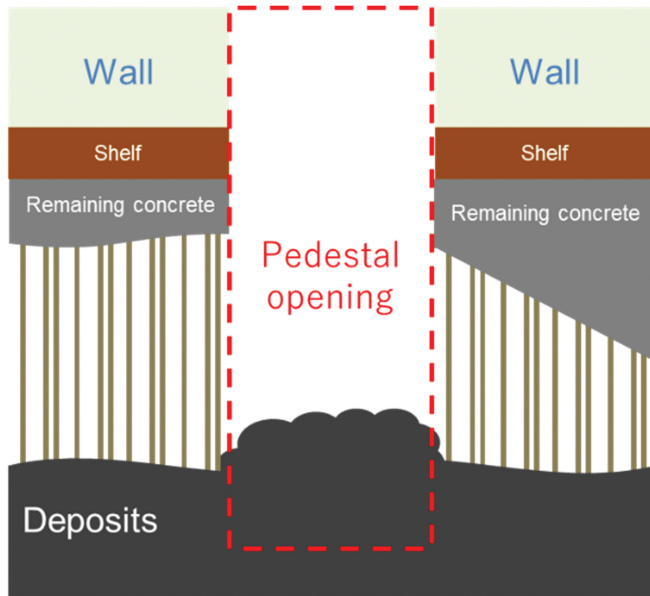
Fig. 19. Illustration of the wall states on both sides of the pedestal opening as seen from the outside (structures and horizontal rebars omitted).
