# **PROCEEDINGS OF THE FIRST INTERNATIONAL CONFERENCE ON RESTORATION OF HERITAGE MASONRY STRUCTURES**

## **On Site and Laboratory Investigation on Some Churches Hit by a Recent Earthquake, in order to Assess the Damages to Materials and Structures**

Binda L.<sup>1</sup>, Anzani A.<sup>2</sup>, Cantini L.<sup>3</sup>, Cardani G.<sup>4</sup>, Tedeschi C.<sup>4</sup>, Saisi A.<sup>4</sup>

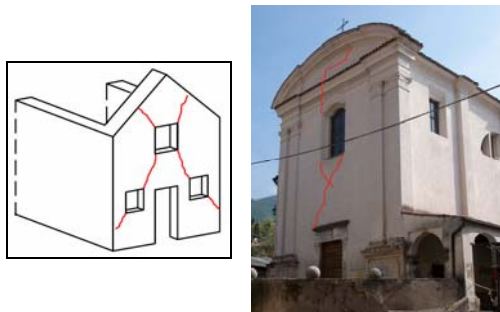
**Figure 3 - S. Antonio at Morgnaga**

This mechanism has been observed in six cases; it is the most frequent one and always involves simple façades, i.e. plane front only connected to the lateral bearing walls. In all the studied cases, the crack pattern has developed along few well defined lines, indicating a good quality of the masonry<sup>8,9</sup>. The crack position is obviously influenced by the openings too. In figure 3 the church of S. Antonio Abate at Morgnaga is presented: on the central part of the façade a series of cracks are visible corresponding to the windows.

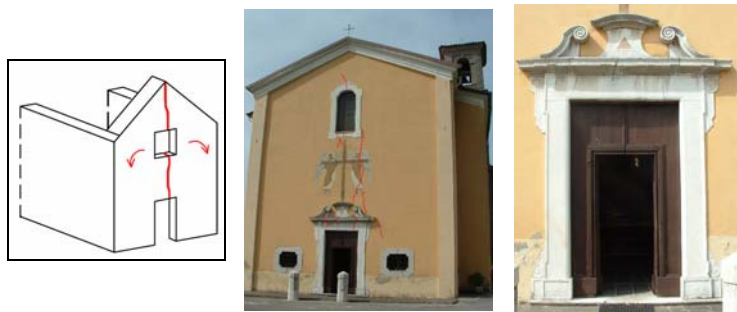
**Figure 4 - SS. Crocifisso at Bogliaco**

In figure 4 the Church of SS. Crocifisso at Bogliaco di Gargnano can be seen: from the photograph a failure line basically vertical and in central position can be noticed. The cracks are probably generated by the out of plane displacement of the lateral walls and are exacerbated by the presence of the openings.

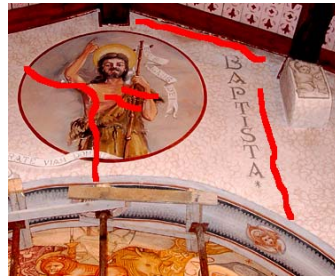
Because of the out of plane confinement on both sides, the triumphal arches only showed in plane failure that has been detected in four cases. In Figure 5 the triumphal arch of the church of S. Giovanni Pavone at Sabbio Chiese shows a particularly evident crack pattern that required supporting structures. A similar problem is evident in Figure 6 at the arch of the apse, where the movement of the keystone also required the use of props.

**Figure 5 – S. Giovanni Pavone at Sabbio Chiese; triumphal arch.** **Figure 6 – S. Giovanni Pavone at Sabbio Chiese; arch of the apse.**

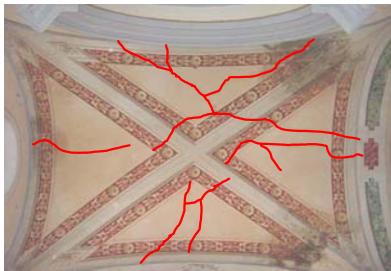
**Figure 7 – S. Pier d'Agrino at Bogliaco di Gargnano**

In four cases the vaults of the central nave looked cracked, often due to the heavy load of the rebuilt roof (Figures 7 and 8).

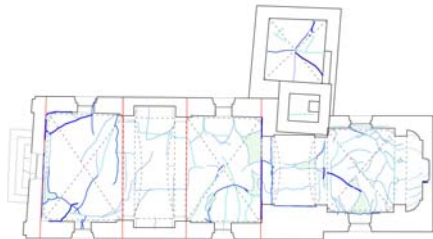
**Figure 9 – S. Benedetto at Pompegnino di Vobarno**

In the case of S. Benedetto da Norcia at Pompegnino di Vobarno (Figure 9) the central nave looks severely cracked, probably because of the presence of a rigid plaster that makes the cracks more evident. The structure has been completely propped to guarantee safety.

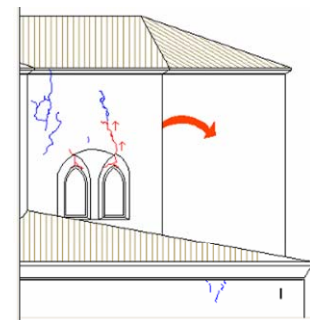
**Figure 10 – S. Michele Arcangelo at Sabbio Chiese**

Four churches are affected by the rotation mechanism of the ending part of the apse. In Figure 10 the church of S. Michele Arcangelo at Sabbio Chiese is illustrated. Two long cracks can be seen in symmetrical position, sometimes cutting the whole wall thickness, indicating a detachment of the ending part of the apse due to out of plane rotation.

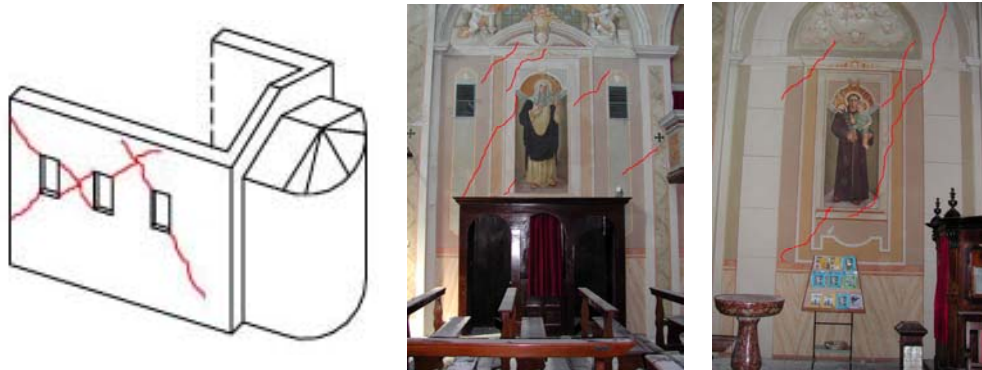
**Figure 11 - S. Antonio Abate at Morgnaga**

Because of the good transversal connection offered by the roofs and by the lateral chapels when present, no out of plane rotation of the lateral bearing walls has been observed, except that in the case of the central plane church of SS. Crocifisso, where the vertical cracks in the façade is prsumably due to a rotation of the lateral walls. On the contrary, shear cracks showed in the case of three churches. The phenomenon is less frequent than the in-plane mechanism of the façade, probably because of the higher in-plane flexural stiffness of the lateral walls and to the higher slenderness of the façade. In Figure 11 the crack patterns appeared on the north and south walls of the church of S. Antonio Abate at Morgnaga are shown.

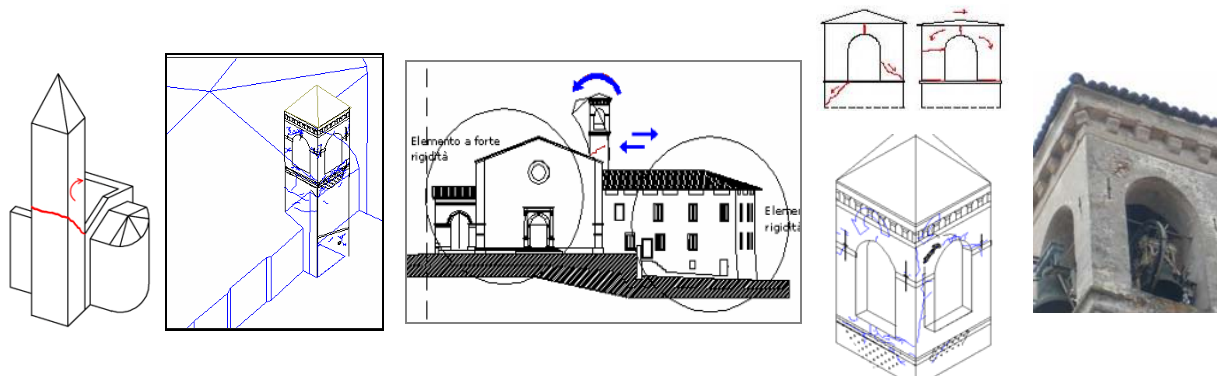
**Figure 12 – Bell-tower of S. Michele Arcangelo at Sabbio Chiese**

The bell-tower was not present in all the case studies. In general its failure mechanisms are influenced by its position with respect to the church and by the kind of connections, considering that it may be particularly vulnerable because of its slenderness. In Figure 12 the bell-tower of S. Michele Arcangelo at Sabbio Chiese is shown, which is affected by severe crack patterns. In particular, the cracks on the east and west fronts indicate a movement of the tower in the north-south direction. In fact, the upper part of the tower can freely move whereas the lower part is well constrained by the church and the rectory. East and west faces of the belfry show a crack corresponding to the keystone, probably due to an out of plane rotation of north and south walls.

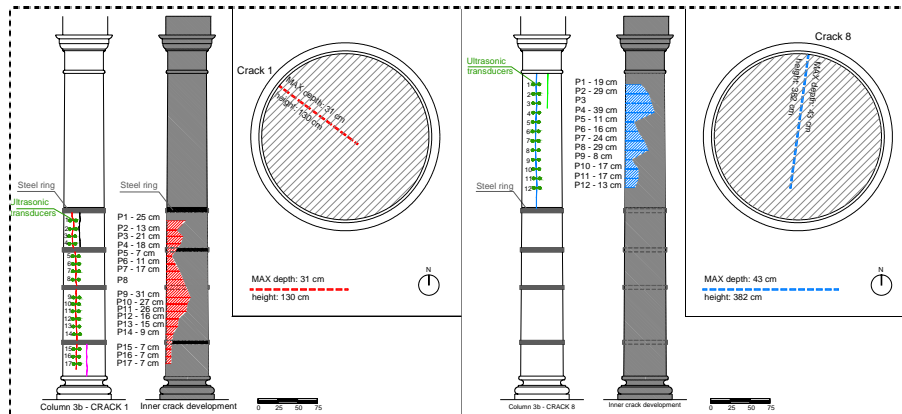
**Figure 13 - Ultrasonic tests to characterize the inner crack development into a column.**

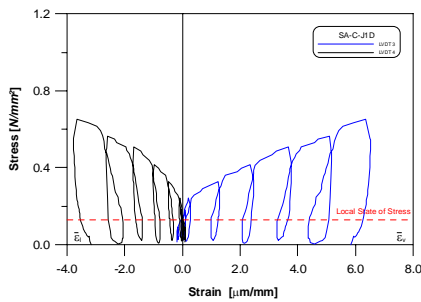
**Figure 16 - S. Antonio in Morgnaga, rectory**

The calculated values of the elasticity modulus allows for the subdivision of the churches into three categories: 1) from 189 to 803 N/mm<sup>2</sup>, corresponding to a very weak masonry with internal voids and no connection between the masonry leaves, 2) from 1063 to 1732 N/mm<sup>2</sup>, corresponding to a better masonry but with poor connections between the leaves, 3) from 2860 to 5260 N/mm<sup>2</sup> a definitely compact masonry well connected transversally. Figures 16 - 18 show some typical diagrams obtained with the double flat-jack test. It is interesting to notice that in these diagrams the previous categories of masonries can be recognised. Figure 16 shows a bilinear response with low stiffness, Figure 17 is typical of medium stiffness, and Figure 18 shows high stiffness of the masonry.
