A case study on corrosion conditions and guidelines for repair of a reinforced concrete chimney in industrial environment

Maddalena Carsana, Matteo Gastaldi & Elena Redaelli

Department of Chemistry, Materials and Chemical Engineering "Giulio Natta", Politecnico di Milano, Milano, Italy

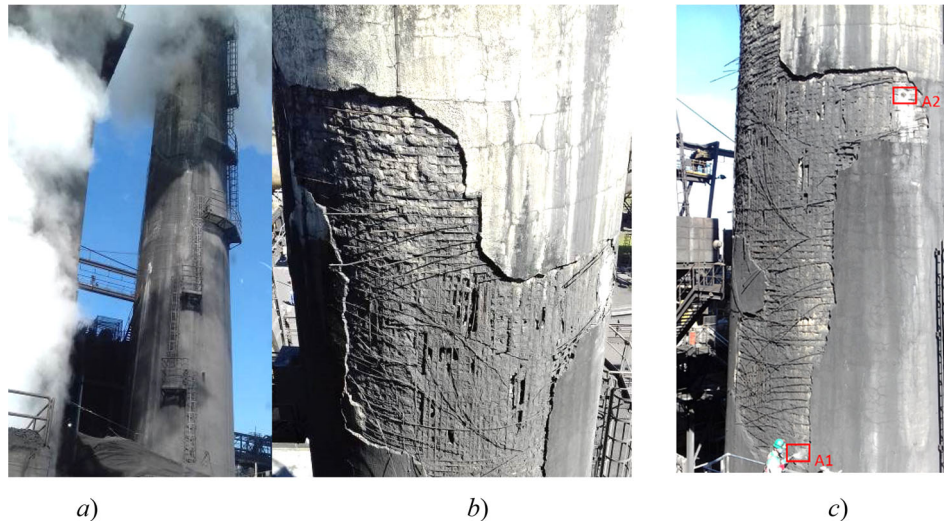
During the several inspections some visual observations of the structure were carried out to assess the signs of deterioration and to locate zones for sampling (Figure 2(a)–(b)). Phenolphthalein test was carried out on concrete samples to assess the depth of carbonation; moreover, both chloride and sulphate contents were measured on samples collected at different depths. Measurements of density, water content and compressive strength were also carried out on two cores collected during the last inspection in zones A1 and A2 (Figure 2(c)). These samples, named respectively A1 and A2, allow to understand the stratigraphy of the cementitious materials used to realize and repair the external wall of the chimney. Core A2 is made up of a concrete portion and an overlying coating of mortar. Differently, core A1 is homogeneous and is characterized only by concrete.

**Figure 2.** Exposure conditions of the chimney (a) and visual inspection carried out (b–c) in June–July 2019 (red rectangles indicate in Figure 2(c) the sampling zones A1 and A2).

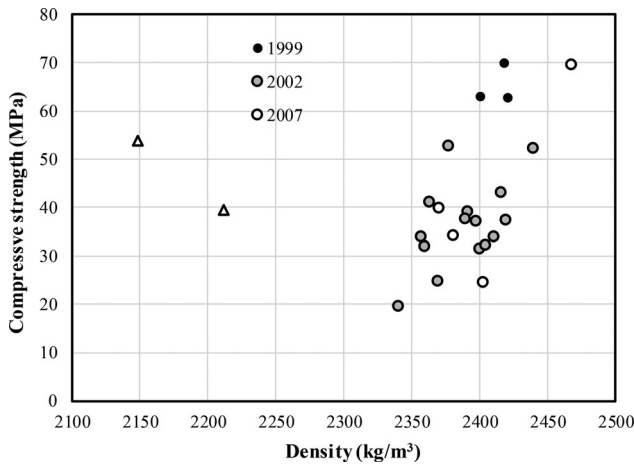
Figure 3. Values of compressive strength and density obtained on cores taken in 1999, 2002 and 2007 (triangles indicate values obtained on repair material).

The investigation of 2007 confirmed again a wide variability of the results. The significant mechanical resistance found initially for the concrete is compatible with a water/cement ratio (w/c) estimated equal to 0.47 and a supposed type of cement (CEM V) evaluated on the basis of recent thermo-gravimetric and chemical analyses made on samples of original concrete collected from zone A1 (Table 3). Microstructural observations carried out on concrete show the presence of several micro-cracks in the cement paste to which both the decrease of mechanical resistance in time and the wide variability of the results could be attributed. Moreover, based on the visual observations of cores, in particular those collected during the first investigations, the presence of macro-cracks which extended along the concrete wall of chimney emerged already since 1999, before the repair interventions. These discontinuities extended to a depth of about 60 mm, i.e., near the steel reinforcements. The formation of these cracks could be traced back to the settlement of the concrete which can crack right at the reinforcements after laying. This hypothesis might be confirmed by the presence of carbonated concrete at the depth of the reinforcements. The presence of such cracks was noticed in various concrete cores at a comparable depth.

On the other hand, the repair materials used in the different interventions were not sufficiently characterized in terms of mechanical performance (triangle symbols in Figure 3); however, if properly placed, they should have guaranteed, in agreement with their technical datasheets, good mechanical and durability properties (for example, in terms of expansion, resistance to vapour diffusion and penetration of carbonation).

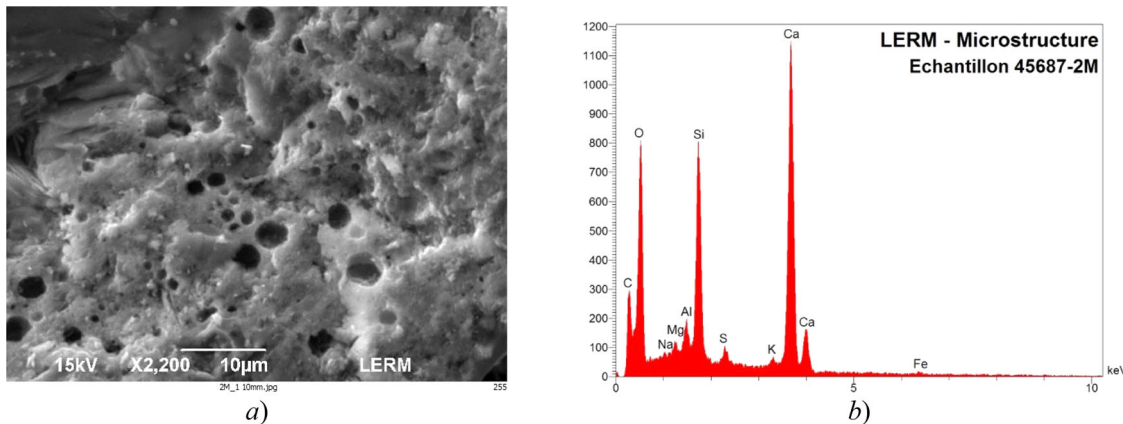
Figure 4. Scanning electron microscope observation (a) and related EDS analysis (b) of the repair mortar sample A2 (LERM SETEC, 2019).

spread on the surface (Figure 4(a)) thus confirming the likely effect of atmosphere contaminants.

Nevertheless, despite promising features in terms of estimated water/cement ratio of this repair material, its cement paste appears to consist of small vacuoles and micro-porosities (Figure 4(a)) which favour the permeability to aggressive agents.

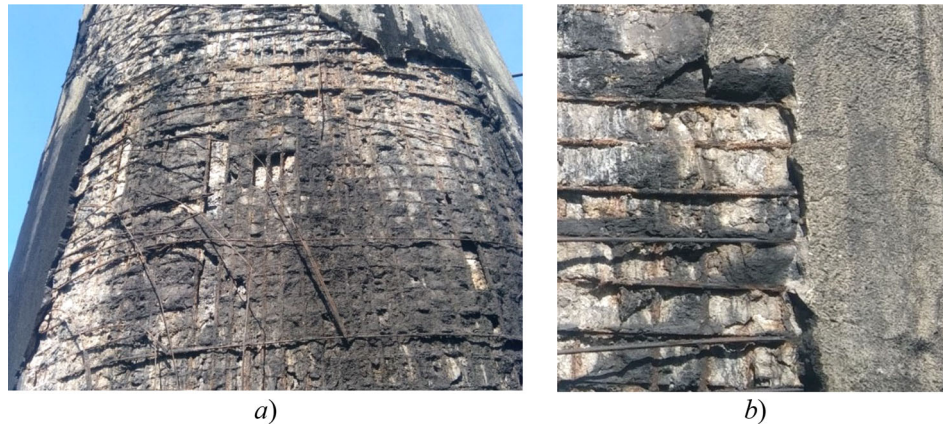
As a matter of fact, regarding the current condition assessment of the chimney, it is possible to distinguish wide delaminated zones, in which the repair material appears already strongly degraded and detached (Figure 5), from those macroscopically intact where the repair material shows superficial cracks with random distribution (Figure 2(b)). These superficial cracks could be the sign of stresses induced by drying shrinkage due to inappropriate execution or to a poor curing of the repair material. In particular, it should be highlighted that the spray technique used for the placement of the repair mortar is not considered adequate

for such high thicknesses (higher than 50 mm). Moreover, once placed, the repair material has to be stable until setting and needs adequate curing; very likely the exposure condition might have made the curing step of repair material critical.

Figure 5. Details of degradation of repair material (a) and corrosion reinforcement (b) of the chimney (documented in June 2019).

However, in the detachment zones the reinforcements are visible (Figure 5(b)) and are in advanced state of corrosion with corrosion products that completely cover the segments of reinforcements taken in the zone A1 (Figure 8). Moreover, in these zones the bars often appear congested (Figure 2(b)); this may have prevented an adequate protection by concrete. Certainly, the maximum carbonation thickness measured on concrete in the last investigation campaign is comparable with that of concrete cover by confirming that not all steel bars are in passive condition. In addition, the presence of condensate on the external surface of the chimney increases the duration of periods of wetting. This may increase the rate of attack of the reinforcements that are already corroding. The temperature of fumes as well as the presence of various contaminants could also

Moreover, condition assessment of chimney has to take into account the fact that currently, following the wide detachments of concrete and repair mortar for restoration, parts of the reinforcements are no longer embedded (Figure 5); thus, they are directly exposed to atmosphere. In addition, the fumes that invest the chimney could represent a criticality also for the reinforcements currently exposed to atmosphere. However, it is necessary to highlight that the steel bars directly exposed to the atmosphere represent a transitory situation (before a planned intervention) and that the best way to protect them from corrosion is to embed them in an alkaline and chloride-free cementitious material.

As far as the repair material is concerned (EN 1504, 2017), the use of a flowable mortar or self-compacting concrete (according to the thickness) is suggested. These materials can be poured inside moulds that, besides hydraulic tightness, provide protection from the environmental aggressiveness in the first hours or days after placing. Pouring in moulds allows to cast the whole thickness of repair material in a single layer, avoiding cold joints. Moreover, the repair material shall guarantee resistance to aggressive substances, hence it shall be a cementitious material with low w/c ratio and pozzolanic or hydraulic additions, besides superplasticiser admixtures. It shall be cured according to prescriptions from the producer, so as to avoid early damage (such as shrinkage cracking) and allow a correct hydration of cement, fully exploiting the beneficial effects related with the pozzolanic or hydraulic additions (such as fly ash and silica fume additions in various amounts). Given the high number of possible additions, the definition of the mix proportions is difficult to perform on-site. Premixed products are commonly used. On the market, a great variety of premixed mortar is available with various properties at the fresh and hardened state. Consequently, the designer should be able to express clear prescriptions on

The repair material shall be applied in a way to guarantee an adequate cover thickness. This parameter shall be chosen by the designer based on both structural and durability requirements. From durability point of view, a design value of 50 mm could be chosen, in agreement with Eurocode 2 (EN 1992-1-1, 2004) that prescribes a minimum value of 45 mm for new structures exposed to the most severe exposure classes. Considering that the expected service life of the repair is 10 years, a design value of 50 mm can be considered more than adequate.

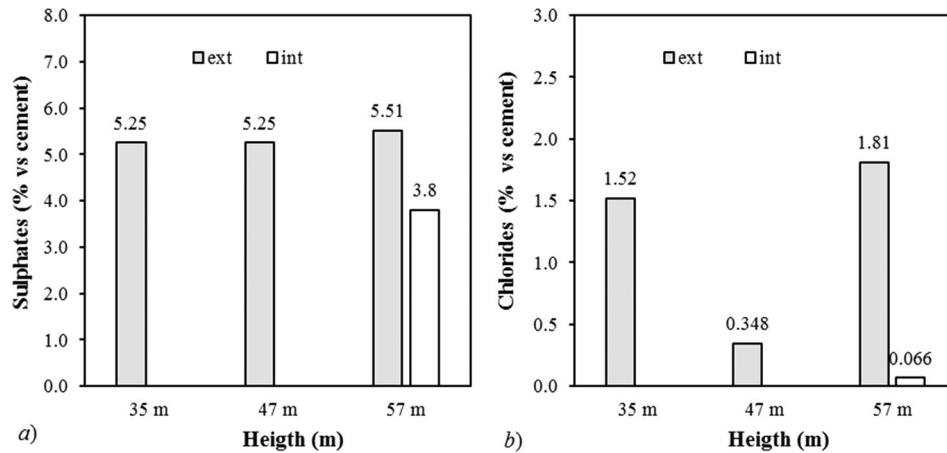
The results of analyses carried out in 2007 (not reported in this paper) were mainly concerning the repair material in which the presence of sulphates was even lower than that of the previous analyses (Figure 6(a)). Recent tests (Figure 7(a)) show negligible values of sulphates in the repair mortar A2. In the original concrete the sulphates content measured during the last analyses is higher than the threshold value only in the outer 20 mm (6.29% by cement mass, Figure 7(a)). Indeed, analyses made by electron scanning microscopy show the presence of compounds based on calcium sulphate and monosulphate hydrates, especially in the outer 15 mm. In general, such concentrations are not

Figure 6. Results of sulphates (a) and chlorides (b) analyses on the external (*ext*) and internal (*int*) sides of concrete cores taken from the chimney in June 1999.

The average chloride content on external side of cores is higher than the maximum of critical threshold range (0.4–1% by mass of cement for carbon steel) with values of 1.52–1.81% by mass of cement; conversely, a negligible chloride content is measured in depth (0.066% by mass of cement, Figure 6(b)). Differently, the analyses carried out after the first intervention (2007), probably on the repair materials applied along the South side of the chimney in partial replacement of the original concrete, showed that the chloride content was 0.25–0.56% by mass of cement, i.e., next to the lowest limit of critical threshold. Recent analyses showed that the presence of chlorides decreases with the depth (Figure 6(b)). However, even at depth of 50 mm a total chloride content higher than maximum limit of critical chloride threshold was measured.

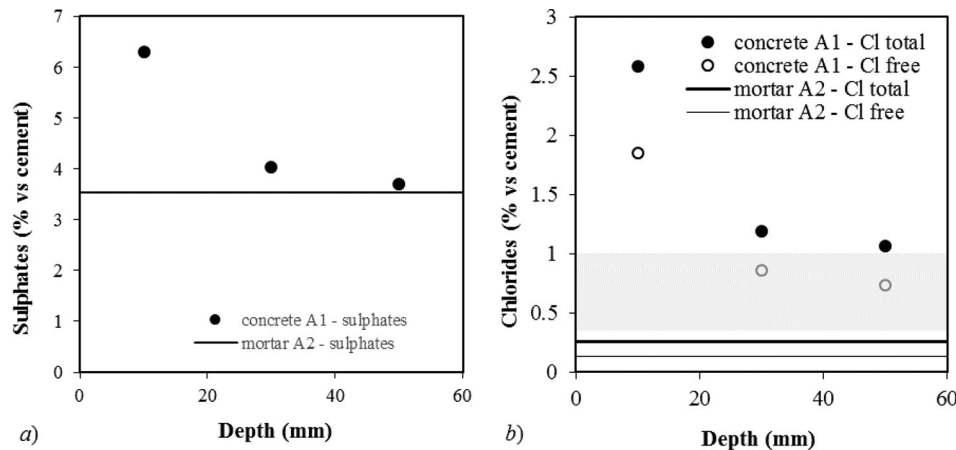
considered significant to confirm that a sulphate attack is in progress, also because they are limited only at surface layer of original concrete. Moreover, the results obtained also through thermo-gravimetric analysis (TGA, Table 3) do not highlight significant differences between samples of repair mortar and those of original concrete.

Figure 7. Sulphates (a) and chlorides (b, free and total) concentration as a function of depth for the concrete sample A1 taken in 2019. Grey background is indicative of the critical range of chlorides 0.4-1% by cement mass (in Figure 7(b)). The average contents measured in terms of sulphates and chlorides on the mortar sample A2 are also reported (black line).

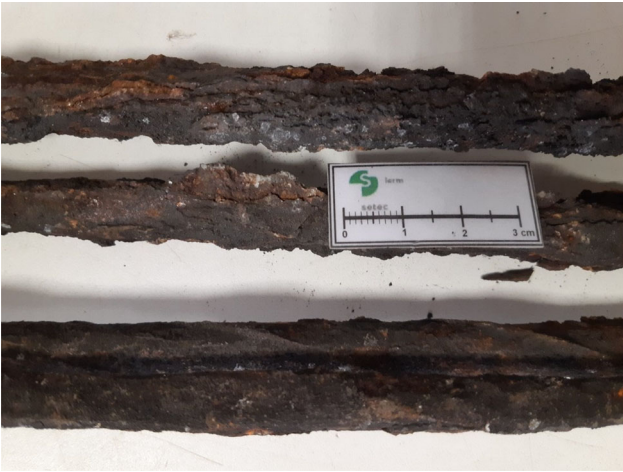
Figure 8. Visual observations of some reinforcement samples (LERM SETEC, 2019).

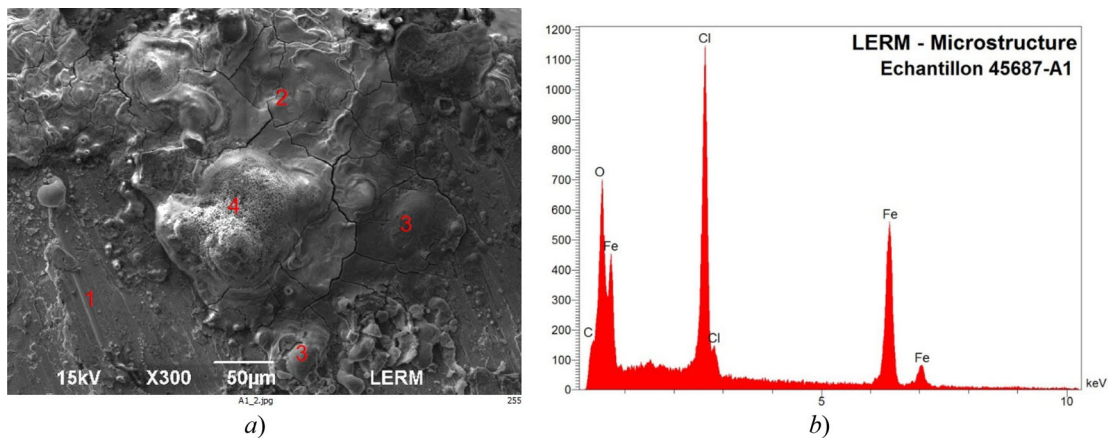
Actually, EDS analysis has allowed to detect the presence of chlorine on the metal surface (Figure 9(b)) as well as to observe the morphology of its corrosion products (Figure 9a). Since the corrosion attack involves a large area of the reinforced segments (Figure 8), the morphology of pitting is not so evident, even if EDS analysis has confirmed the presence of chloride at the depth of steel surface. Differently, the analysis carried out during the same survey on a repair mortar sample shows a chloride content equal to 0.26% by mass of cement to be considered overall on a maximum thickness of 60 mm. Thus, the repair mortar shows a good resistance to chlorides penetration. On the other hand, the documented permanence in the original concrete of chlorides, in quantities certainly not negligible even at depths of 50 mm, represents a risk for the corrosion initiation. This confirms that the repair interventions on the chimney have not implied an appropriate removal of concrete contaminated by chlorides. Nonetheless, in the presence of chlorides at the cover depth, it is necessary to expect that in a carbonated concrete the corrosion rate of carbon steel bars can be high even for low relative humidity. In absence of complete removal of chloride-contaminated concrete, it would be useless to use a repair mortar with a certain resistance to

Figure 9. An example of SEM observation (a) and EDS analysis (b) carried out on steel sample (LERM SETEC, 2019).
