# Corrosion assessment of reinforced concrete elements of Torre Velasca in Milan

Federica Lollini\*, Elena Redaelli, Luca Bertolini

Politecnico di Milano, Department of Chemistry, Materials and Chemical Engineering "Giulio Natta", piazza Leonardo da Vinci 32, 20133 Milan, Italy

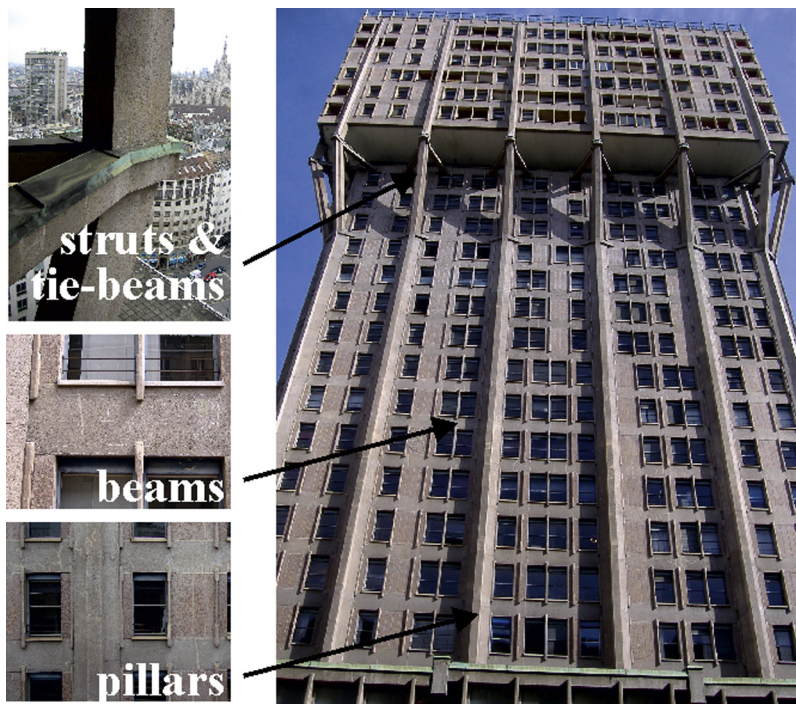
Torre Velasca was designed by the B.B.P.R. studio and built in 1956–1958 (Fiori and Prizzon, 1982). The tower, which is 106 m high and has 29 floors (Fig. 1), two of which are underground, can be divided in three zones: the lower part, from the ground level to the 15th floor, the intermediate part from the 16th to 18th floor, and the upper part till the 26th floor. The dimensions of the lower and intermediate zones are  $21.08\text{ m} \times 38.46\text{ m}$ ; struts and tie-beams, which are present in the intermediate part, support the larger upper part, which is  $27.40\text{ m} \times 44.78\text{ m}$ . The perimeter of the tower is characterised by the presence of projecting load-bearing pillars, beams, struts and T-beams (Fig. 1). According to available documents, major repair works had been carried out on the facades in 1978–1979 and in 1995, due to evident deterioration of structural elements.

Fig. 1. View of a facade of Torre Velasca and indication of structural elements.

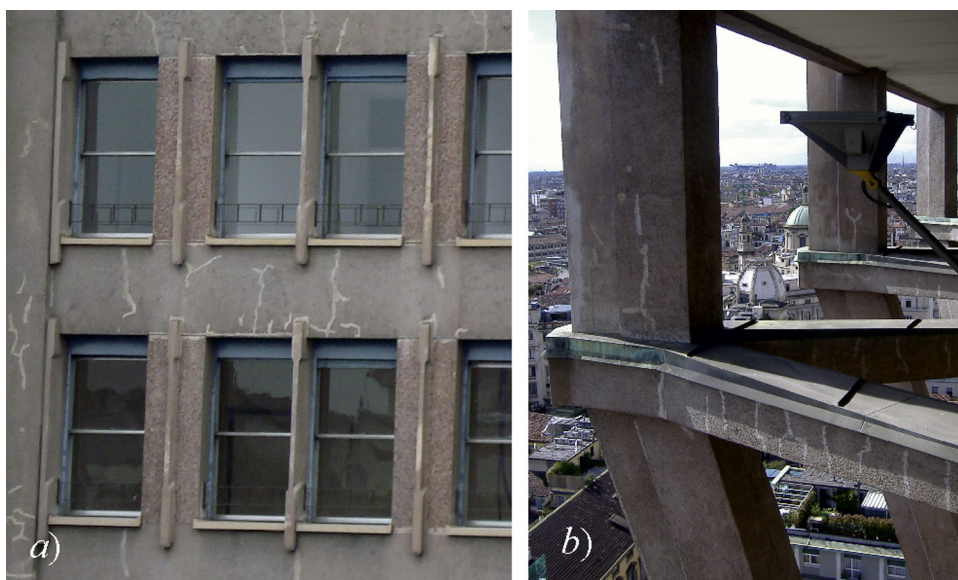
The visual survey of the facades showed the presence of cracks on the render of the pillars. Most of these cracks had been sealed in the past with a whitish product which made them clearly visible (Fig. 2a). Similar cracks were visible on beams, tie-beams and struts (Fig. 2b). On the struts, the render had been repaired over large surfaces (Fig. 2b). In general, no clear signs of corrosion-induced damage were observed on the elements during the inspection.

Fig. 2. Details of elements on the facades of Torre Velasca: pillars and beams (a), struts (b).

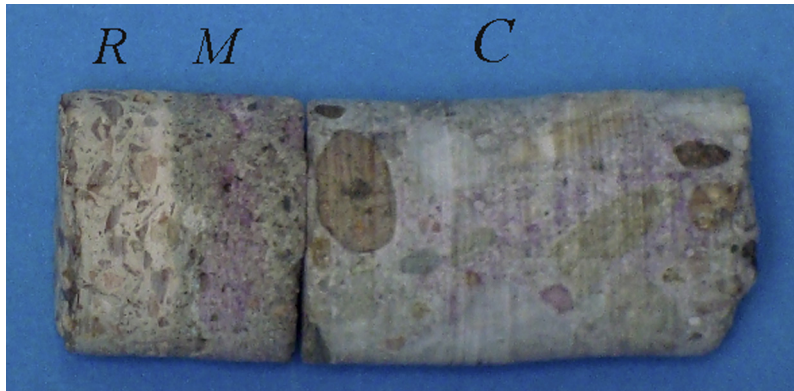
Sixty five core samples, taken from the different elements, were analysed to assess the nature of the different materials that cover the steel reinforcement and to measure the carbonation depth. Their observation showed the presence of three layers: an external render (*R*), an intermediate mortar (*M*) and the structural concrete (*C*) (Fig. 3). The layer of render was usually adherent to the layer of mortar, which, conversely, was often detached from the underlying concrete. Both the render and the mortar appeared very dense with a low porosity: absorption values of 7.3 and 7.9% were respectively measured, as average value of two samples, on the render and mortar, whilst on concrete an average value of 5.2% was detected. The thickness of each layer showed a great variability: the thickness of render *R* was in the range 5–27 mm, whilst the thickness of mortar *M* was between 5 and 50 mm (Table 1). As a consequence, the total thickness (*R* + *M*) showed a great variability with values between 12 and 75 mm. The average values were 13 and 17 mm for render and mortar, respectively, and about 30 mm for the total thickness.

Fig. 3. Typical stratification of a core ( $\Phi=26$  mm) taken from a pillar and designation of layers: R=render, M=mortar, C=structural concrete.

However, from the core sampling it was observed that the render and the mortar layers were often detached from the underlying concrete. It is likely that the detachment was also promoted by damage during coring; nevertheless, these results suggest that the mortar-concrete interface is a weak point. Although at the time of inspection there was no evidence of massive debonding of the render and the mortar layers, this aspect needs a careful investigation, not only for safety reasons (consequence of falling of debris would be extremely serious for people in the street), but also because it may affect the performance of the repair intervention itself. In fact, in the absence of good adhesion, the concrete would no longer benefit from the barrier effect against water, and the corrosion of rebars embedded in carbonated concrete could propagate with a rate that will depend on the moisture content. A detailed survey on the adhesion of the render and the mortar layers is necessary during the design of the repair work. In case it is shown that the layers are not well adherent to the underlying concrete over large areas, the previous repair strategy is not applicable. The original materials should then be removed and the application of a new plaster with a cement-based coating, which reproduces the texture of the original plaster, is
