SURVEY, HBIM AND CONSERVATION PLAN OF A MONUMENTAL BUILDING DAMAGED BY EARTHQUAKE

D. Oreni ^a, R. Brumana ^a, S. Della Torre ^a, F. Banfi ^b

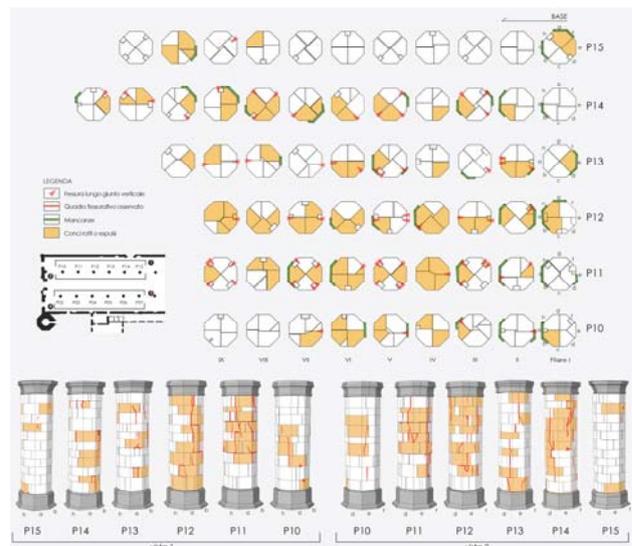
A detailed mapping of the crack pattern and the position of the broken or degraded ashlars were performed, in order to plan the different conservation activities: replacing, integration or consolidation. It was evident that the number of the elements to completely substitute will be added or changed during the restoration site; it will be especially necessary to deep investigate all the areas interested by past restoration interventions, where the cracks were cover using a filling mortars made with the powder of the same stone, hiding any other broken ashlar.

Figure 5. 2D and 3D drawings of the left nave's columns and their stone ashlars. In yellow color, the broken ashlars (diagnostic analysis).

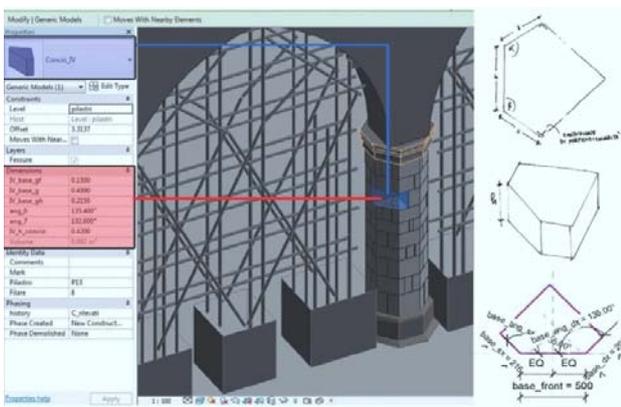
Similarly, it was possible only to make constructive suppositions about the size of the mortar internal core of the pillars (partially visible only in column n. 6), definitely variable in position and dimension.

Figure 7. HBM of octagonal stone pillar n. 6 of the nave. On the right the hands on survey of the only ashlar completely visible.

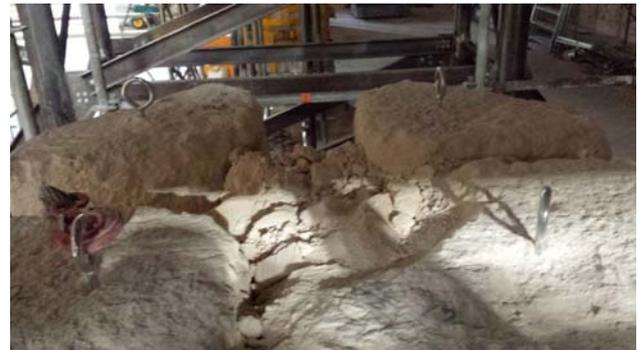
Figure 8. Top images of a pillar during the disassemble step; in the centre, the irregular mortar core of the column.

The first phase of the restoration of the columns consisted in the removing of the vertical loads, by inserting progressively metal temporary structures under the two relevant arches. This operation allowed proceeding with local intervention of stone ashlar replacement or with the complete disassemble operation of the columns.

First were disassemble, starting from the upper part, numbered and reassemble on the floor, the ashlars of the central pillars (P04-05-06-12-13-14), the most stressed by the seismic actions and extremely degraded (Crespi, 2016). This operation allowed to verify the exact geometry of the stone elements, to evaluate the material and thickness of the central core (Figure 8), to recognize the broken elements (not visible from outside) and to refine and rectify the drawings made during the diagnostic phase (Figure 9).

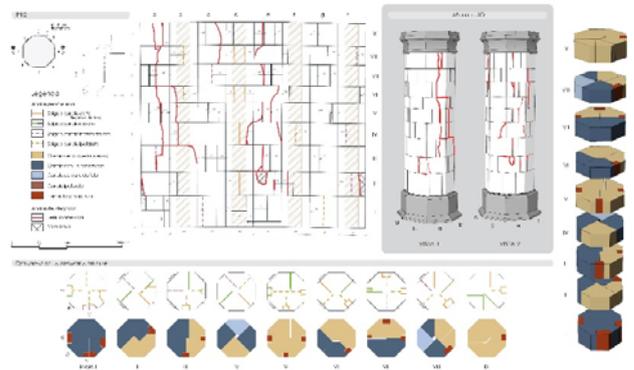
Figure 9. Pillar n. 12: drawings made during diagnostic phase.

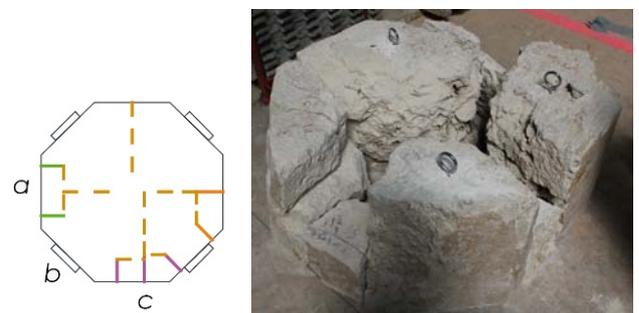
Figure 10. Pillar n. 12 – row I. On the left, diagnostic drawing; on the right the ashlar disassemble and reassemble on the floor of the Basilica.

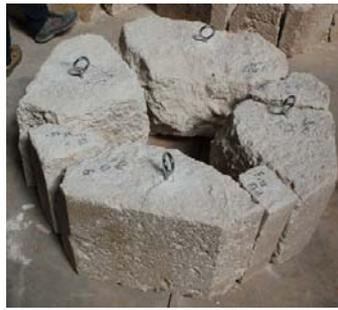
Figure 11. Pillar n. 12 – row III. On the left, diagnostic drawing; on the right the ashlar disassemble and reassemble on the floor.

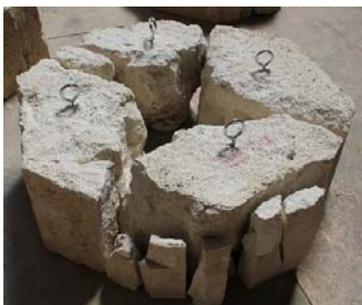
The operation of disassemble of the central columns of the nave has showed a big difference between the shapes of the core of each row, depending from the stone ashlar dimension and disposition. In some rows the central core occupies until the 50% of the total area, compromising the mechanical characteristics of all the elements. The material filling the core is the so-called “incoherent mortar”, poor of aggregates, similar to the mortar analysed in the pillar n. 6, during the diagnostic phase. Throughout the restoration activities, it was possible to recover some stone elements, in some case using metal connection or paste, that were considered seriously damaged in diagnostic step; in that case, in fact, their external condition did not reflect the inner one (Figure 13), therefore it was possible to recover them.

Figure 13. Pillar n. 11 – row I. It is evident the external deterioration of the stone, in good condition in the inner part.
