Case Studies in Construction Materials

A study on the cement-based decorative materials in the San Fedele Church in Milan

Federica Lollini*, Maddalena Carsana, Luca Bertolini

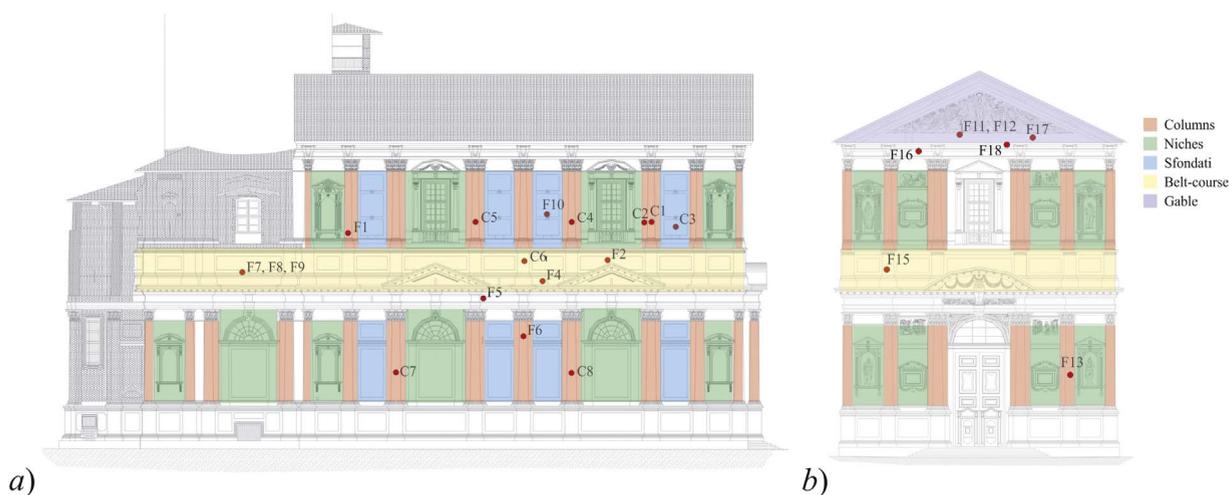
Fig. 2. Indication of the main elements and sampling: left side (a) and main façade (b) of San Fedele Church.

To characterize the different types of materials and evaluate their state of conservation a sampling was carried out. Fragments were taken manually, especially in those areas where materials appeared to be damaged, while other samples were cored to define the different layers of materials. Fig. 2 shows the position of the specimens: letter *F* identifies the fragments taken manually and letter *C* identifies the cores. On the left side, 10 fragments and 8 cores were taken (Fig. 2a), whilst on the main façade 7 fragments (Fig. 2b). Finally, for comparison also a sample of Angera stone was collected (*F3*); this sample was already detached from the substrate and hence the exact location is unknown.

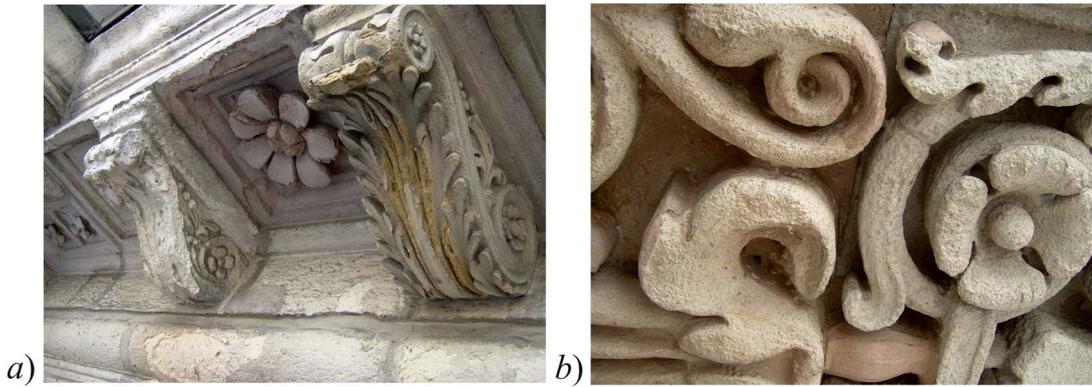
Fig. 3. Damaged decorations in Angera stone on the left side (a) and well preserved decorations made in cementitious materials on the main façade (b).

The façades of the San Fedele Church are characterized by the presence of renders and decorations in cement-based materials, which imitate in texture and colour the Angera stone. Renders are present on the elements of the church as the columns and the *sfondati*. The inspection revealed that the decorations, predominantly present in the main façade, under the gable are similar in the shape, but not in the materials, to those present in the left façade. In fact, those present in the left façade are made in Angera stone and showed, at the time of inspection, a high level of degradation, with exfoliation, granular disintegration and scaling (Fig. 3a), whilst those in the main façade are made with cement-based decorative materials and showed a better state of conservation (Fig. 3b).

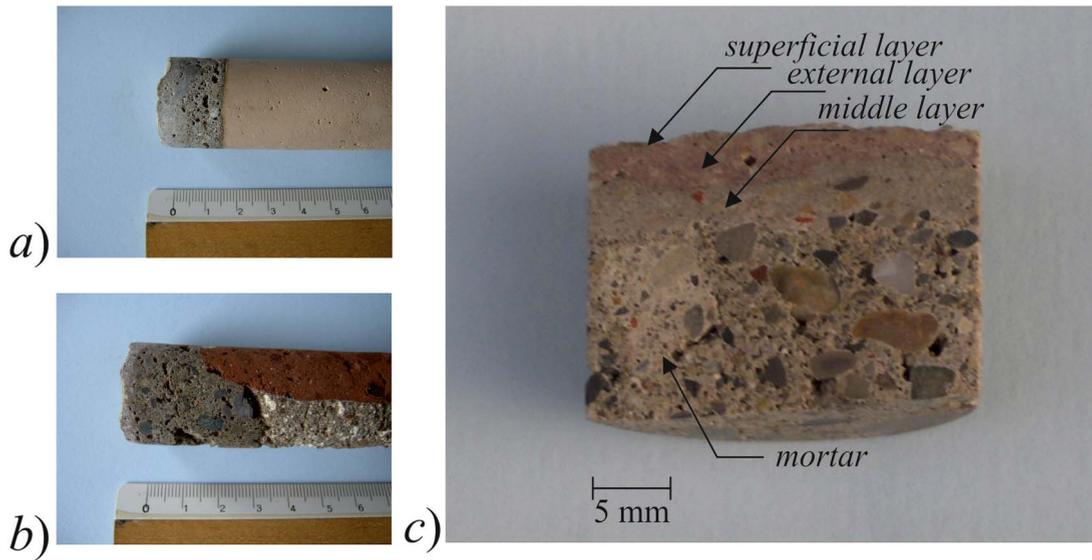
Table 1 lists all the analysed specimens, indicating their location, the stratigraphy, the thickness of each layer and the main results of visual observations. Cores allowed to verify that, in some cases, the column was made with the Angera stone and a layer of cement-based repair render was applied directly on the damaged stone (Fig. 4a). In other cases, the render was applied above burnt-clay bricks as for the columns of the second order (Fig. 4b) or the *sfondati*. Furthermore the macroscopic analysis showed a multilayer

The visual observations showed high cohesion between the various layers of render and substrate and did not show any type of

Fig. 4. Example of sample (C1) cored from a stone column (a) and (C4) from a brick column (b) and example of stratigraphy of the sample (C5) from a brick column (c).

damage, suggesting a good state of conservation of the cement-based decorative materials.

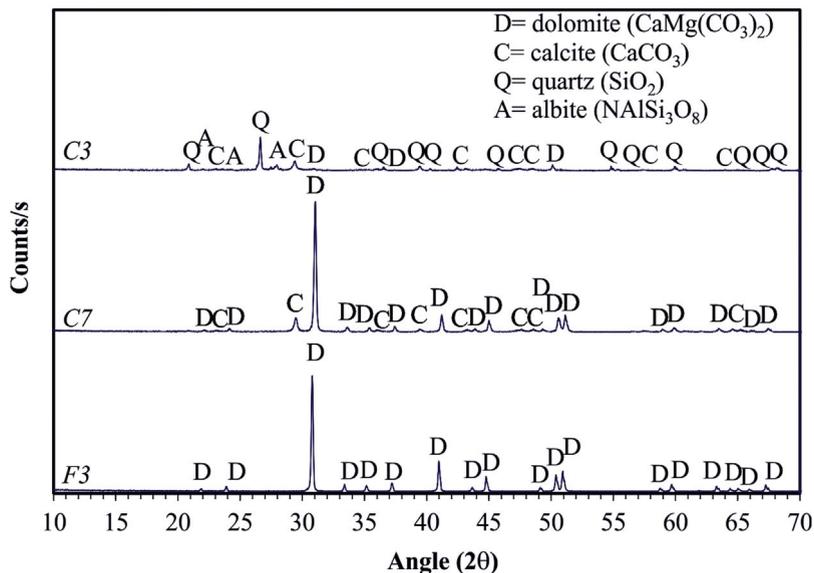
Although the study was focused on the cementitious materials, also a sample of Angera Stone (F3), which visually appeared yellow and porous, was analyzed. From X-ray diffraction (XRD) analyses the presence of the calcium magnesium carbonate (CaMg(CO₃)₂), in the crystalline form of dolomite was assessed (Fig. 5). Fig. 6 shows the thermogravimetric analysis of this sample: a unique relevant mass loss can be observed in the TG curve, at temperature between 550 and 750 °C, which is associated to the decomposition of calcium magnesium carbonate. The mass loss of 47.7% showed that the stone was entirely constituted by dolomite.

Analyses were then carried out on samples of cement-based decorative materials. As far as the composition of the external layer is concerned, in all the samples, the presence of calcium carbonate (CaCO₃) with the crystalline structure of the calcite (C) and of quartz (Q) was detected through XRD analyses and their peaks were always those of greater amplitude (Table 1). Sample C7 was an exception, since quartz was not observed (Fig. 5).

For those samples with a pink or yellow colouration, the XRD analyses showed also the presence of dolomite (D). In particular, it was observed that the samples of the first order of the left side, especially those taken from the stone columns (C7 and F6), had a higher content of dolomite in comparison to those taken from the second order. Comparing the XRD diffractogram of a sample taken from the first order, as sample C7, with one taken from the second order, as sample C3, it can be observed that in both samples

Fig. 5. XRD analyses of samples F3 (Angera stone), C7 and C3.

dolomite was present, however in the sample taken from the second order the dolomite peaks intensity was more pronounced (Fig. 5). In some cases, XRD peaks of other crystalline compounds were detected, which can be attributed to the presence of residual fragments of aggregates in the powders analysed, as, for instance, albite ($\text{NaAlSi}_3\text{O}_8$).

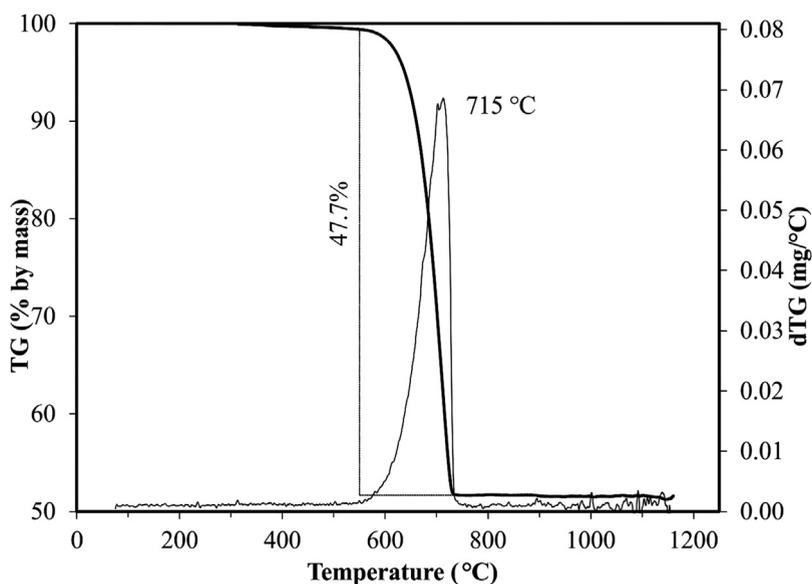
Fig. 6. Thermogravimetric analysis of sample F3: loss of mass of the sample as a function of temperature (TG) and its derivative (dTG).

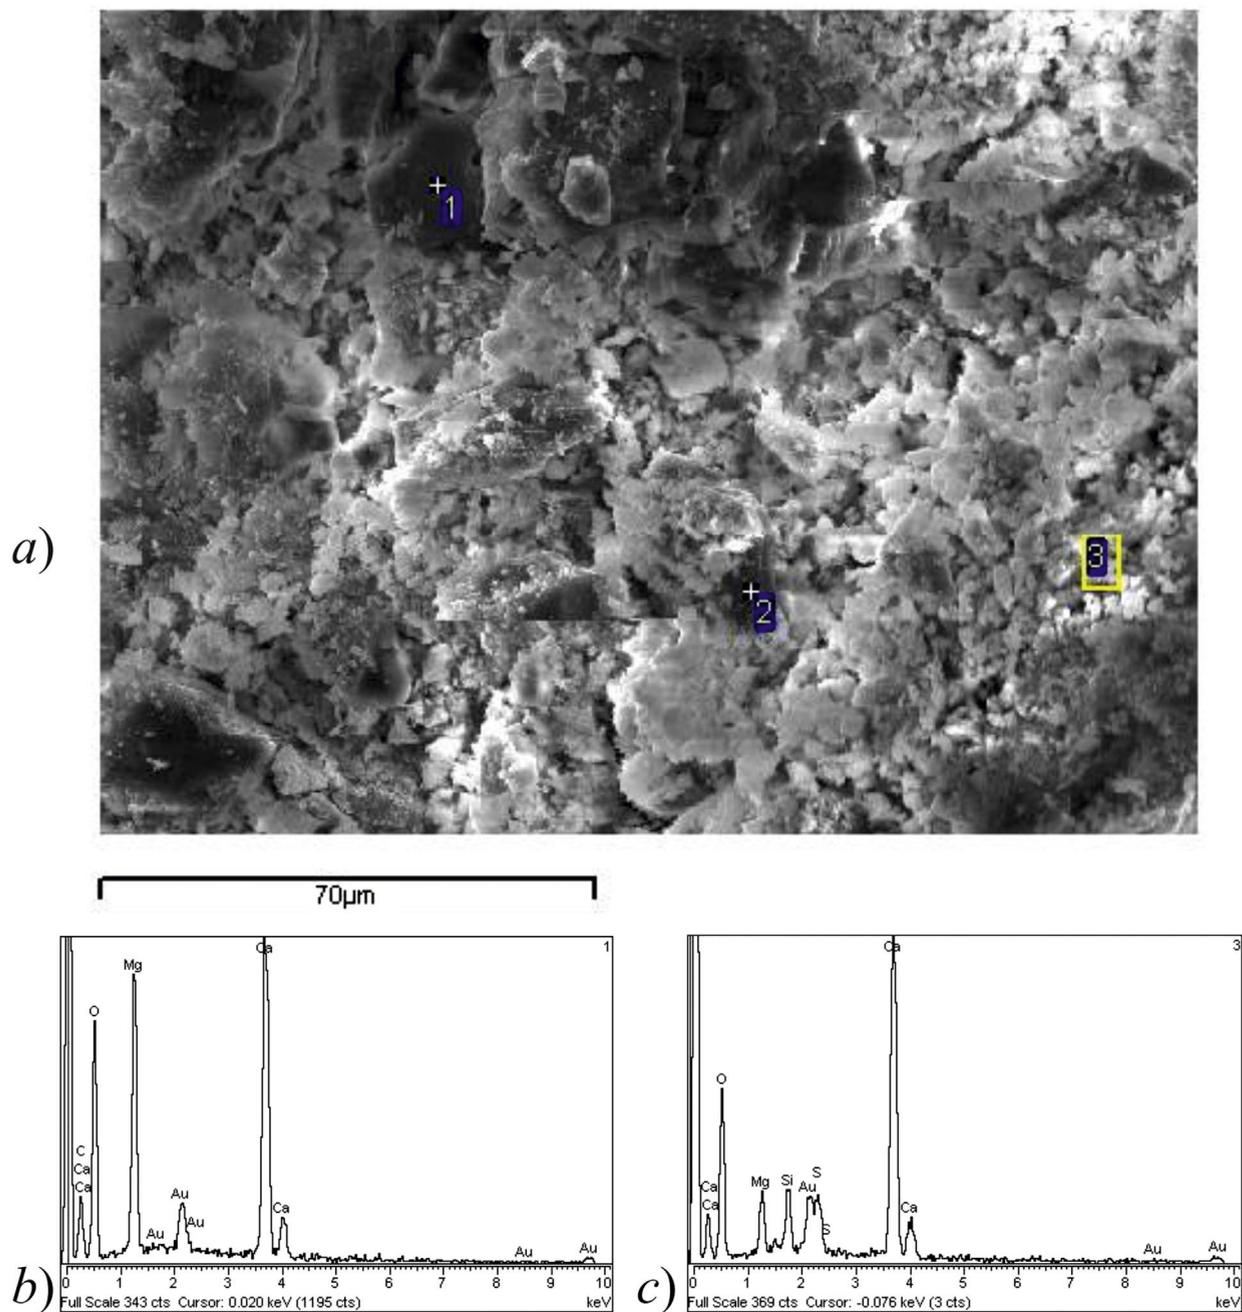
The observations with the scanning electron microscope and elemental EDS microanalysis showed that the matrix of the *external layer* was prevalently formed by calcium carbonated, as evidenced, for instance, by the presence of calcium, oxygen and carbon in the EDS microanalysis of Fig. 7c, as also detected by XRD and TGA analyses. This did not mean that, originally the binder was a lime mortar; as a matter of fact the calcium carbonate might be attributed to the carbonation of a hydraulic binder. An interesting aspect that emerged from EDS analysis of the areas in which there were particles of calcareous binder, was the presence of silicon (Si) and aluminium (Al). Since the analyses were made on spots and, therefore, directly on the particles that constitute the binder, it should be assumed that these elements had been incorporated in the reaction products. It can therefore be assumed the presence of silico-aluminates and, therefore, of compounds able to confer certain hydraulic properties to the binder [6,7]. These compounds typically are non-crystalline and, therefore, cannot be detected with X-ray diffraction analyses. This observation further supports the hypothesis of the employment of a hydraulic binder that could have contributed to the formation of a denser and more compact microstructure within the hardened paste, hardly compatible with the use of a non-hydraulic binder.

The observations with the scanning electron microscope and elemental EDS microanalysis confirmed the presence of dolomite within the cement matrix in the *external layer* of specific samples. Fig. 7a shows that, for instance, dispersed in the cement matrix, particles of dimension up to 10 μm were present, probably of dolomite, since they were constituted predominantly of calcium, oxygen and magnesium (Fig. 7b). In the samples with higher amount of dolomite, also aggregates of Angera stone, with dimensions of 1 mm, were spread in the matrix. Based on these analyses it is clear that the colour of the *external layer* was obtained by blending the binder with the Angera stone finely ground and, furthermore, using the stone also as aggregate. The analyses showed that in the cement-based materials used for covering the stone columns a considerable quantity of finely ground particles of dolomite was present, whilst those applied on substrate of bricks the dolomite content was less or in some case absent.

Fig. 7. SEM image of the binder of the external layer of sample C7 (a) and EDS analyses in spots 1 (b) and 3 (c).

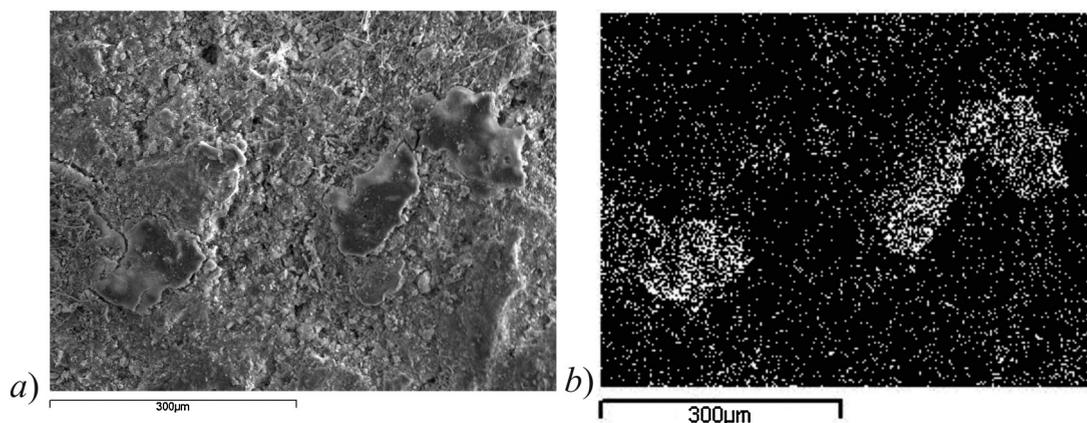
The observations with the scanning electron microscope, carried out on the *superficial layer*, revealed that both on the samples taken from the first and the second order, residuals of organic coating were present, in both façades. From the historic documents it emerged that in the second half of the 20th century several consolidating works were made on the façades of the church. The observations showed that the surface was characterized by the presence of darker and compact areas, probably due to the residues of the coating, and by lighter areas of the underlying cement paste (Fig. 8a). EDS microprobe maps of carbon (C), made on a portion of the *surface layer* of sample C5 (column, Left side – II order), showed that the darkest areas were enriched of this element, confirming the organic nature of the coating (Fig. 8b).

Fig. 8. SEM image of the *superficial layer* of sample C5 (a) and EDS map of carbon (b).

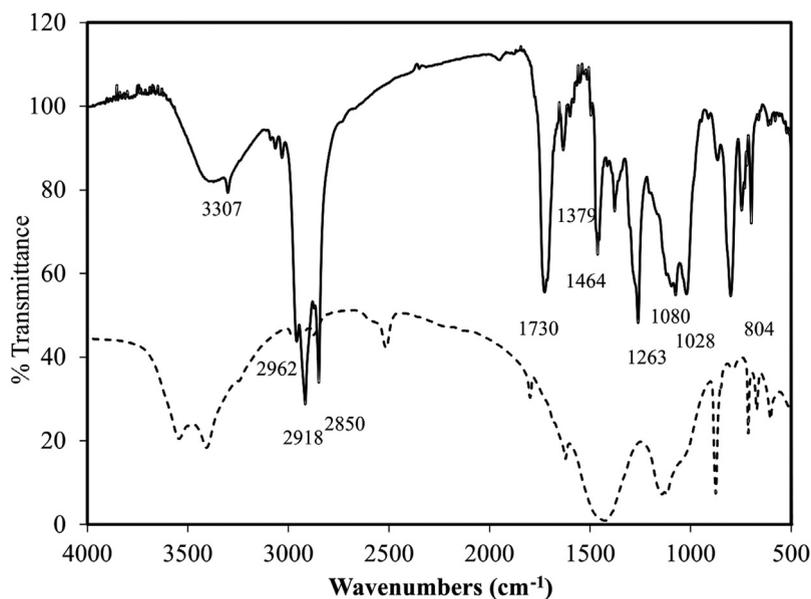
Functional groups of this polymer coating were analysed by FT-IR analyses, carried out on a powder sample taken nearby to core C5, Fig. 9. It can be observed that in an un-treated sample the absorption bands of calcium carbonate from the cement-based substrate (with wavenumbers of 804, 1080 and 1464 cm^{-1}) interfered with the determination of peaks of organic compounds. Only

after the extraction with toluene (full line in Fig. 9), absorption bands that can be correlated with acrylates (2962, 2918, 2850, 1730 and 1379 cm^{-1}), became visible, although a full determination of the organic nature of the coating was not possible [13]. SEM observation clearly showed that only traces of this treatment were present, so that the polymer coating did not affect the performance of the underlying layer.

Fig. 9. IR analyses on the *superficial layer* of sample C5 (full line: after toluene extraction; dashed line: without toluene extraction).

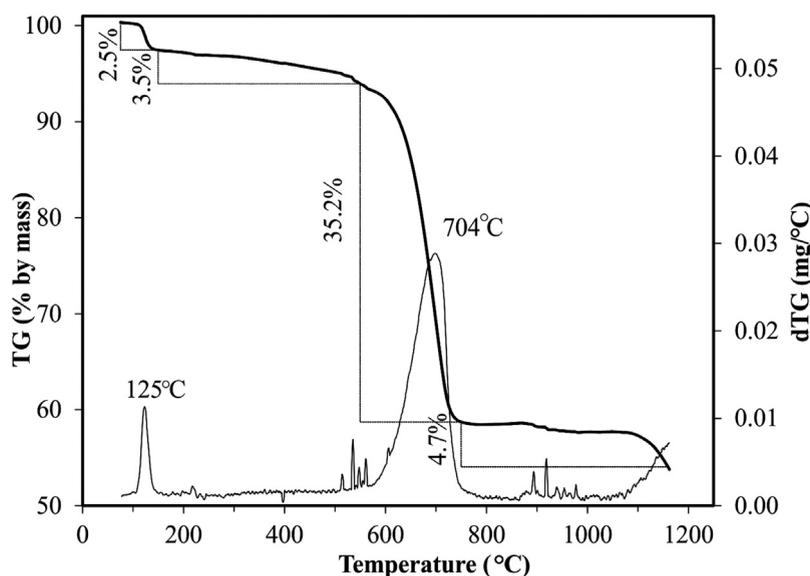
EDS analysis (Table 1). Hence, it might have been intentionally applied with the organic coating (since it was found in correspondence of this) [3]. By means of the thermogravimetric analysis (Fig. 10) the percentage of gypsum present in the samples was evaluated. In the TG analysis the first and last mass losses can be associated with gypsum. The first interval (at temperature lower of 150 °C) corresponds to the loss of water for the formation of hemihydrate and subsequently anhydrite (collectively: $\text{CaSO}_4 \cdot 2\text{H}_2\text{O} \rightarrow \text{CaSO}_4 + 2\text{H}_2\text{O}$) while the second, at temperature above 750 °C, is associated to the decomposition of anhydrite ($\text{CaSO}_4 \rightarrow \text{CaO} + \text{SO}_3$). Hence, through the loss of mass in these two intervals the percentage of gypsum was calculated. For example, in the *superficial layer* of sample C7 (Fig. 10) from the loss of 2.5% by mass observed around 125 °C a content of about 12% of gypsum can be calculated, while from the loss higher of 4.7% at temperatures above 750 °C a content of gypsum higher of 10% can be estimated. Therefore, in this sample, a content of gypsum about 10–12% can be estimated. Where present, the gypsum content ranged between 3% and 17% by mass (Table 1).

Gypsum may also be the result of alteration of calcium compounds due to the effect of sulphur-based pollutants (definitely present, at least since the 20th century, in the urban centre of Milan): in this case the attack was moderate and cannot be considered pathological, since it did not significantly affect the cohesion of the *superficial layer*.

Fig. 10. Thermogravimetric analysis of the superficial layer of sample C7.
