The Architectural Heritage in Seismic Area: Geometrical Survey for Damage Analysis and Strengthening Design

Giuliana Cardani¹(✉) and Paola Belluco²

¹ Department of Civil and Environmental Engineering, Politecnico di Milano,
Milan, Italy

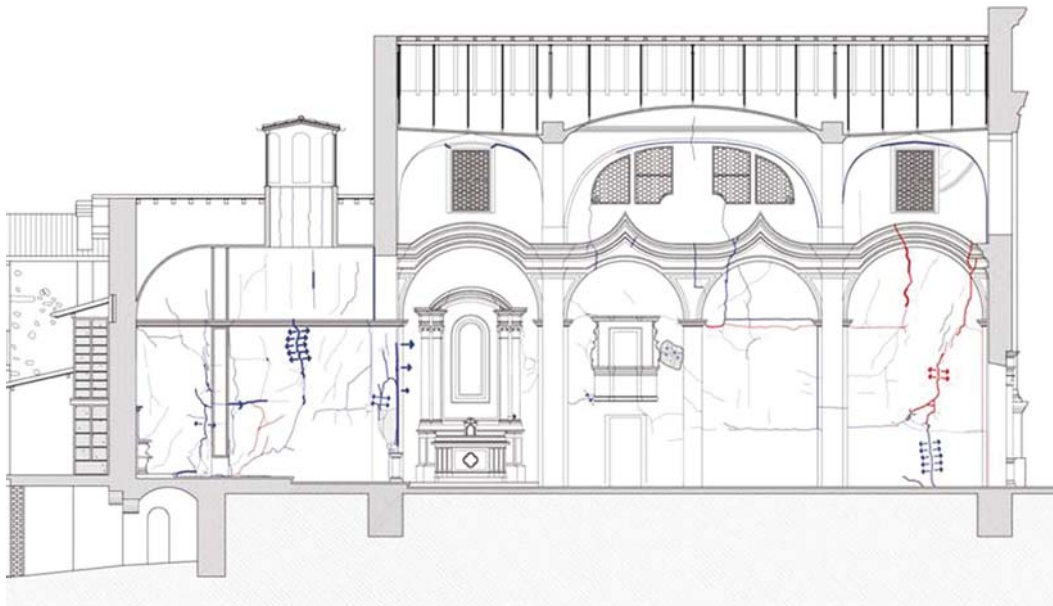
Fig. 3. Example of crack pattern survey of an historic building after a seismic event [8].

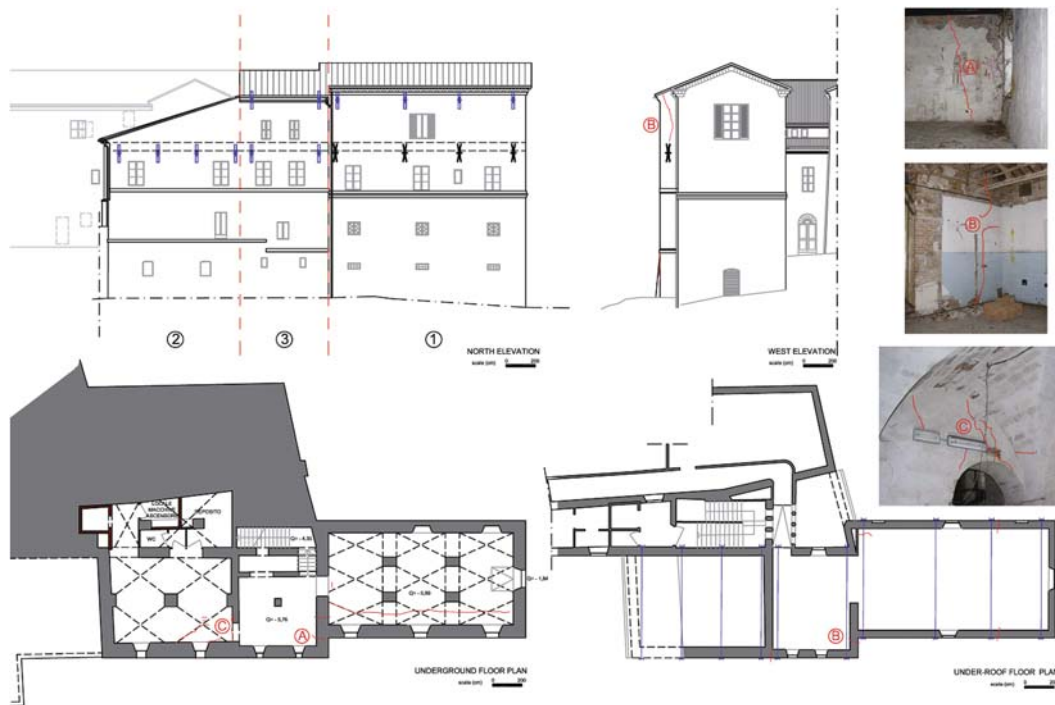
This construction was damaged after a first seismic event in 2016 and, according to the risk of overturning of the North façade, the municipality decided to close the below street, till the necessary protection and safety works were realized. Those works were realized after a short time and nowadays the building presents the last upper floors fully chained up with two series of iron ties rods (Fig. 4).

From the on-site visual inspection of the damage, after subsequent earthquakes, and from the analysis of the geometrical survey (supplied by the owner), it was observed that the main cracks were located only in one portion of the North façade: this portion

Fig. 4. A complex historic building damaged by the earthquake: crack pattern and provisional intervention on the North facade.

corresponds to a subsequent constructive phase that joined two existing volumes, localizing the main internal stairs. It has a different wall thickness and horizontal floor. Cracks are localized mainly in the corners, where walls are not aligned and can be hammered, mainly in the upper floor. Probably far from the emergency time, this observation could have reduced the number of iron tie rods inserted to the real necessary ones, with the aim to avoid the overturning of only this added façade portion.

Such a massive safety intervention was certainly able to avoid collapses during the last seismic events, but has unnecessarily created additional manipulations in the structure, hard to repriminate after their removal. In addition, the overall provisional intervention did not avoid the formation of new cracks in the basement vaults, where maybe tie rods should have been added, together with the intervention in the ground soil, carried out only below one of the three volumes.

The complex geometry of the building with its historical evolution, together with the recent provisional safety works (excessive iron tie rods number and localized ground soil intervention), contributed towards a more vulnerable building, also when it will be definitely restored.

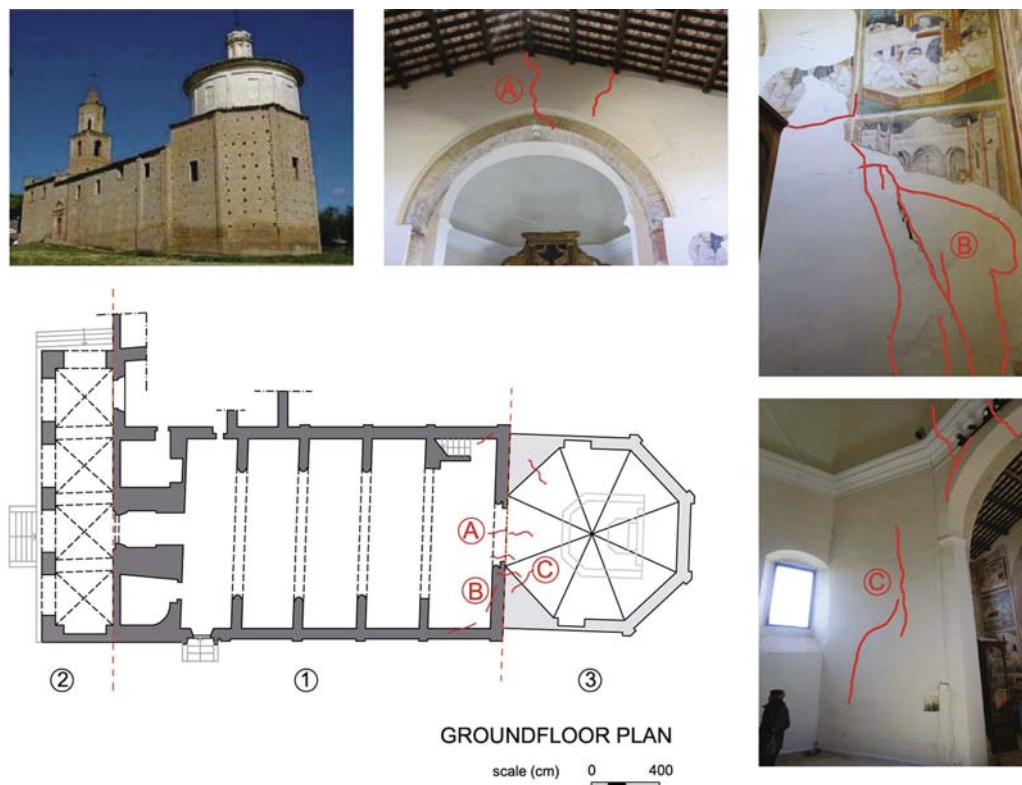
In XVI century the porch (2), strongly adjusted in 1955, and the octagonal apse (3) were added. In XVIII the dome with a cylindrical drum was added above the apse. Observing the damage together with the geometrical survey, the historic evolution and stratification correspond to a clear overlapping of different structures. This is the case of the dome vault, built over the octagonal apse and the back wall of the church of the XV century (maybe of XIII century).

After the seismic event of 2016, a serious crack pattern was observed, mainly due to the different structures reaction (church back wall, apse and dome vault) to the seismic actions: the three structures adjacent but not interlocked caused general hammering, damaging seriously the back wall. In addition soil settlement effects are visible (Fig. 5).

Fig. 5. The earthquake damages on the Santa Maria in Piano's Church dealing with its vulnerability.

This is the case of a seismic damage strictly correlated to the composite complexity of the building, due to the articulated structural evolution over time. This should be taken into account before its restoration in order to better analyze this weak points showed by the earthquake and design an intervention aimed not only to repair the structures but to overcome these vulnerability elements.

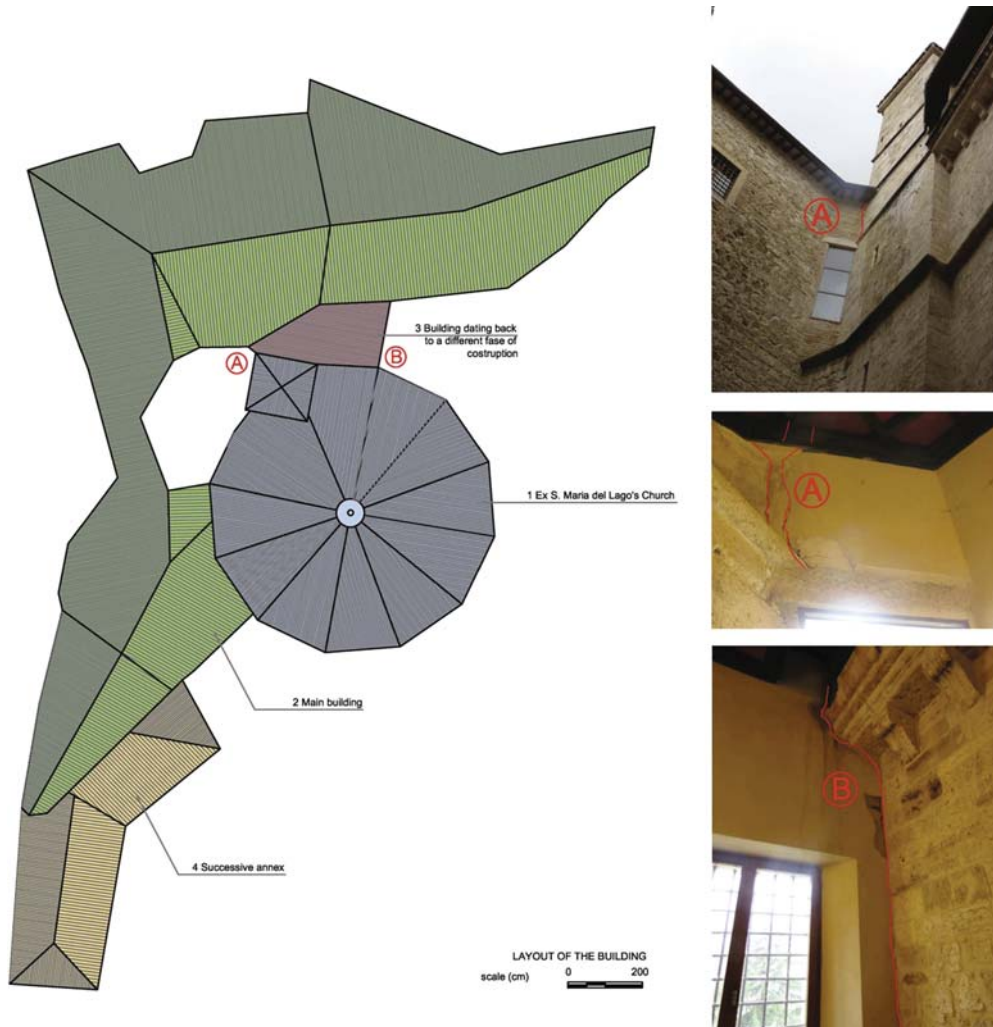
Fig. 6. Malatesta’s Fort layout and damages caused by the earthquake on the weakest part of the building

As in the two above mentioned cases, also in this case the earthquake put in evidence the vulnerable points of a such complex building, made by annexing and filling spaces among preexisting structures but always military and so statically massive.

The main damages are localized in the weak points of the building and referred to the interventions made after 1543, such as “shiner” brick masonry vaults, internal partitional walls and external wall boards, overlapping with non-homogenous materials. In details, a passing-through crack with stone material ejection concerned near the tower: from the historic-stratigraphical analysis of the building it is clear that this portion is a connecting volume filled between the tower and the fortress, made with external wall boards not interlocked with the lateral walls. The walls with higher mass and more compact hammered and detached those connecting walls (Fig 6).
