THE 2012 EARTHQUAKE: AN ABACUS OF SURVEYS AND INTERVENTIONS IN MANTUA CHURCHES

L. Fregonese ^a, A. Campera ^b, B. Scala ^a, A. Adami ^a

^a Politecnico di Milano, Mantua Campus

^b Diocese of Mantua, Cultural ecclesiastic heritage office

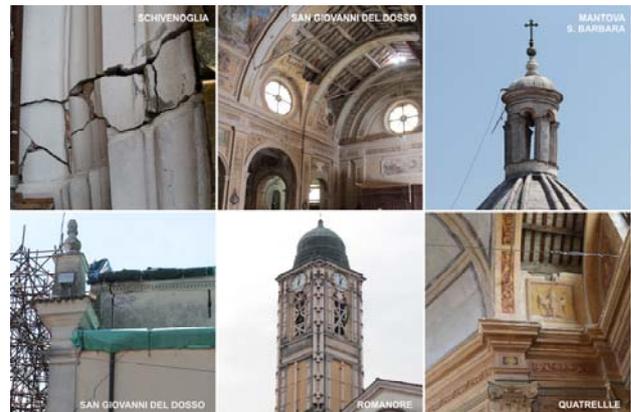
Figure 1: some photos of different damages in the churches of Diocese of Mantua

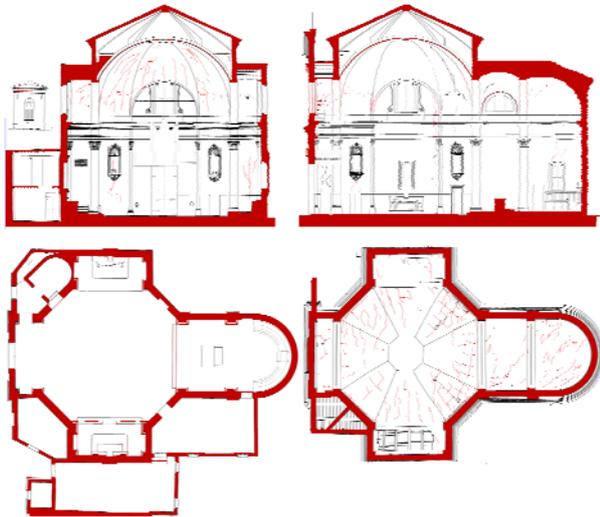
Figure 3: Church of Natività Beata Vergine Maria in Quatrelle. In the results of the survey stage, there are not only the geometric information, but also the description and localisation of cracks.

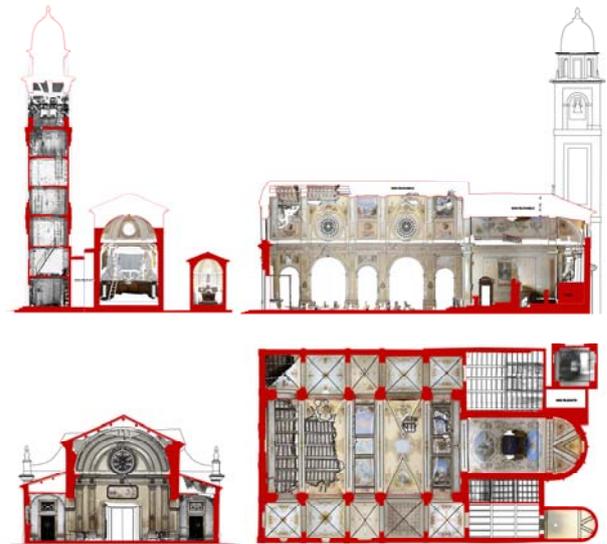
Figure 4: San Giovanni del Dosso, one of the most damaged churches. It was necessary to do a photogrammetric survey to survey not only the geometry, but also the decoration (frescoes, vaults, etc.)

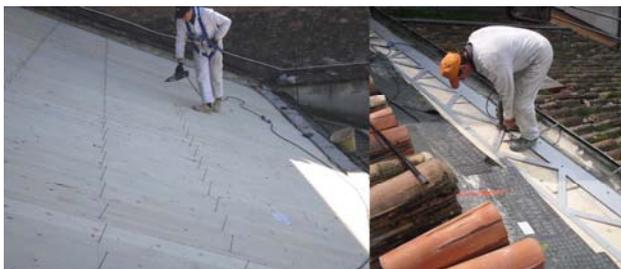
Figure 5: nailings of the wooden planking to the joists and securing the steel perimeter curb.

In the investigated cases the brick curb has fulfilled its primary function of vertical load distribution. It created the conditions for a mutual cooperation between the walls and allowed to counteract the overturning of the out of plane walls. Because of its flexibility, it realized a good adhesion with the masonry even in dynamic conditions.

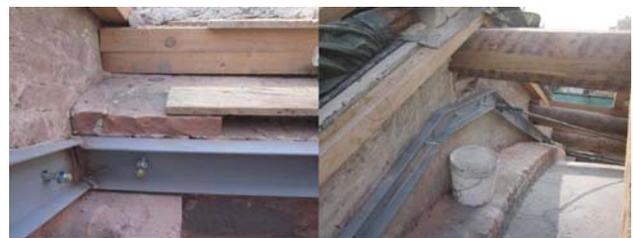
Figure 6: example of hooking of the façade wall to the nave

It has been interesting to analyze the enforcement proceedings in cases of straightening of the facades after they are guaranteed against the complete collapse. The recovery of the sensible out of plumb and detachment from the longitudinal walls of the main nave has been made by a procedure that required a meticulous control of the masonry connections even in the smallest displacements during the movement (rotation) and relocation of the facade to its original position. The first step of the process was the removal of the cover and then the cleaning of the cracks in order to eliminate any obstacles and contrast elements to the recovery of the deformation movement. As support of the façade, a provisional structure in joint-tubes has been made immediately after the earthquake in order to prevent further collapses and has been equipped, in a second time, with the special reinforcements in order to use the scaffolding for the breakdown and the transmission of the tension applied on the facade plane. Where necessary, the structure has been reinforced, by doubling of the tubular profiles. In favor of safety, we have positioned steel plates anchored on the angle between the longitudinal walls of the nave and the transverse wall of the nave bottom to give contrast to the pulling action. The steel cables (internal and external) and a system of jacks connected to a control unit were used to monitor the pulling action so as to ensure a uniform stress on the structure; instead crack meters tested the effectiveness of shooting. The rotation of the facade, pivoting on the base, has been performed by operating the jacks in a very slow way up to recover the reached deformation. The masonry has been fixed at the inner molding of the nave and of the eaves. Afterwards it has been necessary to guarantee the static of the façade by reconnection at the coupling of the front wall with the longitudinal ones.

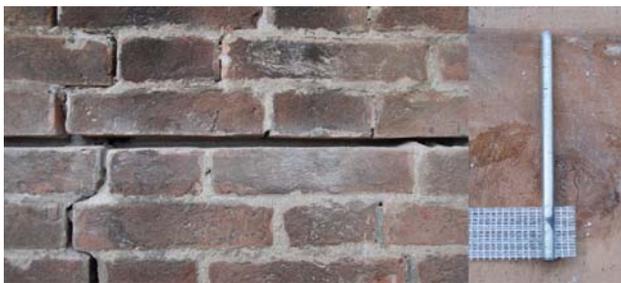
Figure 7: armed stitching along the mortar joints to close the cracks

- closing of cracks with reconstruction of the wall texture with brick and lime mortar;
- stitching of masonry with solid bricks, made dry by stainless steel helical bars installed with dry-fix technology;
- making of armed masonry through improved adherence bars installation in holes drilled with rotary/ roto-percussion drill, immersed in a fluid slurry of binder products;
- repairing of cracks in the walls by inserting hardwood wedges and/or iron and mortar;

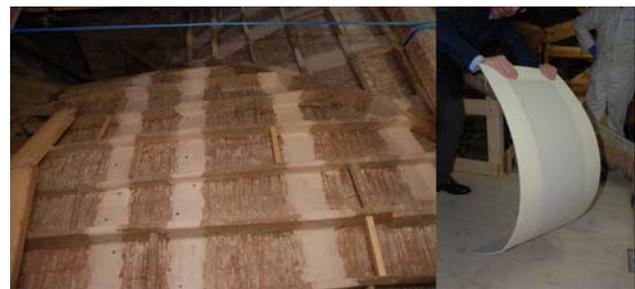
Figure 8: consolidation of the vault with bandages

In the case of vaults made of bricks “in foglio” (with no structural function) the previous operations were the mending and clogging of the connections. In these situations, on the extrados of the vault, we placed structural bandages with the application of carbon fiber fabric. This operation was particularly delicate. In fact, the improper execution could compromise the validity of the procedure. Therefore, after cleaning the surfaces, we levelled them with suitable mortar.
