Assessment of Post-Earthquake Damage: St. Salvatore Church in Acquapagana, Central Italy

Abstract: This article proposes a multidisciplinary approach for the assessment of seismic damage from the perspective of conservation and prevention. A comparison of the state of damage has been carried out in a case study, St. Salvatore church in Acquapagana (MC), as an example of church, which underwent two important seismic events in the Central Italy area, the 1997 and the 2016 earthquakes. The comparison of the state of damage passes through the following stages: (a) the territorial seismic overview; (b) the historical description and material analysis; (c) the identification of macro-elements with activated damage mechanisms; (d) the comparison between the two seismic events both from a territorial- and building-scale perspective. This work puts together the archived and the on-site survey data with those elaborated starting from seismogenic information, available from the National Seismological Institute, and it provides a strategy also for other similar conditions. This work is to be considered a contribution to a wider study that could be carried out in the areas hit by the 2016 eart

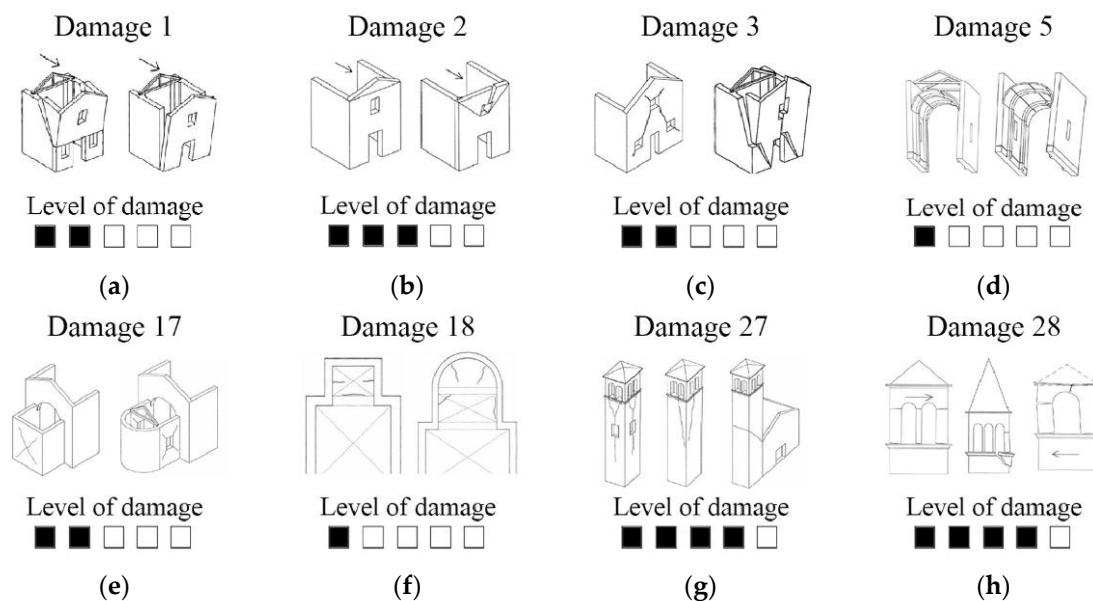
Figure 10 shows the activated mechanisms and the relative damage, reported by the team of surveyors. This interpretation, made for each macro-element, leads to elaborate the general damage index of the church (I_d); in this case, the reported value is equal to 0.32 [52].

Figure 10. Activated mechanisms and level of damage. Source data: [52]. (a) Overturning of the façade; (b) mechanisms of the upper part of the façade; (c) in-plane mechanisms of the façade; (d) longitudinal response of the lateral wall, in plane; (e) shear mechanism of the apse; (f) vaults of the apse; (g) bell tower; (h) upper portion of the bell tower.

As a result of the survey, the church was declared inaccessible [52]. Some of the mechanisms, in the church façade and in the bell tower, that occurred in the apse area have a serious or rather diffused damage. To these aspects could be associated with the given assessment of accessibility.

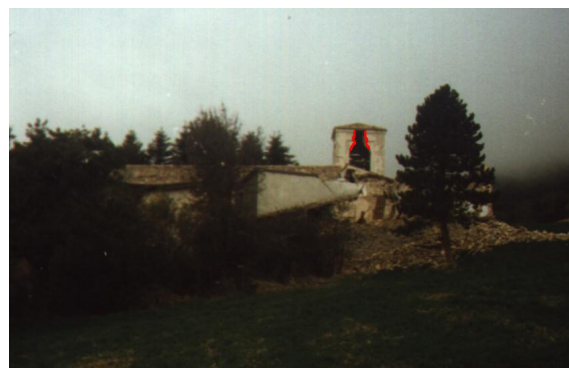
After this series of shocks, the church suffered severe damage, as the collected images document. The south portion of the complex collapsed, while the upper part of the bell tower was strongly affected, losing portions of walls (Figure 12) in correspondence to the opening, probably due to the good connection of the transversal walls, which determined the migration of the damage in the weakest and unbound part of the structure.

Figure 12. The image shows the state of damage post the 1997 earthquake of the east side of the building. In the foreground, the portion of the collapsed monastic complex is visible, while in the background, the damaged bell tower appears [56].

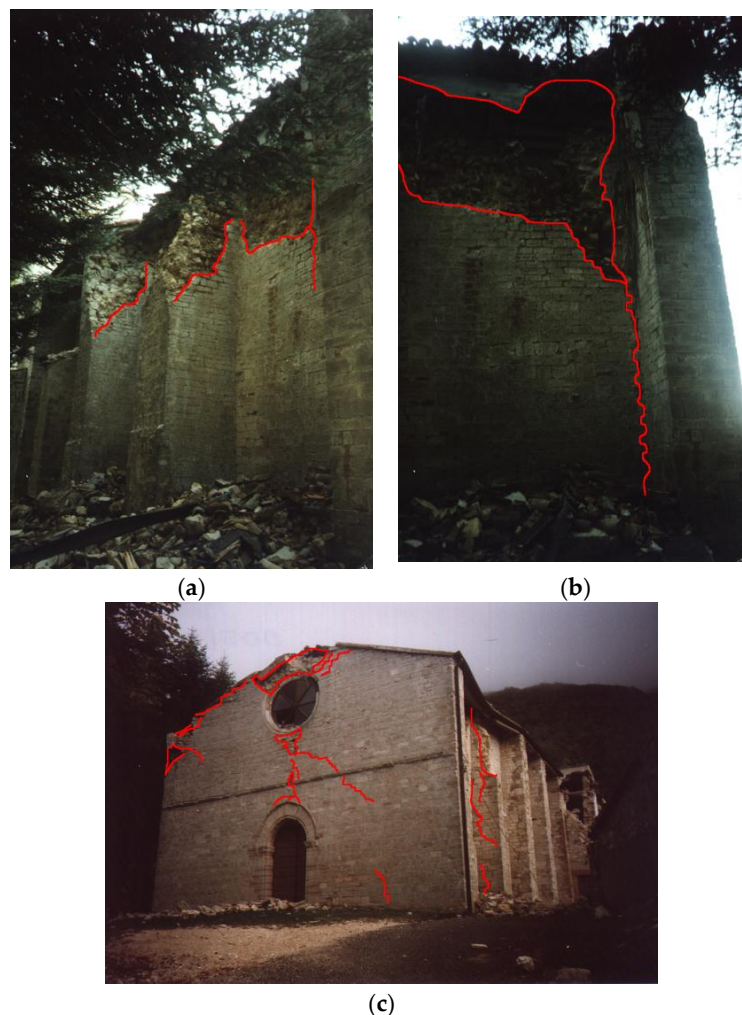
As mentioned in Section 2.2, the connection between lateral walls of the nave and the façade is well realized (see the image of the corner in Table 2). This aspect influences the response of the building against horizontal forces, developing a box-like behavior. Indeed, the collapse of lateral walls is located in the upper area, in contact with the roof. In this regard, the information about the substitution of the roof in the 1960s helps to understand the damage. Under seismic cycles, the concrete roof pounded on the masonry walls, causing local damage. The correlated state of damage is clearly visible in the upper part of the lateral walls (north and south) and of the buttresses (Figure 13a). Moreover, the multi-leaf walls, shaken and pounded, show the separation of the external leaf from the standing interior one. This phenomenon is visible both in the north walls (Figure 13b) and in the gable part of the main façade (Figure 13c). As in the case of the north wall, in the portion above the rose window in contact with the roof, the pounding effect caused the loss of a part of the masonry. In Figure 13c, this is visible as rubble on the ground in front of the church. The main façade also showed in-plane shear cracks in the area, which goes from the gable to the lower south west corner. These kinds of cracks followed the path of the mortar, denouncing the lower strength capacity of the mortar compared to that of the masonry. Moreover, none of the cracks cross the blocks of stone, confirming the good quality of the masonry evaluated in Section 2.2.

Figure 13. Post-1997 earthquake damage of the exterior of the church. Photo source [56]. (a) Collapse of the upper part of the buttresses and of the lateral walls; (b) partial collapse of the north wall of St. Salvatore church; (c) damaged gable, left portion of the upper side of the façade, shear crack in the central part under the rose window and collapse of the upper portion of the buttresses of the south side.

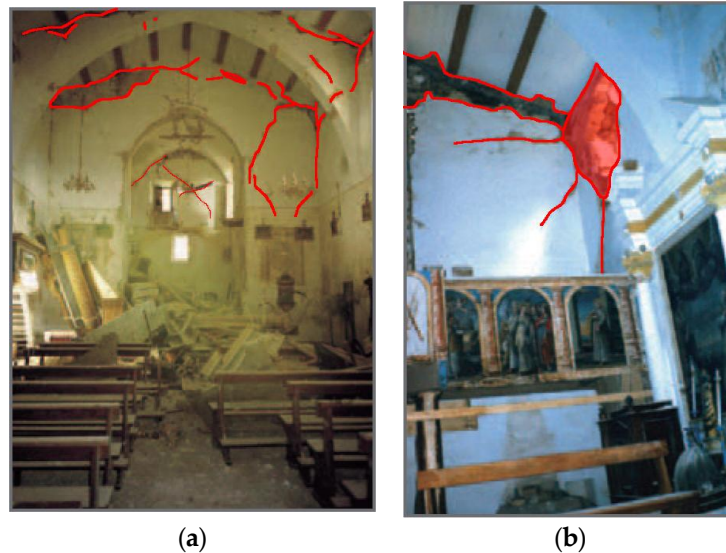
Finally, the damage also occurred the interior of the church. The stiffness of the concrete roof determined shear cracks in the triumphal masonry arches, as shown in Figure 14a. Furthermore, from the images of the church interior, the loss of both the internal leaf of the façade wall and of part of the upper portion of the lateral walls (Figure 14b) is visible. The explanation of this damage is the same as the exterior damage.

Figure 14. Post-1997 earthquake damage of the interior of the church. Photo source: [57]. (a) View of the triumphal arches towards the apse area. Diffuse shear cracks and pounding damage. (b) Inside view of St. Salvatore church. Partial collapse of the wall and of part of the internal leaf of the wall of the main façade at the tympanum level.

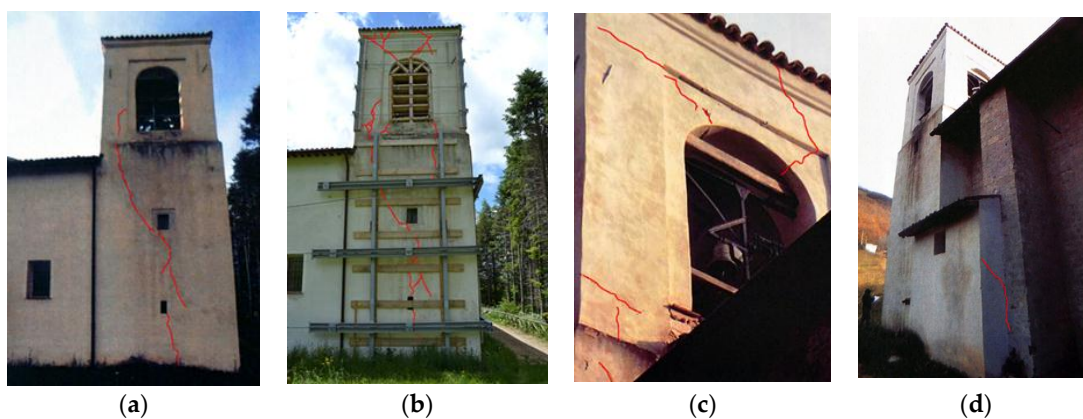
Laboratori Universitari di Ingegneria Sismica) team after the 2016 earthquake. Both the bell tower and the church building present a significant state of damage. Externally, in particular on the east side, the bell tower appears compromised: along the height, shear cracks are present; due to the plaster, it is not possible to affirm that the cracks follow the mortar. Probably the path of the cracks, at some points, provides evidence of the discontinuity of the masonry caused by reconstruction after seismic events (Figure 16a,b). This is visible in the upper part of the bell tower. Indeed, Figure 12 confirms that this portion was rebuilt after the 1997 earthquake. Moreover, the upper part of the bell tower, on the west side, shows not only shear cracks, but also torsional ones (Figure 16c). The presence of the tie rods efficiently works: indeed, this portion of the tower reacts with a box-like behavior effect, providing a contrast to the torsional action and causing cracks at the base of the terminal part of the bell tower. Figure 16d shows a diagonal and vertical crack that should be connected to the pounding effect between the annexed body and the buttress of the nave, which shows Mechanism 5 (see Section 2.3).

Figure 16. Exterior post-2016 earthquake damage. (a) Shear cracks along the height of the bell tower [47]; (b) damaged bell tower with provisional interventions; (c) torsional and shear cracks [47]; (d) diagonal and vertical crack in the annexed building in contact with the buttress of the north wall of the nave [47].

- In the bell tower, an additional steel structure, tying together the four walls of the bell tower, could guarantee ductility and reduce torsional movement of the upper portion.
- The existing independent steel structure, used to carry the bells, has shown a satisfactory response to seismic actions and probably has reduced the damage to the masonry structure.

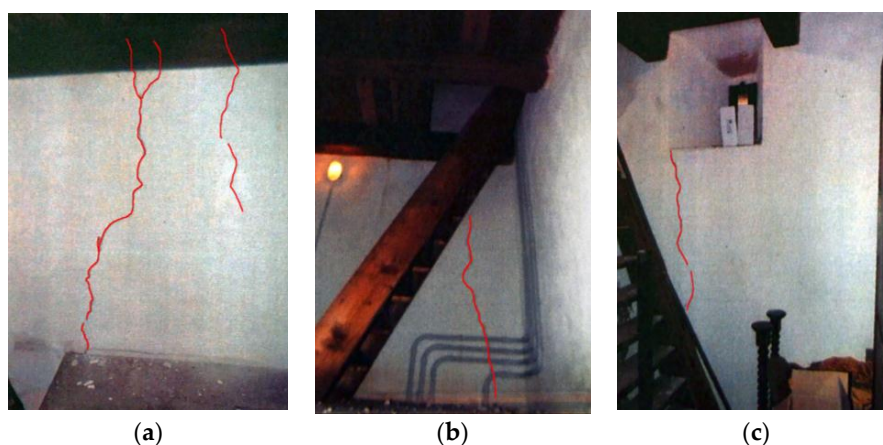
The state of damage observed outside has a correspondence with the interior part of the bell tower, where the cracks cross the different levels of the structure (Figures 16c and 17a,b).

Figure 17. Interior state of damage of the bell tower. (a) Shear cracks of the ground floor [47]; (b) continuous part of the shear crack of the first floor [47]; (c) shear crack on the north side [47].

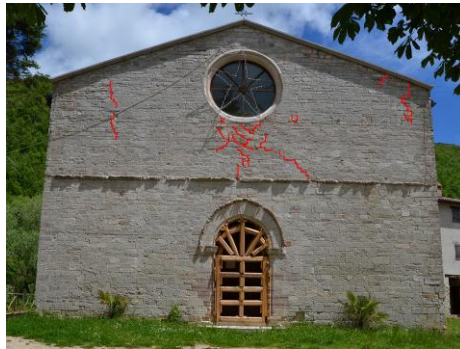
The damage of the church building appeared more concentrated in the principal façade. Indeed, from external images (Figure 18), the façade shows light visible lesions in correspondence with the timber beam of the roof, which causes shear cracks because of the pounding effect. Light lines of damage are present, retracing the discontinuity of the masonry due to the post-1997 earthquake reconstruction of the gable of the façade.

Figure 18. Post-2016 earthquake damage of the external façade with the damage pattern.

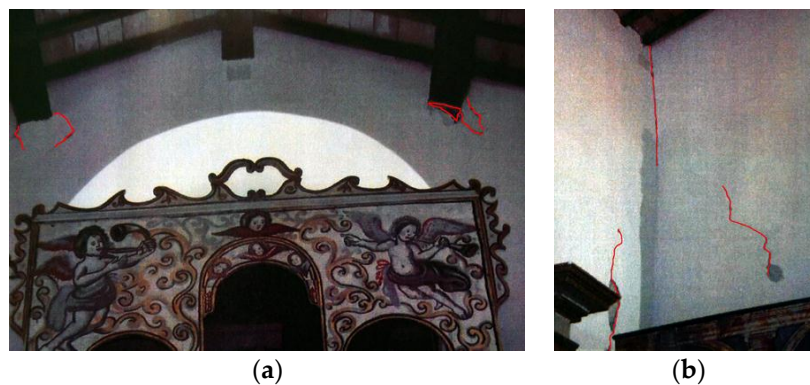
The pounding effect of the timber beams of the roof, introduced post-1997 earthquake, is more evident from the interior of the church (Figure 19a). The overturning mechanism of the façade is shown in Figure 19b. A vertical line of discontinuity denounces the overturning of the façade, evaluated in Figure 10, underlined also by the diagonal cracks in the lateral walls.

Figure 19. Post-2016 earthquake damage of the inside view of the west wall of the church. (a) Cracks at the intersection between the beams of the roof and the facade [47]; (b) vertical crack between the façade and the lateral wall where there are also diagonal cracks [47].

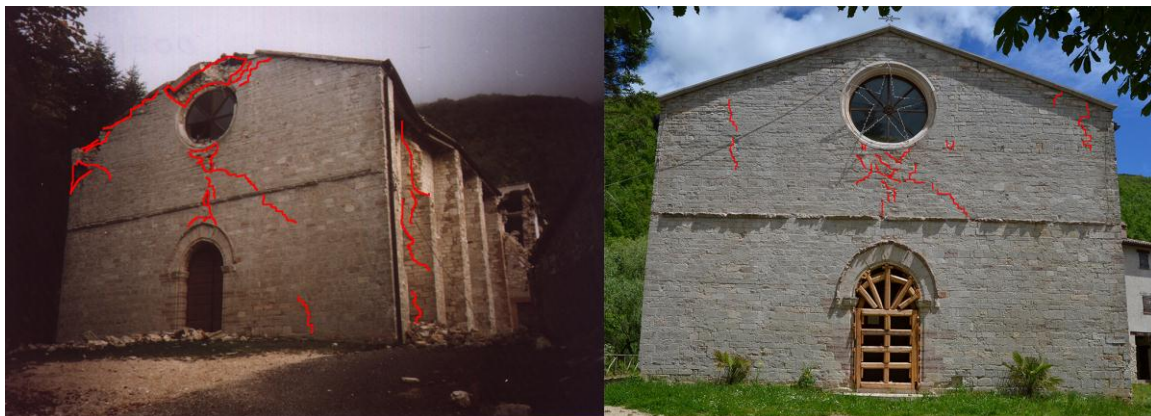
At the building scale, from the comparison of the state of damage between the two earthquakes, some considerations can be made. Observing Figure 21, the shear cracks on the plane of the façade, below the rose window are lightly marked from the recent earthquake.

Figure 21. Comparison of the state of damage on the façade after the 1997 earthquake (on the left) and the 2016 one (on the right).

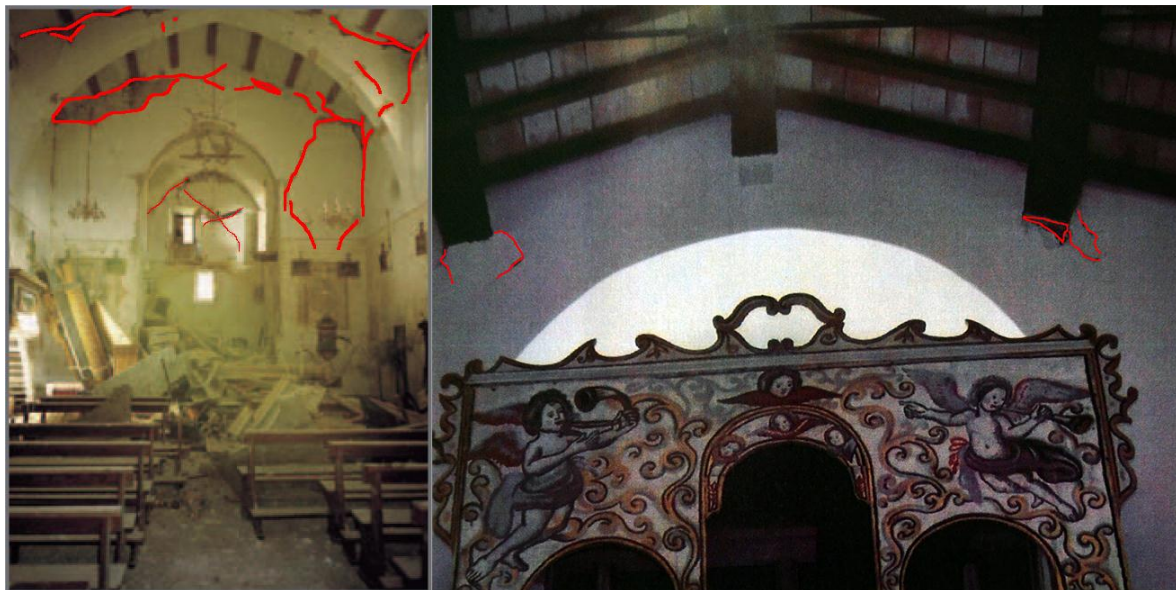
On the contrary, the upper portion of the gable, in contact with the roof, is in good condition, and it does not show the separation of the leaves. It seems that a good interlocking between the internal and the external leaf of the façade has been performed with the post-1997 earthquake intervention. Moreover, the substitution of the heavy concrete roof with a light timber structure (Figure 22) has contributed to reducing the mass, which during the cyclic dynamic effects of the earthquake, could have severely damaged the façade.

Figure 22. Comparison of the types of roof and the relative state of damage after the 1997 earthquake and the 2016 one.

The effectiveness of these interventions seems to be demonstrated, even if further studies should be done in this regard. An improvement in the connection between the timber beams and the wall is recommended. A good box-like effect of the building was observed in both events. Nevertheless, the rather high level of damage of Mechanisms 1 and 2 (Figure 10) suggests the use of tie rods at the level of the gable, in correspondence with the transversal walls. In the case of the bell tower, the tie rods helped to keep the four walls together and to limit the damage. The interventions performed on the main façade, on the lateral masonry walls and on the buttresses have provided good seismic performance.
