DAMAGE EVOLUTION IN CHURCHES DUE TO REPEATED EARTHQUAKE SHOCKS

Maria A. PARISI¹, Claudio CHESI², Gessica SFERRAZZA PAPA³

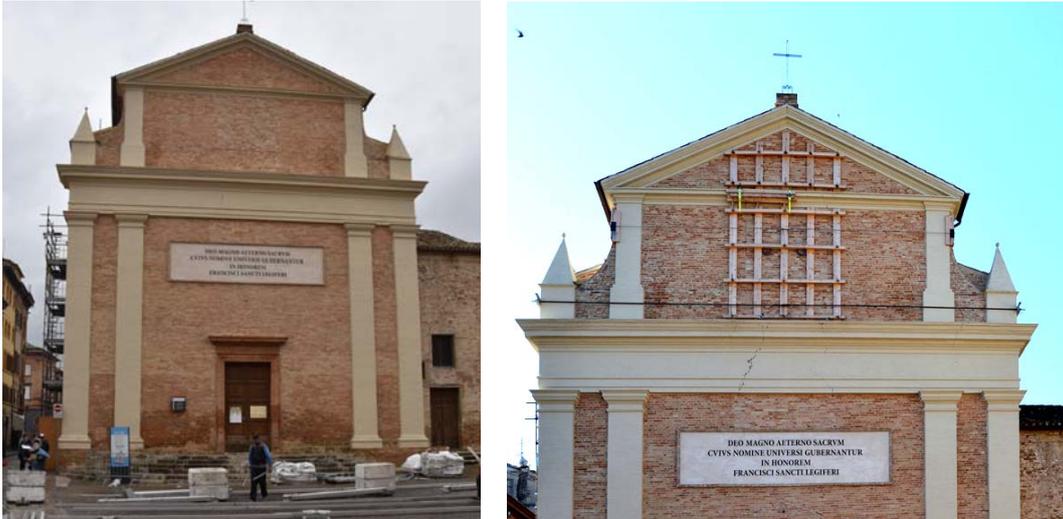
In fig. 5 the exterior of a church in the province of Macerata shows damage progression with subsequent events (Parisi & Sferrazza Papa, 2017). Initially the crack pattern was modest, but it expanded at the end of October, requiring provisional interventions. Figure 6 shows the interior in correspondence of the façade. Scaffolding that had been mounted before the earthquake in order to perform restorations of the stuccos supplied a means to reach the upper part of the church for inspection after the event. Pictures in fig. 6 were taken in the same days as those in Fig. 5. Damage was already significant in the first survey, with detachment of the end wall from the vault and deep cracks at the centre of the panel, but it was much more advanced later, as may be seen along the border.

Figure 5. Damage to a façade, progressing with subsequent shocks.

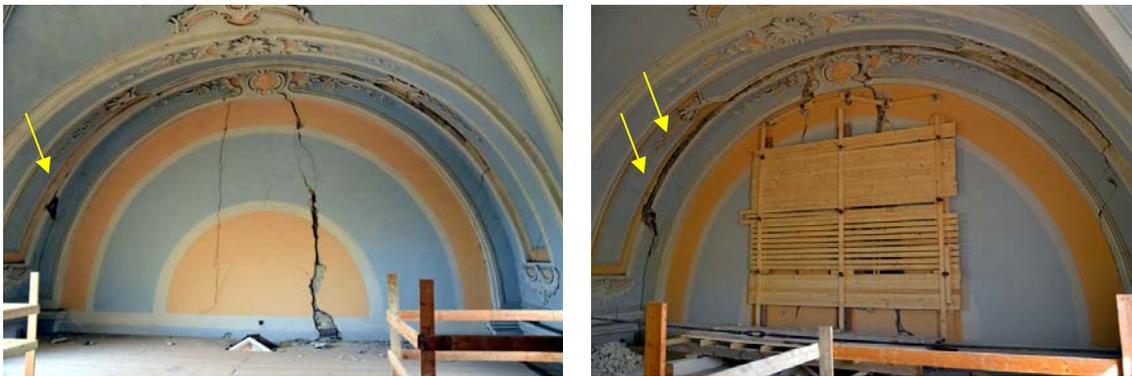
Figure 6. Interior damage to the same façade of fig. 6.

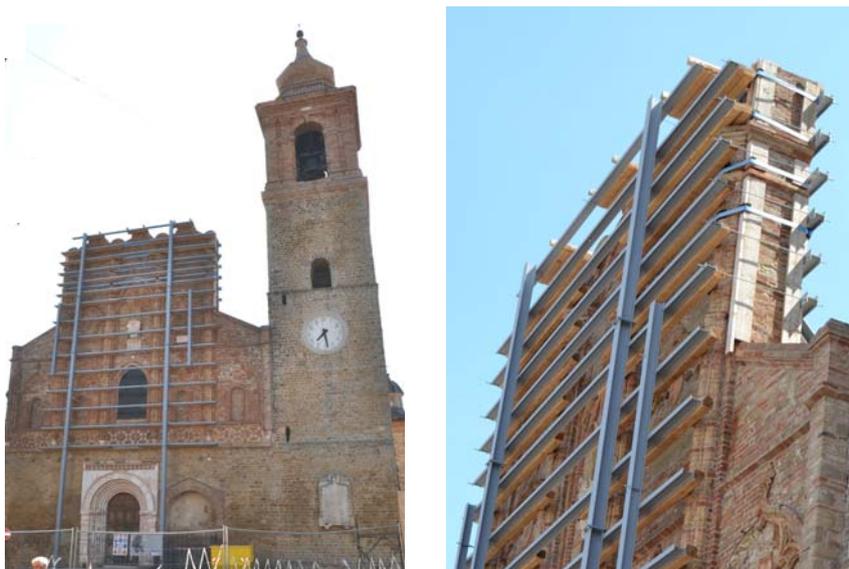
Figure 7. Façade with rectangular tympanum.

In the church in fig. 7 the upper portion of the façade, slender and with a rectangular shape that leaves top corners rather unrestrained, suffered some rotation with the shocks of October 26 and 30, with a maximum at the left corner. Comparing this case to the previous one, the influence of the architectural typology on the outcome is evident. This church, in a village closer to the Abruzzo region, recalls in the façade the Romanic churches of Abruzzo, with a typical squared aspect. This type of façade has shown to be particularly vulnerable during the earthquake of L’Aquila, 2009. An example has been the collapse of the right side of the façade of the church of Saint Peter in Coppito. Façade vulnerability toward out-of-plane collapse had been in some cases recognized and reduced, with positive results. In the church of St Gregory, in fig. 8, a tall pointed tympanum had been restrained with a metal strut in the back that anchored it to the body of the church. As a result, no damage was observed.

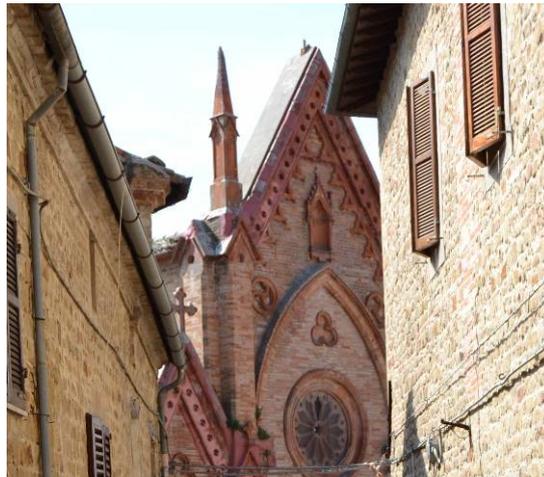
Figure 8. Pointed tympanum.

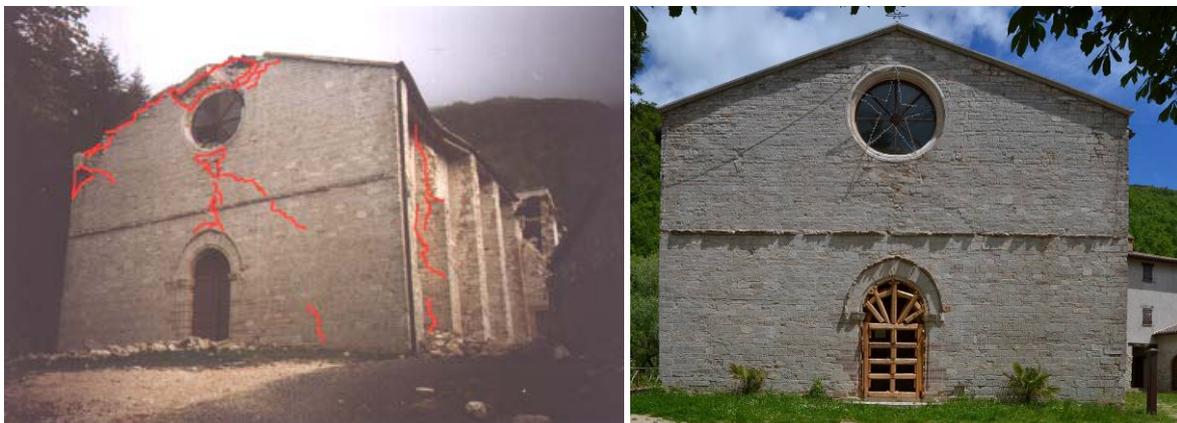
Finally, no significant damage was observed to the façade of the church of San Salvatore in Acquapagana that had been repaired and improved after the damage occurred in the 1997 Umbria-Marche earthquake. At the time, this church had suffered extended damage, with the collapse of the upper part of the tympanum and of the left corner of the façade; severe shear cracks appeared from the tympanum to the lower corner of the façade; the upper part of the lateral walls collapsed together with some portions of the buttresses. Figure 9 compares the two outcomes.

Figure 9. The church after the 1997 earthquake (left) and the 2016 sequence (right).

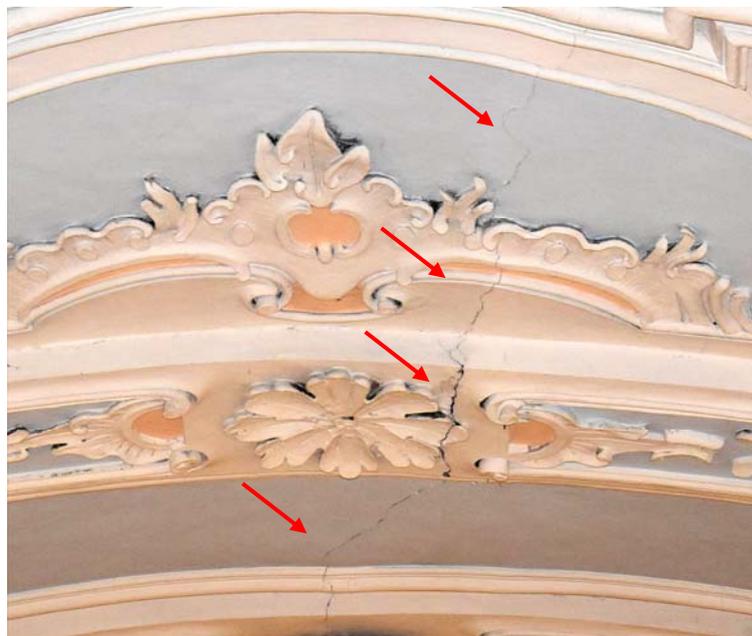
The same church of figures 5 and 6, for which damage in the façade area had occurred, showed an important response in the upper part also in the transversal direction, with damage corresponding to this mechanism. In this case, the ribbed barrel vault over the central nave tended to open, with a longitudinal crack and some lowering of the central part of the arches. The crack line is visible in Fig. 10. Both effects were found increased in the second survey.

Figure 10. Longitudinal crack in the vault.

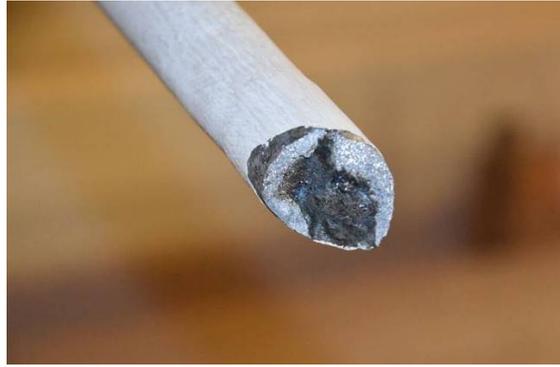
Correspondingly, crack lines were present in the nave lateral walls. Indeed, the full development of the mechanism has been prevented by the presence of steel ties at the base of the arches. The effective contribution of the ties in stiffening the system and retaining the walls and vault is demonstrated by the rupture of the central tie that occurred in August 2016 and by the subsequent ruptures of two more ties with the two main shocks that arrived in October. The steel tie broken during the August 2016 event is shown in Fig. 11.

Figure 11. Steel tie failure.

After the ties failed, the church was promptly secured by repairing the broken ties and inserting additional ones to increase lateral capacity.

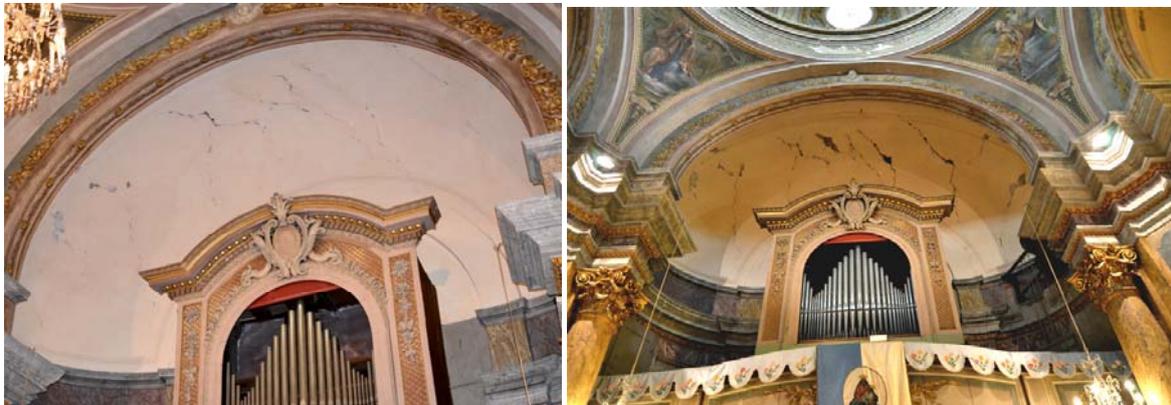
The first case is a church with circular plan, which presented serious cracks at first survey time. Cracks were located in the four semi-circular vaults holding the drum and the dome. These last two elements have not reported serious damage in the entire earthquake sequence. On the contrary, damage to the vaults increased with the following events, bringing one of them to collapse limit.

In order to explain such behaviour, the presence of a steel plate hoop confining the drum must be considered. This reinforcement protected the top elements according to the intentions, but the damage occurred in the inferior vaults, which were more difficult to protect with limited interventions. Figure 12 shows the initial cracking and then the advanced damage in one vault.

Figure 12. Damage progressing in a semi-circular vault.

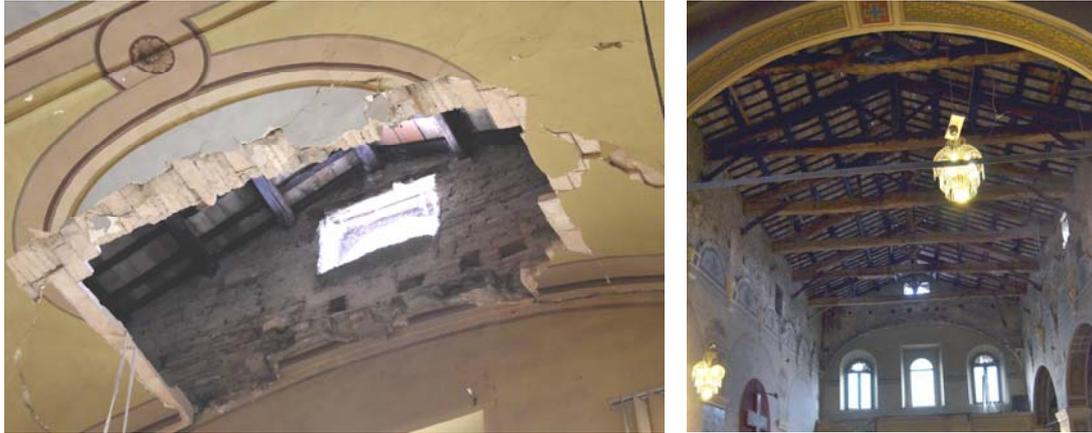
The progression of damage was extreme in the case of fig. 13, where part of the vault had collapsed after the first strong shock and a complete collapse occurred with the following one. This was a case of thin layer vaults, where the bricks are laid flat, resulting in a thickness of only a few centimetres. This kind of vaults is very common in Central Italy and it has shown its high vulnerability in this as well as in other earthquakes. Research programs are in progress to characterize these elements and identify effective interventions to improve their behavior (e.g. Borri et al., 2014). Strengthening may also be based on advanced materials, in order to keep the vault light. In the figure, through the opening due to local collapse the first picture shows a detailed view of the composition of the vault structure. The second image shows the situation after the global collapse and puts into evidence the timber roof structure, which has maintained a good connection with the walls and very likely helped in the global response of the church.

Figure 13. Local and global collapse of a thin brick vault.

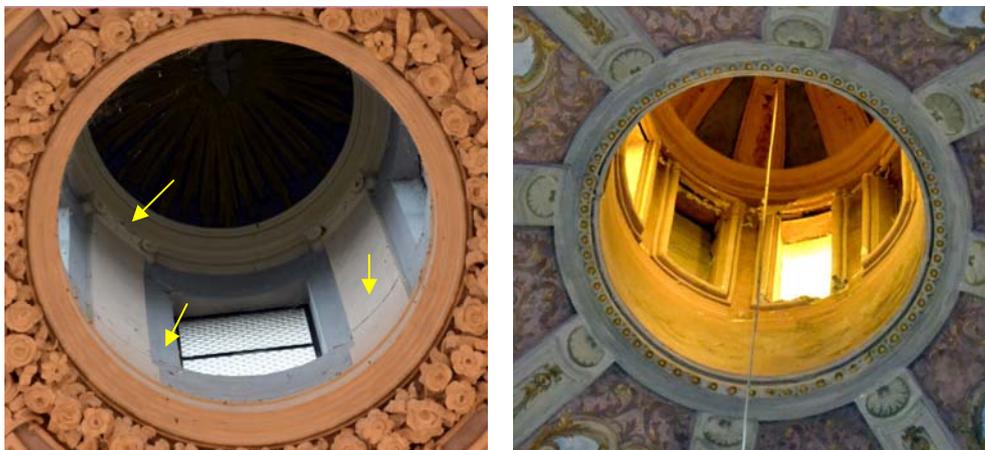
Figure 15. Damage to lanterns.

Figure 15 shows two cases where cracking at the base and on top of the openings had appeared. For the lantern at the left in the figure, during the first survey, no other damage was observed in the dome underneath. Yet, the possibility of further damage that could bring to the collapse of the lantern in the circumstance of a strong aftershock induced to prevent access to the public for the church until repairs were performed. This church could not be re-inspected during the subsequent inspection campaign, but the information came that severe damage to the lantern had actually occurred as foreseen. It is worth noting that the damage from rotation due to torsion occurred in these lanterns, as well as in the façade in fig. 7, has been observed in many other cases, like belfries and in a tower that is part of a historical palace.
