DAMAGE SURVEY OF A HISTORIC TOWN AND COMPARISON WITH PAST EVENTS AFTER THE 2016 CENTRAL ITALY EARTHQUAKE

Luca SBROGIO¹, Giuliana CARDANI², Maria Rosa VALLUZZI³

The paper presents a systematic damage survey supported by a GIS system and a specific form, both aimed at defining, if possible, a relation between the damage on each intervention and the damage of a building as a whole.

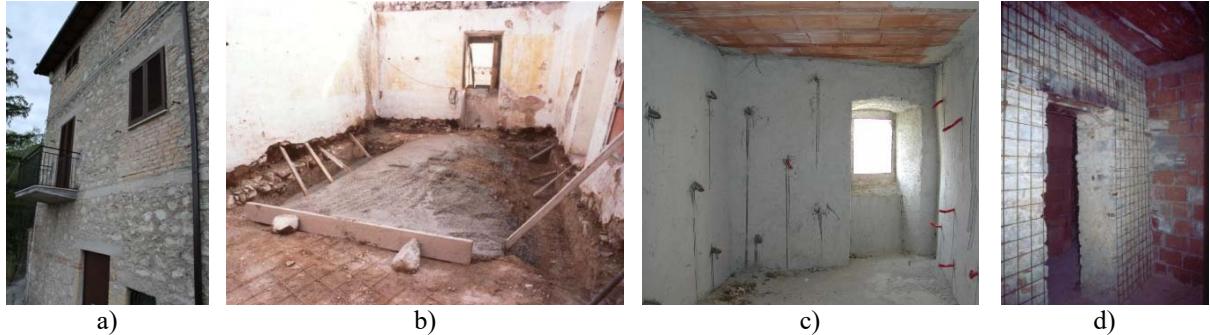
Figure 3. Examples of ‘heavy’ interventions on simple historic masonry buildings: a) r.c. tie beams; b) r.c. vaults jacketing; c) grout injections; d) r.c. wall jacketing (Cardani 2003)

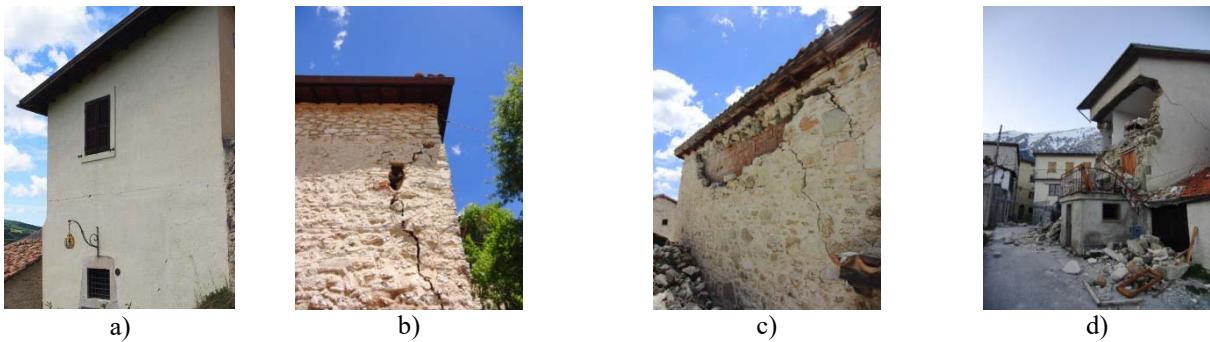
The most frequent damages that might be caused by interventions on horizontal components are: (i) horizontal cracks in walls, where r. c. tie beams are inserted in walls (Figure 4a); (ii) tilt or overturning of corners (Figure 4b); (iii) damages in walls (‘half-moon collapse’) due to the ‘beam effect’, which leaves the masonry under tie beams almost unloaded (Figure 4c); (iv) the overturning of the entire wall (Figure 4d). R. c. tie-beams can also break due to poor rebar junctions, insufficient stirrups, worn materials or flexural failure if the supporting role of the wall beneath fails during the quake. Furthermore, local damages can be caused by added r. c. lintels in poor masonry (Figure 6a).

Figure 4. Damages induced by r.c. tie beams above poor masonry: a) horizontal crack at floors level, b) overturning of building corners; c) half-moon shaped overturning; d) overturning of entire walls

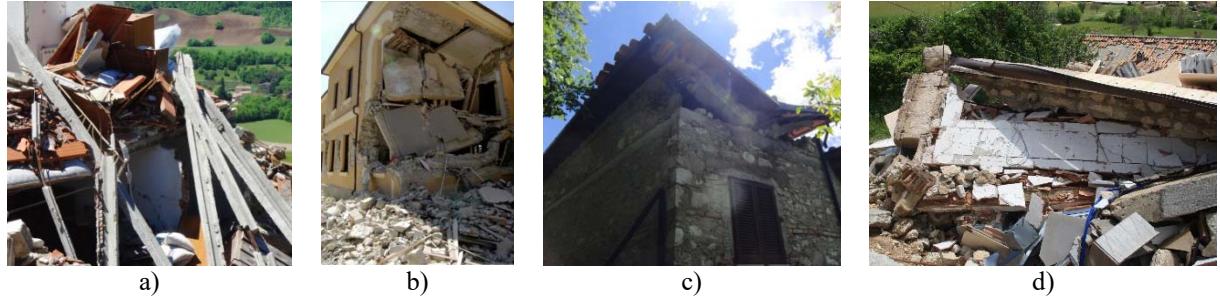
beams, fragile to shear forces (Figure 5a). This kind of floor suffers for bricks and/or beams disjointing and shear failure at supports, adding their noticeable weight to the collapse. Concrete floors with hollow brick blocks are sometimes subjected to collapses for lack of supporting walls (Figure 5b) but more often they induce collapse in walls below due to irregular distribution of loads and hammering (Figure 5c). Vaults suffer the detachment of the r. c. coating from the masonry or mechanisms caused by thickness reduction due to infill removal.

As a general rule, due to the weight of the modern structural interventions, the more harmful they are, the higher their position is: a heavy r. c. roof can cause the complete collapse of the building under its weight, without being particularly damaged by itself (Figure 5d).

Figure 5. Damages in r.c. roofs and floor slabs: a) shear failure in precast r.c. beams; b), c) damage of floors and roofs due to the failure in supporting walls; d) rigid collapse of the roof

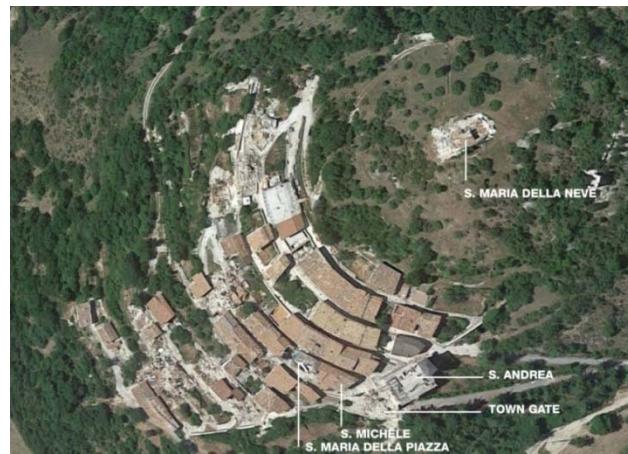
Figure 7. Aerial view of Campi after 2016 earthquake (8)

A synthetic view of Campi nowadays is shown in Figure 7. The village has suffered most damages in its public buildings (3 out of 4 churches still existing inside walls perimeter collapsed, the tower heavily damaged, the only surviving gate collapsed under the ruins of S. Andrea) and in the road system. Most of the damaged buildings are located in the lower and Western part of the town, a trend which is

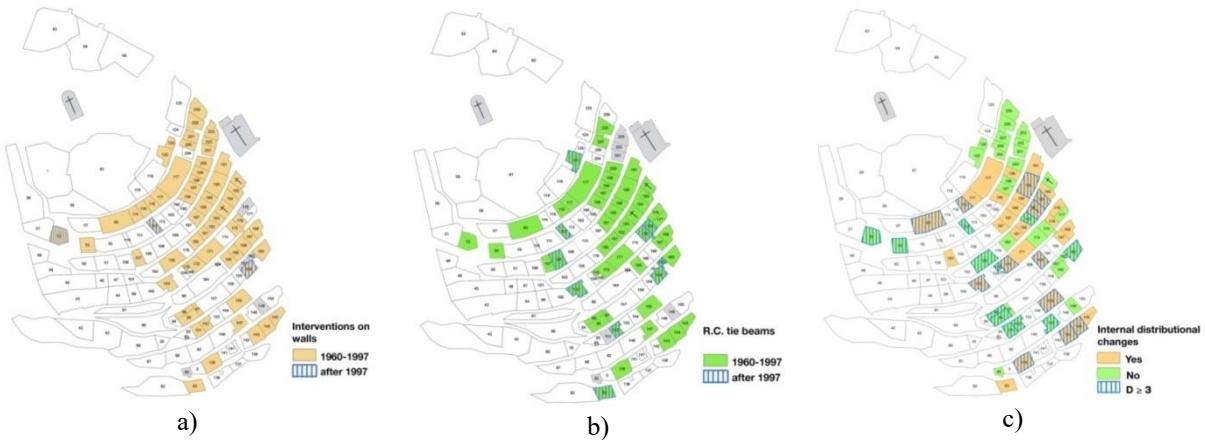
GIS querying showed that houses with oldest (early '80s or even before) or without interventions, are located in the village lower western part, thus explaining their heavy damage. It cannot be excluded that there was some focus effect on seismic action on this side of the rock bank, since this phenomenon is confirmed over the centuries (Cardani 2003). Queries also showed that only one building has never undergone interventions (UMI 2-UI 85) which is completely collapsed on 2016 October 30th. Thanks to the substantial uniformity in architectural type, the internal layout, the materials and techniques used for restoration since 1979, the whole set of buildings can be considered to belong to the same vulnerability class (Munari 2010). The distribution of the most substantial changes is given in Figure 10.

With reference to changes in the internal layout of houses (e.g., shift in internal partitions, integrations of new stairs, insertion of new walls), Figure 10c shows that there is no meaningful relationship between them and remarkable damage, being equally distributed among the houses.

Figure 10. Distribution of heavy structural and architectural modification in Campi di Norcia (grey means no change): a) strengthening of walls with modern techniques; b) introduction of r.c. tie beams; c) layout and other functional changes compared with 2016 estimated damage $D \geq 3$

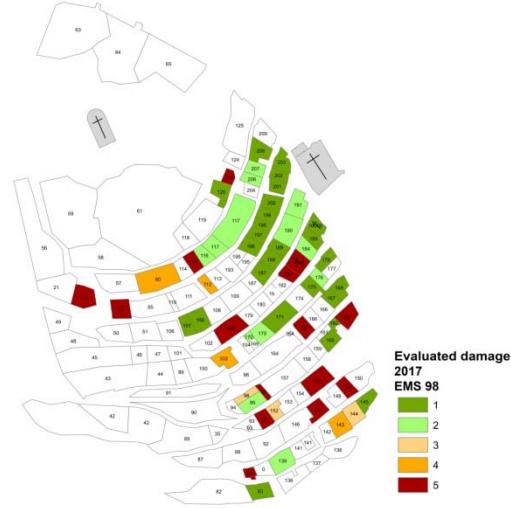
Out of 59 buildings (i.e., terraces houses and the two churches inserted at the ground floor of two of them): 13 collapsed ($D=5$), 4 show major structural damage, 3 are damaged and 13 are slightly damaged ($D=2$) (Figure 11).

Figure 11. Observed damage in Campi di Norcia after 2016 earthquakes to be compared with Figure 12

The comparison between on-site damage (Figure 11) and predictions (Figure 12) shows quite a number of differences. Vulnus and GNDT form both identify as highly vulnerable buildings which actually show slight or even no damage at all, such as those near S. Andrea church (Figure 7), except for the church inside the row which is collapsed (but which was evaluated as averagely vulnerable). In other situations, they may agree but sometimes not: the two isolated houses on the upper left part, which are totally ruined, are identified as almost not vulnerable by Vulnus and highly vulnerable by GNDT form (a glimpse of one of them is in Figure 5a).
