Influence of degradation at the base of a support post in a collapse of an old guardrail: A forensic analysis

Luca Sgambi*

Department of Civil and Environmental Engineering, Politecnico di Milano, Milan, Italy

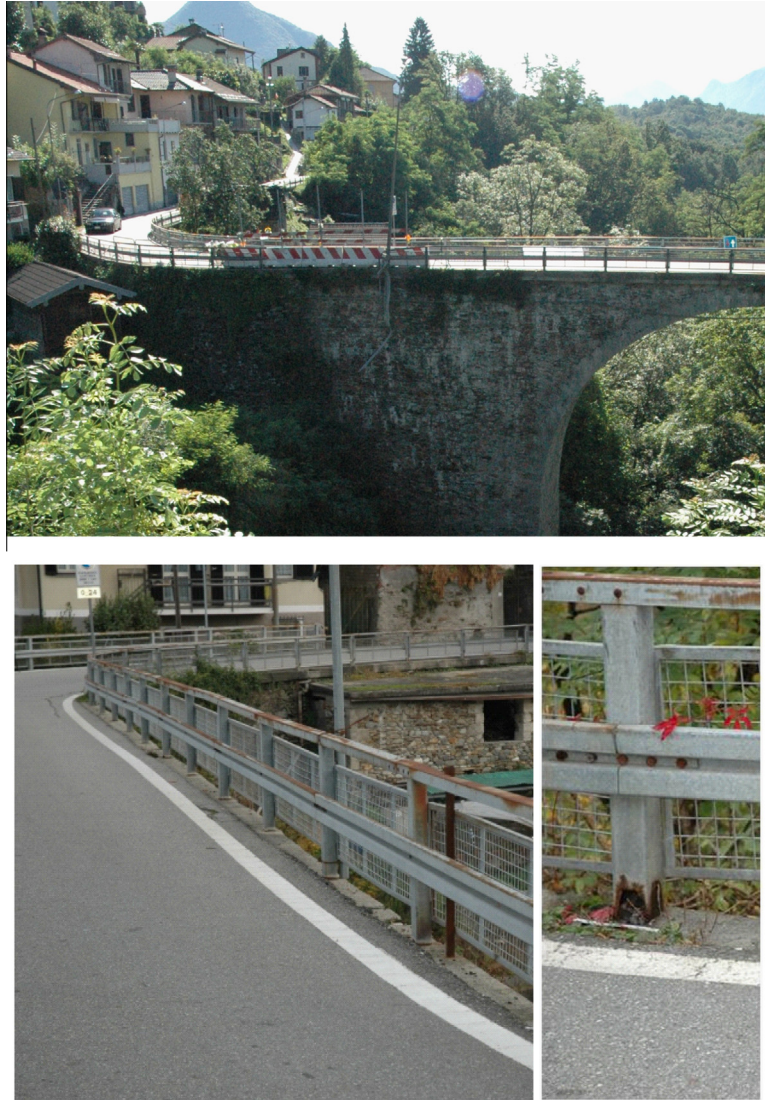
The case analysed in this paper relates to an incident involving a guardrail with strong signs of structural deterioration (Fig. 1). The guardrail was installed in 1970 for the protection of road traffic on a bridge located in a mountainous area. To access the bridge the road makes a sharp bend where a speed limit of 30 km/h was imposed to prevent the loss of control of the vehicle on a curve.

Probably because of the anti-freeze salts used in winter to prevent the formation of ice on the roadway and the lack of an adequate system of collection and distribution of rainwater, the base of certain guardrail posts had heavily corroded over the years.

Fig. 1. Photos of the accident site (above), of the support guardrail posts (bottom left) and image in detail of a severe deterioration at the base of a post (right).

At the base of support posts, as highlighted in Fig. 1, there is a state of deterioration by corrosion that reduces the resistant section of the post. From the statistical point of view, out of 50 posts examined 32 posts seemed to be in good conditions, 14 with an evident state of deterioration and 2 posts strongly deteriorated (one of them is shown on the right side of Fig. 1). Unfortunately it is not possible to determine the condition of deterioration of the two posts involved in the accident since the violent impact and the subsequent collapse of the posts made it difficult to interpret the actual state of the posts involved. For this reason, in order to examine the influence of the state of deterioration at the base of the post on the dynamics of the accident, a state of conventional deterioration was assumed reducing the thickness in a uniform manner, from the design value of 3.5 mm to a value of 1 mm.

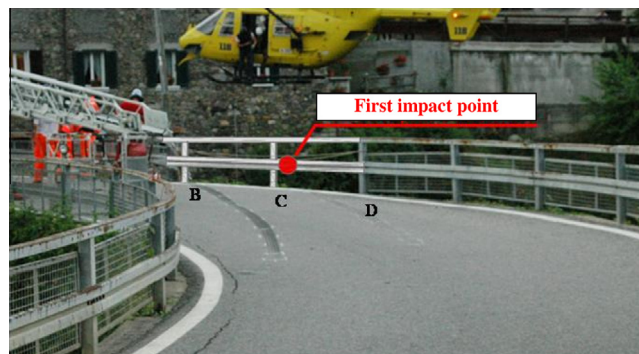
Fig. 3 shows the side of the accident photographed during the recovery operations of the vehicle. Using a drawing software, part of the guardrail that had collapsed was virtually reconstructed in its original location. With the letters B, C, D the three support posts involved in the impact are indicated. The braking points show how the vehicle impacted on the guardrail with the right front side almost at the support post indicated by the letter C.

Fig. 3. Virtual reconstruction of the guardrail and assessment of the point of first impact.

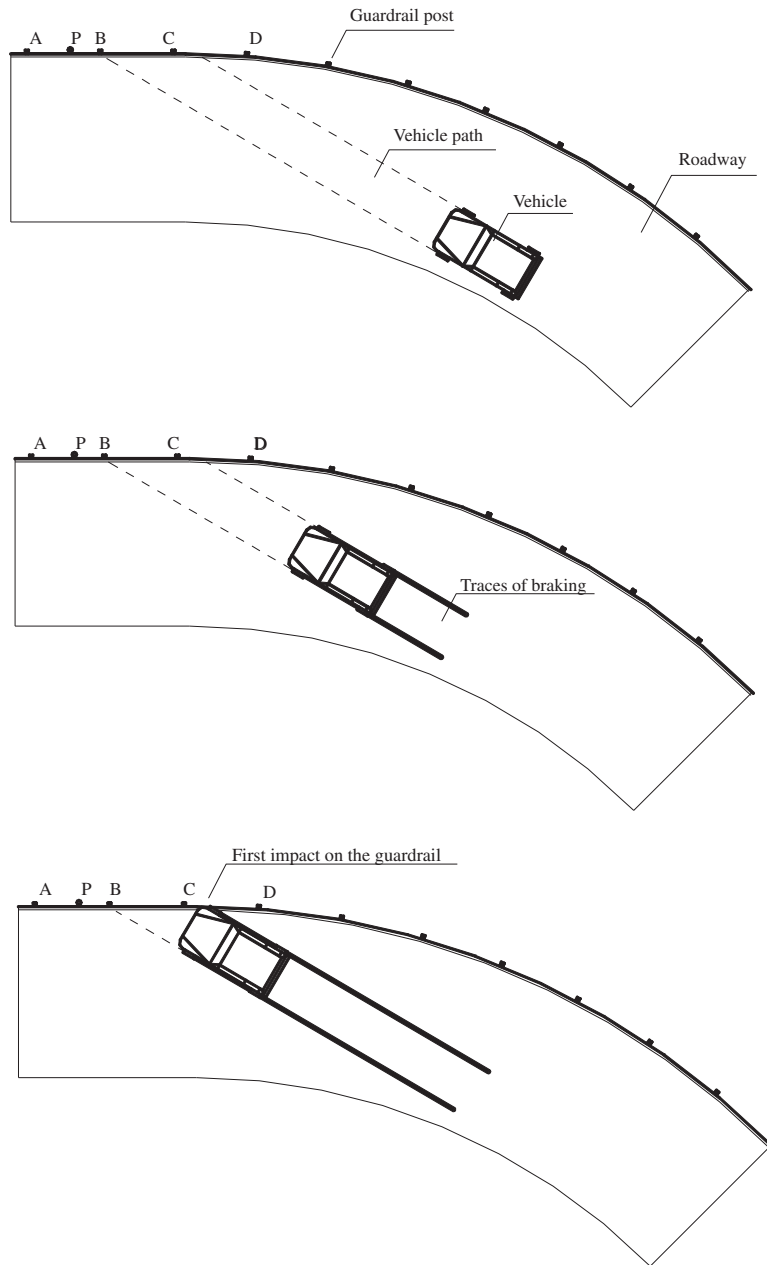
The dynamics of the impact are reconstructed in a qualitative manner in Figs. 4 and 5. Fig. 4a shows the approach of the vehicle to the guardrail when the driver realises that he is no longer able to control the vehicle at the bend and starts to brake abruptly.

Fig. 4. Virtual reconstruction of the phases of the accident and collapse of the guardrail.

the vehicle that is launched against the guardrail (Fig. 4b). The impact between the vehicle and the guardrail occurred close to the support post C, a few centimetres to the right of the same (Fig. 4c).

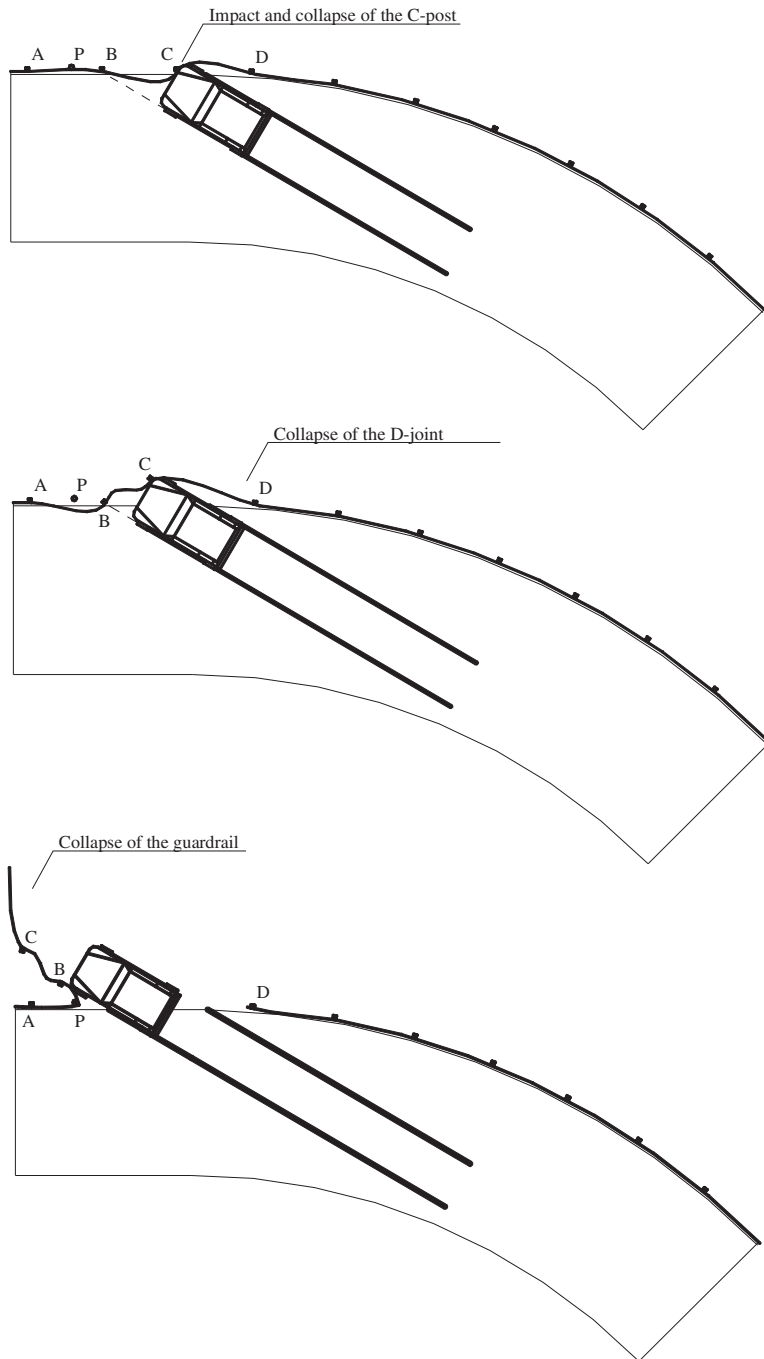
Having still almost entirely its kinetic energy, the vehicle continues on its way veering off the roadway and deforming the W-beam of the guardrail about 1 m in transversal direction. The main belt of the guardrail undergoes a large deformation, resisting in deformed position through an action of axial compression provided from the BC, and a tensile force, provided from the side CD (Fig. 5b). Such resistant mechanism is the main resistant mechanism of the guardrail that can only occur

Fig. 5. Virtual reconstruction of the phases of the accident and the collapse of the guardrail.

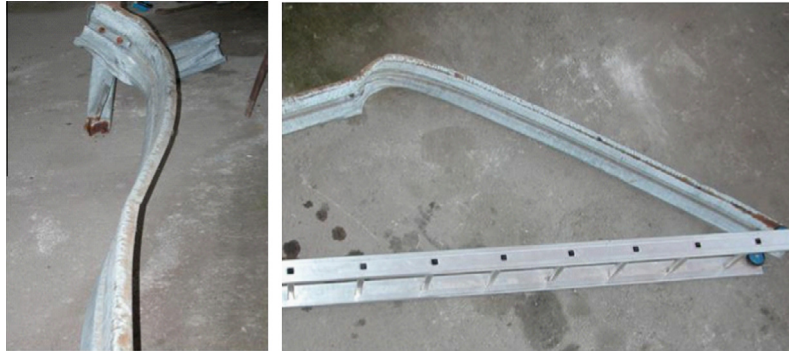
Fig. 6 shows plastic deformations present on the main W-beam of the guardrail after the collision. The figure on the left shows the segment BC, that is the segment on the left hand side of the point of impact. Such part shows a clear sinusoidal deformation that suggests the absence, at the time of collapse, of an axial tensile force. The segment on the right hand side instead appears in different conditions (the CD segment can be seen in Fig. 6 on the right) that seems to be rectilinear, as if during the collapse it had been only subject to strong traction force.

Fig. 6. Plastic deformations or deteriorations present on the main bend. On the left part BC, on the right part CD.

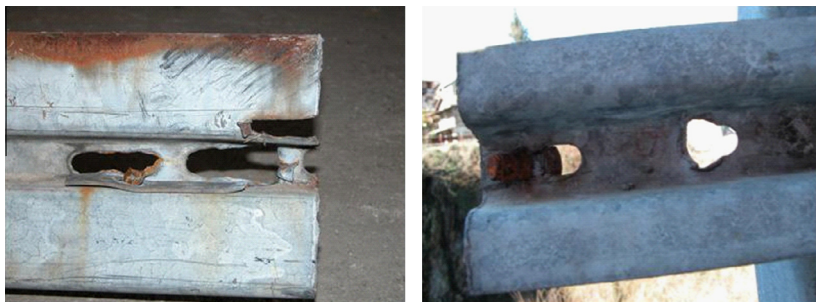
The strong traction present in the CD segment of the W-beam of the guardrail caused the collapse of the bolted joint in D due to plate bearing failure. Fig. 7 on the left shows traces of bearing action on the W-beam of the CD part. It should be noted how the fixing holes of bolts, initially of 2 cm in diameter measured up to 5 or 6 cm. Fig. 7 on the right shows the joint of the W-beam on the right of the CD segment and not directly involved in the collision. It should be noted that two years after the accident a bolt, that had wedged into the plate during the collapse of the joint, is still visible.

Moving the plasticized steel at the side of the bolt, the bearing action caused strong axial traction in the bolts of the joint that has caused the failure of the bolts due to the loss of the lock nut. The guardrail, devoid of the resistant action of the D joint, opened up as shown in Fig. 5c causing the vehicle to jump off the road and the subsequent impact against the slope of a mountain.

Fig. 7. Detail of the collapse due to plate bearing stress in the D joint. On the left the part of joint belonging to the CD segment, on the right the part of joint that remained in situ.

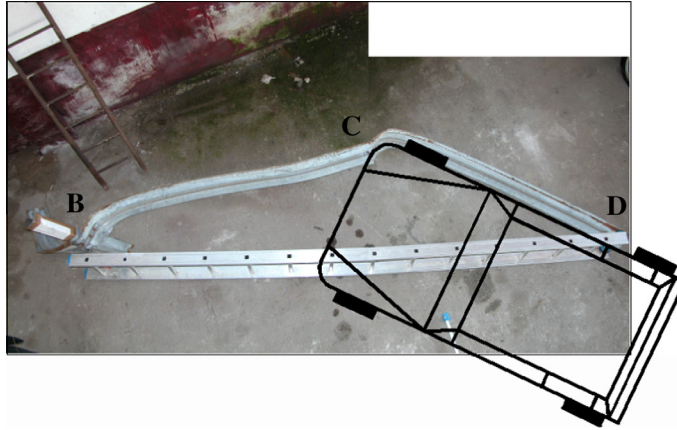
Virtually elaborating some images, we are able to reconstruct in Fig. 8 the deformation of the guardrail and the qualitative position of the vehicle at the time of the collapse of joint D.

From the reconstruction of Fig. 8 two important information can be inferred. Even by offering a little strength, the guardrail post positioned in C contributed to the vehicle braking. In fact, if the pole in C had had a zero resistance, the local deformation of the guardrail in C would have been different and it would not have shown the change of curvature that is evident in Fig. 8. Moreover, considering unimportant the axial plastic deformation present in the guardrail and knowing the distance between the two support poles, from Fig. 8 it is possible to deduce that at the moment of the collapse of the joint in D the guardrail showed a central shift of about 1 m.

Fig. 8. Qualitative reconstruction of the position of the vehicle and of the plastic deformation of the guardrail at the time of collapse of joint D.

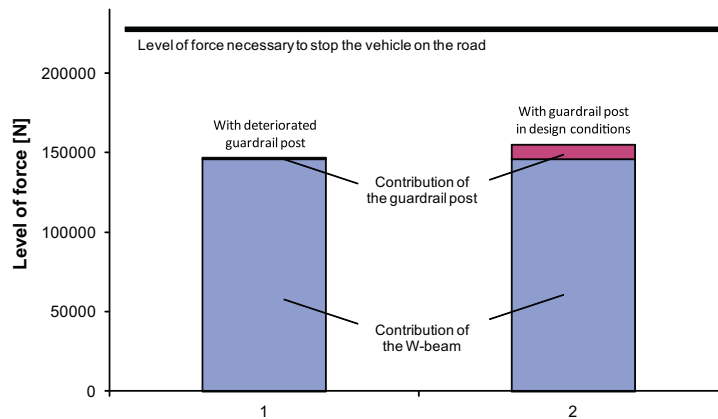
Fig. 12. Resistance offered by the guardrail. The histogram 1 is refers to the barrier with the guardrail post conventionally deteriorated (thickness of 1 mm) while the histogram 2 refers to the design situation (thickness of 3.5 mm). The black line represents the threshold of resistance necessary to stop the vehicle on the road.

greater than the estimation of the force that caused the collapse of the barrier (approximately 150,000 N). The histogram of Fig. 12 compares the contributions to the resistance offered by various resistant mechanisms during the impact. The histogram on the left refers to the barrier with the guardrail post conventionally deteriorated (thickness of 1 mm) while the histogram on the right refers to the design situation (thickness of 3.5 mm).

From the comparison of Fig. 12, the resistance offered by the support post C in design conditions (absence of deterioration) can be quantified as 6% of the total resistance of the guardrail. In conditions of conventional assumed deterioration, the resistance of the support post C contributes 1%. Therefore, the conventional deterioration assumed caused a loss of only 5% on the total resistance of the guardrail.
