# Corrosion failure of post-tensioning tendons in alkaline and chloride-free segregated grout: a case study

Maddalena Carsana\* and Luca Bertolini<sup>1</sup>

*Department of Chemistry, Materials and Chemical Engineering "G. Natta", Politecnico di Milano, via Mancinelli 7, Milan 20131, Italy  
(Received 3 September 2013; final version received 29 November 2013; accepted 9 December 2013; published online 26 March 2014)*

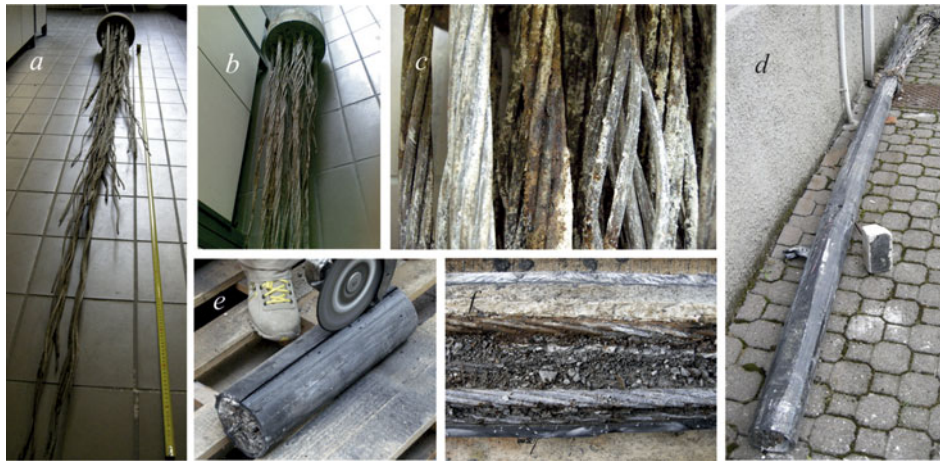
anchor head where the tendon failed, and a further portion that was near to the failure zone, but the injection grout was still present inside the duct (Figure 1). The visual observation of the failed strands near the anchor head (Figure 1(a)) showed the presence of corrosion products and many localised attacks (Figure 1(b)). This phenomenon occurred mainly in the parts where residues of a whitish unhardened paste were found on the surface of the steel (Figure 1(c)). All the corrosion attacks were localised, some of which were shallow while others were very penetrating. Localised attacks initiated preferentially at the regions of contact between the wires (Figure 2).

Figure 1. Portions of the failed tendon analysed in the laboratory.

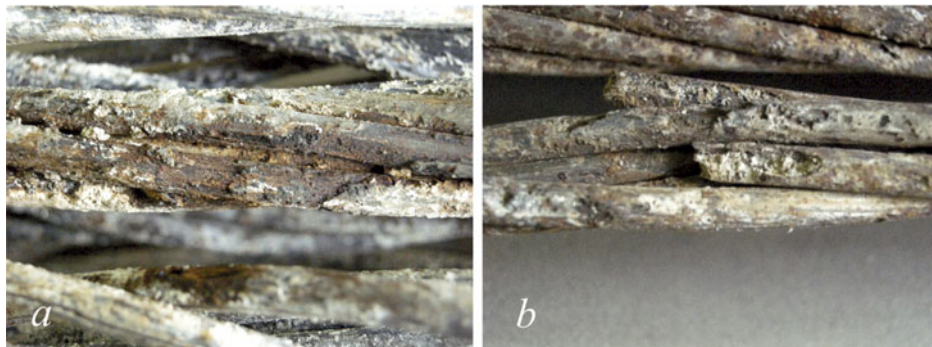
Figure 2. Examples of corrosion attacks observed on the surface of the strands.

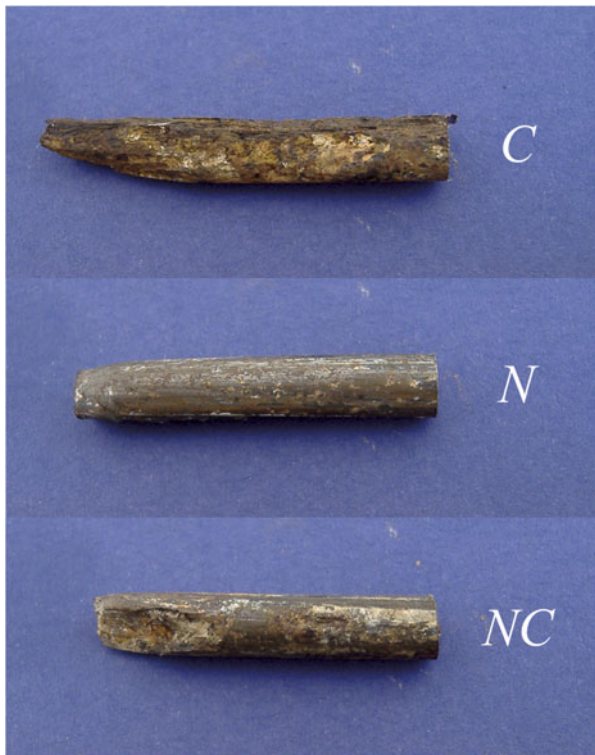
head), and the extent and depth of corrosion attacks. Corrosion attacks were randomly distributed along the length of inspected portion of the tendon. The rupture was classified as: C when most of the cross section was depleted by the corrosion, N when a clear ductile necking failure was observed and NC when a mix of corrosion and ductile final failure occurred. Figure 3 shows examples of the three types of failure.

Figure 3. Examples of the types of failure observed on the wires of the tendon failed in service.

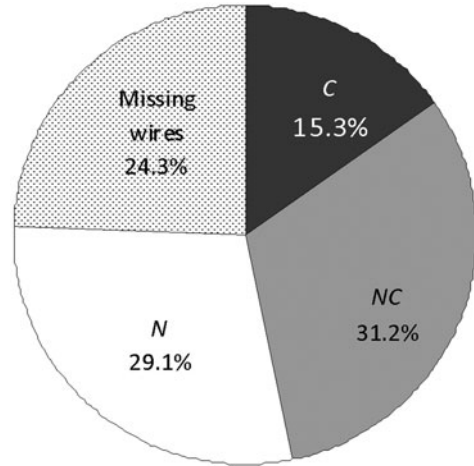
Figure 4 shows that about 15% of the wires had the cross section mainly consumed by corrosion attacks and, therefore, it may be assumed that they failed before the rupture of the tendon. Furthermore, for slightly more than 30% of the remaining wires, fracture may be attributed to partial corrosion (type NC). Wires that have undergone only necking and those that are missing constitute 53.4% of the total; for these wire, it is reasonable to assume that the cross section was essentially undamaged at the time of failure. Assuming, in the first approximation, that the condition for NC can be considered on average as a reduction of cross section due to corrosion of 50%, it may be estimated that the reduction in the whole cross section of the tendon due to corrosion attack occurred before the final failure was approximately 30%. Such a value can justify the collapse under service, taking into account that the post-tensioning force was equivalent to about 75% of the tensile stress of the steel.

Figure 4. Summary of the types of failure (C, corrosion; N, necking; NC, corrosion + necking) observed on the wires of the tendon failed in service.

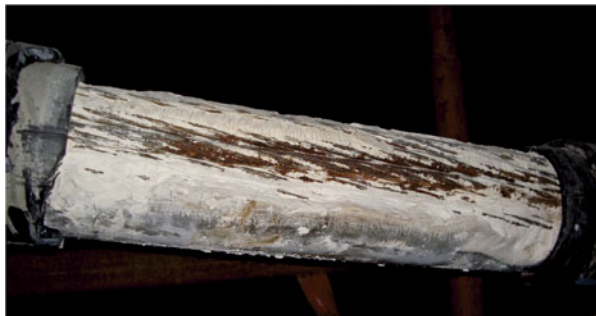
Figure 5. Example of an aperture in the duct of a tendon showing the whitish segregated grout embedding corroding strands.

on the surface of the strands that emerged from grout W (Figure 5), in few cases also deep penetrating attacks could be observed.

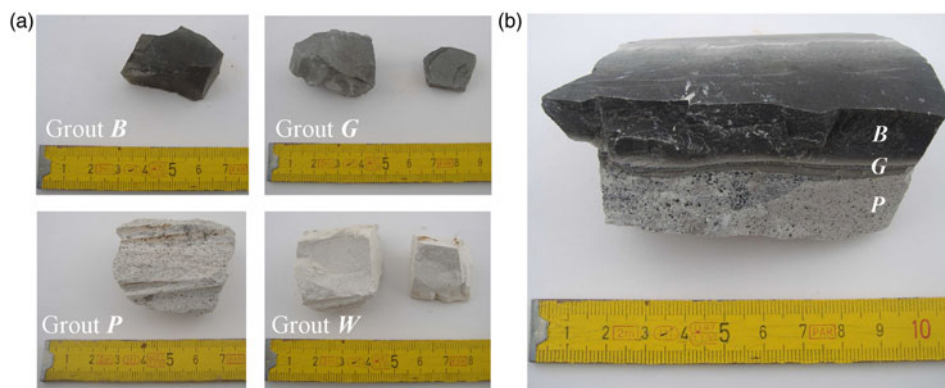
Figure 6 depicts the different aspect of the filling material found in the inspected tendons. On the basis of the

observation of more of 60 samples, collected during the inspection of the tendon failed in service and of tendons removed afterwards, the consistency and the colour of the grout were detected and the filling material was classified as follows: G = hardened grout with a regular aspect and the typical grey colour; B = hardened grout with a dark grey (almost black) colour; W = unhardened whitish grout (i.e. in the form of a plastic paste, if wet, or a weak and friable material, if dry); P = light grey coloured hardened grout with black spots. As a general trend, types G and B were found at the bottom of the duct, type W on the top and P at an intermediate position. Voids (V) were also found in some cases in the upper part of the duct.

Figure 6. Different types of aspect of grout collected from the removed ducts of the inspected tendons (a) and example of stratification of the grout after segregation (b).

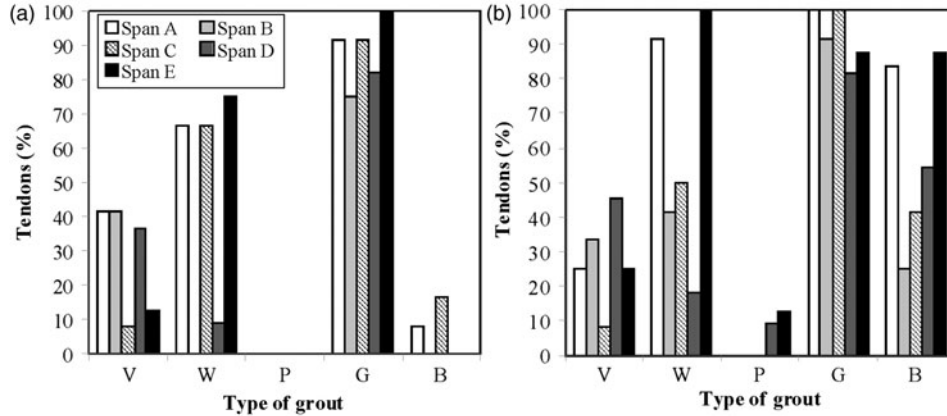
Figure 7 summarises the results of the inspections on the apertures, showing the percentage of tendons where the different types of grout were detected along the surface previously in contact with removed ducts. Data have been analysed separately for the apertures of the injection side (Figure 7(a)) and in the opposite side (Figure 7(b)) of the five spans (A–E) of the bridge. These graphs, while representing the results of a simplified analysis, which is subjective and limited to visual observation of the surface exposed after partial removal of the duct, show the coexistence of different types of grout in the tendons of the spans of the bridge.

Furthermore, it can be seen that the presence of W grout was higher in the side opposite to that of injection. In most cases, only traces of this grout were observed (usually in the form of a thin stripe on the top of the duct), but in few cases a remarkable amount of W grout was detected and embedded strands were covered by corrosion products or even showed localised attacks. Grout P could be rarely detected from the surface.

Figure 7. Percentage of tendons showing the presence (even only in traces) of the different types of grout (V, voids; W, unhardened whitish grout; P, light grey grout; G, grey hydrated grout; B, dark grey grout) in the apertures on the inclined parts of the injection side (a) and the opposite side (b).

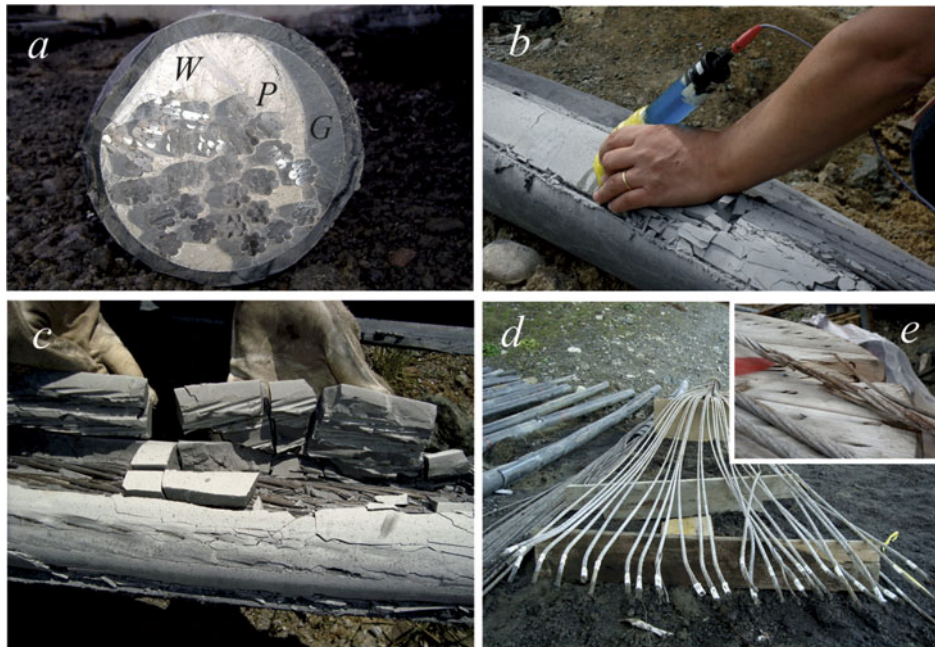
outside the bridge (Figure 8). Each cutting section was observed in order to detect the presence of different types of grout along the length of the tendon (Figure 8(a)). Then, in the two external segments with the anchor heads, the polyethylene duct was removed and the corrosion potential of steel strands was measured versus a Cu/CuSO<sub>4</sub> reference electrode (Figure 8(b)) before the grout could dry out. The filling material was observed in order to document the types of grout and their position and to collect samples for laboratory analysis (Figure 8(c)), and

Figure 8. Inspection of a tendon removed from the bridge: (a) types of grout observed on a cutting section, (b) measurement of the corrosion potential of steel strands, (c) inspection of the grout, (d) inspection of the steel strands and (e) detail of wires of a strand broken due to corrosion.

thereafter each single strand was removed and carefully checked (Figure 8(d)) to detect the presence of broken wires and corrosion attacks (Figure 8(e)).

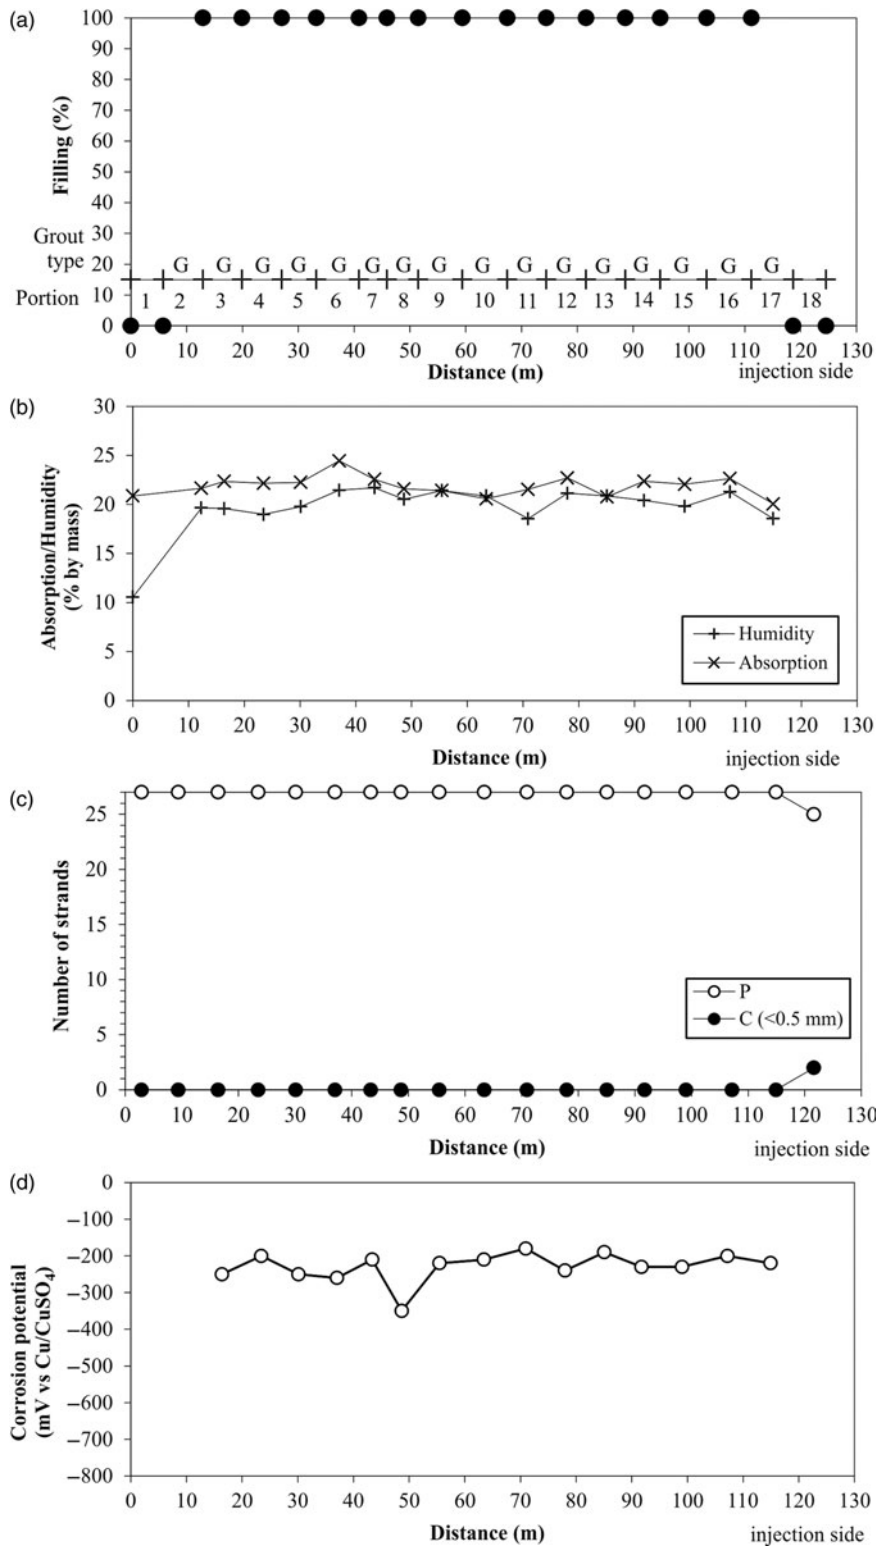
The filling was complete, except for the end portions with the anchor heads (#1 and #18), where, however, the grout was ejected as a result of the damage occurred during the removal operations. In all the other portions, only type G grout was found. Grout samples were collected from each segment of the tendon to measure the moisture content and the water absorption (Figure 9(b)). The moisture content of the grout at the time of sampling approached the absorption of the sample (equal to about 20% by mass, Figure 9(b)), i.e. the grout along the duct was still saturated with water. Figure 9(c) shows the results of the observation of the 27 strands along the length of the tendon, showing that most of the surface of the steel was in passive conditions, and only few attacks with a penetration depth lower than 0.5 mm were observed on one strand near an anchorage. Figure 9(d) shows that the corrosion potential of the steel embedded in the grout was in the range of  $-250/-200$  mV versus Cu/CuSO<sub>4</sub> along the tendon.

The potential measurements, which were carried out immediately after the removal of the duct, showed that this technique is not able to detect those areas in which small localised attacks were present. Measured potential values were those typical of passive areas in water-saturated grout (Bertolini et al., 2013), while lower values of corrosion potential that are expected in the neighbourhood of localised attacks could not be detected by the reference electrode placed on the external surface of the grout.

Figure 9. Example of the results of inspection of a tendon: (a) filling degree and types of grout observed on the cut sections, (b) moisture content and water absorption of grout specimens taken from different segments, (c) number of passive wires (P) and corrosion attacks (C) and (d) corrosion potential of the steel strands.

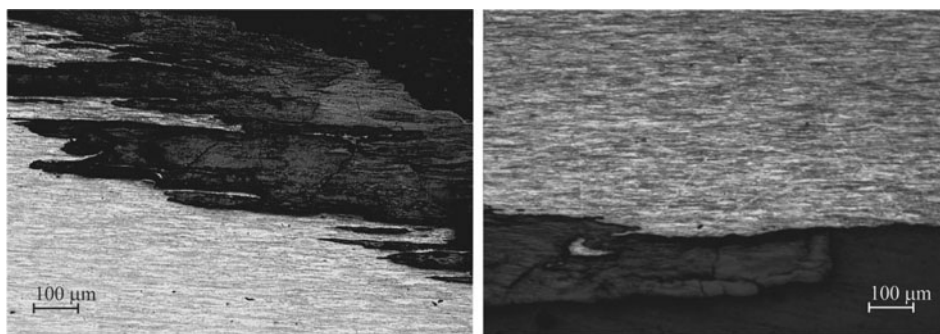
Chemical analysis measured on a sample of steel wire is shown in Table 2, while the microstructure is shown in Figure 10. The surface of the corroded wires often shows the presence of significant amounts of corrosion products, which often have a brownish colour but, in some cases, also with a blackish colour. The presence of blackish corrosion

Corroded areas and fracture surfaces of representative samples of steel wires were observed. Figure 11(a), for example, shows the failure of a wire, which took place in correspondence of a localised corrosion attack. Figure 10 shows the thick layers of flaky corrosion products observed on metallographic sections. At the scanning electron microscope (SEM), the fracture surface, where it was not masked by corrosion products, was ductile and characterised by the presence of elongated dimples (Figure 11(b)).

Figure 10. Metallographic sections of corroded wires from the tendons failed under service.

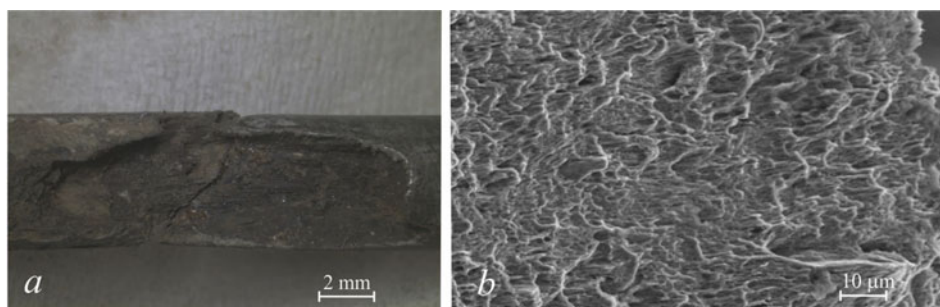
Figure 11. Stereomicroscope image of the two parts of a broken wire (a) and SEM image of the ductile fracture surface (b).
