# Investigation on Performance Decay on Photovoltaic Modules: Snail Trails and Cell Microcracks

Alberto Dolara, *Member, IEEE*, Sonia Leva, *Senior Member, IEEE*, Giampaolo Manzolini, and Emanuele Ogliari

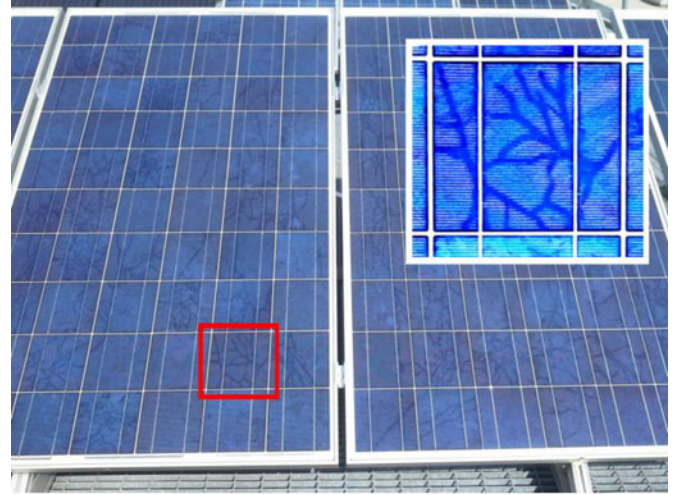
Fig. 2. Visible picture of STPV modules at SolarTech Lab and magnification of few cells affected by snail trails.

PV modules affected by the snail trail phenomenon are polycrystalline type and are named A4.1, A4.2, A4.3, and A4.4 (see Fig. 1). For the sake of brevity, from now on, the modules affected by snail trails will be abbreviated as STPV (snail trails PV), while the PV module beside the investigated modules as REFPV.

The four STPV are made by the same manufacturer, while REFPV was made by another one. All the modules have been produced in 2011 and exposed to the sun light at the beginning of 2012 in similar environmental condition. Before installation, each module was tested showing good agreement in terms of performances with the corresponding datasheet. The STPV modules at that time did not show any problem in terms of the snail trail phenomenon or other issues. After less than six months, these PV modules started to show the snail trail phenomenon with simultaneous performance decay of the PV plant. Fig. 2 shows a picture of two PV modules affected by the snail trail phenomenon made at the time of installation at SolarTech Lab.

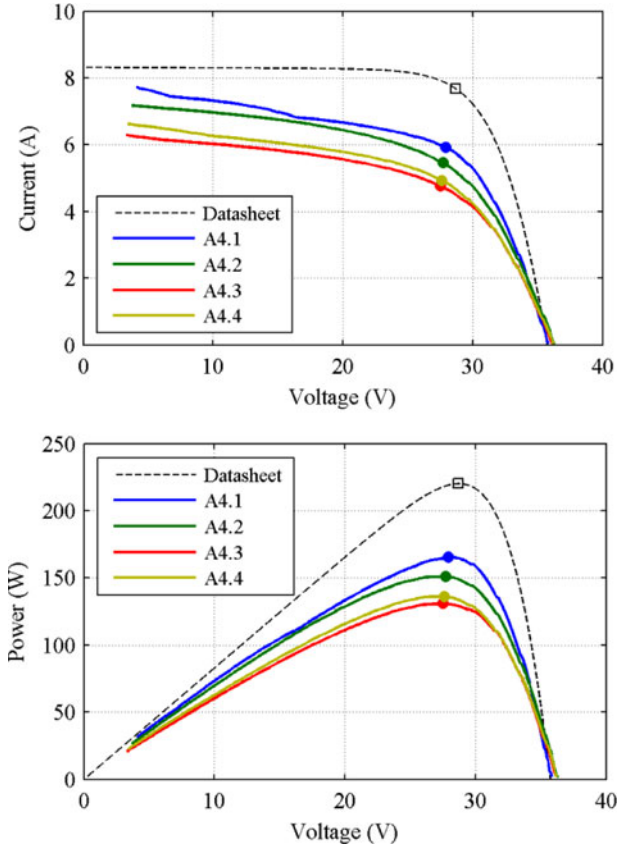
Fig. 4. Measured  $I$ - $V$  and  $P$ - $V$  curves of the four PV modules affected by the snail trail phenomena normalized at STC in comparison with datasheet curve.

In Fig. 4, the measured curves for the four STPV modules are shown together with the curves calculated from datasheet.  $I$ - $V$  curves have different values but from a quantitative point of view; they share the following aspects

- 1) They are all below the datasheet curve, in particular at maximum power point conditions.
- 2) The performance decay is mainly related to photo-generated current reduction.
- 3) The  $I$ - $V$  curve has a significant slope at low voltages, suggesting a lower shunt resistance in the equivalent circuit.
- 4) The open-circuit voltage coincides with the reference value.

These results suggest that it is more likely the cell cracks instead of the snail trails are the reason for the performance loss. If the majority of the cells are isolated by breakage, they cannot contribute to the photo-generated current. This confirms what can be seen by the photos shown in Figs. 2 and 5: If massive ST became visible usually the affected cells are heavily broken.

The maximum power point reduction of STPV respects the datasheet ranges between 24.8% and 40.5%; the range between 21.4% and 37.1% can be assumed because of snail trails phenomena. It is mainly related to the photocurrent generated and lower shunt resistance as also previously discussed.

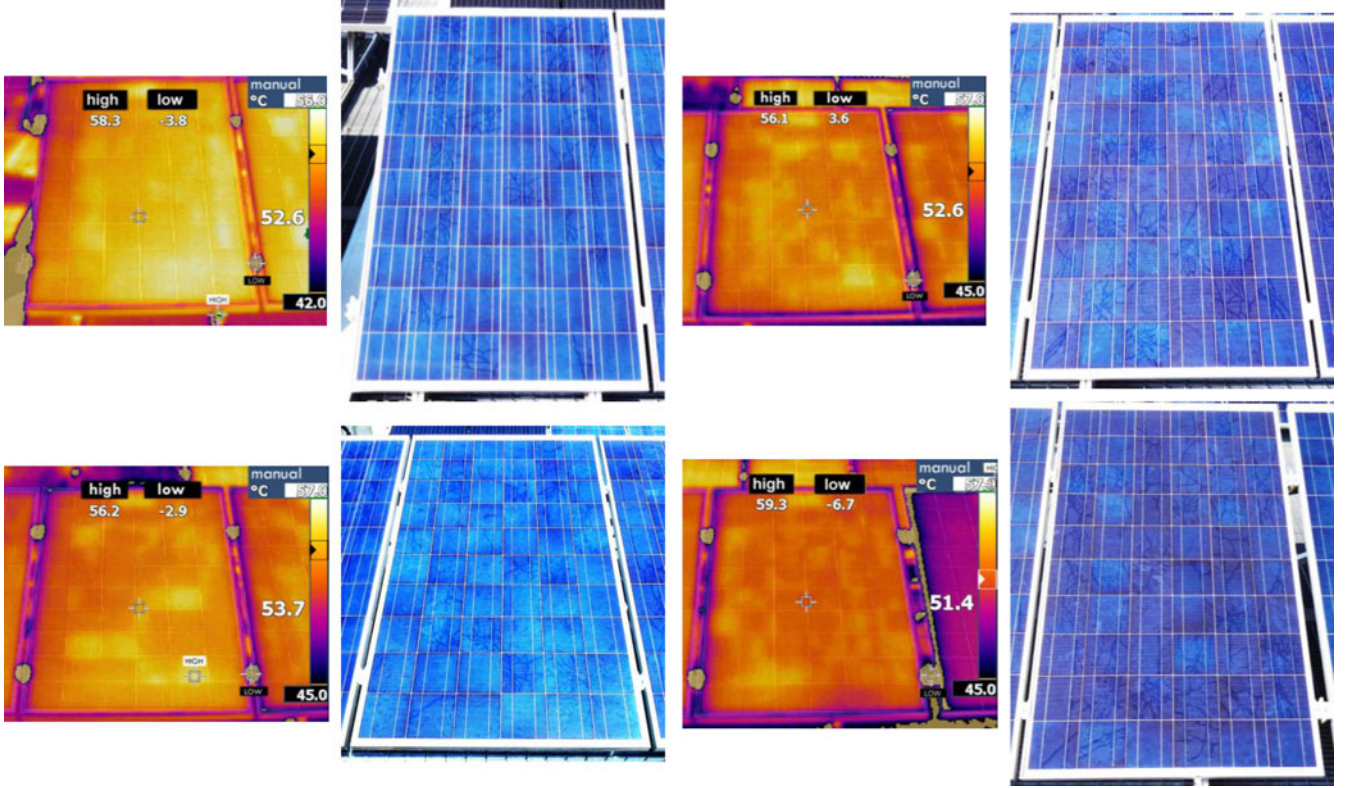
Electric measurements of PV module performances were combined with a thermal analysis of modules surface to find out potential hot spots. Fig. 5 shows a thermal picture of PV modules. All modules shows nonuniform thermal behavior (lighter parts indicate higher temperatures).

Reference PV modules have uniform temperature distribution (besides marginal boundary effects). Hotter spots that coincide with cells affected by the snail trail phenomenon indicate that they have been damaged and are not working properly.

Fig. 5. Thermal image and picture of PV modules A4.1, A4.2, A4.3, and A4.4, starting from the top left, moving horizontally.

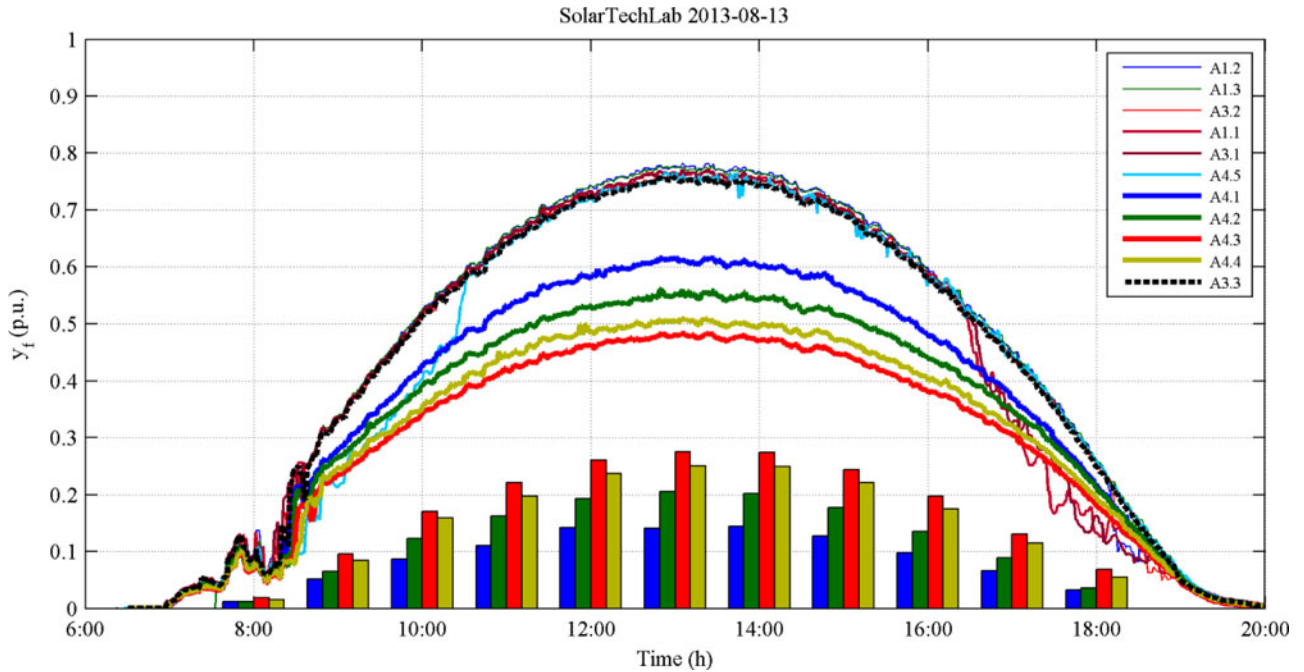
Instantaneous Final Yield of PV modules for three different randomly chosen days in August are shown in Figs. 6 and 7. In Fig. 6,  $y_F$  of all PV modules oriented as STPV and in production at the SolarTech Lab on 13th August is reported. The thick curves distinguished by blue, green, dark yellow, and red colors represent the power production rate of the STPV, numbered A4.1, A4.2, A4.3, and A4.4, respectively. The other

curves represent other PV polycrystalline modules oriented as STPV at SolarTech Lab. Beside minor shading issues at sunrise and sunset of few modules (see the light blue of A4.5 and dark red of A1.1 and A3.1), Instantaneous Final Yield ( $y_F$ ) of STPV is always the lowest. It could be noted in Fig. 6 that performance of the REFPV (A3.3) is representative of the other modules having an average behavior. This module is considered as the reference module in Fig. 7.

The difference of Instantaneous Final Yield ( $y_F$ ) increases with the solar radiation achieving an absolute value between 18% and 30% at 12 A.M. solar time (about 1:30 p.m. local time).

When the solar radiation is low and the contribution of the diffuse radiation is higher (before 9:00 and after 18:00), the performances of STPV are close to the reference panel. This result suggests that snail trails negatively affect the conversion efficiency of the direct solar radiation; however, further investigation should be performed.

Fig. 6. Daily production of the all the polycrystalline PV modules present in the SolarTech Lab in August 13, 2013. The A4.1, A4.2, A4.3, and A4.4 PV modules were affected by snail trails phenomena. A4.5 and A1.1, A3.1 PV modules were affected by partial shading at sunrise and sunset, respectively. The PV module A3.3 is the polycrystalline one taken as the reference. The bar chart shows, hour by hour, the difference in term of power between STPV modules and REFPV one.

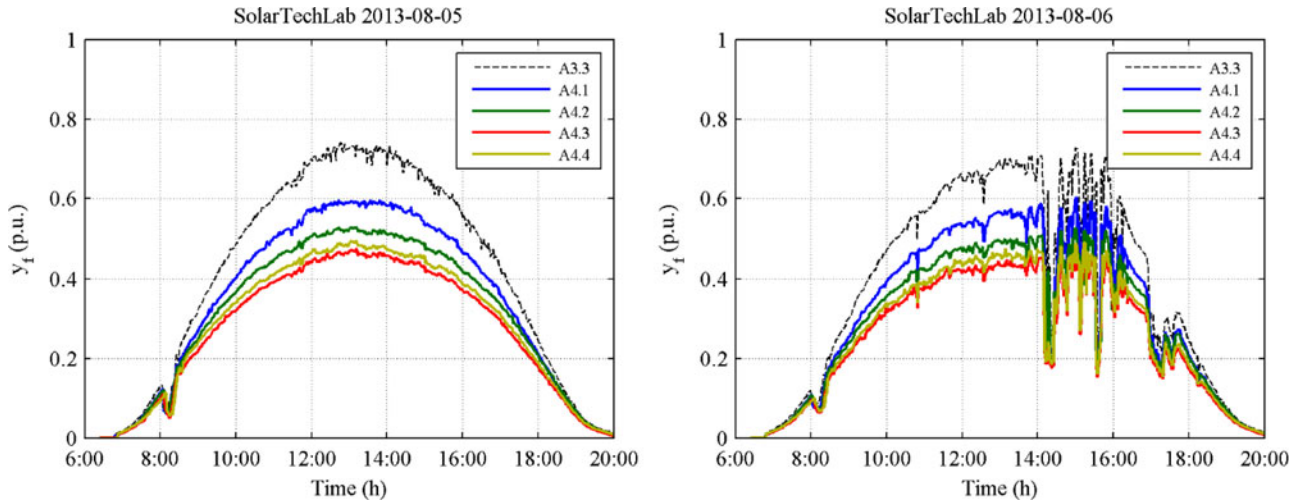
The same considerations can be extended to the curves reported for two additional days (August 5 and 6, respectively) in Fig. 7 where, only one reference PV module is shown, the one beside the investigated modules.

Fig. 7. Daily energy production of the four module affected by snail trails phenomena (A4.1, A4.2, A4.3, A4.4) in comparison with reference curves (A3.3), recorded in two days of August 2013 (August 5 is on the left, and August 6 is on the right).

Moreover, it can be outlined that performances decay is higher in days with high solar radiation for all STPV.
