The disaster on the A14 in Bologna: a missed multidisciplinary approach to road safety

P. Villani*,

* Politecnico di Milano - Department of Civil and Environmental Engineering, Italy
paola.villani@polimi.it

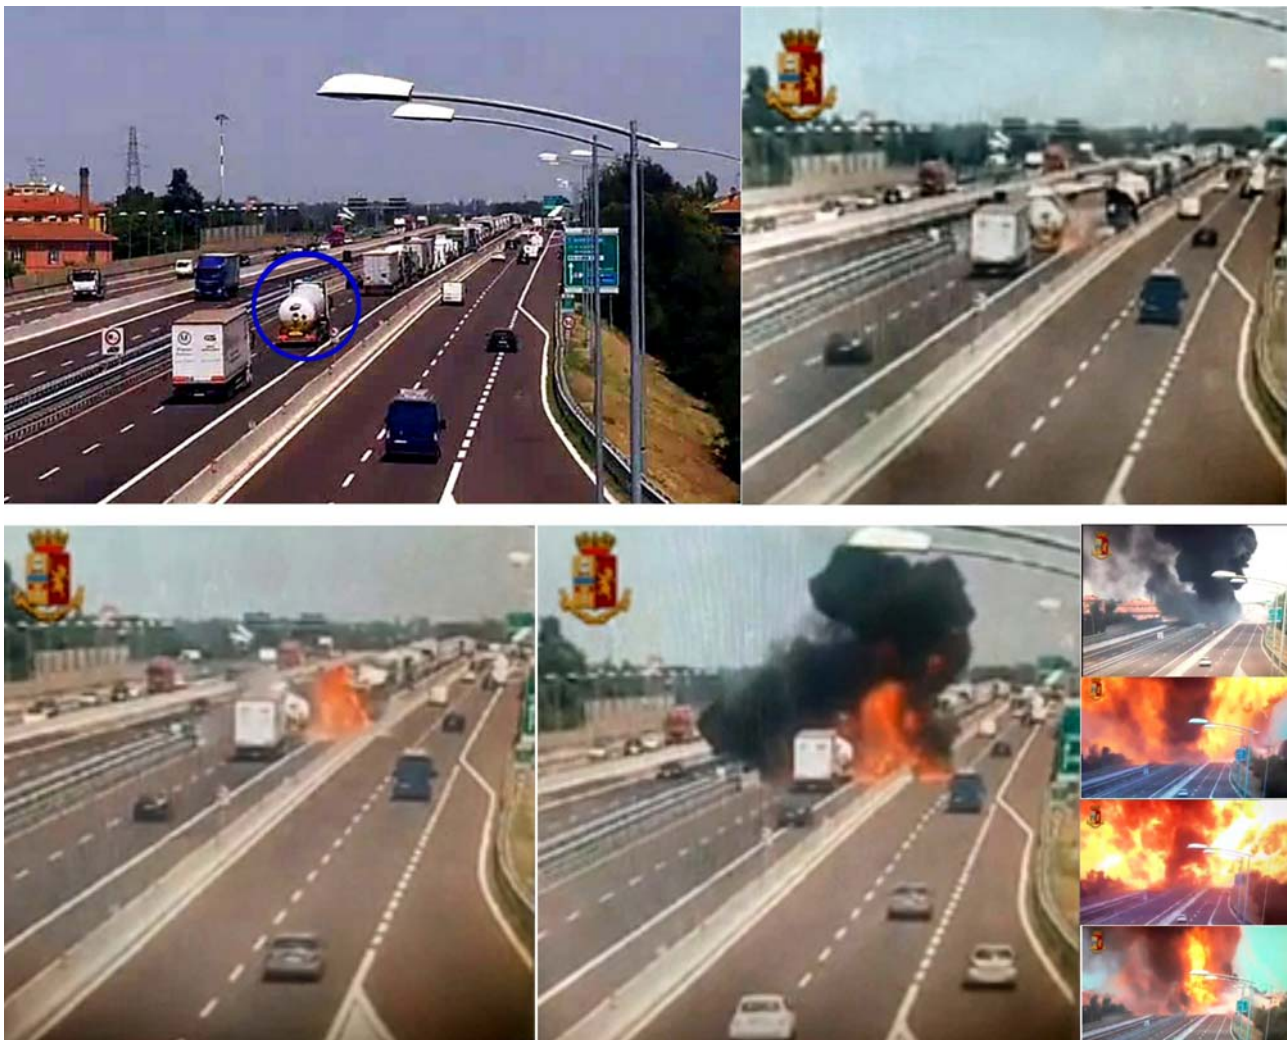
Figure 1 On the A14 Bologna motorway the rear-end collision, the first explosion and shortly after the second

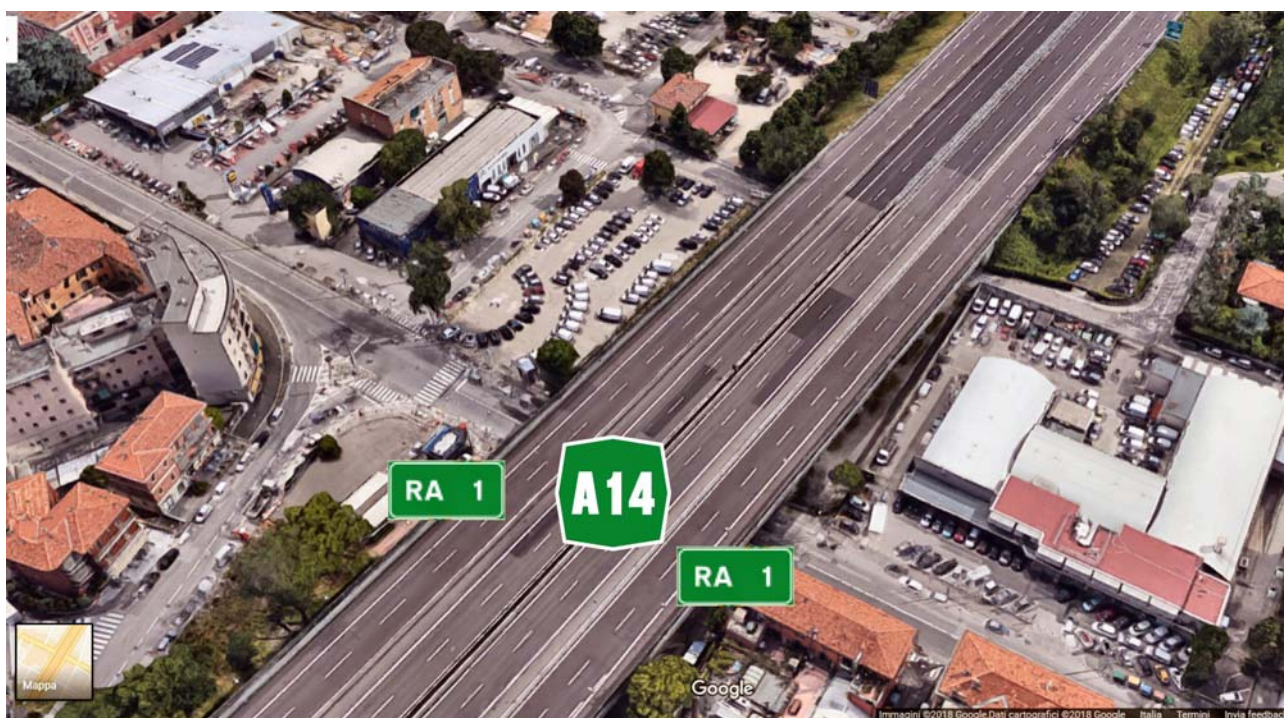
Figure 2 Accident concentration zone

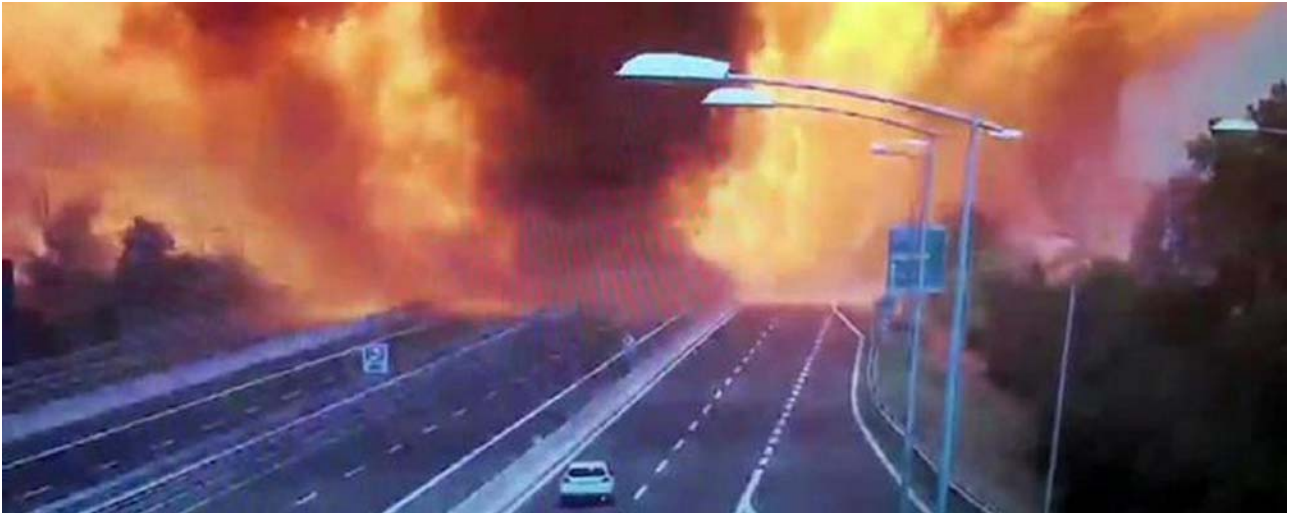
Figure 4 Second explosion in which, in a few minutes, the first rescuers have already eliminated the traffic

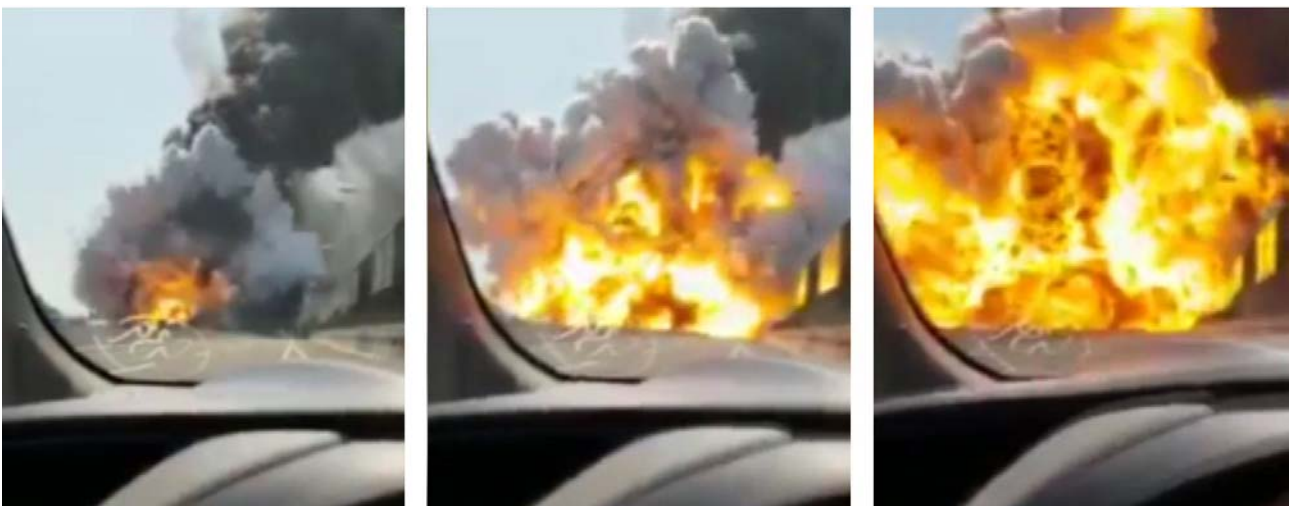
Figure 5 The second explosion seen from a car stopped in motorway lane

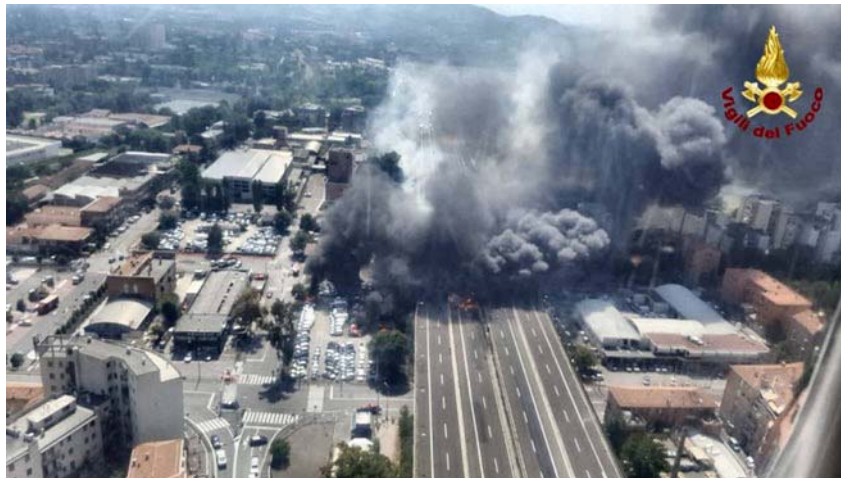
Figure 6 Smoke after the second explosion

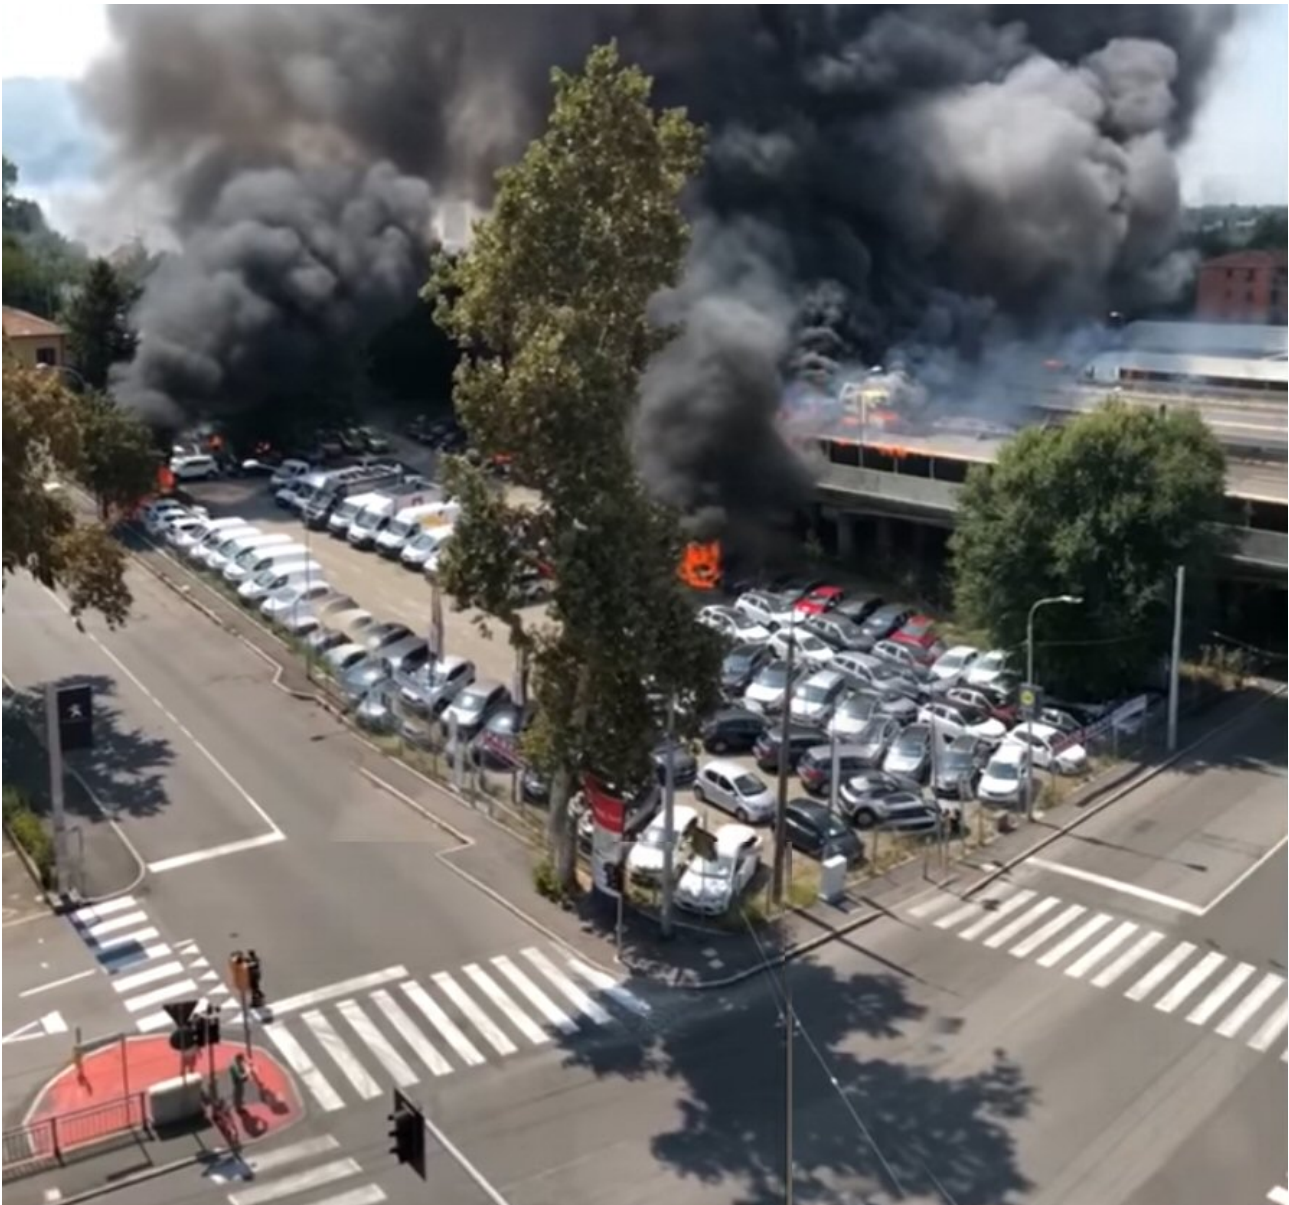
Figure 7 The second explosion also caused the cars blast under the bridge

The explosion of the tanker was felt throughout the area, blew up the windows of shops and homes, the huge blast caused the explosion of cars in the two dealers under the bridge.

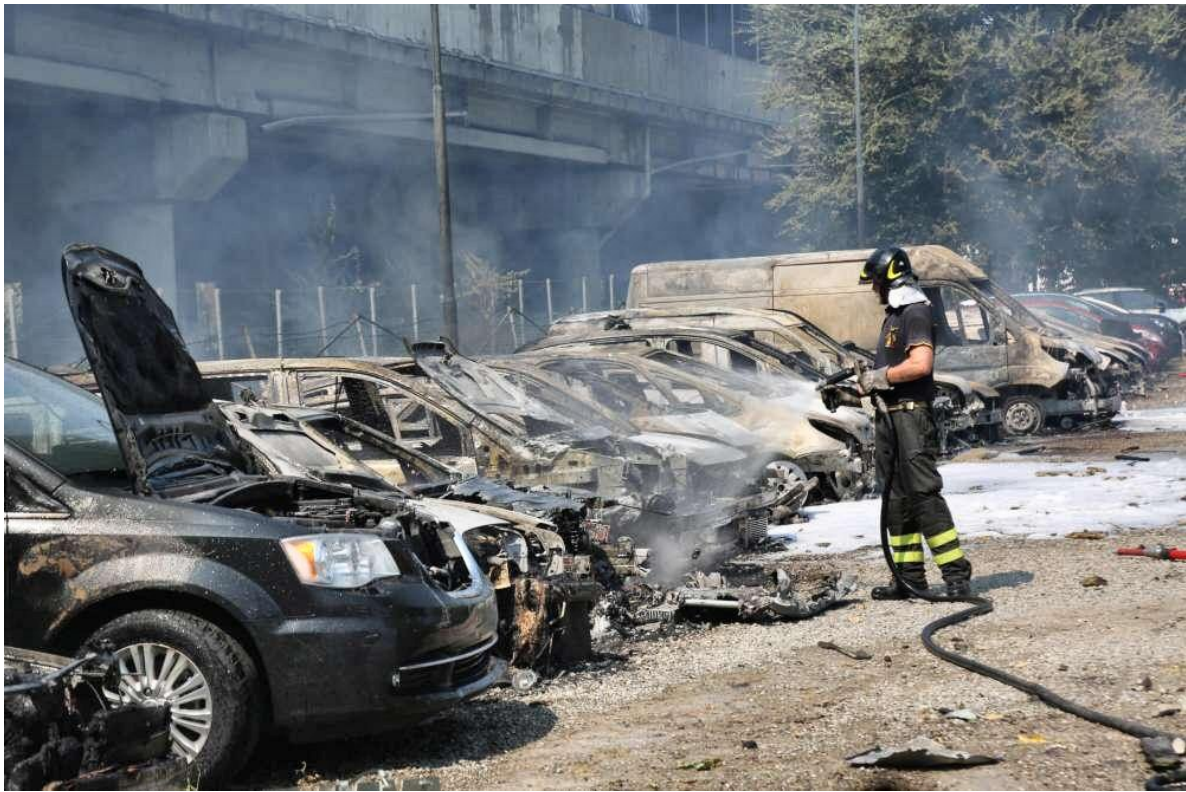
Figure 8 Firefighters extinguish car fire under highway bridge

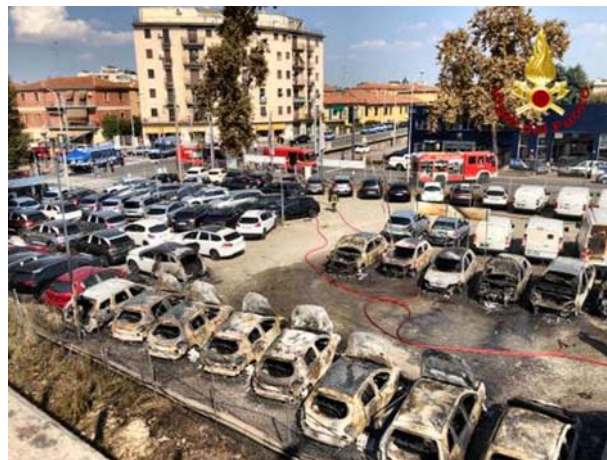
Figure 9 Combustion of cars of two concessionaires located under the road bridge

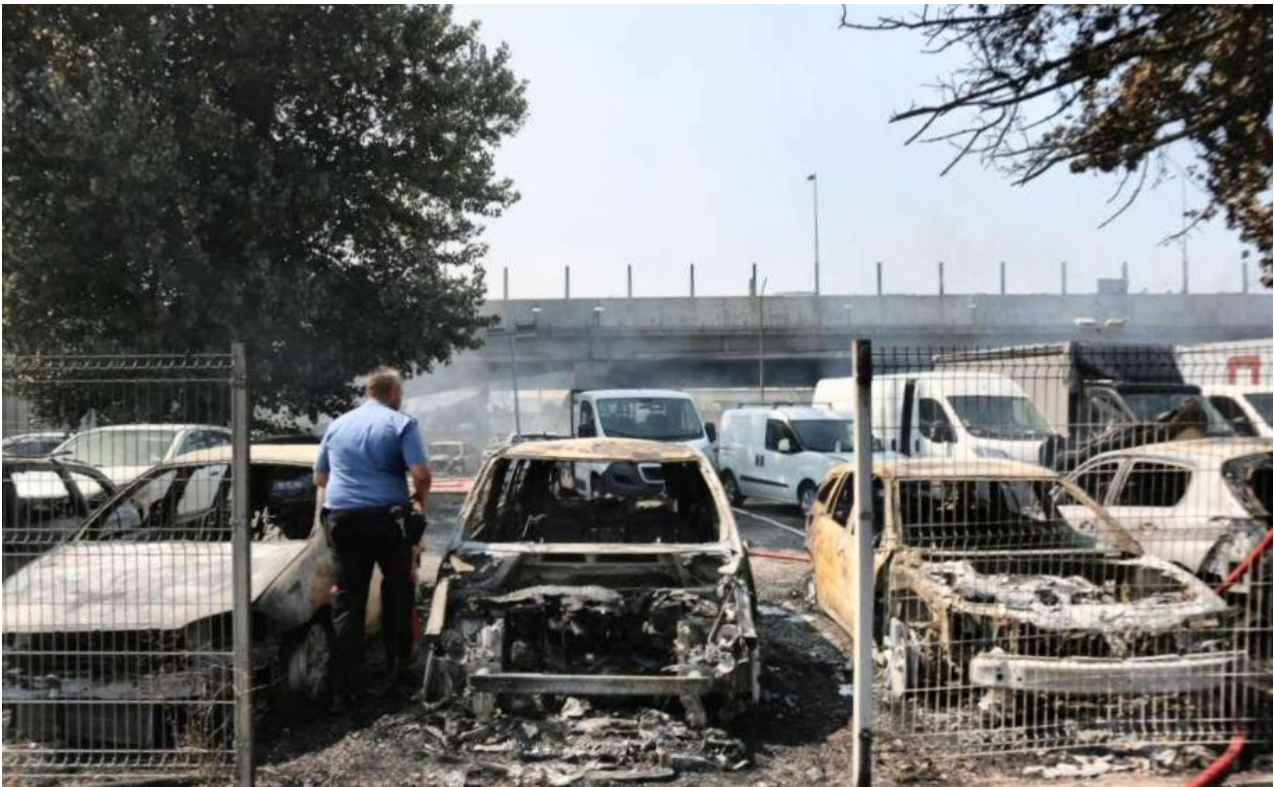
Figure 10 Debris of carbonized vehicles under the road bridge

Whoever wanted to engage in specific analysis to determine if the phenomenon of the Bologna explosion was really an electric arc will be able to note that a projection of high energy sprays are visible in some debris of carbonized vehicles, as well as - another proof is the explosion and the pressure determined by the shock wave that struck the window frames in the area.

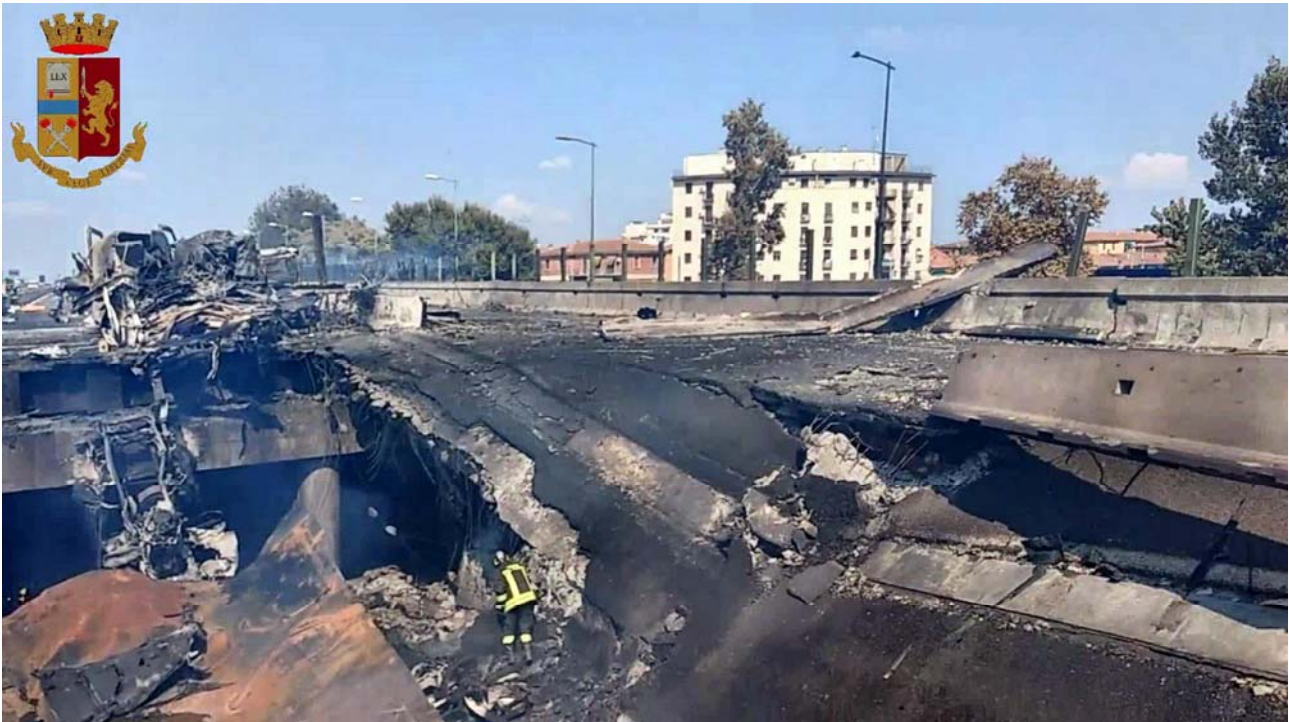
Figure 11 The road viaduct after the explosion

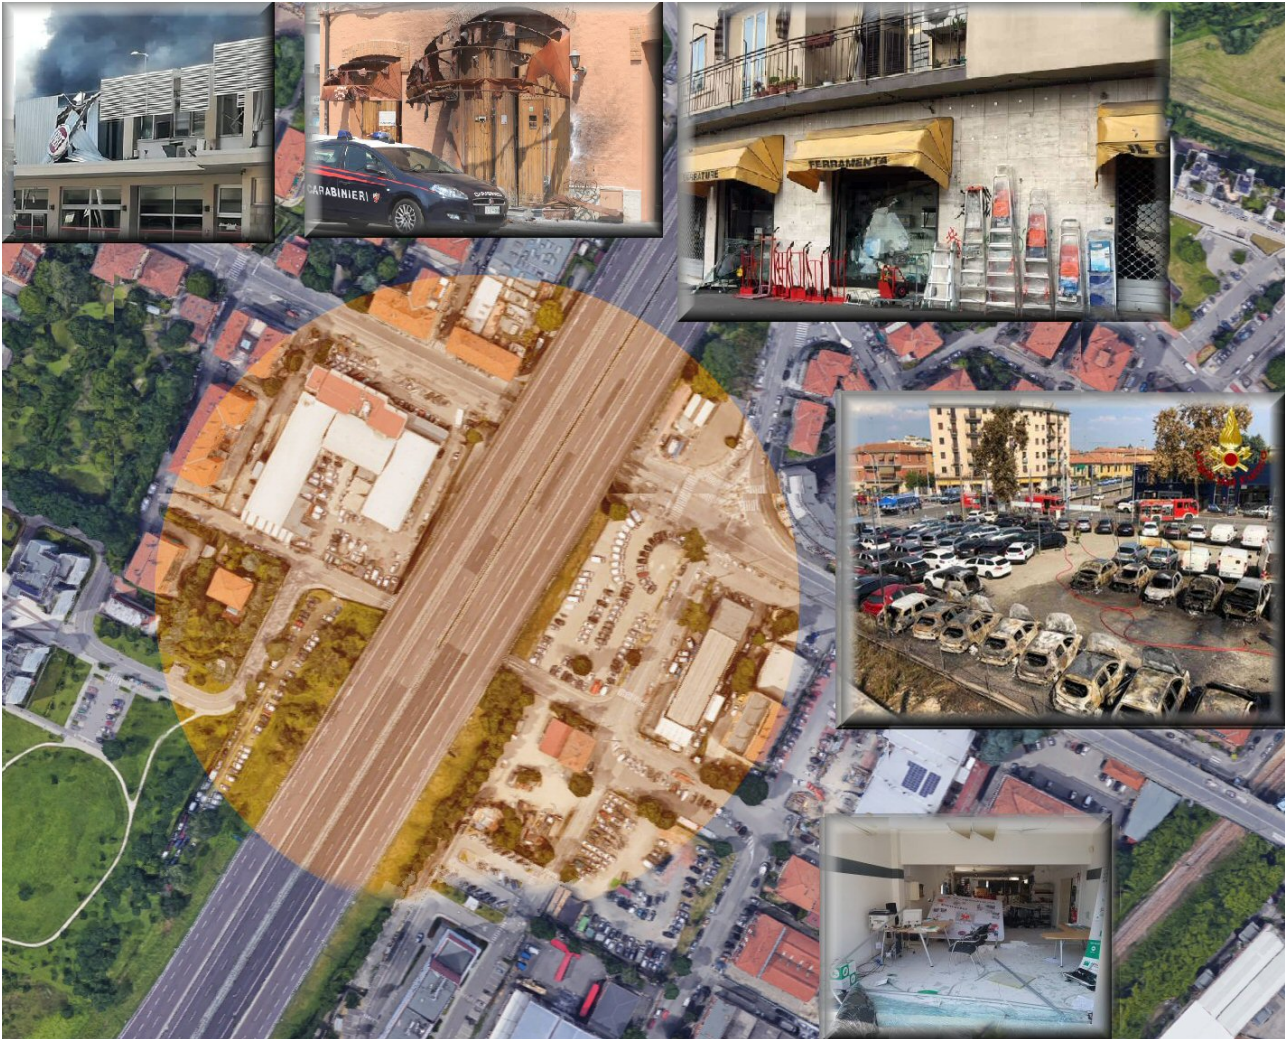
Figure 12 Area affected by the explosion

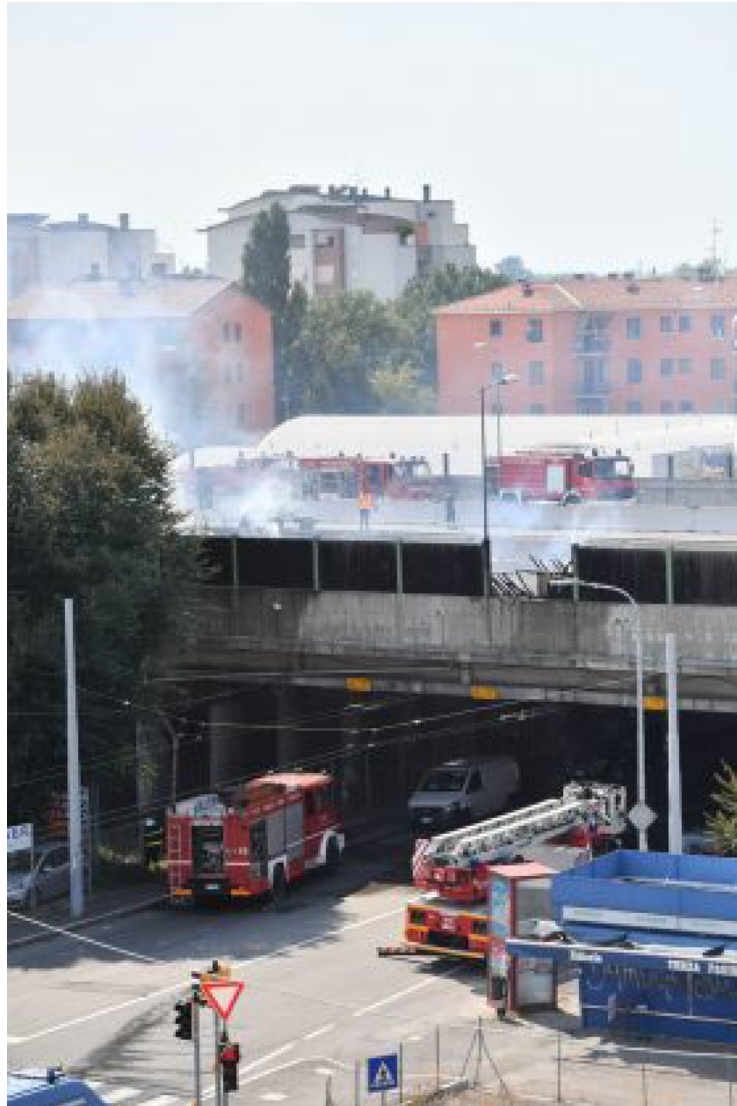
In this case of Bologna, the heating due to the overlying fire may have caused the loss of insulation of the cables and may have caused an electric arc between the cables hanging on the bridge of the A14.

Figure 13 The power cables of the filament line, cables with 600 V voltage, will have been affected by the fire and this led to the explosion.

The arc discharge can be caused by the action of the flames, when they attack the live conductors and damage or carbonize their insulation.
