Dynamics and causes of the collapse of the Morandi viaduct in Genoa

P. Villani*,

* Politecnico di Milano - Department of Civil and Environmental Engineering, Italy
paola.villani@polimi.it

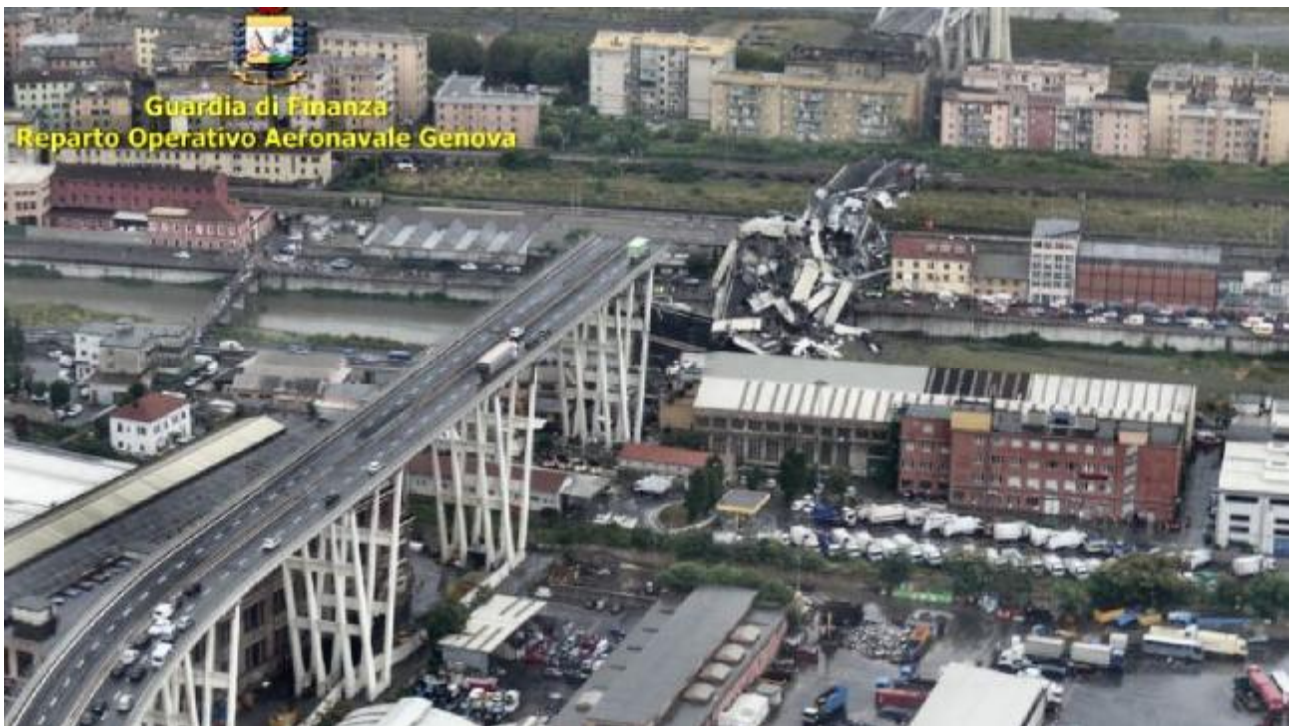
Figure 1 The collapse of the Morandi viaduct in Genoa on the photo taken by the Guardia di Finanza helicopter

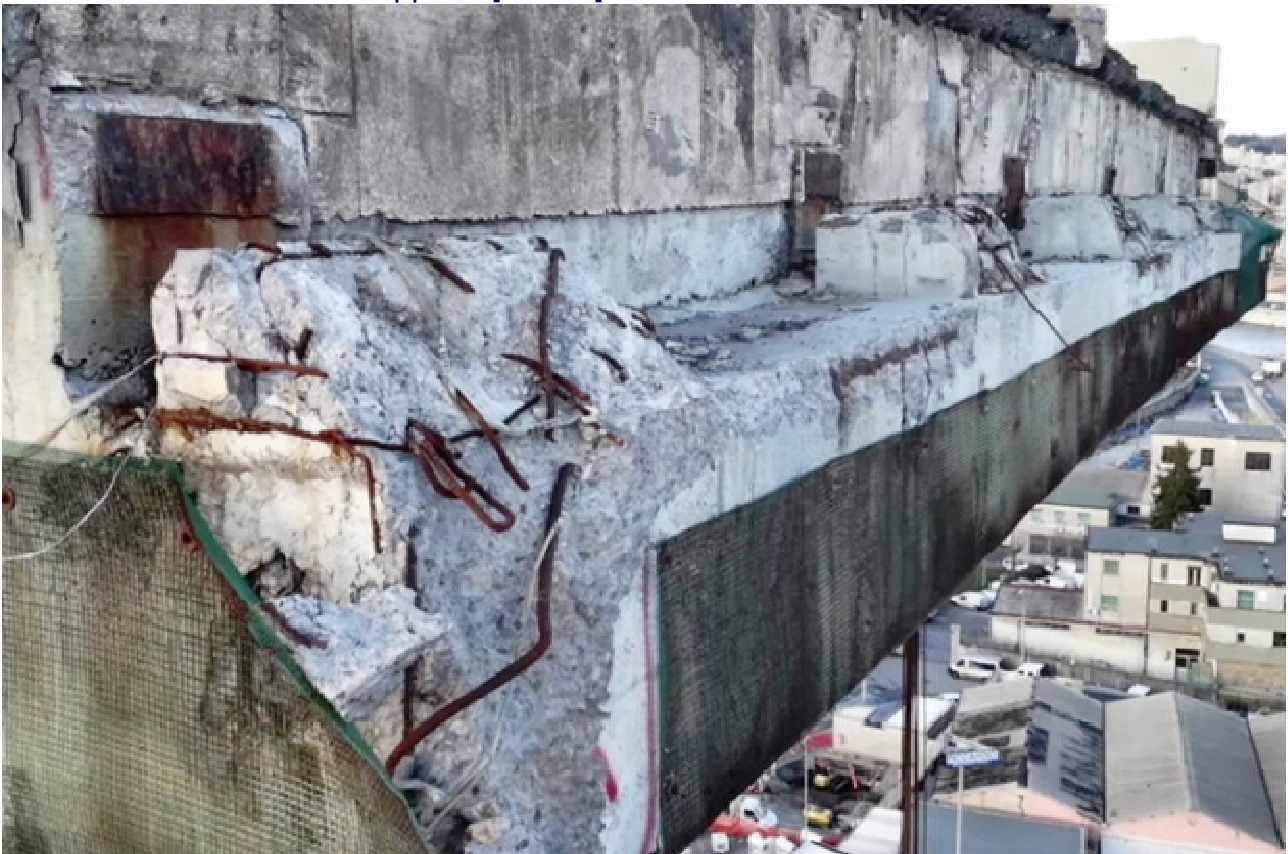
Figure 2 Detachment of the concrete cover, carbonation and oxidation of the reinforcements

There was been material leakage during the period 2011-2016, perhaps as a result of the October 4, 2010 flood. But the Morandi viaduct is not on the list of urgent interventions. Consequences: detachment of the concrete cover, carbonation and oxidation of the reinforcements. Networks were placed to avoid material losses.

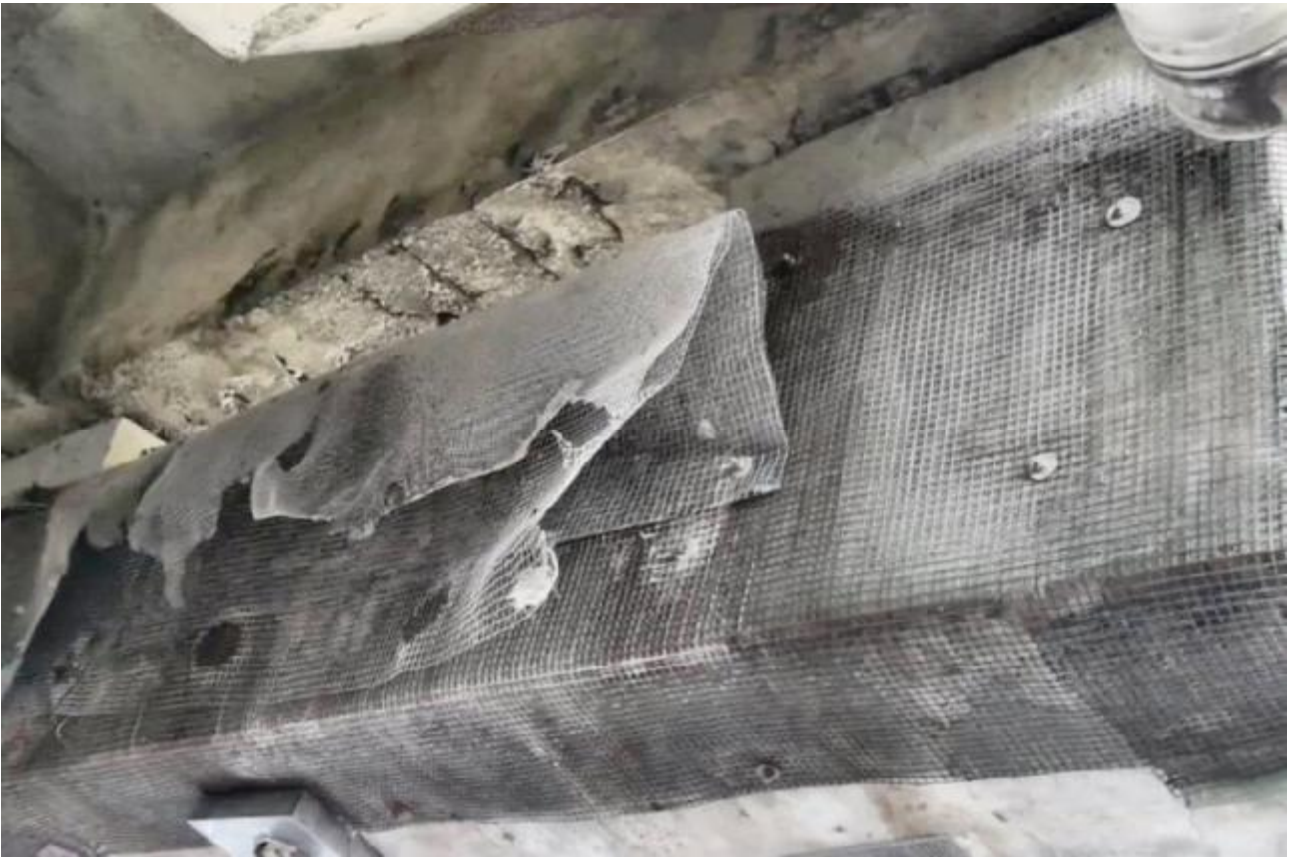
Figure 3 Networks were placed to avoid material losses

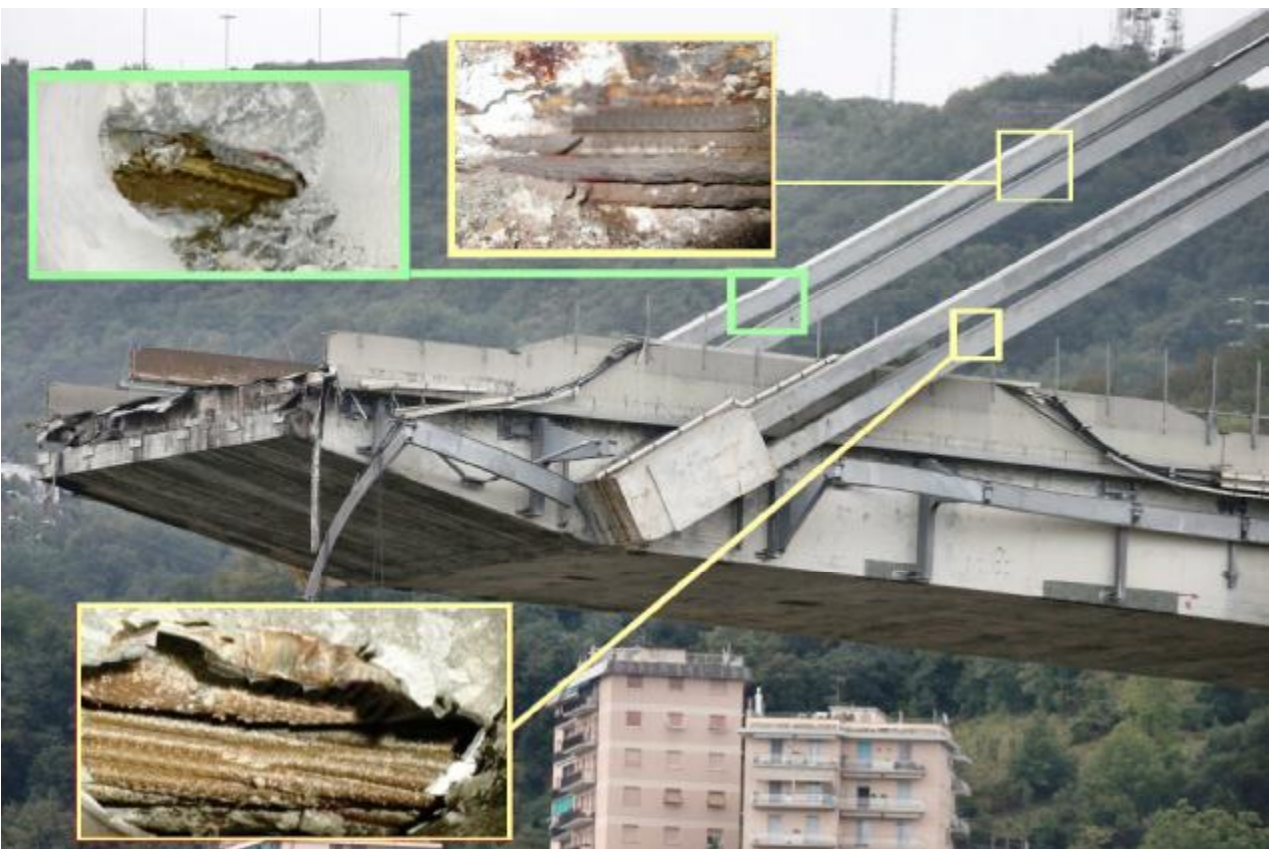
Figure 4 [Source Spea Engineering - January 2016] Diagnostic investigations on the stays of stack 9 and stack 10. The carrot carried out shows oxidation in the strands, corrosion and breakage of prestressing cables. The protective sheath is oxidized inside. Corrosion of the internal tie rods in the stay of the pile 10. The carrot investigates only secondary armor [Note 3].

The state of conservation of the tie rods antennas 9 and 10 was acceptable; however, the results of the reflectometric tests showed a slow trend of degradation of the cables constituting the tie rods (reduction of total cable area from 10% to 20%)

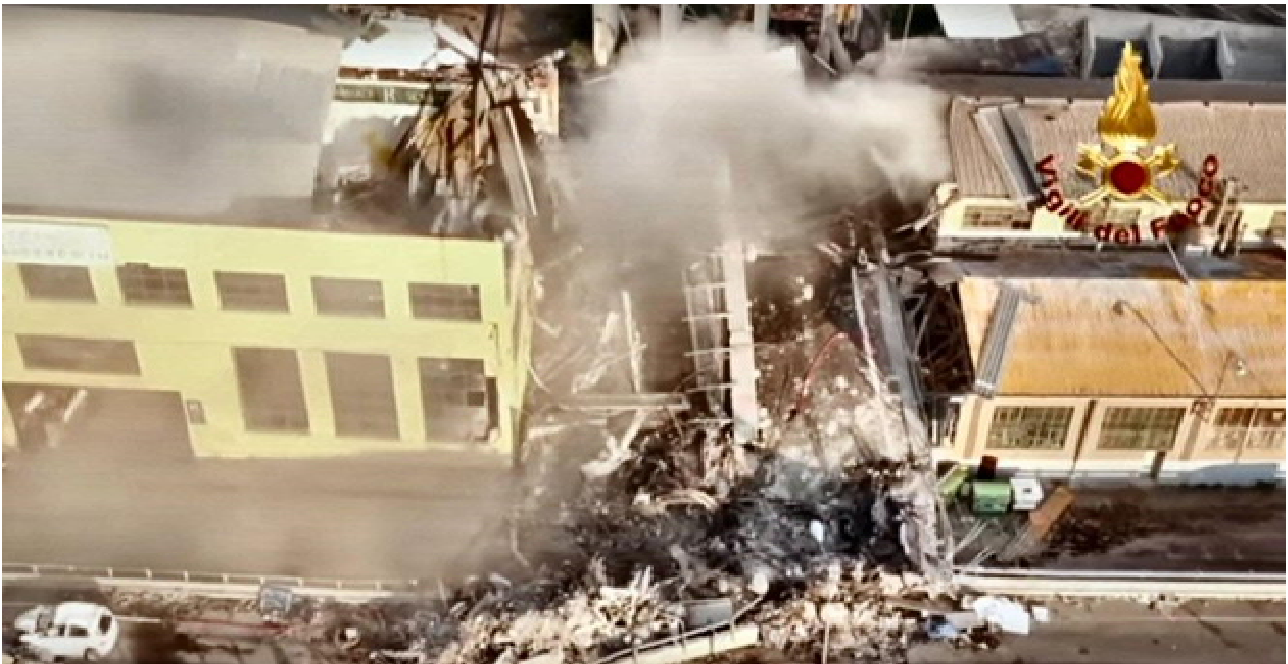
Figure 5 Firefighters and many engineers have immediately found traces of explosion

The collapse of the Morandi viaduct is not caused by structural failure: the elements collected and which are presented here as in a classic probative incident do not prove the structural collapse as the first cause of the collapse of the viaduct. Firefighters and many engineers have immediately found traces of explosion.

These are evidence of an explosion: the ruins are completely different from those found in cases of structural collapse. Two distinct collapses that have happened in a few minutes.

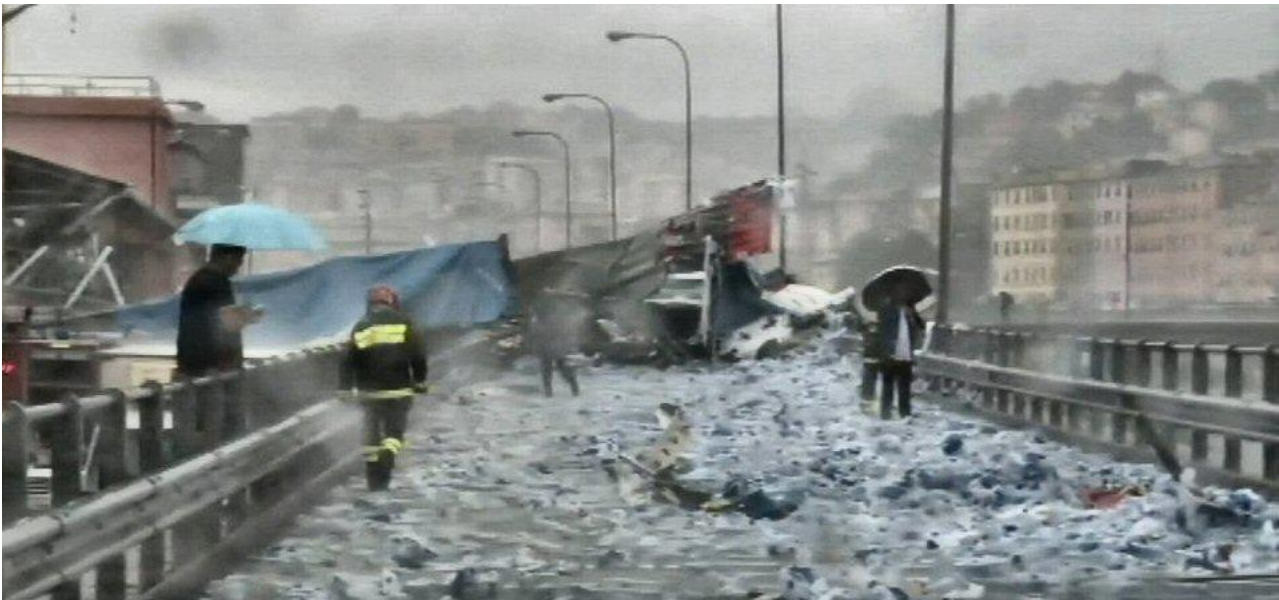
The images on August 14, 2018 were very clear. Firefighters run on a surface covered with gravel and small rubble in the whole area of the Polcevera viaduct, Cornigliano side.

Figure 6 Firefighters run on a surface covered with gravel and small rubble in the whole area of the Polcevera viaduct, Cornigliano side

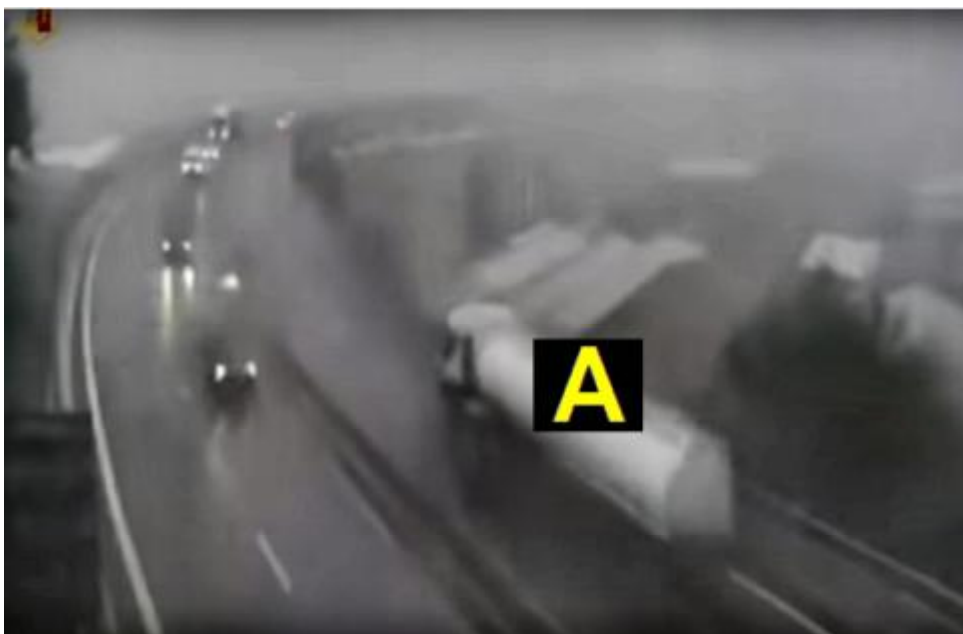
In the video at 00:55 - a yellow truck uses about 35 to 40 seconds to enter the bridge section that subsequently collapsed. As can be seen from the webcam images this truck is near battery 9 after 50 seconds. The white tanker truck [Figure 7, Vehicle A] transits at 2:11 minutes - at 3:00 minutes, it is on the roadway then collapsed.

Figure 7 A white tanker is in transit on the motorway section, it is direct south.

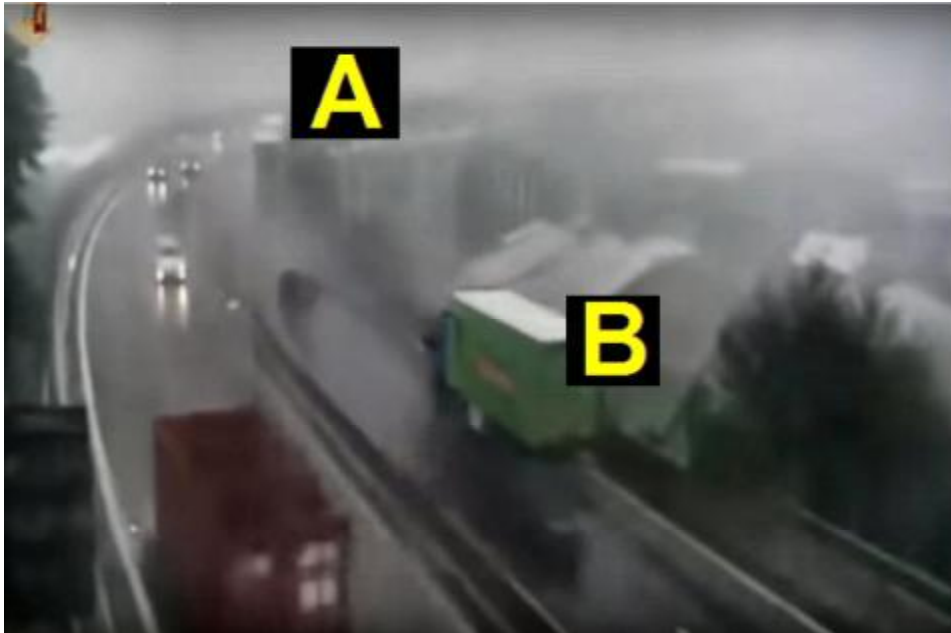
Figure 8 The green truck is in transit on the motorway section, it is direct south.

The green truck passes at 3:10 - it stays a few meters from the collapsed section.

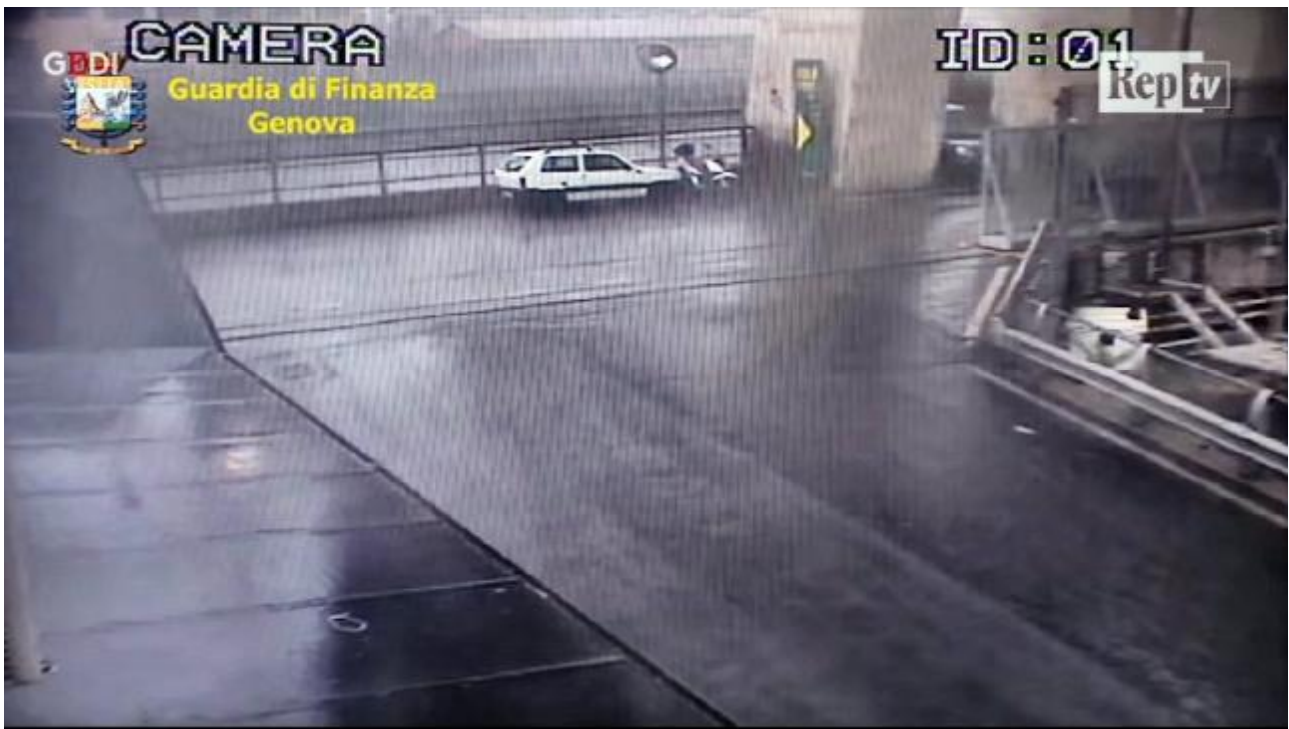
And in the webcam [Note 5] under the pylon 9 you see a sudden glow.

Immediately after the bridge deck is translated and then collapses.

Figure 10 In the webcam under pylon 9, you see a sudden glow: at the top, the reflection of the viaduct on the wet roof. This is a relevant image that helps to determine the speed at which the bridge collapses and the provenance of the debris. This image explains the early phases of the collapse

Webcam under pylon 9: at the top the viaduct deck reflection on wet roof. This is a relevant image that helps determine the speed at which the bridge collapses and where the debris comes from.

This image explains the first several phases during collapse.

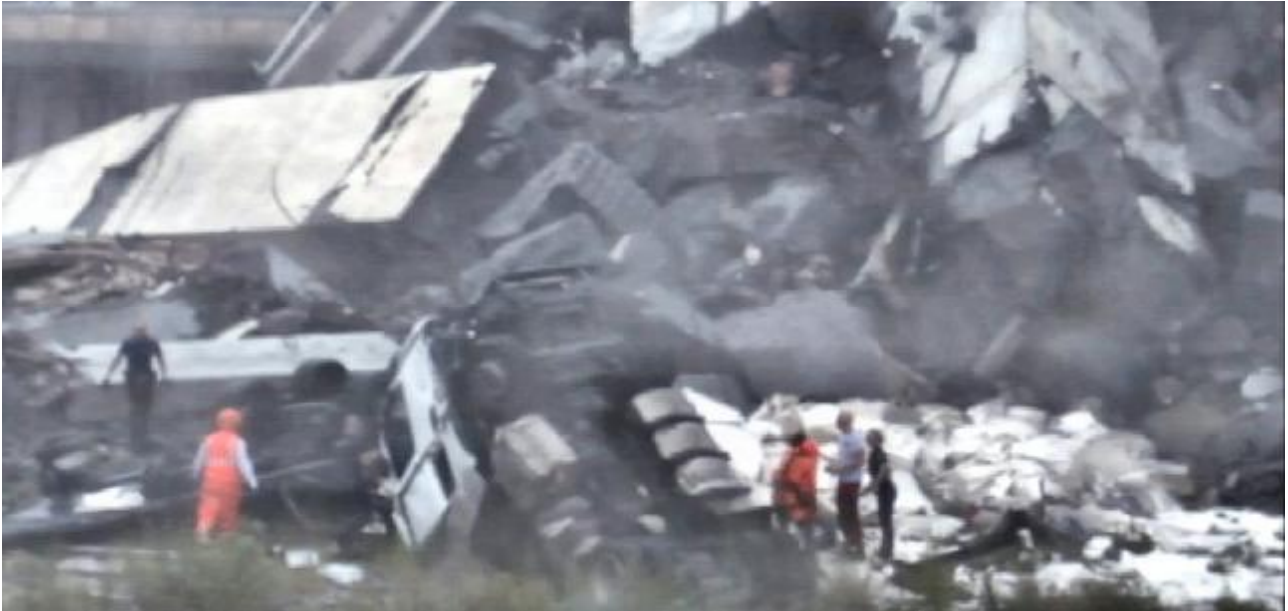
This white truck tank is the key to solving the collapse of the Polcevera viaduct. By observing the images is clearly visible the tractor of the tank between the debris of the bridge.

Figure 11. The tractor of the tank between the debris of the bridge.

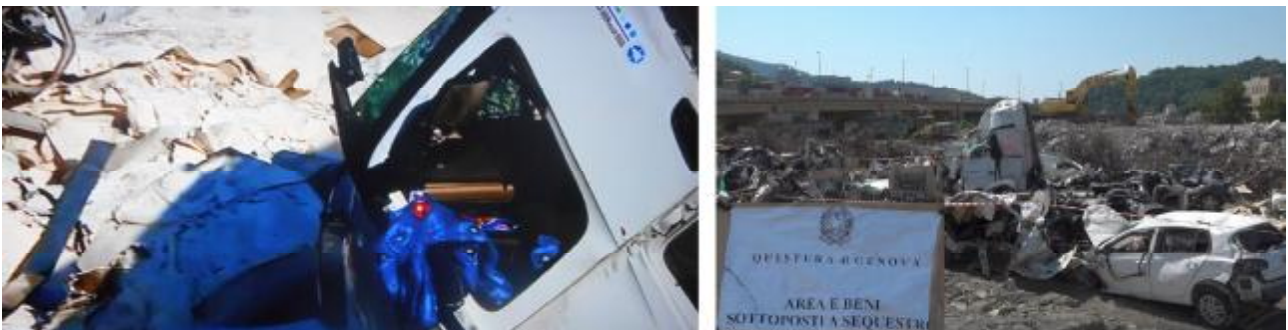
Figure 12. The tractor of the tank between the debris of the bridge and now debris area under investigation

On the ground remains the tractor, it will have been pushed and dropped in the explosion. The tank is exploded and we cannot find it.

The tractor is blackened. A logo on the vehicle door and little else. Another white lorry near but no trace of the tank.

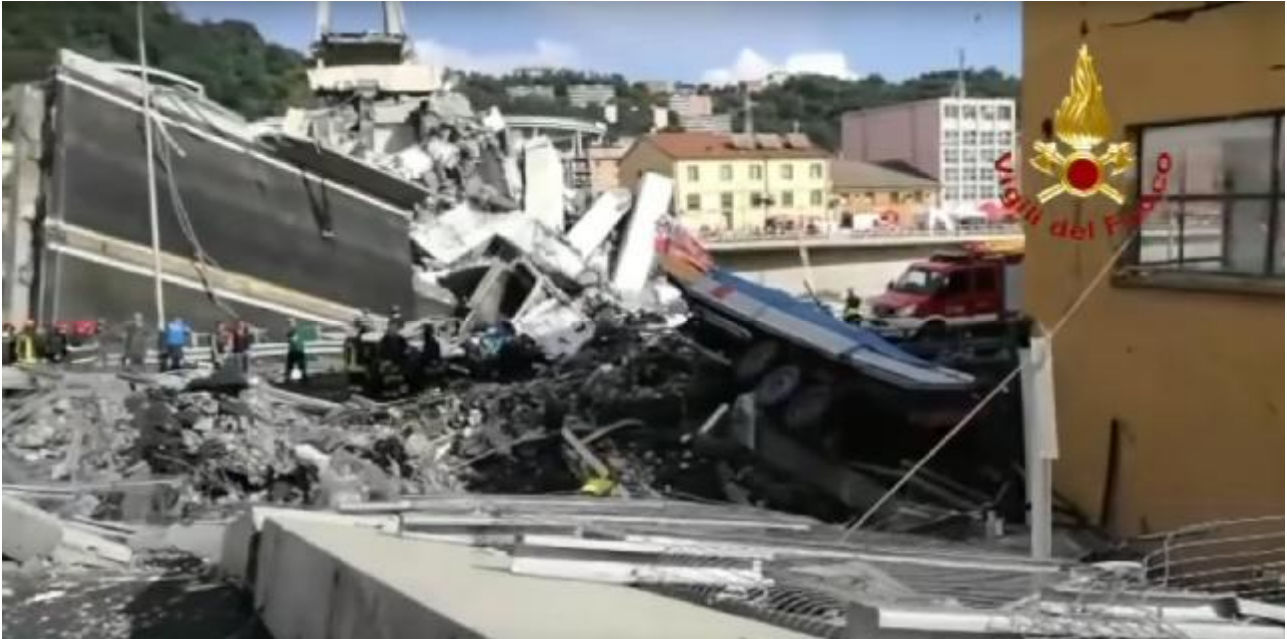
In this area the i have also collapsed roofs of some warehouses under the Morandi Viaduct, where it remained above blocked the green truck.

Figure 13 Collapsed roofs of some warehouses under the Morandi Viaduct
