Post-earthquake diagnostic investigation of a historic masonry tower

Antonella Saisi ^{a,b}, Carmelo Gentile ^{a,b,*}

^a Politecnico di Milano, Milan, Italy

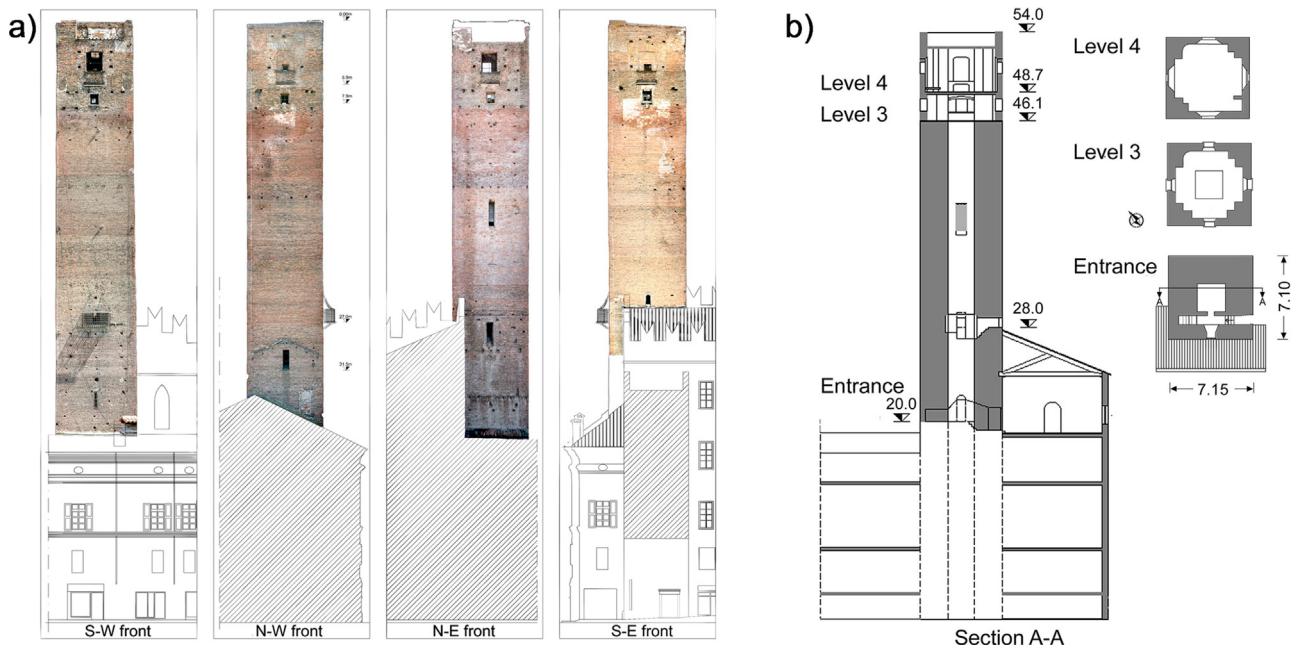
Fig. 2. Fronts and section of the tower (dimensions in m).

It is worth underlining that the local structural issues in the top part of the building are worsened by the change in the masonry resisting section shown in Fig. 2: at the upper levels 3 and 4 (Fig. 2), the nearly square plan, about 2.4 m thick, turns into corner masonry piers and untoothed infillings. The section decrease is especially significant at level 4 for the piers on North and South corners. Furthermore, the pier on South corner is partially dismantled and contains a merlon shape as well as an embedded water pipe. In addition, the lack of any mortar encrustation in the merlon surface could suggest weak connection in all the piers at the same level.

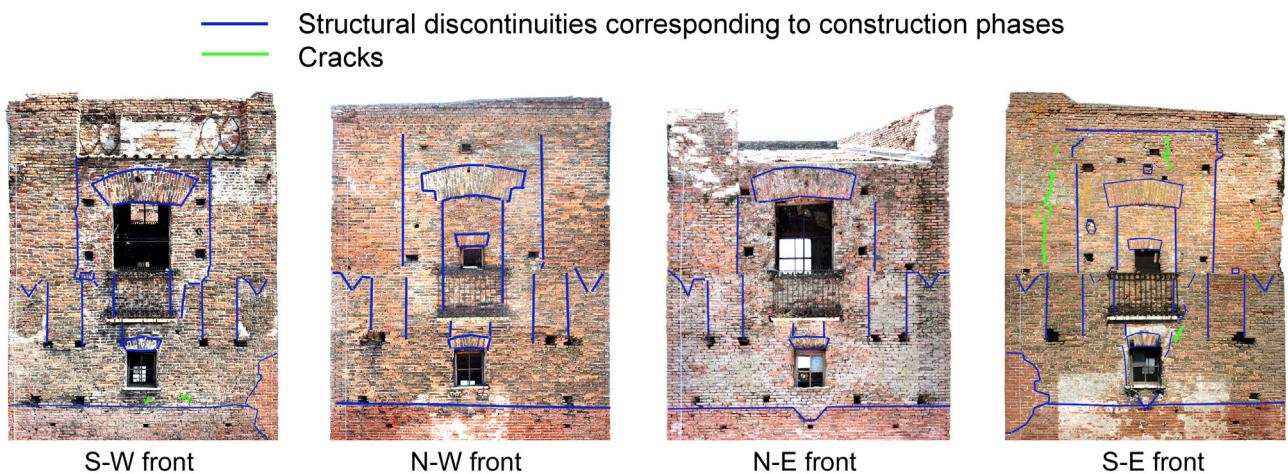
A first hypothesis, based on the surface discontinuity survey (Fig. 3), could recognize the following construction phases (which are very difficult to date): (i) erection of the main building until the height of 46 m (probably concluded in 1227); (ii) subsequent addition until the merlon level; (iii) adding of 4 corner piers

Fig. 3. Map of the discontinuities on top of the tower.

On the contrary, the upper part of the tower (i.e. the upper region about 8.0 m high, Fig. 2) exhibited damage related to the abovementioned detachment of several construction phases, worsened by the natural decay (Figs. 3 and 4). The poor state of preservation of the masonry is confirmed by the low average value of the sonic velocity (600 m/s) obtained from pulse sonic tests.

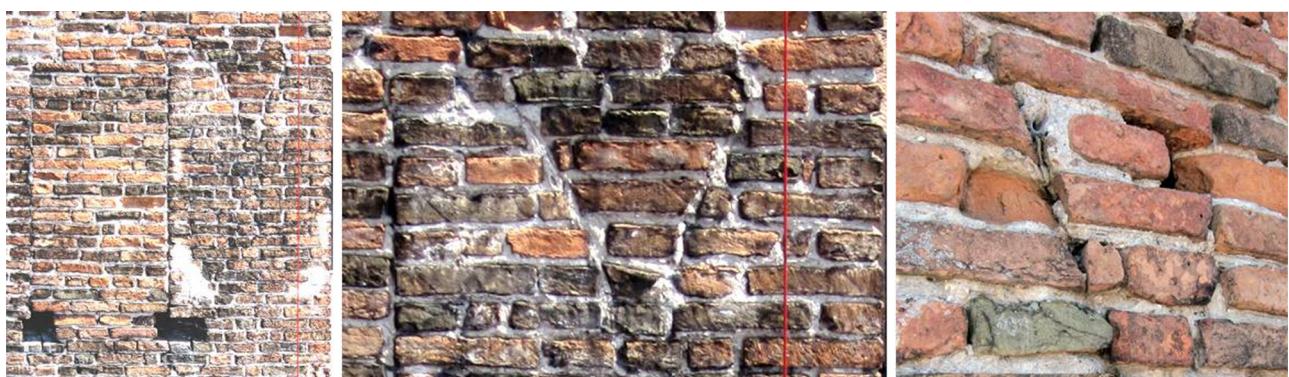
Fig. 4. Probable merlons embedded in the masonry texture.

The infillings between merlons (Figs. 4 and 6) are conceivably the most critical areas because there is an almost complete lack of connection between the infillings and the neighbouring portions of the same wall; in addition, the unusual layout and the extension of the scaffolding holes (Figs. 4 and 6) at the base of the infillings often significantly weakens the local resistance, so that the prevention of local overturning mechanism should be one of the priority interventions.

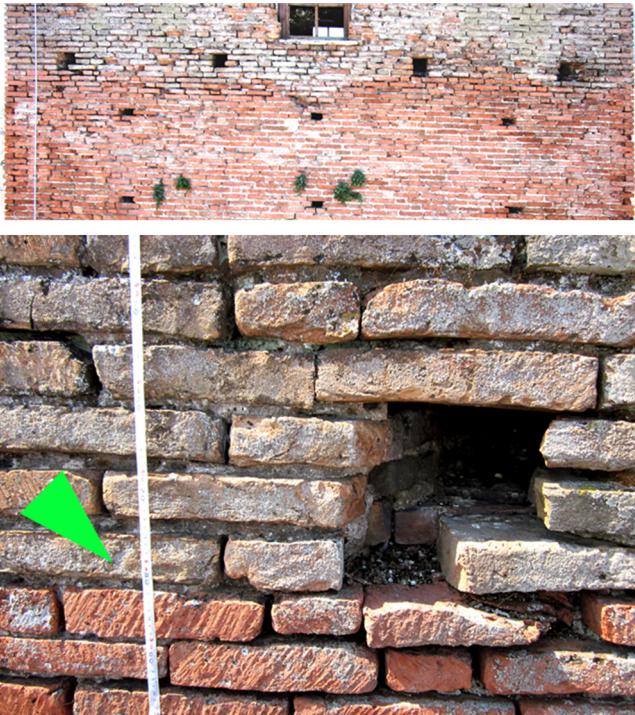
Fig. 5. Change of the surface workmanship at about 8.0 m from the top.

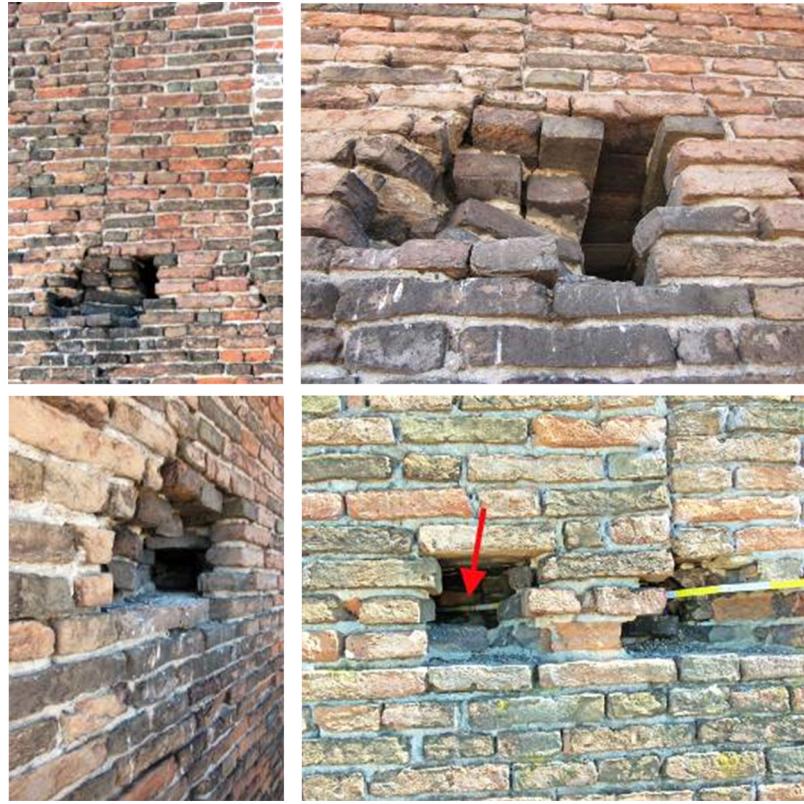
Fig. 6. Details of the infillings between the merlons on the N-W front.

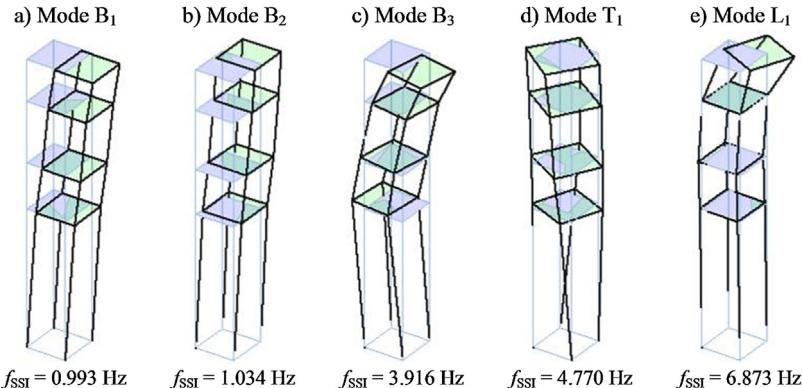
- the last identified mode is local (L) and only involves deflections of the upper portion of the tower (Fig. 9e). The mode shape seems dominant bending, with significant components along the two main planes of the tower. The presence (and generalized detection) of a local vibration mode provides further evidence of the structural effect of the change in the masonry quality and morphology (including un-toothed opening infillings and discontinuities) observed in the upper part of the tower during the preliminary visual inspection.

Fig. 9. Sample of vibration modes generally identified from ambient vibration measurements (SSI, 31/07/2012, 16:00–17:00).

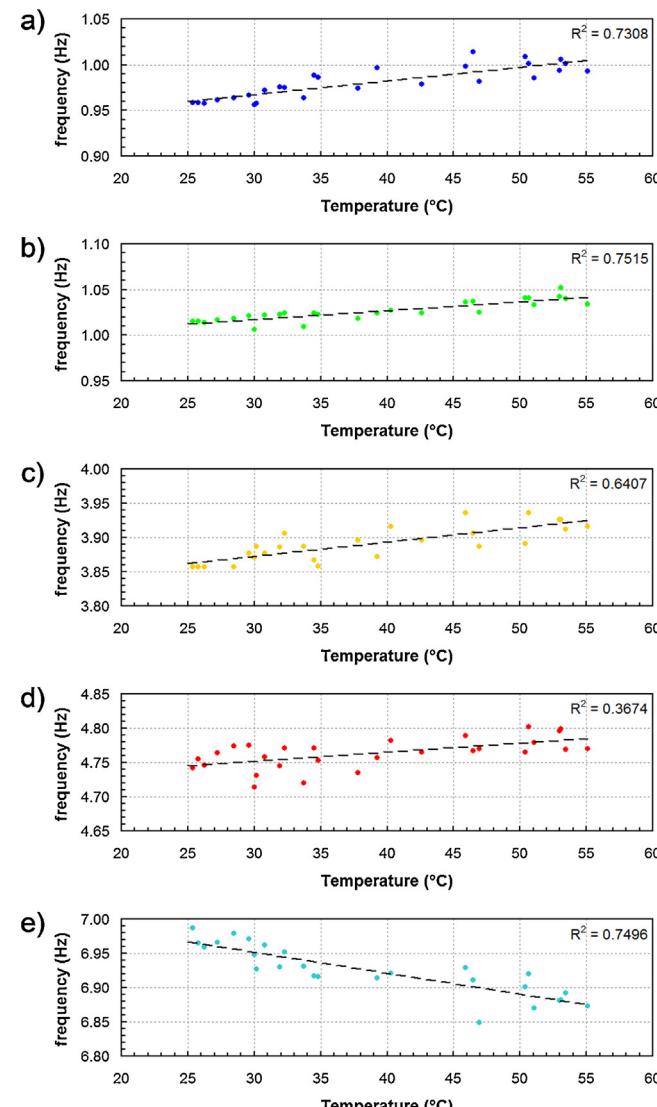
**Fig. 10.** Frequency (SSI) variation versus measured outdoor temperature (S-W front). a: mode B1; b: mode B2; c: mode B3; d: mode T1; e: mode L1.

Unlike the global modes, the natural frequency of the local mode L1 (Fig. 10e) decreases as the temperature increases and the coefficient of determination assume a high value ($R^2 \geq 0.75$). This result suggests that the thermal expansion of materials in a very heterogeneous area of the structure causes a general worsening of the connection between the masonry portions; hence (and again in agreement with the main observation of the visual inspection), further evidence is provided of the poor state of preservation of the upper part of the tower.
