Minimally Invasive Detection Technologies for the Defects in Ancient Timber Structural Building

Keywords: Defects, Timber, Minimally invasion, Micro drill resistance, Stress wave

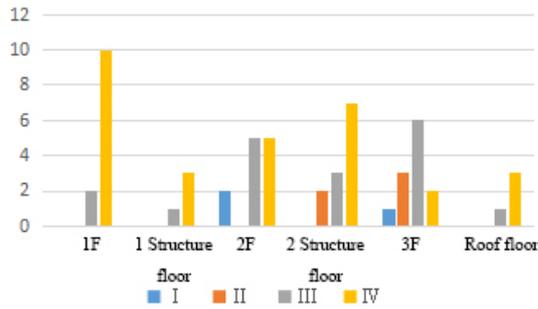
Fig. 5 Defects summary of columns in each floor

Preliminary survey. In order to facilitate the detection and recording, the columns of each floor are numbered from the southwest corner. the fracture parameters were recorded, the type of defects were divided, and the defects distribution of each floor were summarized (Fig. 5, Fig. 6). Different floors have different degrees of defects. Overall, the defects of the columns in the first floor is most serious. Comparing the degree of defects in the columns of each floor, the permanent columns whose diameter is 270mm have been decayed the most serious. From the maximum direction of cracks in each column, the defects is most serious on the east and west sides of the columns, followed by the south and the north.

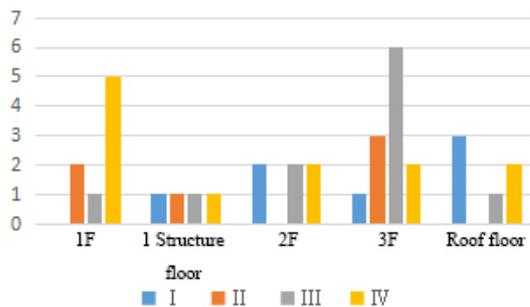
Fig. 7 Defects summary of beams in each floor

The defects of beams is mainly based on cracks. The development of these cracks severely impairs the bearing capacity of beams. When the external load exceeds the bearing capacity of the elements, the elements will be defected. The beams of each floor is numbered from the lowest one in the south, and the fracture parameters of each beam are recorded. The defects were classified, and the defects directions of each beam were summarized(Fig. 7, Fig. 8). The beams on each floor of the Feiyun Pagoda also suffered from varying degrees of defects. The first floor and the third floor were most decayed. From the perspective of the maximum cracks in each beam, the degree of defects in the four directions of the east, west, south, and north is basically the same.

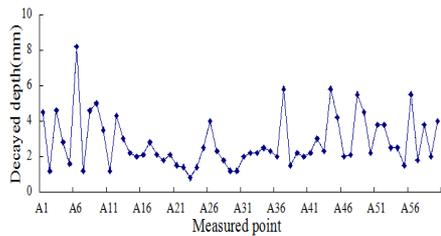
Fig. 9 Defects depth of the first floor

The surface defects data is summarized and plotted as a line graph (Fig. 9, the first floor was taken as an example). The average defects depth in the columns of the first floor is about 2.8mm, and the maximum is about 9.0mm. The average depth of defects in the columns of the second floor is 2.5mm, and the maximum is approximately 12.0mm. On the third floor, the average defects depth is about 1.4mm, and the maximum is about 6.0mm. For beams on the second floor, the average defects depth is 1.0mm; the maximum is close to 4.0mm. For Dou-gong sets, the average depth of defects on the east side is about 1.3mm, the depth in south side is about 0.9mm, the depth in west side is about 1.7mm, and the depth in north side is about 1.8mm. In general, the southern Dou-gong sets suffered less defects, while the northern side of the Dou-gong sets was most heavily defected, even close to 6.5mm.

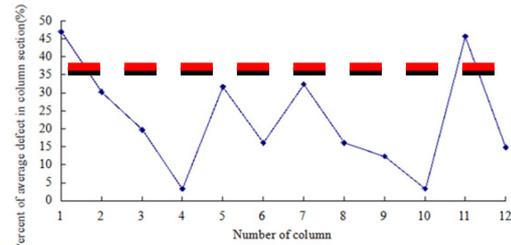
Fig. 10 Percentage distribution of defects in columns of the first floor

Stress-wave tomography test. Based on the data obtained by stress-wave tomography, the percentage of defects area per section was calculated and the average of the three section percentages of the same column was taken to compare (Fig. 10). Except the highest percentage of decay area in the columns 1 and 11, the overall quality of the remaining columns is good, at least within the investigated height (0.50-0.15m). For the two columns with the highest percentage of “defects” areas (column 1 and column 11), the column 11 was chosen as an example to conduct a detailed analysis of the 2D reconstruction chart of each section (Fig. 11).

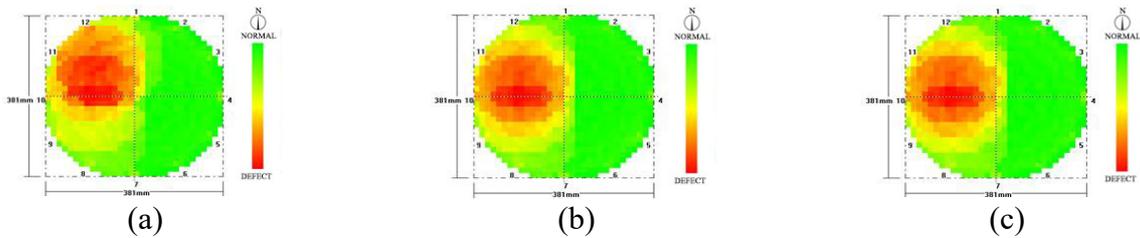
Fig. 11 2-D reconstruction chart of column 11 (a, b, c)

(Colors from green to red indicate defects from slight to severe)

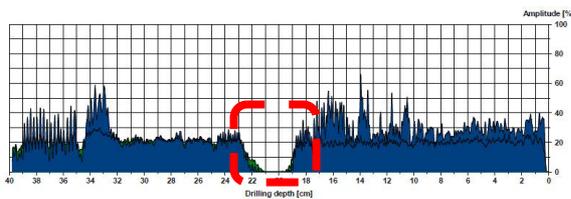
Fig. 12 Point 1 of column 11-a

Because of the limitations of the article space, all the test data cannot be expressed. Here, the a section of the column 11 in the first floor with more severe defects is taken as an example for detailed analysis. The resistographic drilling test was performed on the column 11 from three measuring points, and the following spectrum was obtained. From the spectrum followed, it was observed that the resistance almost dropped to 0 in the range of 19-23cm, 22-40cm, and 6-15cm, and it can be judged that there was defects here (Fig. 12, Fig. 13, Fig. 14). By connecting these measuring points in a certain way to form areas, the defects range can be displayed in more detail (Fig. 15). At the same time, it can be observed that there is a momentary decrease in the resistance value at about 28cm in fig. 14, and the range of the fall is very small. Combining with the stress-wave tomography, it is not defects. It may be caused by timber shrinkage which is the normal phenomenon of cracks. Using the same judgment method, the defects range of the column 11 on the b and c sections was obtained. Then a three-dimensional defects model (Fig. 16) was created by the spectrum.

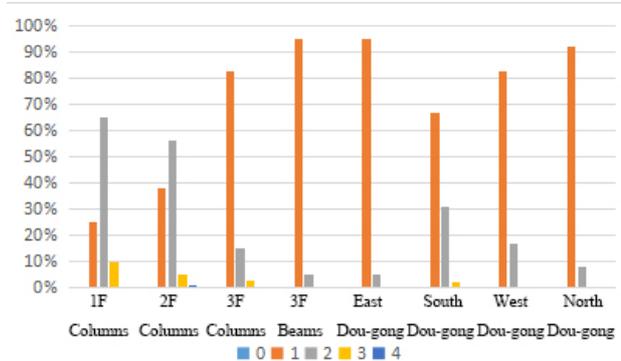
Fig. 17 Distribution of Defects Levels of structures of Feiyun Pagoda

Analysis. Combining all the studies that have been conducted, the different defects levels of beams, columns, and Dou-gong sets according Table 1 (Fig. 17) can be classified. The results of the study showed that the defects of timber structures in the Feiyun Pagoda was concentrated on the first and

the second levels, and most of them were on the first level. Therefore, it is concluded that most of the timber structures of Feiyun Pagoda have slight defects, but the overall performance is basically intact.

Research shows that load-bearing elements of Feiyun Pagoda basically have a certain degree of minor defects, a few of them are moderately rot, and fewer of them are very corrupt. The overall defects degree of the timber elements on the north side of Feiyun Pagoda is the largest, while the defects on the south side is the smallest. The reason for such an assumption is that the north side of the pagoda has been kept wet for a long period of time, and it has received less sunlight, which has grown pests and bacteria.

Due to the wall covering on two sides of the Feiyun Pagoda, the ventilation is poor, so the defects degree of the timber elements in the first floor is the greatest. Because of the rising pagoda height, the timber elements in the second and the third floor have better ventilation and sunshine, and the degree of timber structural defects has been gradually reduced. On the same floor, the defects of the columns is mainly concentrated on the base of them, because the base of the column is vulnerable to flooding of the floor. Compared with columns, beams and Dou-gong sets have less defects, because they are less likely to come into contact with the moisture of the floors' surface.

In the repair and protection work of the Feiyun Pagoda, the elements which were slightly decayed will be reinforced, and the moderate defects elements should be done appropriate demolition and replacement. During the repair process, special attention should be paid to elements that are prone to moisture and poor ventilation. These elements are generally located on the base of columns, outside of pagoda and roofs.
