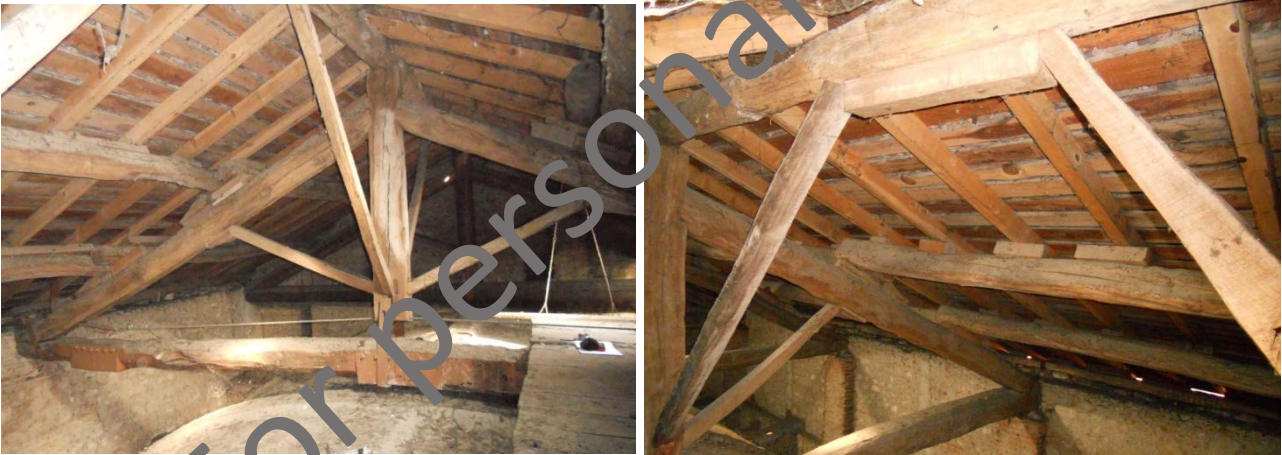
Figure 2. Queen-post truss with potentially unstable layout.

204
205 Instabilities in the structural scheme, usually due to insufficient joint constraints, are identified
206 first. They occur mainly in double-level, queen-post trusses (figure 2), with details probably
207 inspired by examples in classic architectural treatises, which have influenced constructional
208 practice contributing to their diffusion (e.g. Palladio A, 1570). It is worth noting that joints need to
209 be observed accurately to establish the kind and level of constraint they may offer. Insufficiently
210 constrained structures may be capable of supporting symmetrical vertical loads, resorting also
211 to some joint semi-rigidity to respond to minor load deviations. The resisting system, however, is
212 not adequate for asymmetrical vertical loads or for the horizontal forces generated by seismic
213 action. This condition will correspond to a D.

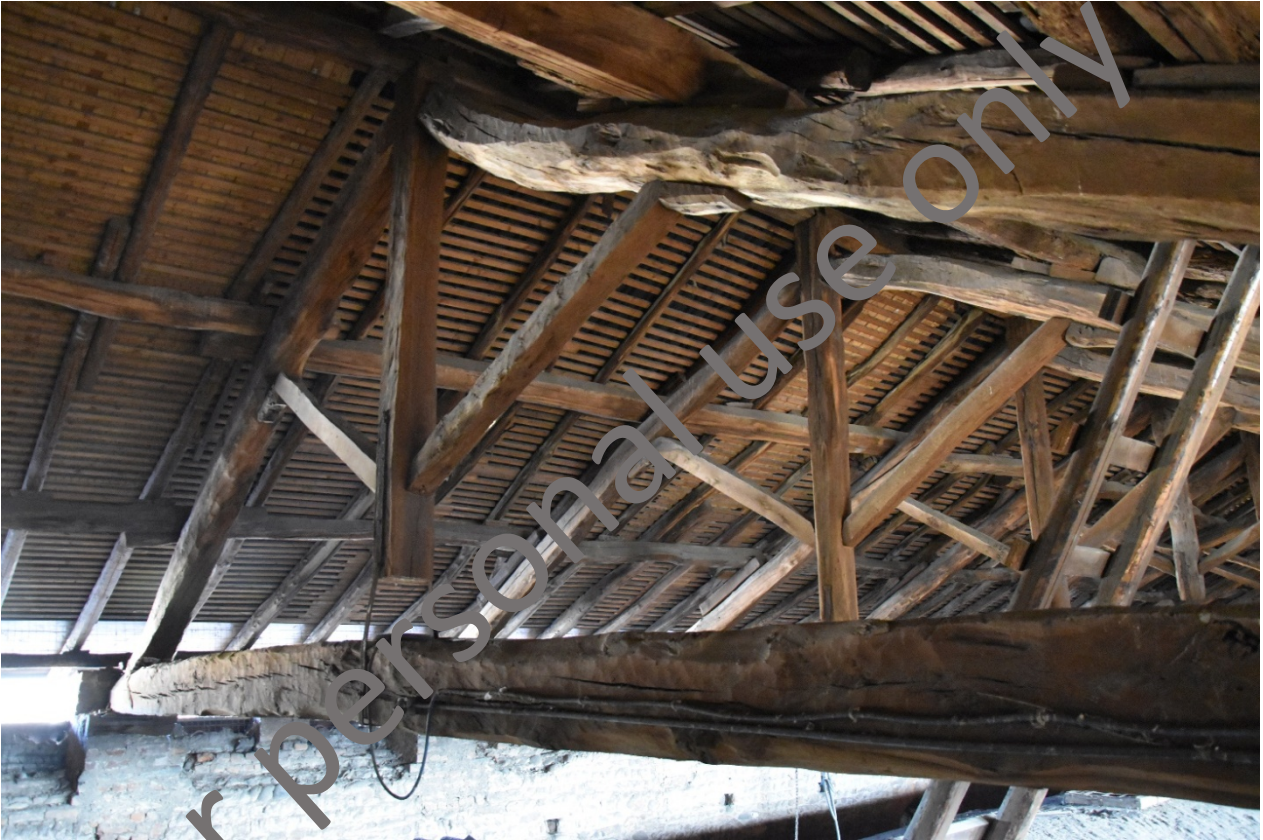
Figure 3. Connections between king-post structures.

214
215 Transversal secondary trusses supply good connectivity, classified with A. (Chesi et al. 2012).
216 Often, the connection between trusses is simpler, with purlins and a ridge plate as in figure 3,
217 sometimes with the addition of transversal struts, or diagonal bracings (Parisi et al. 2016). The
218 most common situation presents two purlins per rafter, which may give satisfactory results if
219 purlins and rafter are well connected: it would be graded up to A in the best conditions.
220 Intermediate situations, mainly related to quality of connection, purlins cross section and
221 regularity, are more difficult to grade and will range between B and C. When only one purlin per
222 rafter is present, or more purlins with insufficient connection, the assembly is deemed too
223 deformable in the transversal direction (C to D).

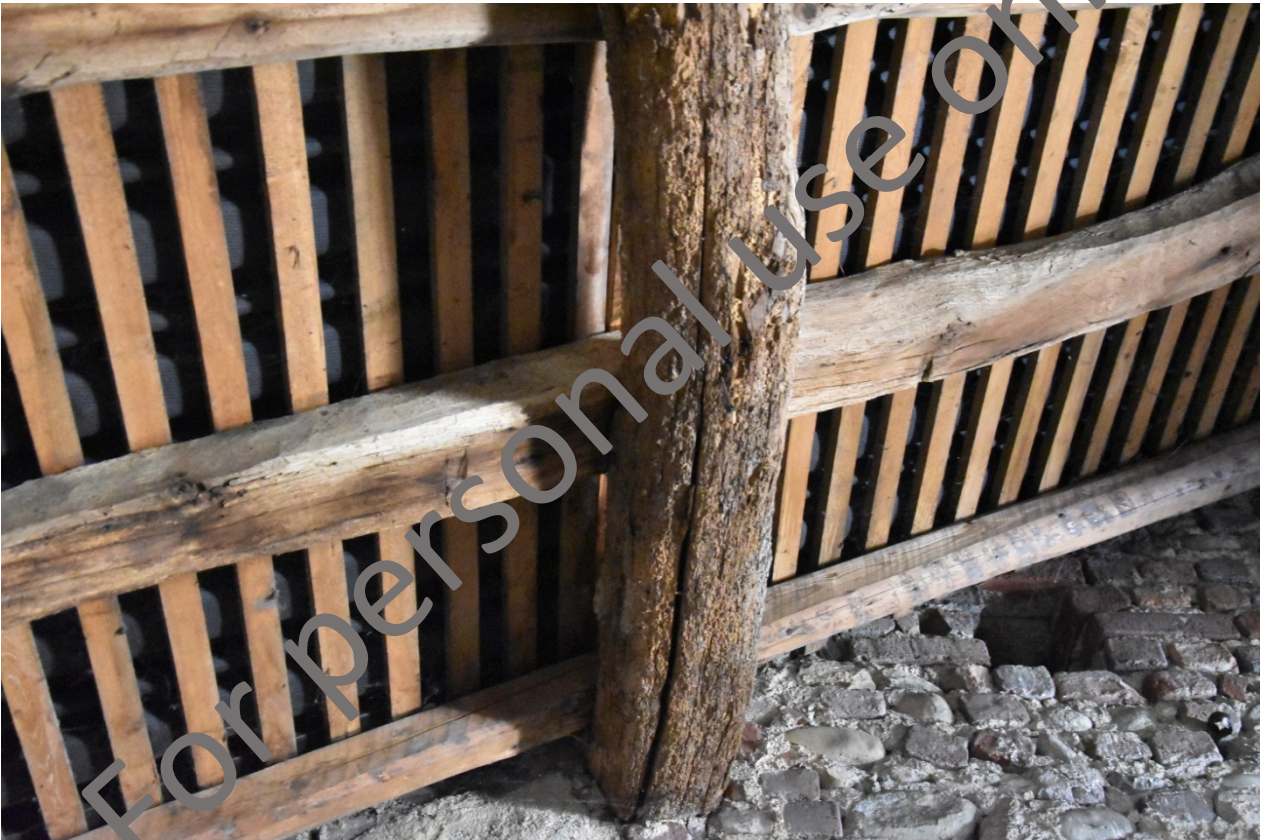
Figure 4. Irregular cross section of the rafter .

267
 268 Evaluation of the bearing capacity of a structural element requires measuring length and cross
 269 section, detecting possible irregularities along the length, as in figure 4, in order to identify its
 270 minimum cross section area (Lourenço et al 2013, Sousa et al 2014). Only off-site it will then be
 271 possible to define loads, perform structural analysis and check structural adequacy.

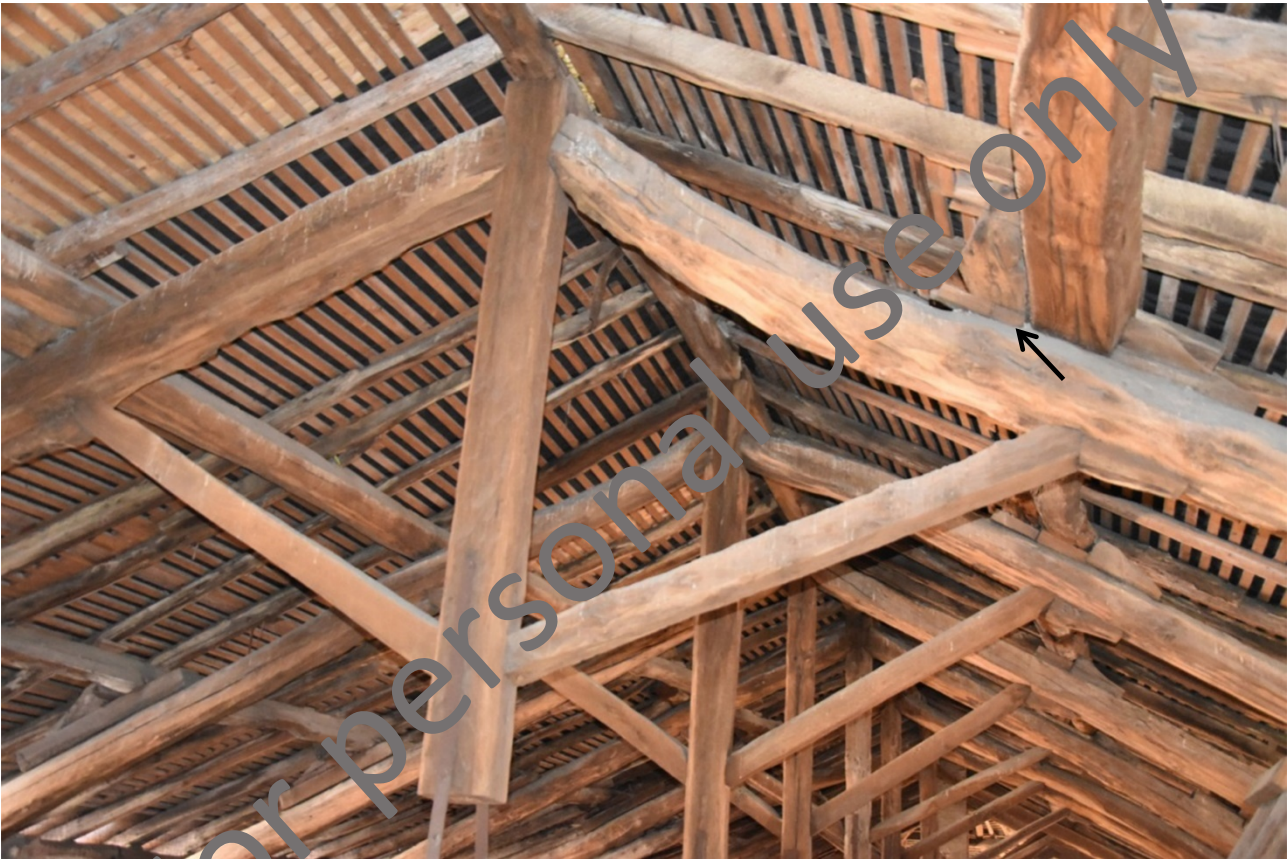
Figure 5. Biotic decay due to insects.

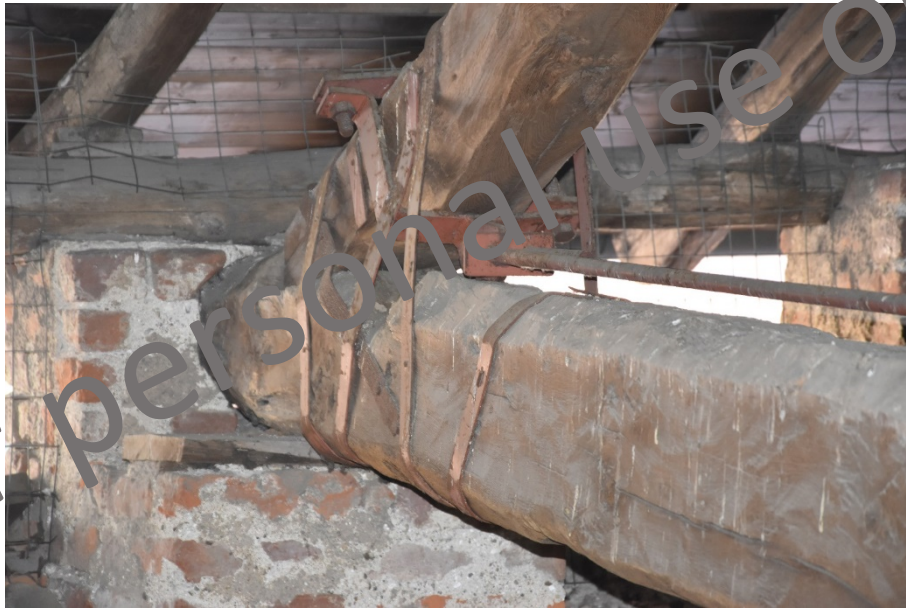
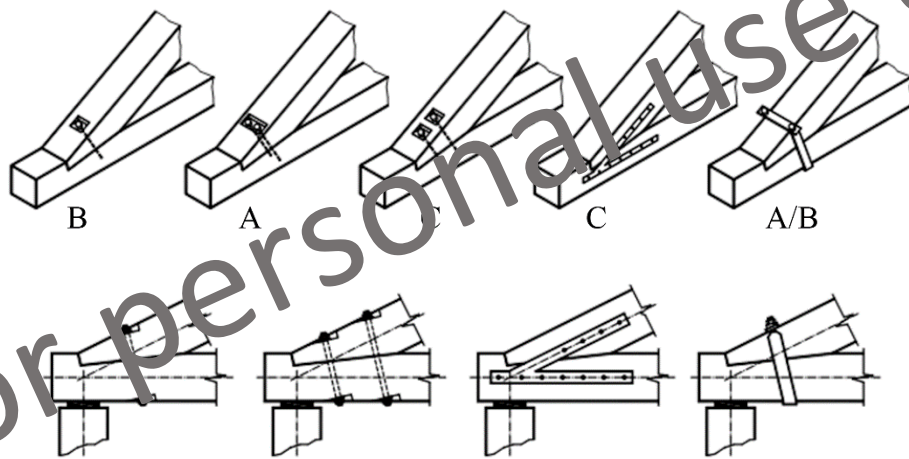
Figure 6. Wedges adopted to recover contact at the rafter (right rafter and purlin).

294 Excessive deformation could derive from a connection that lost effectiveness. Sometimes the
 295 presence of wedges applied in correspondence of a significant deformation indicates an
 296 intervention carried out for remediating a lacking connection (figure 6).

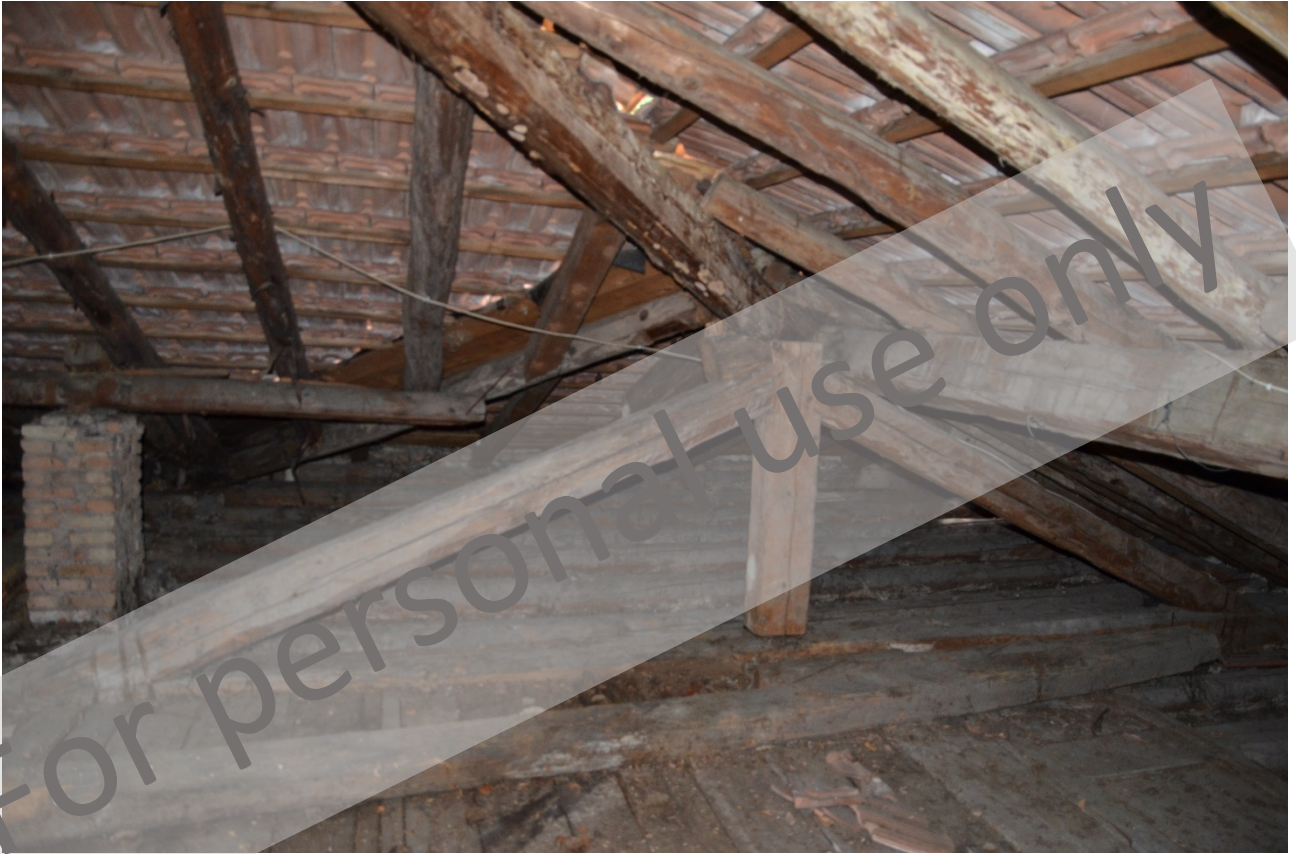
Figure 9. The roof structure analysed: (a) internal view (b) numerical model with main elements
