## REDUCING THE SEISMIC VULNERABILITY OF TIMBER ROOFS: A CASE STUDY

Maria A. Parisi<sup>1</sup>, Chiara Tardini<sup>2</sup>

A complex roof, covering a large, century-old mansion which had not been recently maintained, has now been examined as case study. The objective is dual: on the one side, testing the applicability of the procedure on a large roof and its effectiveness in showing the possible critical points in an organized way; on the other, considering the capability of the procedure, which synthetically indicates the need for interventions and their importance, as a basic tool for comparing and estimating costs and benefits of different intervention strategies. For the case examined, the seismic vulnerability has been estimated according to the procedure; criticalities have been pointed out; on this basis, the analysis of a possible intervention strategy and consequent reduction of vulnerability levels has been performed.

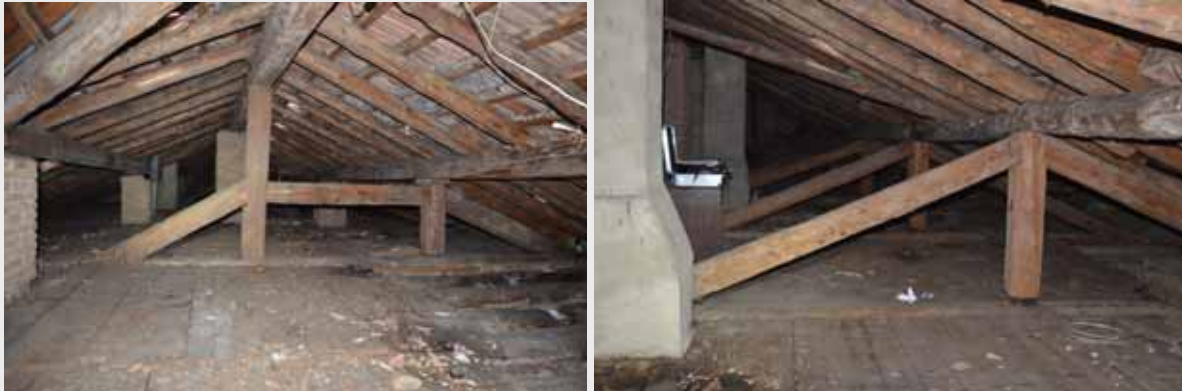
Figure 2: Different trusses

22. STRUCTURAL UNIT nr. 12					
22.1 ANALYSIS of the STRUCTURAL UNIT	Is the structural unit labile?		YES	NO	
			x		
THIS STRUCTURE IS LABILE: IT IS NECESSARY TO MODIFY THE RAFTER-POST- STRAINING BEAM CONNECTION IN ORDER TO AVOID LABILITY.					
22.2 ANALYSIS of STRUCTURAL ELEMENTS

asymmetric vertical loads or horizontal forces, not counting on the albeit uncertain semi-rigidity of the joints. One such case is surveyed in figure 3. The statically insufficient situation of these trusses is graded D.

For critical situations related to structural typology, first consideration goes to the two unstable trusses. Static adequacy could be obtained either adding a bracing element or strengthening the joints with metal bolts; the latter option has been assumed in this simulation.

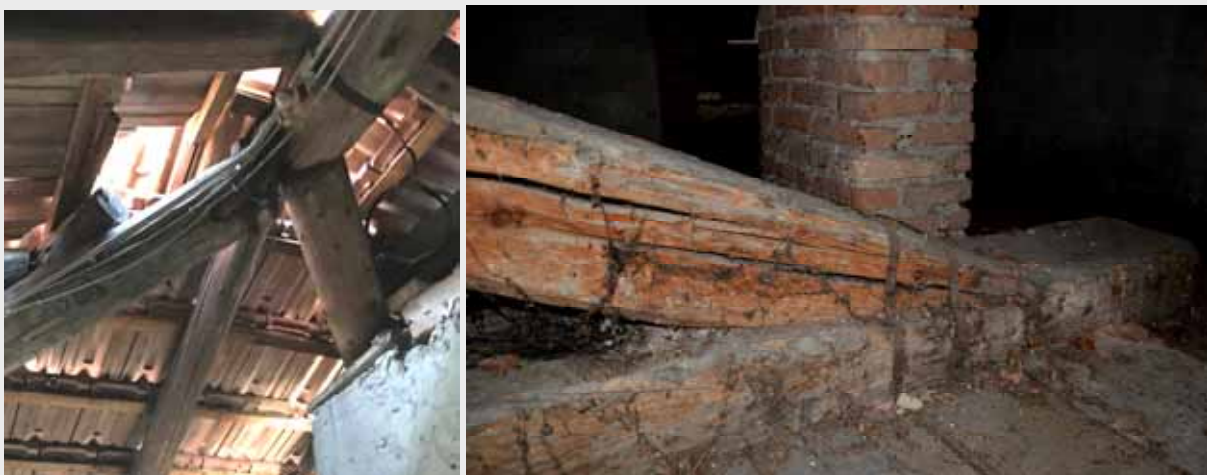
Figure 4: (left) A corner joint; (right) Rafter-to-chord joint

Connections at carpentry joints appear rather critical from a seismic point of view. The main joints, at the rafter-to-chord node, have metal closures that are degraded and hardly effective (fig. 4). The notch is mostly shallow and roughly cut. The connection between corner elements is entrusted to metal elements that appear questionable in keeping the system assembled in dynamic conditions. A global grade D may be assigned.

The application of bolts to avoid disassembly has been assumed for carpentry joints at the various locations, and primarily at the rafter-to-chord joint; an estimate of the necessary number of bolts is immediate, as well an evaluation of the costs; use of small diameter screws has been assumed at the chord toe to avoid brittle failure by sliding shear (figure 5); finally, suitably designed metal connectors were proposed for the roof corner elements.
