# When Preservation Meets a 20<sup>th</sup>-Century Building with Curtain Wall. The Case of the Torre Galfa in Milan

Davide Del Curto, Chiara Stanga

This paper discusses if the renewal of a 1950s building is compatible with the purpose of preserving a curtain wall of architectural value.

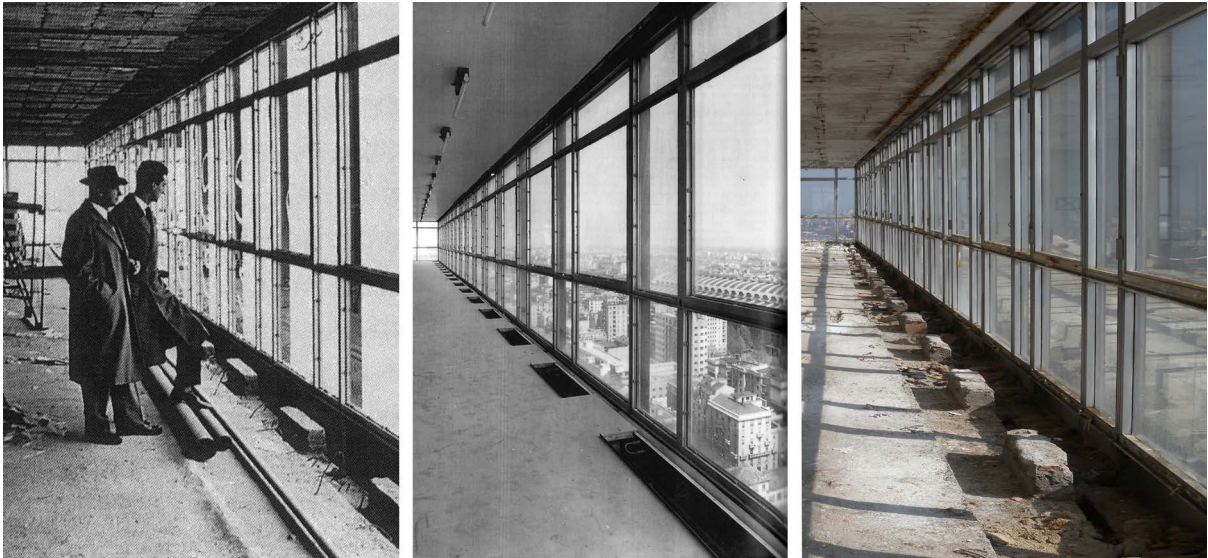
Despite years of neglect, nowadays both the metal and glass components are mostly well preserved. On the other hand, the iron elements connecting the curtain wall to the slab are affected by corrosion and the rubber gaskets are mostly vulcanized (fig. 6).

Figure 6. Galfa Tower curtain wall. Comparison among building site (GRECO, MORNATI 2012, p. 93, left), interiors in 1959 (GRECO, MORNATI 2012, p. 122, middle), interiors in 2015 (Photo D. Del Curto, right).

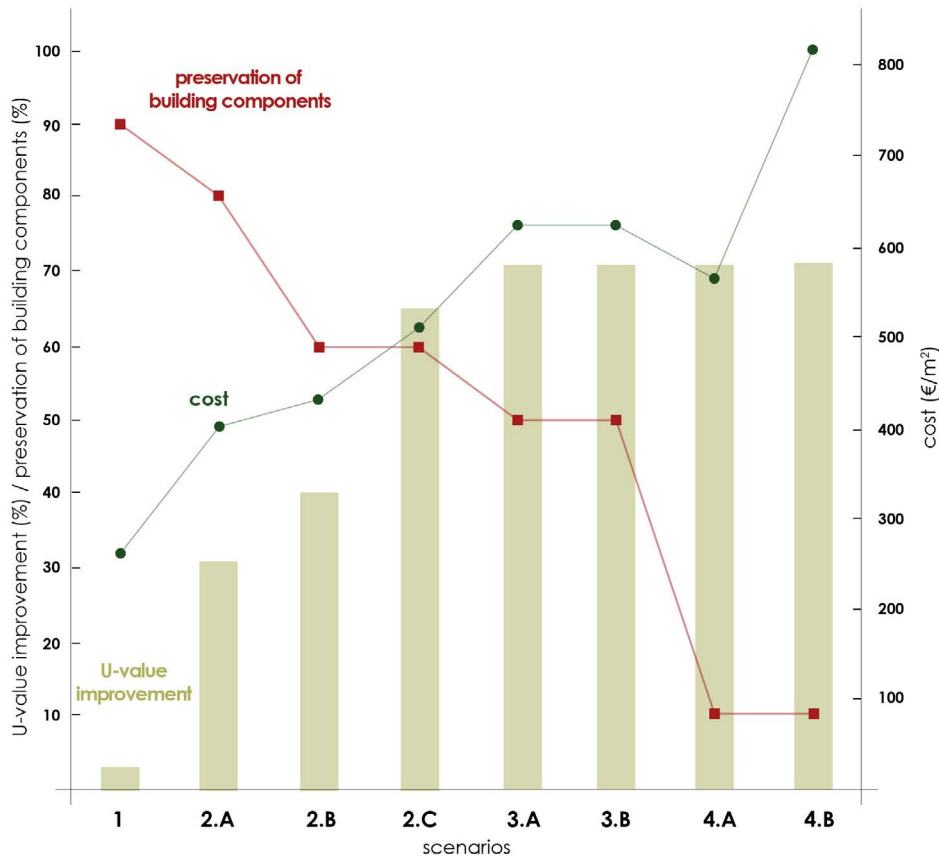
The results obtained with each scenario are compared in figs. 14, 15. In fig. 15, the different scenarios are indicated on the X axis. The cost is indicated on the Y axis, right side and represented by the green line. The energy improvement is indicated on the Y axis, left side and represented by green columns. The preservation of the building components and materials is represented by the red line. The preservation of the building components and materials trend is highest for Scenario 1-Maintenance, and it decrease for Scenario 4-Replacement. On the contrary, costs are minimum for Scenario 1 and maximum for Scenario 4.

Replacement results into a major increase of the U-value, even if comparable to Addition. 4.A results in a +71% (0,50 W/m<sup>2</sup>K), 4.B. in a +73% (0,46 W/m<sup>2</sup>K), thanks to the double-skin technology of the façade. They are otherwise poorly satisfying in preserving the original materials (10%), since the original façade would be entirely replaced with a new one. They are both costly since they consist in making a new façade. 4.B is the most expensive due to the introduction of two high performant windows (€/m<sup>2</sup> 817).

Figure 15. Comparative chart among different scenarios (elaboration by the authors).
