# Damage assessment of three medieval churches after the 2012 Emilia earthquake

**Abstract** The architectural heritage was severely damaged by the seismic sequence that occurred in Emilia (Northern Italy) in May 2012. This paper investigates the seismic behavior of three masonry churches that were damaged by the 2012 Emilia earthquake. The analyzed churches are located in the South-East area of the province of Mantua: they are representative of some churches, denoted as “Matildic churches”, belonging to the territorial area between Lombardia, Emilia Romagna and Toscana and built during the Matilde di Canossa domain, between the X and the XI centuries. The study was based on detailed field surveys, in situ tests, visual inspections and existing archives in order to obtain an accurate knowledge of the churches and a proper evaluation of the damage caused by the earthquake. Then, detailed finite element models of the churches were developed and non-linear dynamic analyses with different peak ground accelerations were performed. The numerical simulations provided a deep insight into the seismic behavior of the analyzed churches, identifying the damage patterns and the main collapse m

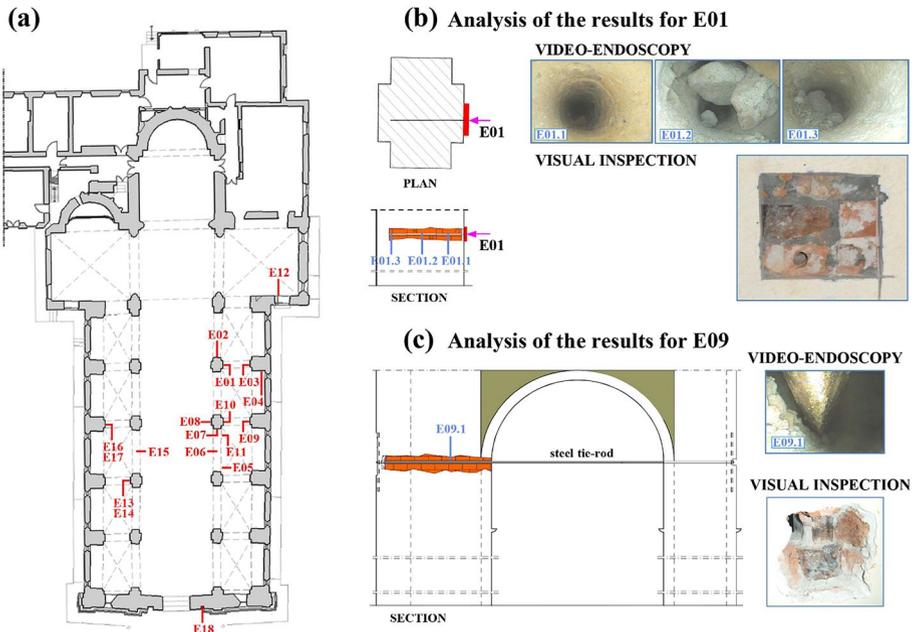
As a result of this qualitative survey, two different typologies of masonry were detected. The oldest Romanesque masonry of the transept and the façade—characterized by a greater thickness—proved to be a multi-wythe masonry made of two exposed faces with square and regular bricks and an inner core filled with irregular material bonded by quite compact mortar; the absence of voids was revealed. The XVI century masonry of the central nave and the aisles proved to be compact and consisting of solid bricks for the entire wall thickness; sporadic discontinuities were observed.

Figure 11 shows the locations and some images of the video-endoscope and visual inspections on a column of the central nave and on an arch of the aisles, in correspondence with a tie-rod.

**Fig. 11** a Locations of the video-endoscope inspections, b video-endoscope inspection on a column, c video-endoscope inspection in correspondence with a tie-rod

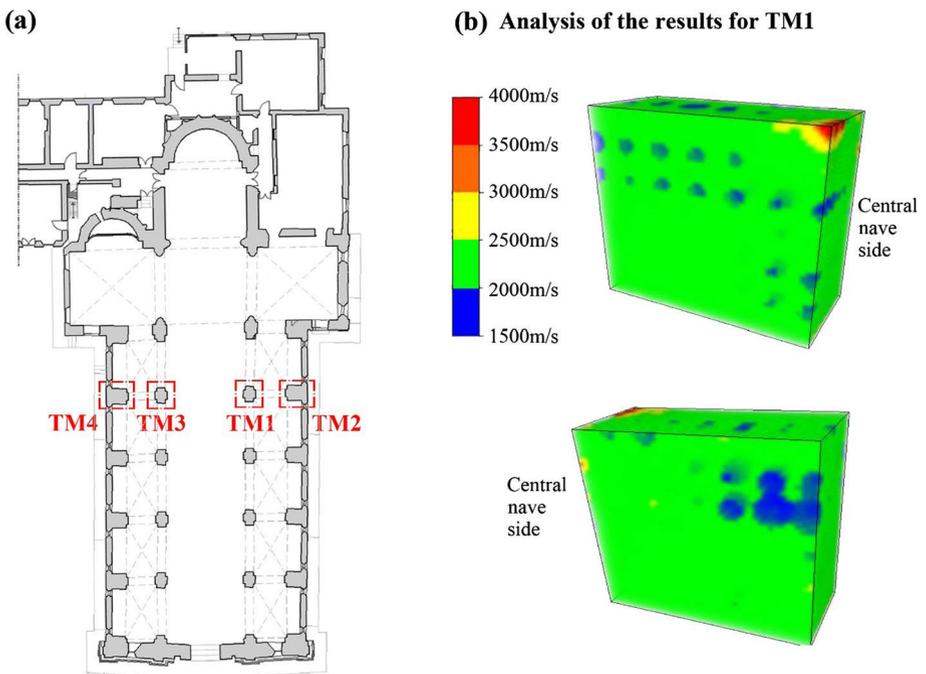
From the data processing, it can be noted that the masonry sections investigated by sonic and tomographic tests are characterized by values of sonic speed mainly within 2000 and 2500 m/s. This result indicates a medium-compact masonry of fairly good execution. The absence of very low and heterogeneous speed values indicates that large masonry discontinuities are not present (i.e. internal holes or poor quality units). It has to be noted that, even if any sonic or tomographic test was performed on the Romanesque masonry, not too different findings may be expected on the basis of the outcomes obtained through the endoscopic inspections.

**Fig. 12** a Locations of the sonic tests, b tomographic survey on a column

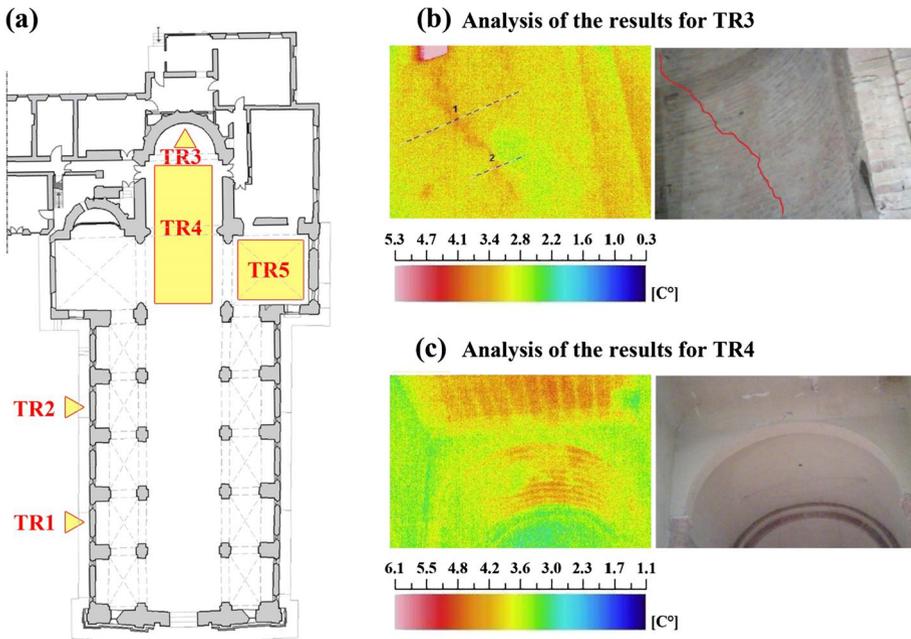
Figure 13a indicates the locations of the termographic tests. In Fig. 13b the results of the test on a portion of the apse wall are shown: the measures of different superficial temperatures highlight the presence of probable through-cracks that may create a discontinuity enabling the access of air. In Fig. 13c the results of the test on the ceiling of the central nave and of the presbytery are reported: different superficial temperatures evidence that the bearing structure is composed of wooden joists. The presence of some zones with

low emission temperatures is observed, highlighting problems of humidity related to water infiltrations from the covering.

**Fig. 13** a Locations of the termographic tests, b termographic test on the apse wall, c termographic test on the presbytery and central nave covering

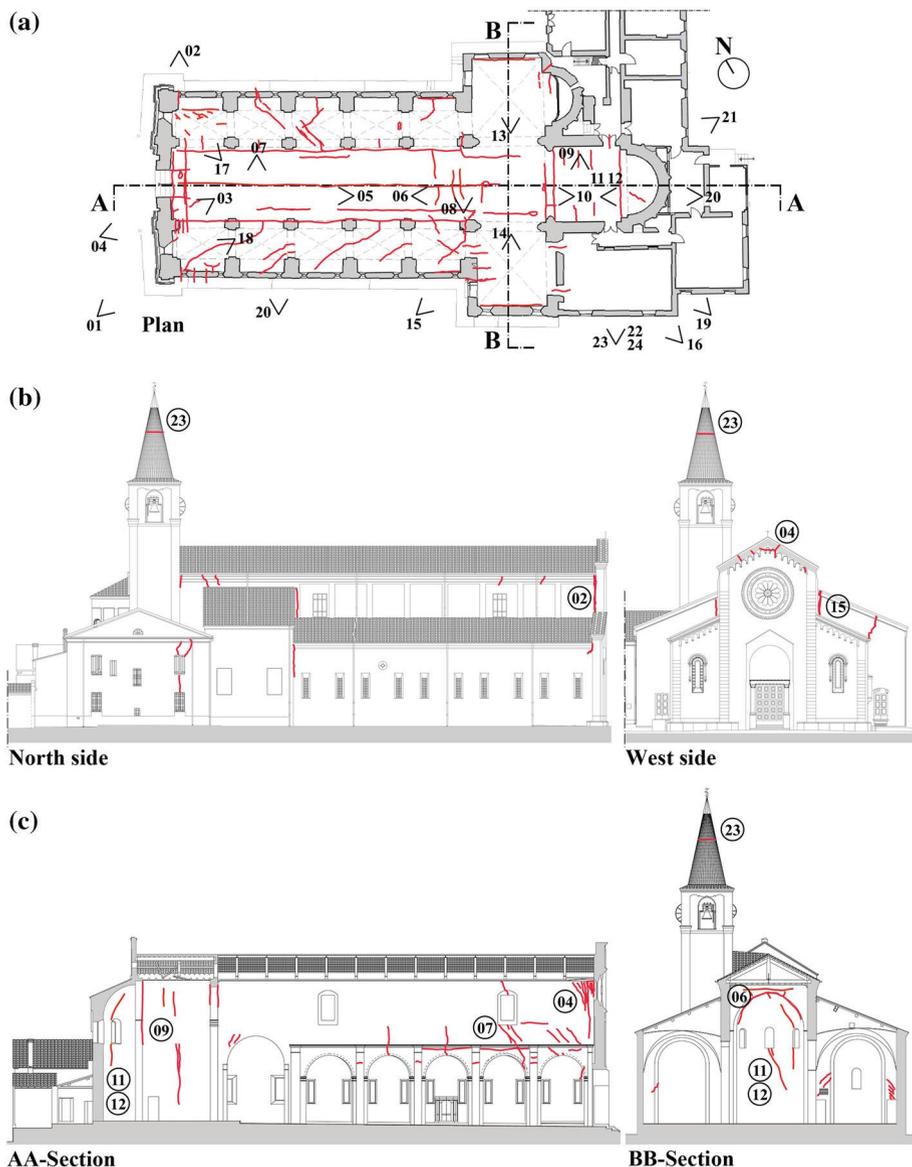
**Fig. 14** San Benedetto Abate church damage survey: crack pattern

Figures 14 and 15 summarize the crack patterns observed in San Benedetto Abate church.

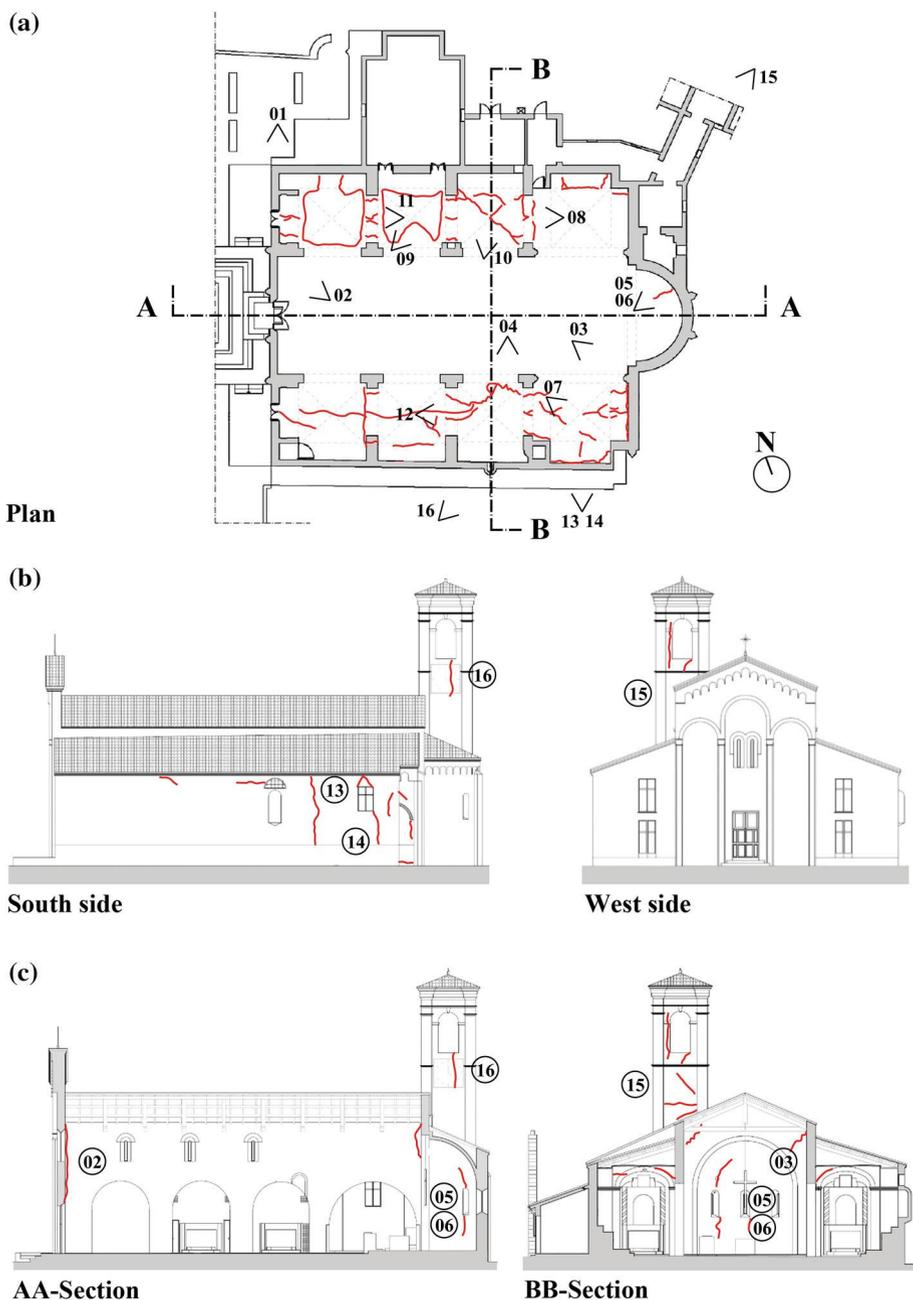
Fig. 16 San Fiorentino Martire church damage survey: crack pattern

Figures 16 and 17 summarize the crack patterns observed in San Fiorentino Martire church.

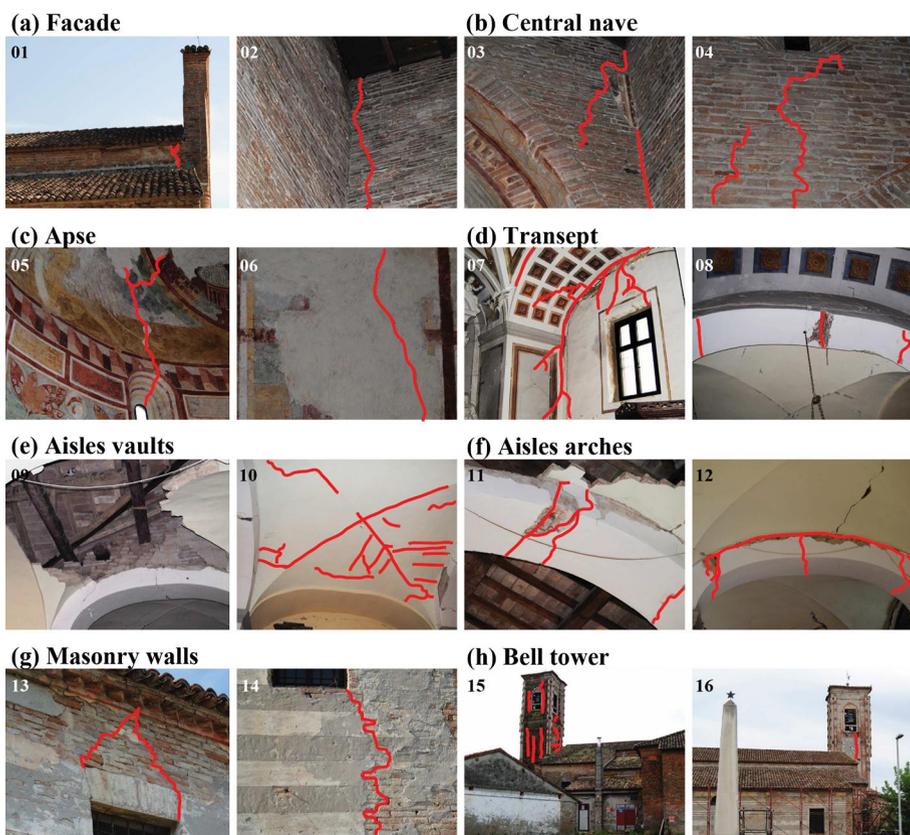
**Fig. 17** San Fiorentino Martire church damage survey: photographic documentation

- *Façade* Through vertical cracks along the connection region between the façade and the longitudinal walls of the central nave have been reported, Fig. 17a (photos 01–02). The damage survey has highlighted the lack of effective connections between the elements: such a deficiency could lead to a definitive separation of the façade from the lateral walls with an out-of-plane overturning of the façade.
- *Central nave* A lack of effective connections between the transversal wall delimiting the apse and the longitudinal walls has been observed and some cracks have been identified, Fig. 17b (photo 03). Such damage may cause the out-of-plane overturning of

the apse. In addition, some cracks starting from the corners of the openings can be detected, Fig. 17b (photo 04).

- *Apse* Vertical cracks near the openings of the apse have been reported, Fig. 17c (photos 05–06). The presence of the openings in the wall and the thrusting vaults may be the causes of the damage. Such cracks also can trigger an overturning mechanism of the apse wall.
- *Transept* Vertical cracks in the corners between the longitudinal and transversal walls and cracks along the connection between the longitudinal walls and the cross vaults

have been detected, Fig. 17d (photo 07). The damage was due to the horizontal thrust actions, both in the longitudinal and in the transversal directions, producing the detachment of the elements and the trigger of an overturning mechanism of the transept

lateral wall. Some cracks were also detected at the keystone and imposts of the arches that separate the transept from the aisles, Fig. 17d (photo 08).

- *Aisles* The damage of the aisles concerns:
  - vaults: the damage of the cross vaults consists of: (i) the complete collapse of the vaults of the first two chapels in the left side, Fig. 17e (photo 09); (ii) the partial collapse and a diffused crack pattern in the other vaults, with cracks oriented both along the diagonal ribs and along the edge structures, Fig. 17e (photo 10). The damage was probably due to the excessive vibrations of the edge bearing structures with a different relative displacement between the elements. This caused a detachment between the vaults and the load-bearing masonry walls and, in some cases, the collapse of the structures. It has to be considered that the detachment may be also ascribed to the different periods in which the elements were built and to the consequent impossibility to carry out an effective connection between the aisles and the central nave;

- arches: survey of cracks at the keystone and impost locations with the possible collapse of the arches supporting the vaults, Fig. 17f (photos 11–12);

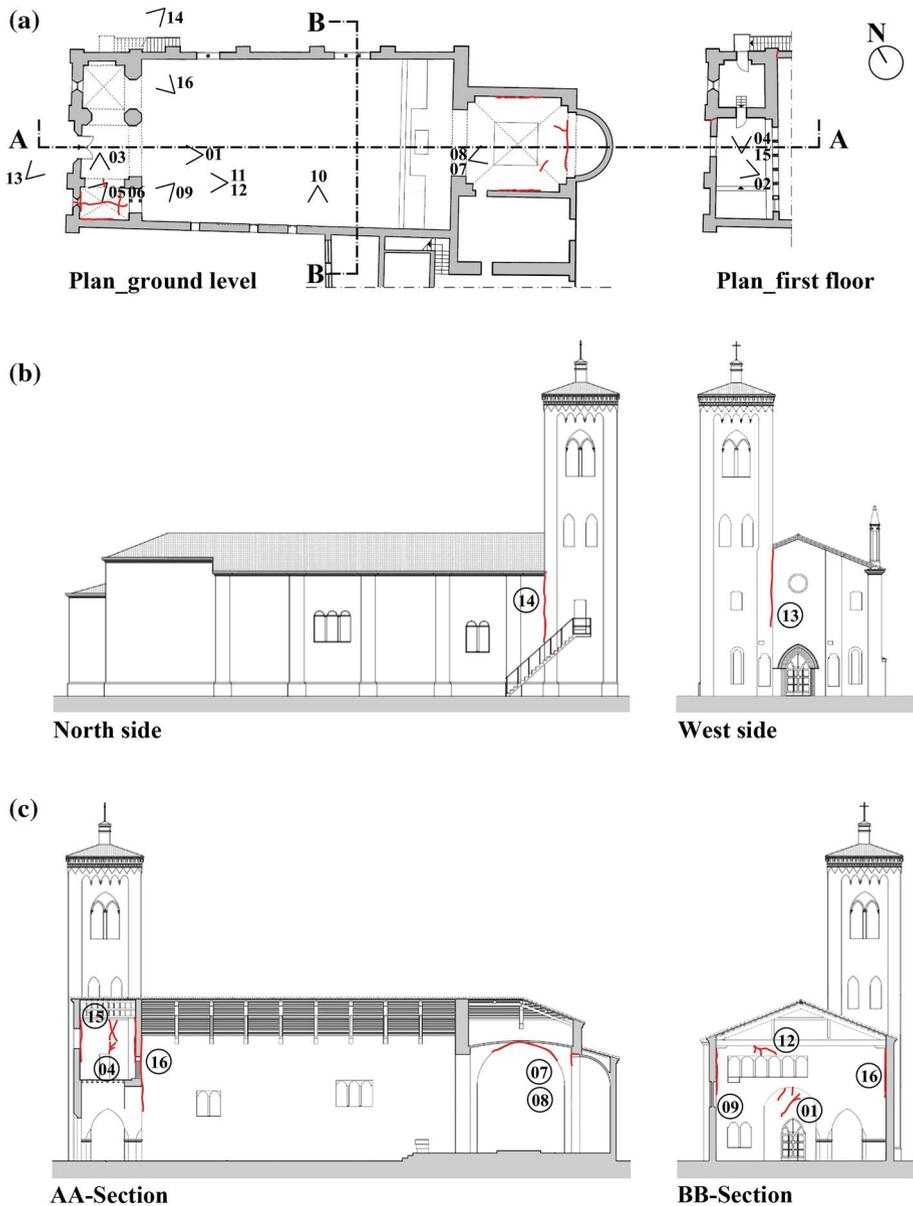
**Fig. 18** Santa Maria Assunta church damage survey: crack pattern

Figures 18 and 19 summarize the crack patterns observed in Santa Maria Assunta church.

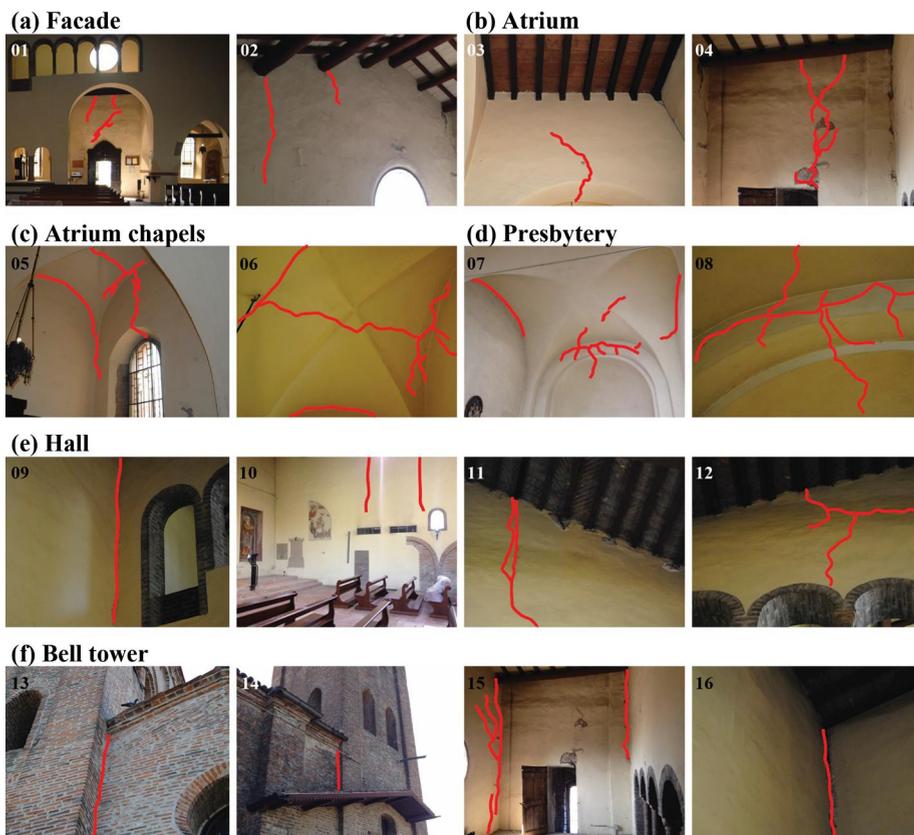
**Fig. 19** Santa Maria Assunta church damage survey: photographic documentation

- *Façade* Vertical cracks in correspondence with the entrance door extended up to the rose window have been reported on the internal side of the church, Fig. 19a (photo 01). In addition, vertical cracks extend from the wooden rafters of the roof, Fig. 19a (photo 02). These cracks can be related to the presence of openings and concentrated loads, and they are due to the seismic action longitudinal component.
- *Atrium* Vertical cracks have been observed in the longitudinal walls of the atrium: at the ground floor in correspondence with the keystone of the arches of the lateral adjacent chapels, Fig. 19b (photo 03), and at the first floor in correspondence with some openings, Fig. 19b (photo 04). The latter cracks are due to the presence of discontinuities and to the seismic action longitudinal component.

- *Atrium chapels* The damage survey showed vertical cracks starting from the openings of the façade, Fig. 19c (photo 05), along the connection region between the vaults and the walls, Fig. 19c (photo 05) and in the cross vaults, Fig. 19c (photo 06). These cracks

are due to the presence of openings and to an excessive oscillation of the walls that are not restrained by the thin and light vaults system.

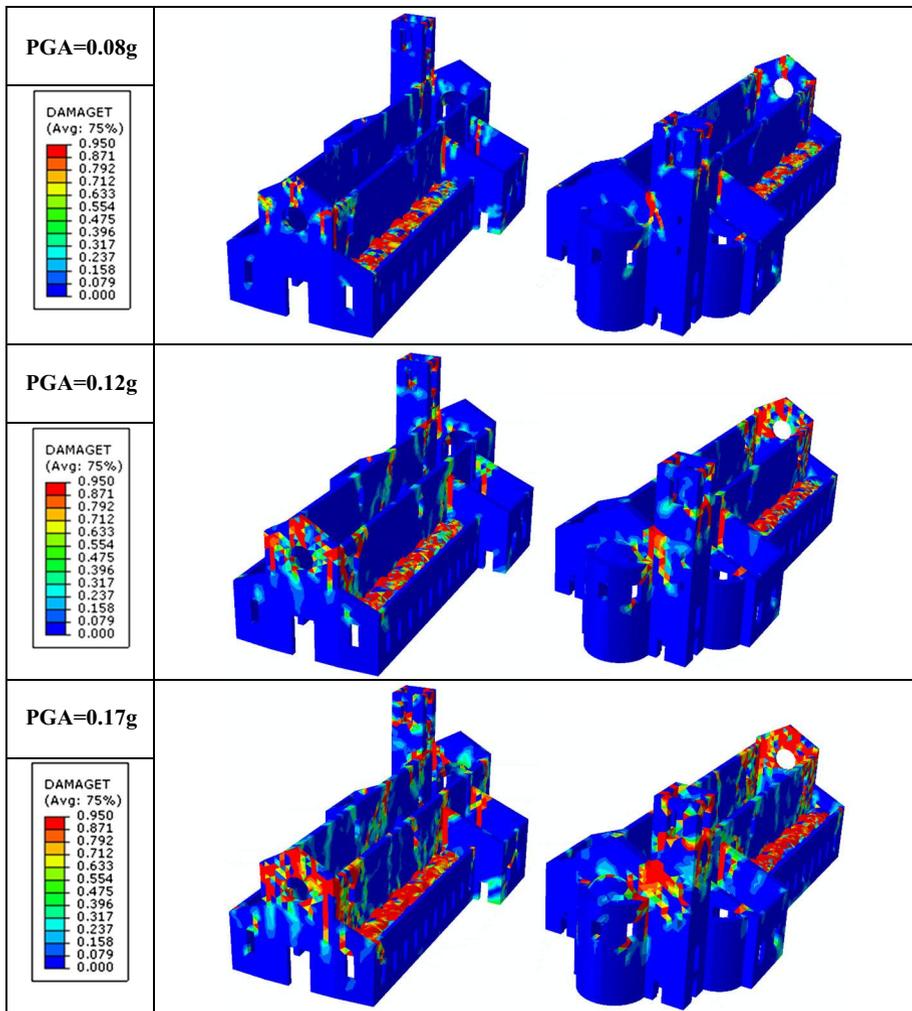
**Fig. 28** San Benedetto Abate church: tensile damage contour plots at the end of the non-linear dynamic analyses for different peak ground accelerations

The non-linear dynamic analyses under higher values of PGA highlight a widespread damage in the aisles chapels: it is consistent with the cracks observed in the vaults *in foglio* of the aisles from in situ surveys. A vertical damage is evident in the connection region between the façade and the longitudinal walls: a possible overturning mechanism of the façade can be expected considering the poor connection between the walls. The façade exhibits a widespread damage that clearly increases with the peak ground acceleration. The connection region between the bell tower and the perimeter walls shows a damage concentration due to the different stiffness and geometry of the elements. Moreover, a considerable damage spreading from the corners of the openings is registered in the belfry: it is consistent with the crack pattern observed after the field survey. Vertical damage starting from the top is recognizable in the walls of the central nave. Additional damage can be found near the openings in the walls, starting from the corners: it is compatible with the cracks observed from the in situ survey.
