# An insight in the late Baroque architecture: An integrated approach for a unique Bibiena church

This paper investigates the case study of *Sant'Antonio Abate* church in Villa Pasquali. This building was realized by Antonio Luigi Galli da Bibiena in the second half of the XVIII century.

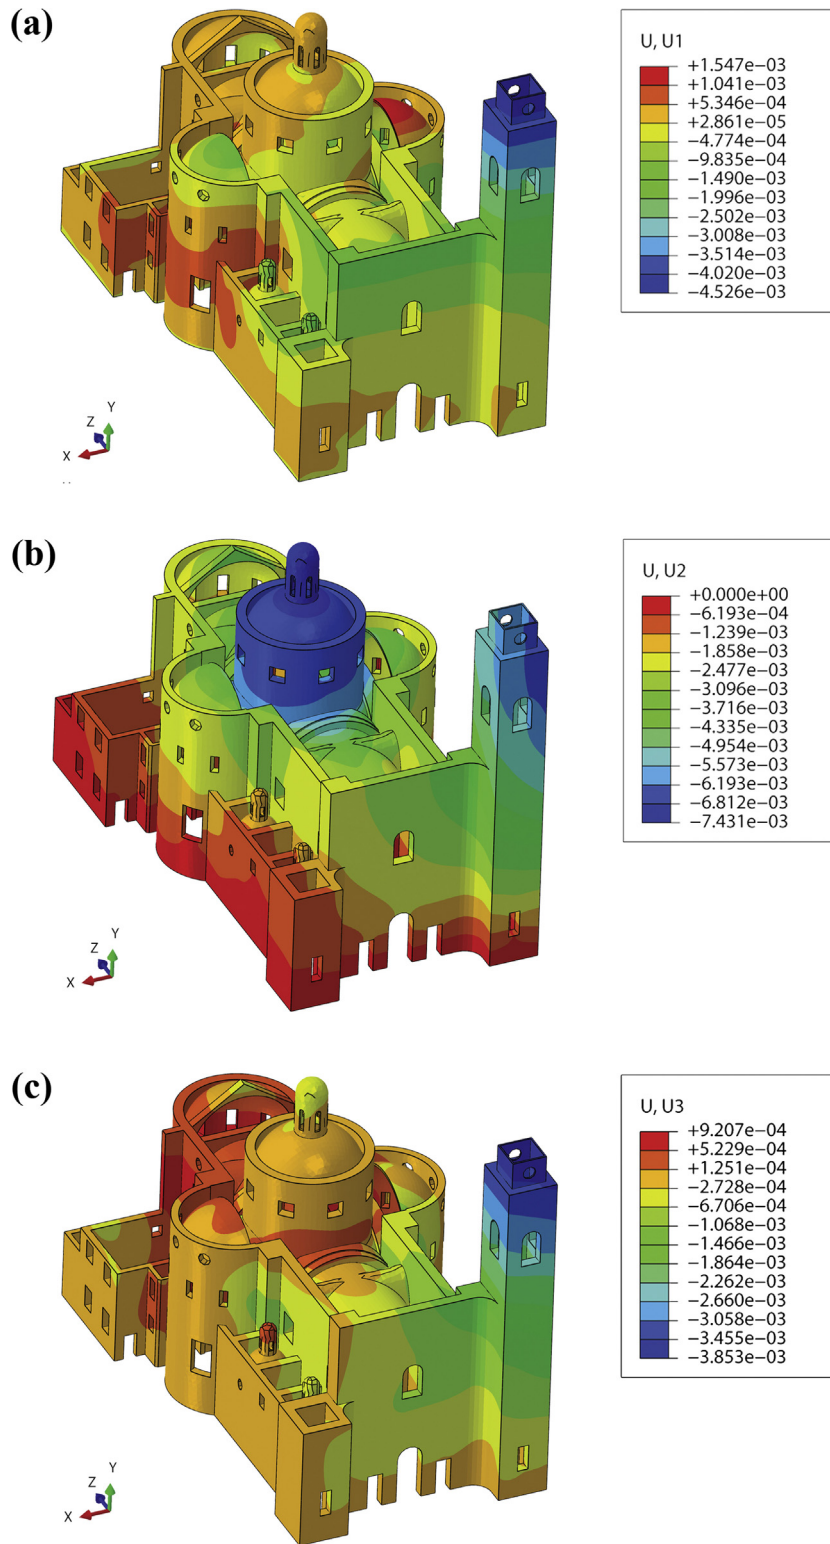
A preliminary analysis of the church under gravity loads was performed. Fig. 6 shows some numerical results in terms of displacements for the entire church. The maximum horizontal displacements are registered for the bell tower and the maximum vertical displacements are observed in correspondence with the central dome and the drum, due to their considerable self-weight.

**Fig. 6.** Map of displacements (expressed in m) in (a) longitudinal direction; (b) transversal direction; (c) vertical direction.

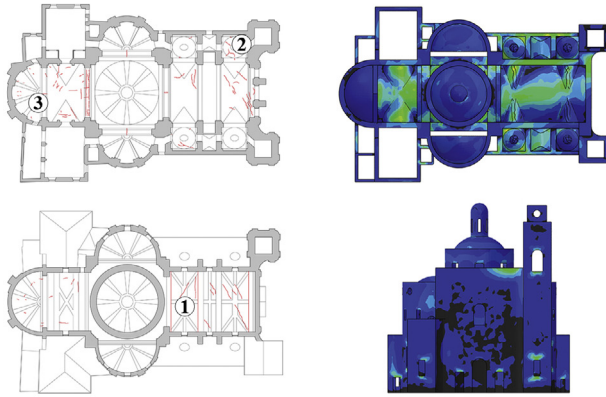
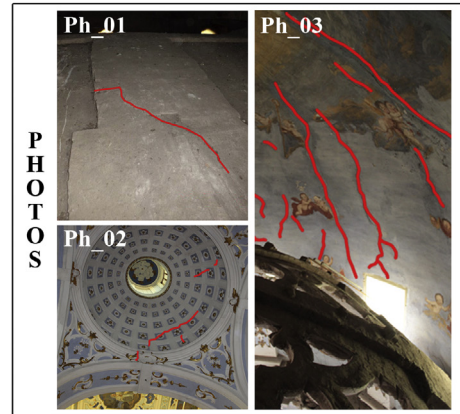
**(a) Plans\_ground level (top) and under roof level (bottom)**

- *Cracks on the vaults and arches.* On the barrel vaults of the nave and the presbytery cross cracks between the vaults and the arches are evident. A large crack pattern was observed also at the haunches and crown of the vaults and, in particular, some diagonal cracks with a northeast–southwest direction were concentrated in the area closest to the bell tower. Some minor cracks were observed on the perforated vaults of the apse and on some small masonry domes of the lateral chapels. A significant crack pattern characterized by both vertical and diagonal cracks was detected on the continuum vaults of the apse and pseudo-transsept. Moreover, despite the tie-rods, all the triumphal arches that support the main dome and the one between the apse and the presbytery are characterized by cracks in crown.

- From a top view of the numerical model, Fig. 7a, a tensile stress concentration on the barrel vault of the nave and the presbytery is related to tensile stresses in longitudinal direction: this reveals that the cross cracks are due to a disconnection between the elements of the vaults and the arches, probably associated with an opening mechanism of the main nave. From a frontal view of the model, a tensile stress concentration is located in the corner between the façade and the bell tower, due to tensile stresses in the transversal direction: the cracks, which are mainly located in the first portion of the barrel vaults, seem to be due to both the asymmetric configuration of the main façade and the presence of only one bell tower that, in the upper part, is subjected to a transversal displacement in the south-east direction.

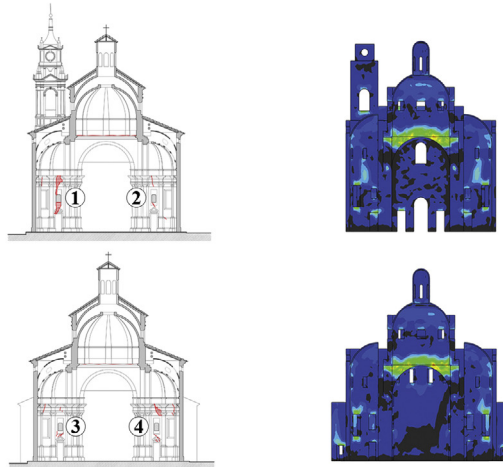
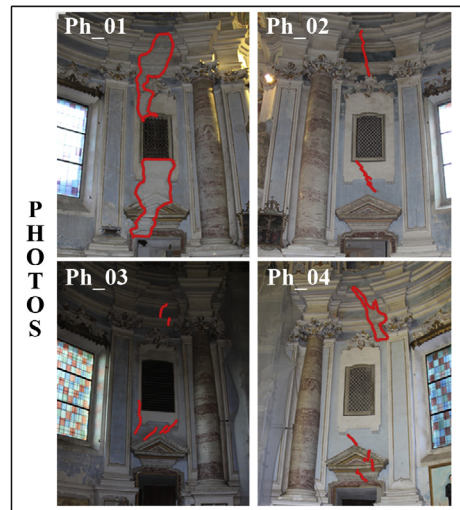
**(b) Cross section\_toward South (top) and toward North (bottom)**

- *Cracks on the main dome.* A horizontal crack at the base of the drum was reported during a first survey after the 2012 earthquake. No significant cracks were observed on the bottom perforated vault and it was impossible to check the presence of cracks in the upper one.

- *Cracks on the walls of the pseudo-transsept.* Vertical cracks (or sign of ancient repaired cracks) characterize all the four connections between the chapels of the pseudo-transsept and the central space.

- In Fig. 7b, the tensile maximum stresses in the cross sections appear in correspondence with the main dome. The numerical analysis indicates the presence of a critical point at the base of the drum, probably related to the significant weight of the dome and the drum on the arches defining the central space. However, the numerical analysis does not justify the four vertical cracks in the lateral chapels.

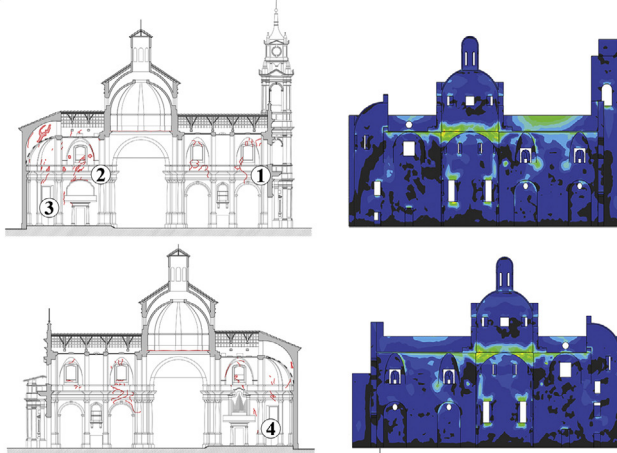
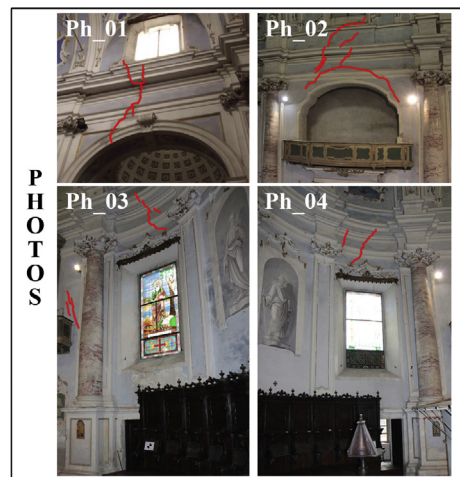
**(c) Longitudinal sections\_toward East (top) and toward West (bottom)**

- *Cracks on the longitudinal walls of the nave, presbytery and apse.* Significant diagonal cracks are located in correspondence of the discontinuities, i.e. windows, choir and organ, mainly along the east side.

- The two longitudinal sections of the numerical model, Fig. 7c, reveal a tensile stress concentration in correspondence with the upper windows, but the map does not correspond with the damage survey. This seems to demonstrate that the crack pattern is not probably due to gravity loads, but to seismic actions.

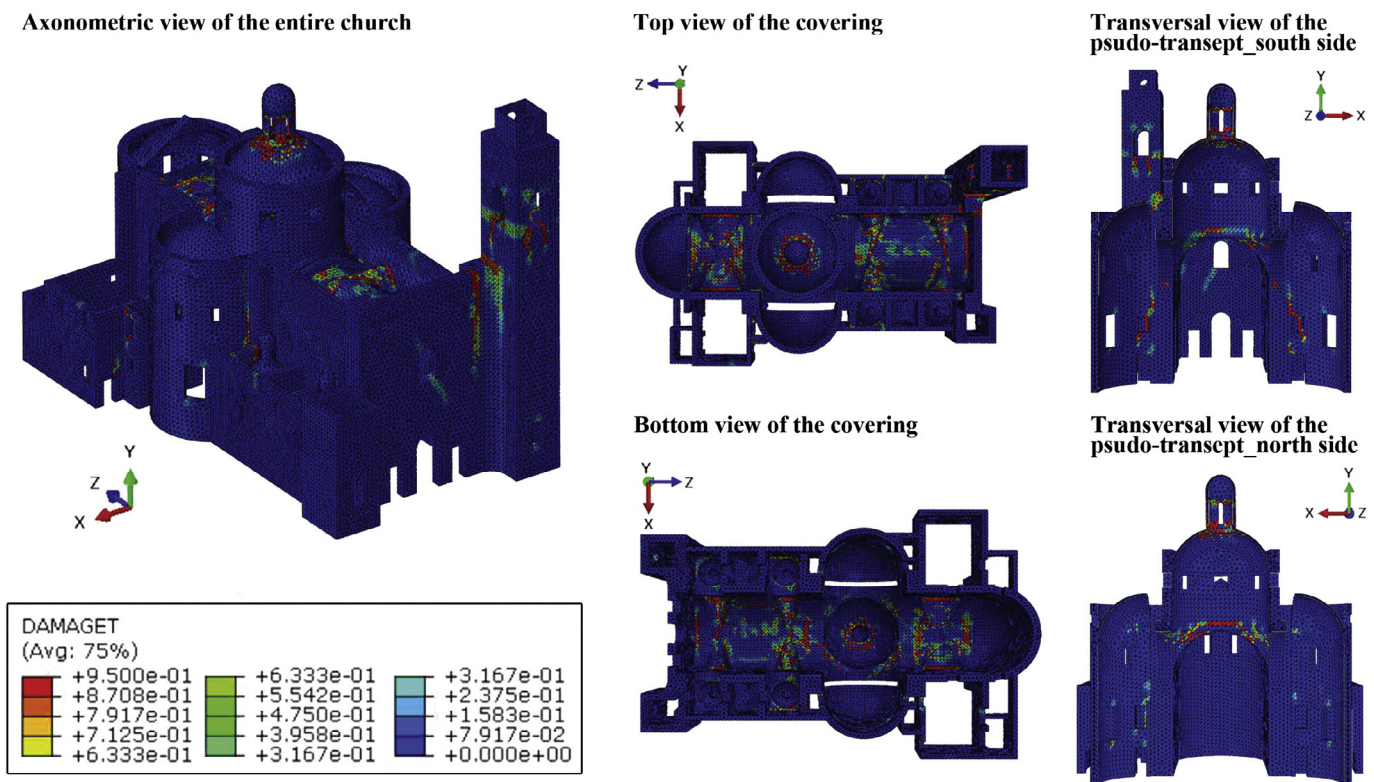
- The nave and presbytery vaults suffered a significant damage, already shown by the gravity loads analysis and compatible with the cracks detected in situ. Damage is localized along the diagonal ribs of the cross vaults. In particular, a significant damage can be noted in the connection region between the façade and the nave vault.

- A clear damage is registered at the base of the lantern placed at the top of the central dome, however not visible in the real crack pattern.
- The transversal sections in correspondence with the pseudo-transept indicate a considerable damage at the base of the central dome, along the pendentives and in the semi-domes of the transept: this damage is confirmed by in situ survey and already highlighted by the numerical simulations under gravity loads. Moreover, a severe damage is registered near the openings of the transept: these cracks are observed in the surveyed damage and did not emerge clearly from the previous analyses.

- The façade shows a visible damage close to the central window. Moreover, a vertical damage is detected in the connection regions between the bell tower and the façade (as already indicated also

in the gravity load analysis) and between the bell tower and the perimeter wall. There is a widespread damage near the openings of the belfry, not visible in the real crack pattern.

- The lateral side of the model shows a slight damage that is consistent with cracks observed near the openings of the nave, the lateral chapels and transept walls.

Fig. 8. Tensile damage contour plots obtained at the end of the non-linear dynamic analysis.
