Snail Trails and Cell Microcrack Impact on PV Module Maximum Power and Energy Production

This paper analyzes the impact of the snail trail phenomena on photovoltaic (PV) module performances and energy production. Several tests (visual inspection, maximum power determination, dielectric withstand, wet leakage current, and electroluminescence test) were carried out on 31 PV modules located in a PV plant in Italy. The electroluminescence test highlighted the strong correlation between the appearance of snail trails and presence of damaged cells in PV modules. The daily energy produced by four PV modules affected by snail trails ranged between 68% and 88% of the energy produced by a damage free commercial PV module over the same period.

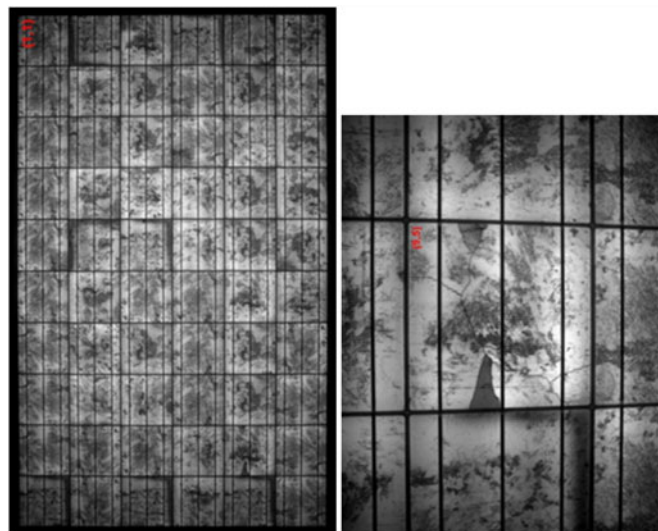
Fig. 4. EL image of PV modules #14.

The last indoor test was the EL which was performed on all the modules. As a term of comparison, the EL image of a PV module without visual defects (#14) is reported in Fig. 4.

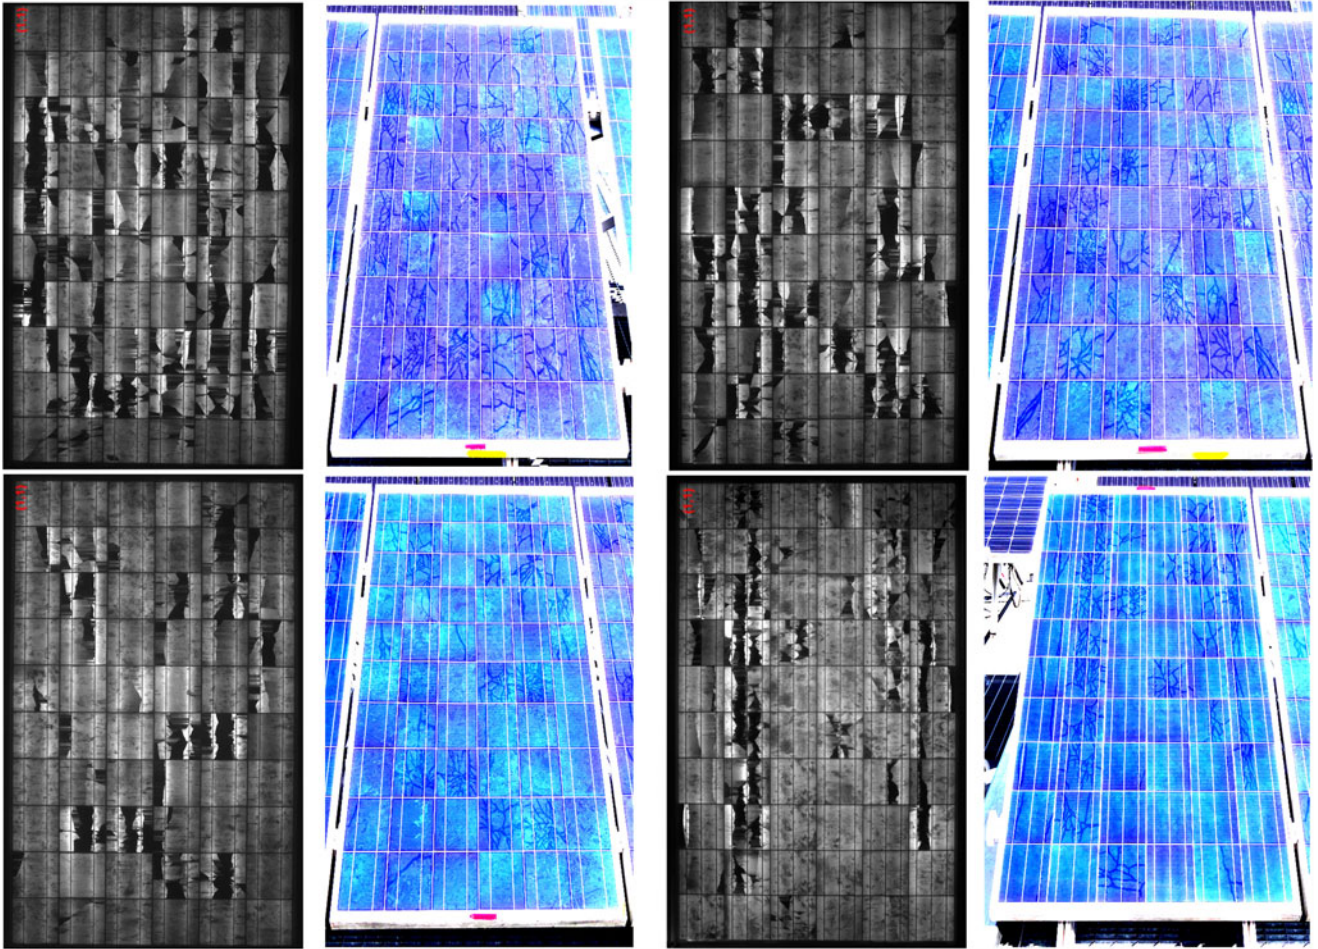
Among the 16 modules affected by snail trails, four among the ones with the lowest EFF were selected for the energy test at SolarTech^{Lab}. The selected modules are #17, #18, #23, and #24 whose EL results are reported in Fig. 5, together with their visual imagery. Black areas in EL images represent electrically separated sections. The positions of cell are indicated in terms of coordinate (row, column) within the PV module, e.g., position (1,1) is on the left, top.

Starting from PV module #17, several snail trails are visible, e.g., in positions (3,1), (4,1), and (5,1). Furthermore, cracks are distinguishable in some cells located in positions (6,3) and (10,2). In addition, poor finger contacts are visible [see cell (5,4)]. Same considerations can be extended to the module #18 and #24, where snail trails are visible in cells (2,1), (2,2), and (3,3) in #18, while in #24, they are located in positions from (1,2) to (6,2). In addition, in these cases, poor finger contacts are present in cell (4,4) and position (6,1) and (7,1) in #18 and in #24, respectively.

In the case of PV module #23, several snail trails are visible, e.g., in position (1,5), (1,6), and (1,7); these correspond to electrically separated areas in EL images. Furthermore, cracks are distinguishable in some cells, e.g., in position (5,3). Again, poor finger contacts are visible, e.g., on cell (5,4), and not uniformity in light is present, e.g., on cells (7,4) and (5,3). For the module

Fig. 5. EL image and picture of PV modules #17, #18, #23, and #24 starting from top-left.

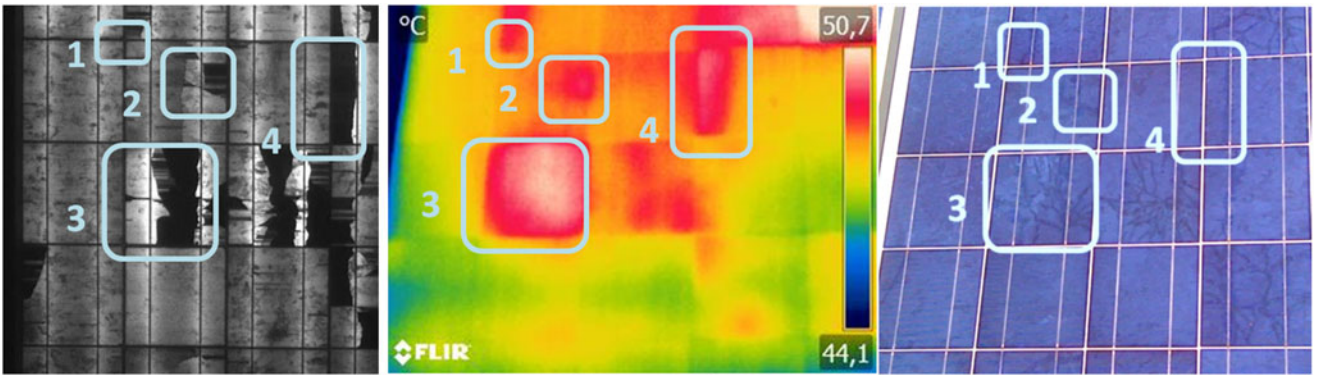
Fig. 6. EL, thermal, and visual images of #23 PV-module from (7,1) to (9,3) cells.

#23, in addition to EL analysis which outlined the same issues of the previous models, a thermal image together with EL and visual images of cells from (7,1) to (9,3) cells are shown in Fig. 6. Comparing the three images, it is possible to identify a link among visual defects, hot parts, and electrically separated areas.

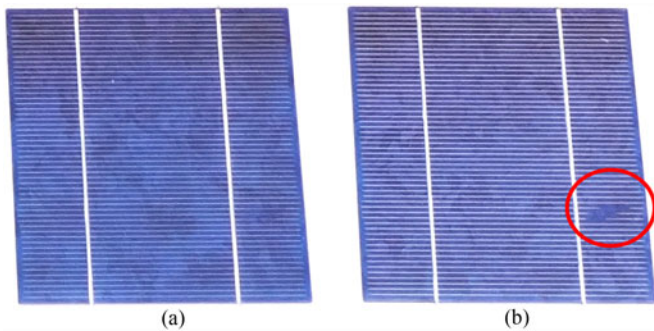
Furthermore, a comparison in terms of visual images was performed. The PV cell visual inspection outlined only minor variations from 2013 to 2015. In general, only one or two cells in each PV module showed new snail trails, affecting a very limited area of the PV cell. This can be seen in Fig. 9, where in 2015, a small defect, which was not present in 2013, has appeared in the bottom right area of the PV cell.

Fig. 9. Comparison among the state of the same PV cell. (a) year 2013 and (b) year 2015.

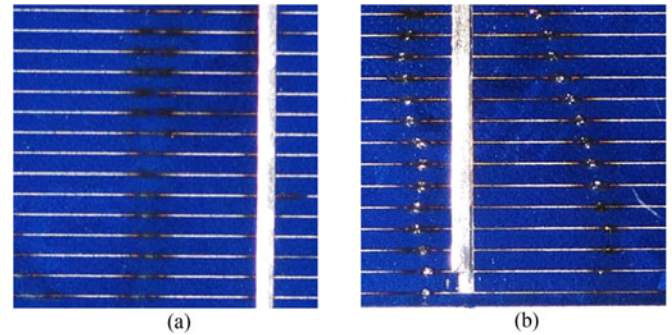
Moreover, only in a few cells of each module, a variation of the fingers close to the snail trails was observed moving from case a to case b.

- 1) *Case a*: Fingers are not interrupted, and there is only a color variation from metallic gray to black [see Fig. 10(a)].
- 2) *Case b*: Fingers look broken, and small metal agglomerates with spherical shape are present in the center of the finger [see Fig. 10(b)].

Fig. 10. Status of the fingers under the snail trails. (a) Year 2013 and (b) year 2015.

There is no clear explanation of this snail trail evolution. Over the two-year period, no further decrease of performance was observed, and only very minor evolution of new grid finger discoloration occurred. A localized hot spot caused by the high current density near the cracks in the PV cell can be the justification. Over time, the initial damage that looks like a burn evolves to a localized fusion of the metallic material, leading to a permanent damage of the cell and of the encapsulant. A microscopic change of “old” discoloration represents a reason that has to be investigated further.
