ASSESSMENT OF A FIRE DAMAGED CONCRETE OVERPASS: THE VERONA BUS CRASH CASE STUDY

Roberto Felicetti¹

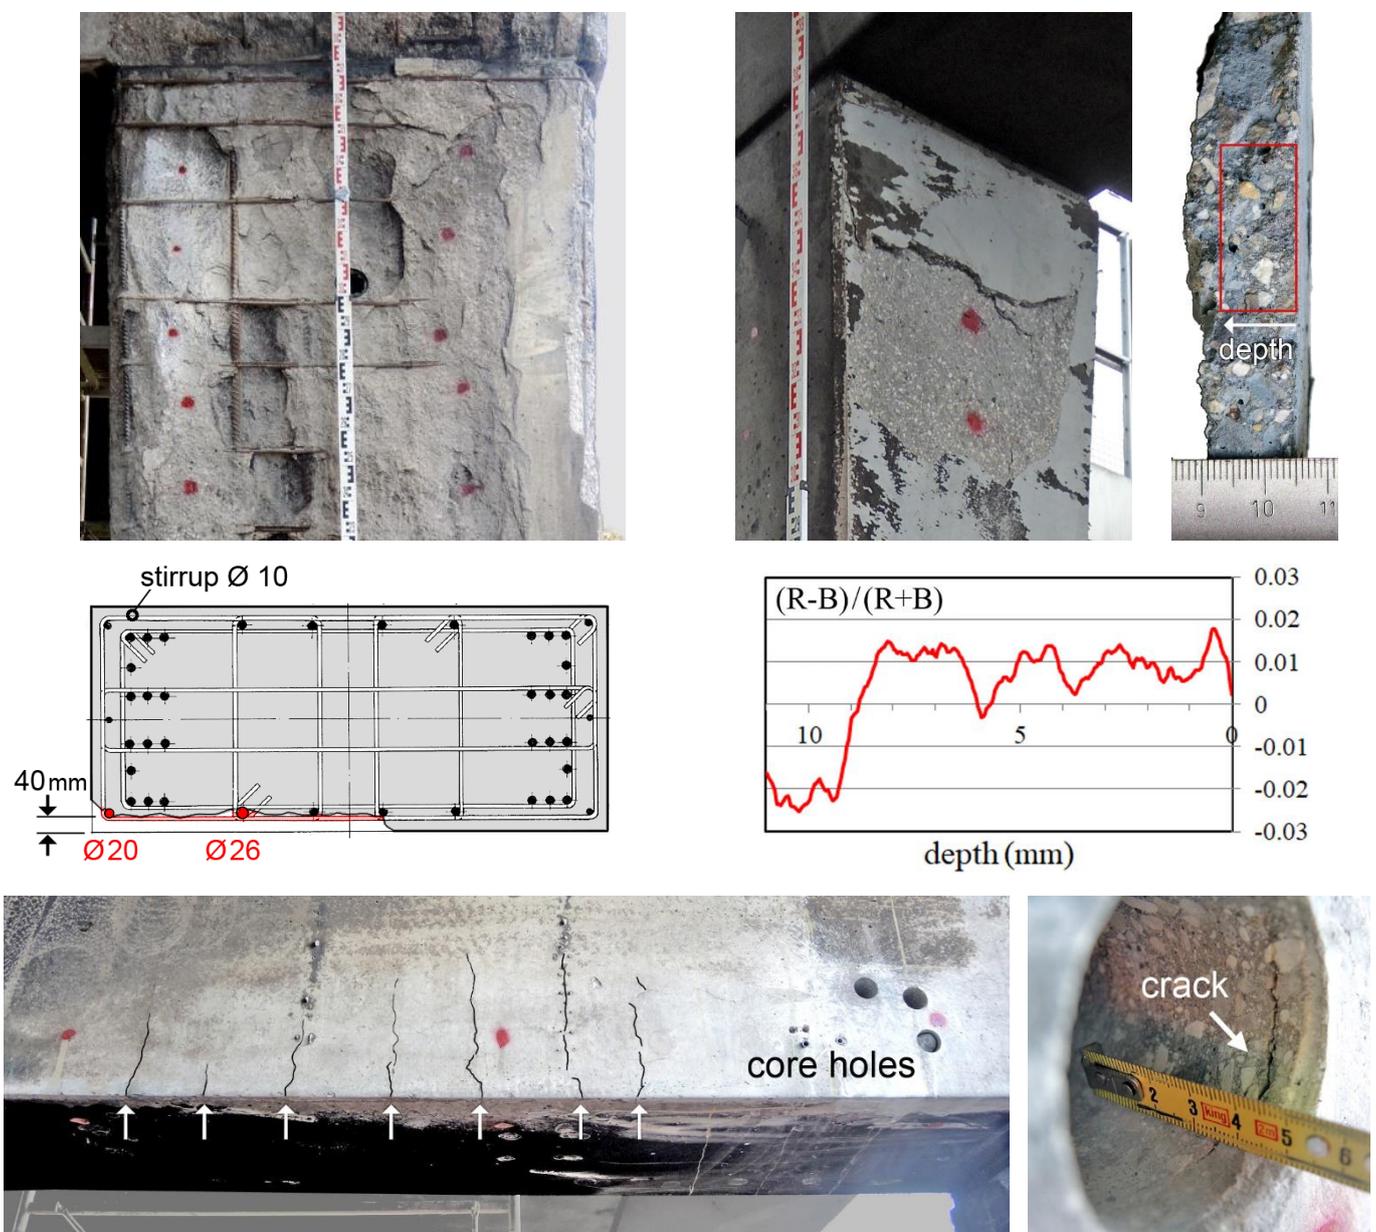
The visible damages observed during preliminary inspection (Figure 2) include spalling on the upper half of pillar 1, with direct exposure of two longitudinal rebars and some stirrups (then, a small share of the member reinforcement). A stable delamination of large plates (10-15mm thick) was recognized at the top of pillar 2. Here the fractured debris could be easily removed and inspected for discoloration. Extensive incipient delamination was detected by hammer tapping also at the intrados of the transverse beam, together with regularly spaced vertical cracks with the same pitch as the stirrups. In summary, no lack of rebar protection affected these latter two elements.

Despite of the direct impact of flames, the intrados of the box girder showed no sign of spalling and just limited delamination, exhibiting a sound response to the tap test. Structural analysis under dead loads showed that the compressive stress borne by the bottom flange next to the support was 5N/mm^2 , outlining a worse condition than the top section of the pillars (average sustained stress 2N/mm^2). This highlights the likely benefit brought in by polypropylene fibre in the most critical part of the structural system.

Figure 2. Observed damage patterns: spalling at the top of pillar 1, stable delamination at the top of pillar 2 and discoloured detached plate, equally spaced cracks and incipient delamination at the bottom chord of the transverse beam.

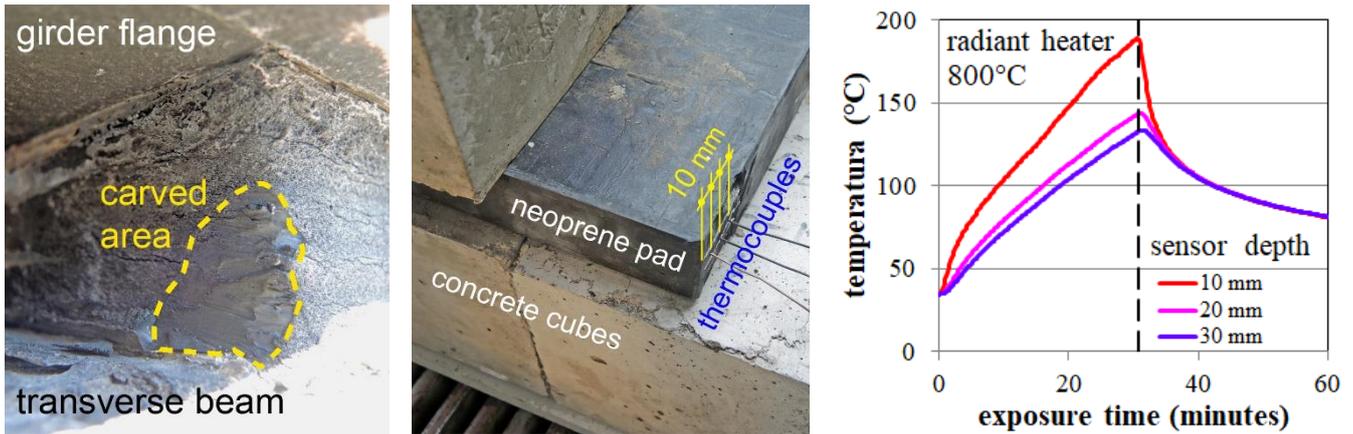
Figure 3. Charred skin removal from a neoprene bearing pad and heating curves resulting from the radiant heater test.

A last aspect deserving attention was the possible damage undergone by the elastomeric bearing pads laid between the transverse beam and the box girders. Visual inspection showed a charred surface on the most exposed sides (Figure 3). However, carving a thin slice was sufficient to expose an intact material with rubbery consistency. In a laboratory test, a like pad was stacked between concrete cubes and exposed to 30min intense radiant heating (about 50kW/m^2). The specimen showed limited charring depth (4mm) and decreasing heating rate, due to the protective effect of the charred layer and the high conductivity of the reinforcing metal shims. The maximum temperature at 10mm depth was below the onset of decomposition as indicated by thermogravimetric analysis [6], confirming the good fire endurance of this component.

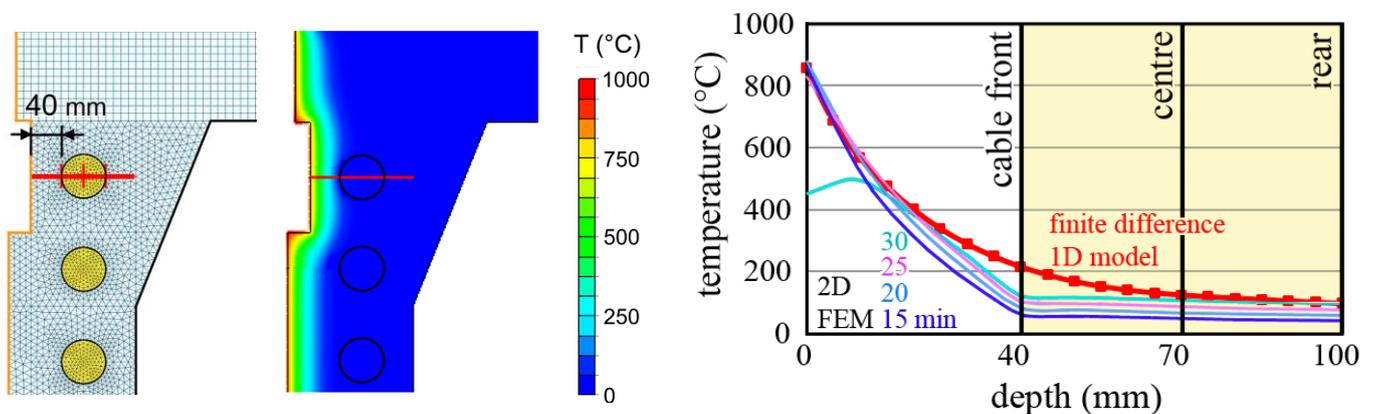
Figure 6. FE model of the recess region of the girder and maximum temperature envelope profiles in the cable and its cover.

Going back to the most critical part of the structure, it can be concluded that the post-tensioning cables underwent a not significant heating (< 120°C, Figure 6), whereas temperature exceeded 300°C in the first 30mm of the most exposed cover. Though concrete is expected to retain most of its strength at this temperature, stability in presence of possible fractures and durability in case of increased porosity were also of concern. Then, a check on the residual capacity was performed by neglecting any contribution from this layer. The results showed that the extra capacity in the hogging bending moment region dropped from +30% to +10% relative to the design bending moment (Figure 13). Even though the safety check were passed, the sizeable loss of resisting area caused a rise of the neutral axis at the Ultimate Limit State from 20% to 50% of the cross-section depth, significantly affecting the rotation capacity of the weakest cross-section in this redundant scheme. Some strengthening works were then recommended to the highway management to reinstate the original sectional ductility as well as cover stability.

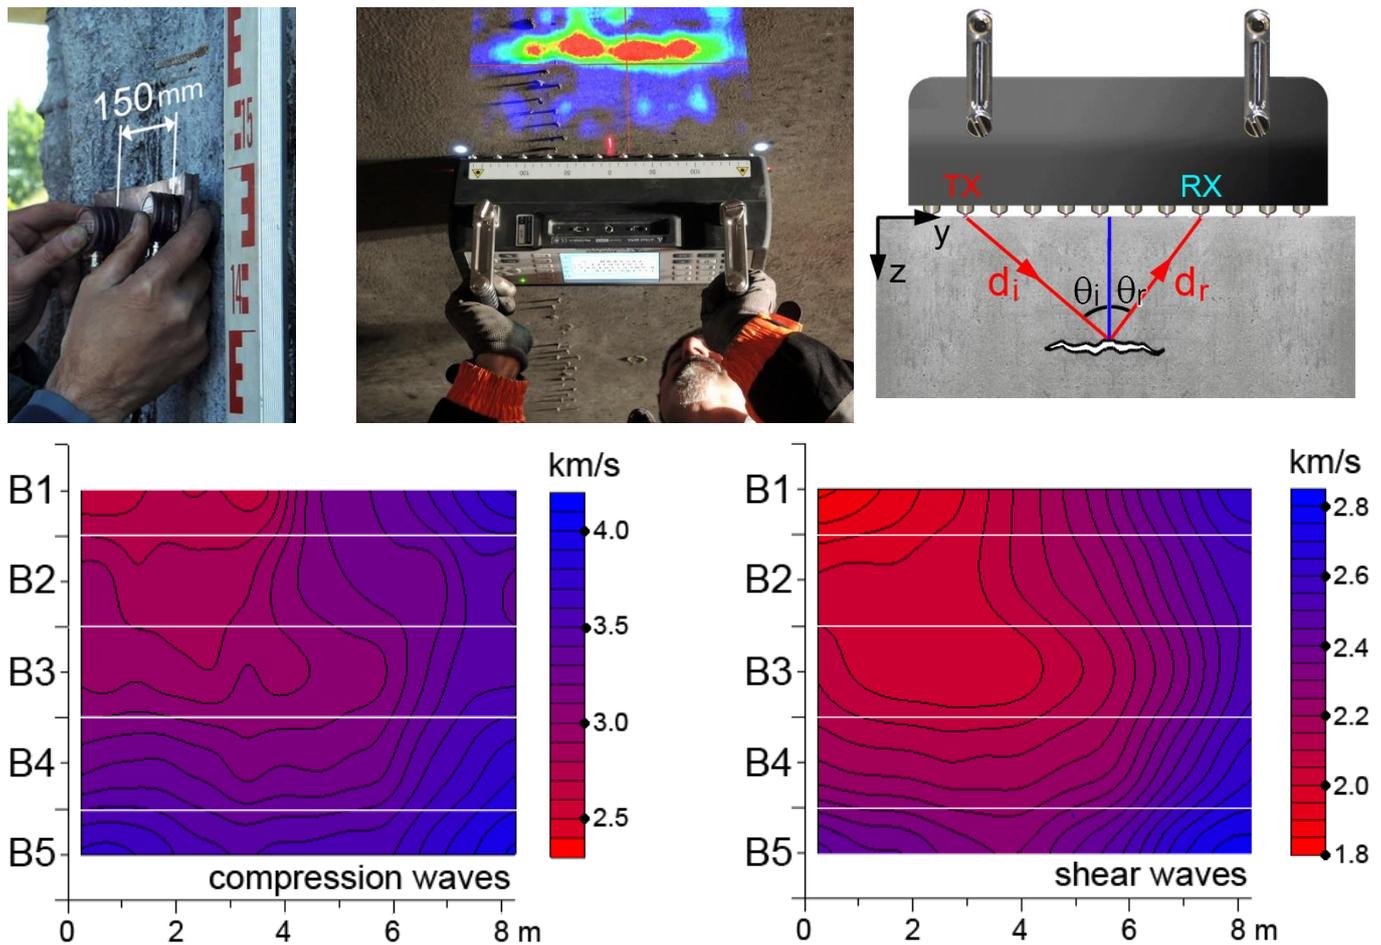
Figure 7. Setup for fast UPV mapping via the indirect method and the A1040 MIRA tomograph; their respective pulse velocity maps detected at the intrados of the 5 box girders composing the deck (abscissa measured from the portal edge).

Besides the different magnitude (shear waves are slower than compression waves), the resulting map (Figure 7) is very similar to the one obtained by means of the traditional UPV method. However, merging 66 waveforms in one measurement allows offsetting the local disturbance due to cracks, rebars and other defects, producing a smoother output. To be mentioned is that both mapping techniques were implemented at the pace of 25 test points per hour, minimizing the traffic disruption in this strategic highway.

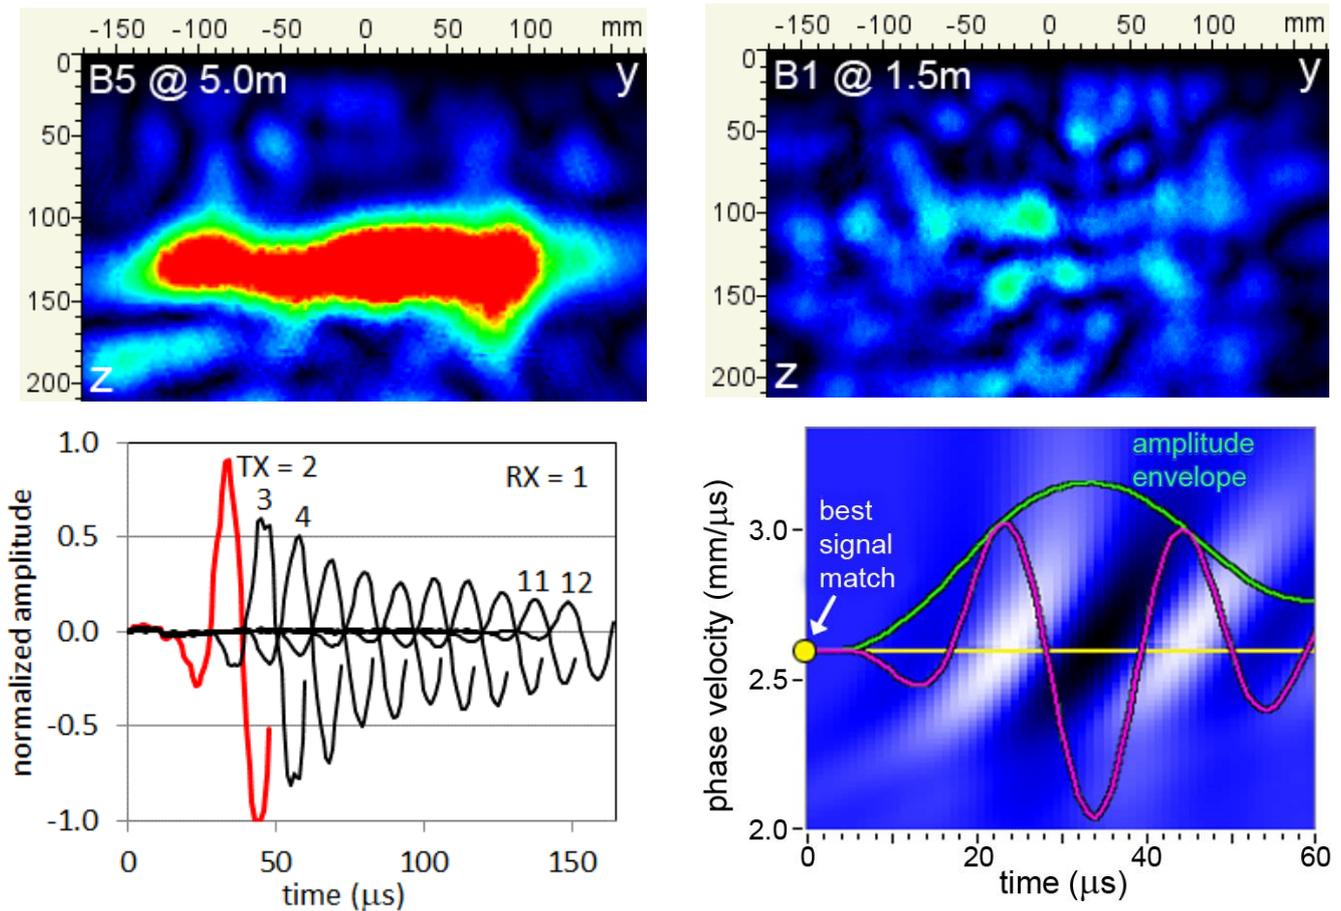
Figure 8. Different strength of the bottom-echo in case of pristine and damaged concrete flanges, regular increase of arrival time at increasing transmitter-receiver distance, assessment of surface wave velocity by optimization of the pulse alignment.

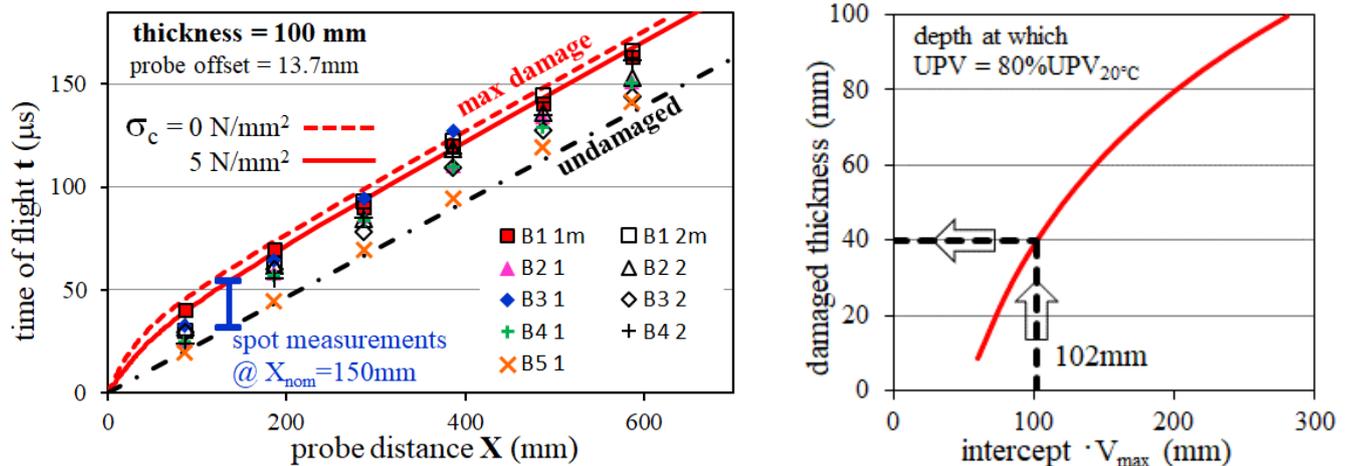
Figure 11. Comparison between experimental pulse refraction measurements and the theoretical X-t curve descending from the assumed fire scenario; quick assessment of damage depth according to the semi-empirical correlation proposed in [13].

In-situ measurements were taken along the central axis of each box girder, at 1m and 2m distance from the edge of the supporting transverse beam. The comparison against the theoretical trends (Figure 11) shows that all results lie between the plots pertaining to undamaged concrete (a straight line of slope $1/V_{20^\circ\text{C}}$) and to the maximum expected damage above the localized fire source. A good correspondence is observed between damage depth and the location in the general velocity maps of Figure 7, with smoothly decreasing effects in beams 4 and 5. The effectiveness of spot measurements at $X=150\text{mm}$ nominal probe distance in discriminating damage levels in this range is also highlighted.

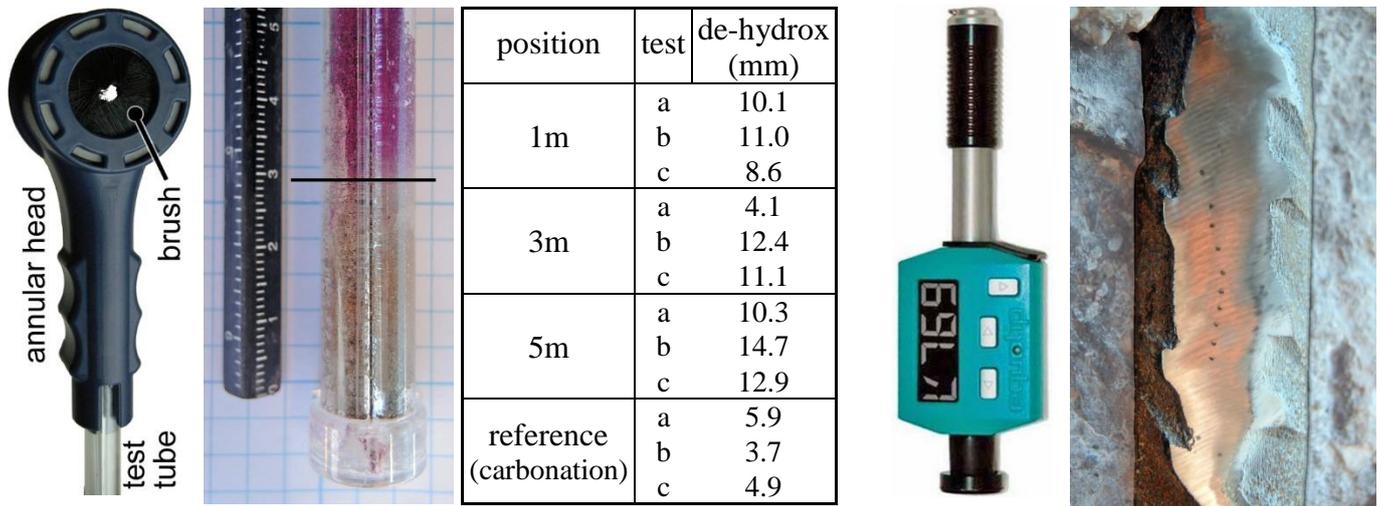
De-hydroxylation depth. Calcium hydroxide is the main source of alkalinity in concrete pores. It is decomposed by heating above 450°C , leading to the formation of calcium oxide, which is a highly hygroscopic product. For this reason, the reaction is reversible and can be recognized only if no water is used while sampling, as is made possible by collecting drilling powder via the Carbondest[®] kit [13]. Tests performed on the portal confirmed the lower impact of fire, as anticipated by colour analysis. Checks on the exposed web of the first girder (Figure 12) gave slightly lower values than expected ($<15\text{mm}$ vs. 16.7mm in Figure 11), confirming the assumed fire scenario as a cautious description of the event.

Figure 12. The Carbontest[®] kit, a de-hydroxylated powder sample (scale factor 2.25) and results collected on the exposed web of the 1st girder; Leeb dynamic hardness tester and resulting indentations on the smoothed face of an exposed rebar of pillar 1.

Dynamic hardness tests on rebars. Steel rebars may recover a significant share of their initial strength during cooling, though this strongly depends on their metallurgical features (alloying elements, thermal and mechanical working process [15]). The dynamic hardness test (Leeb method) is a viable tool to assess their residual performance regardless of original quality [5]. Tests were performed on one rebar exposed by spalling in pillar 1 and a reference piece uncovered by chiselling on the opposite side. The results (mean rebound index / std deviation = 515/6 and 536/8, respectively) showed a marginal decay of the rebar response (-4%), which corresponds to an almost double loss of yield strength. Given also the minor contribution to sectional capacity (see Figure 2), this confirms the little impact of fire on this element. A permanent loss of strength about 10% can be ascribed to heating up to about 700°C [15], which seems coherent with the other observations.

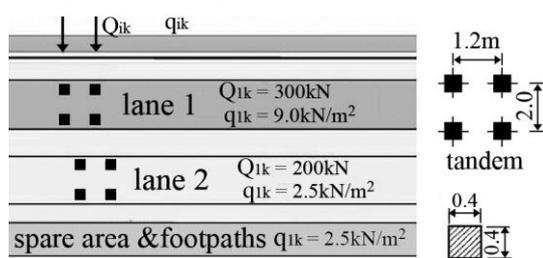
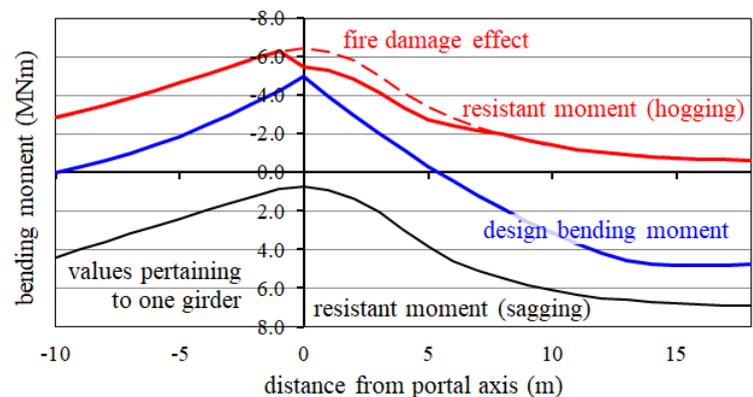
Figure 13. Design loads and diagrams of the design and resistant bending moments for the most fire damaged girders
