Potential Causes for Cracking of a Laser Powder Bed Fused Carbon-free FeCoMo Alloy

Jan Platl¹, Daniel Rainer¹, Harald Leitner², Christoph Turk², Francesco Galbusera³, Ali Gökhan Demir³, Barbara Previtali³, and Ronald Schnitzer¹

¹Department of Materials Science, Montanuniversität Leoben, Leoben, Austria

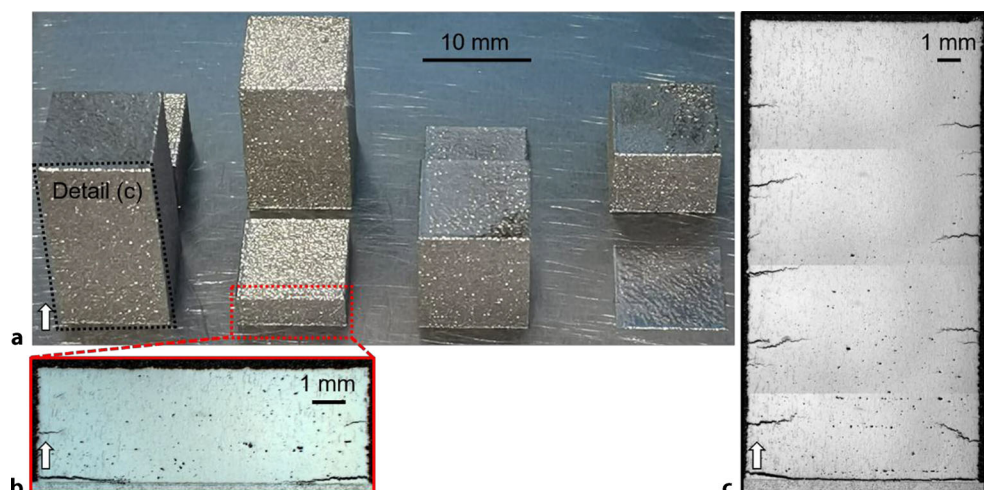
Fig. 1a shows an overview of the fabricated specimens. At this macroscopic level, the occurrence of cracks or delaminations cannot be deduced. Hence, LOM micrographs of

Fig. 1: **a** Macroscopic specimen overview. LOM micrographs of specimens with **b** 100 layers, and **c** 500 layers. It can be seen that cracks start from the transition zone to the building platform and from sample edges. The white arrows mark the building direction

samples with 100 layers and 500 layers are depicted in Fig. 1b and c, respectively. These cross-sections exhibit cracks, which initiate from the edges of the samples, and also the presence of a delamination between AM sample and build platform at the bottom of the micrographs is obvious. Additionally, Fig. 1c shows that all cracks propagate almost perpendicular to the build direction, which is indicated by the *white symbols* in the left bottom corner of the micrograph.

A regular arrangement of the cracks can be seen in both samples. This regularity indicates stress accumulations, which lead to the formation of the observed cracks. In a recent work [11], we determined similar stress accumulations by means of strain profile measurements using synchrotron radiation. These accumulations are responsible for crack formation of a LPBF carbon-containing cold-work tool steel. As the manufacturing process is identical, the investigated alloy may also have failed through process-related thermal stresses in the tensile regime at the sample edge.

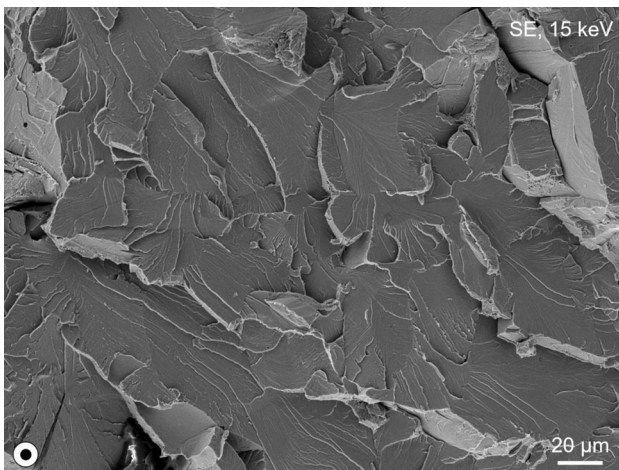
Fig. 2 depicts an exemplary SEM fractograph of the crack surface. Based on its morphology, the failure mode can be clearly assigned as brittle transcrystalline cleavage fracture.

Fig. 2: Exemplary SEM fractograph showing transcrystalline cleavage fracture. The *white symbol* marks the building direction

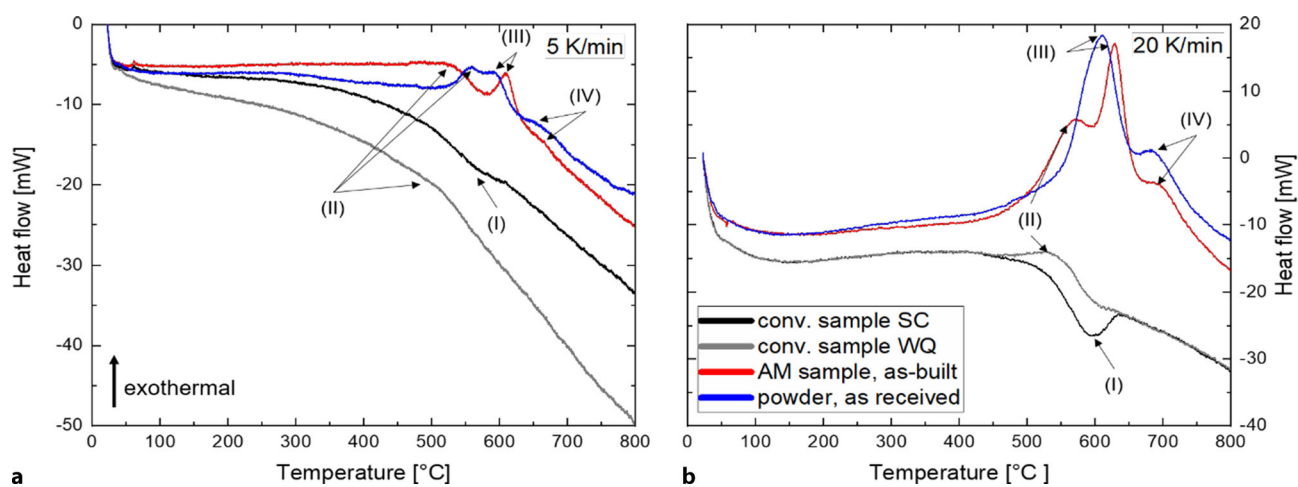
The occurrence of brittle ordered domains has been investigated as a first possible reason for the observed cleavage fracture. Therefore, DSC heating experiments were conducted in accordance with investigations performed by Turk et al. [12]. Special attention was paid to the heat flow at a temperature of $\sim 590^\circ\text{C}$ [13], at which a disordering peak should emerge if the material contains ordered domains. Fig. 3a and b depict typical DSC curves, in which the heat flow is plotted as a function of the sample temperature, for the two heating rates of 5 K/min and 20 K/min, respectively. It can be clearly seen in Fig. 3b that the endothermal ordering peak (I) at a temperature of 590°C only exists in the conventionally manufactured slow cooled (SC) sample.

This can be explained because this ordering process requires a certain amount of time, which cannot be guaranteed if the material is quenched too rapidly. Although LPBF is characterized by extremely rapid cooling conditions, the formation of these brittle ordered phases could have been possible during in-situ tempering processes by layers welded on the already existing ones. However, the conventionally manufactured and rapidly quenched (WQ) reference sample, the powder, and the AM sample exhibit no such endothermal disordering peak. Therefore, it can be concluded that no disordering process has occurred because no ordered domains were present in the starting condition (i.e. as-built state of the AM sample) at the beginning of the DSC experiment. Consequently, the formation of brittle ordered domains is not likely to cause the transcrystalline material failure of the LPBF samples.

Furthermore, the conducted DSC measurements provide information about possible precipitation reactions. From Fig. 3a, it can be deduced that, apart from the endothermal ordering peak, no further peaks and consequently no precipitation reactions are obvious during heating of the SC sample. This can be explained because overaging at 800°C with subsequent furnace cooling results in a pure FeCo matrix from which no Mo could be precipitated as it has already been incorporated in μ -phase formation. In contrast, the three remaining samples comprise a FeCo matrix, that is highly supersaturated in Mo due to rapid cooling rates. All depict the presence of peak (II) at temperatures ranging from 500 to 560°C . This peak can possibly be attributed to a Mo diffusion and clustering process, which was also observed for the same material in conventionally manufactured condition by Leitner et al. [21]. Peaks (III) and (IV) are obvious in Fig. 3b for the powder and the AM sample. Those can be assigned to the formation and subsequent coarsening of the μ -phase and are again in good agreement with investigations performed for the same alloy in conventionally manufactured condition [14, 15]. No clear statements about the role of precipitates in cracking can be drawn solely from these DSC experiments. Their detailed investigation will be the subject of future studies.

Fig. 3: DSC curves for different sample conditions at heating rates of **a** 5 K/min and **b** 20 K/min. Peak (I) only emerges during heating of the conventionally manufactured slow cooled (SC) sample. Zero lines have been subtracted

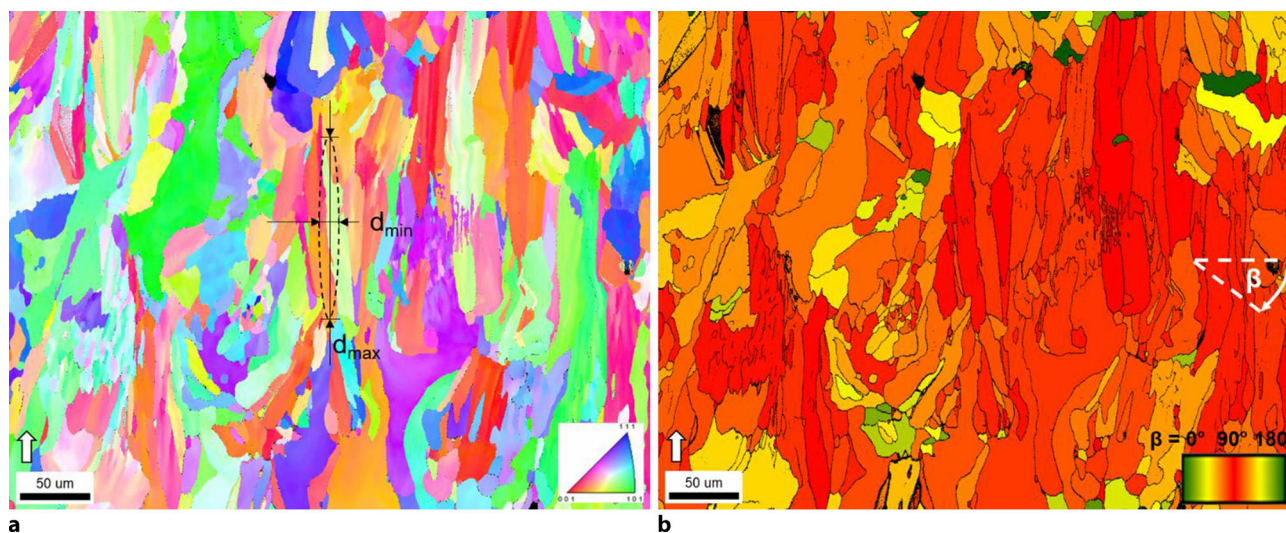
Fig. 4a shows the inverse pole figure (IPF) color map, which was determined using EBSD on the electropolished surface, of a sample with 100 layers. The *white arrow* in the bottom left corner marks the build direction during

Fig. 4: **a** IPF color map for bcc phase with calculated $d_{\min} = 19.2 \mu\text{m}$ and $d_{\max} = 86.5 \mu\text{m}$. **b** GOS map depicting a strong epitaxial grain growth. The white symbols mark the building direction

LPBF. More than 99% of the area have been indicated as a body-centered cubic (bcc) phase. Therefore, the as-built microstructure is highly likely to consist of a Mo-supersaturated FeCo martensite that formed during rapid cooling. It can be seen that most grains are elongated in build direction. By taking into account the chosen layer thickness of $40 \mu\text{m}$, it can be concluded that grain growth occurs towards several layers.

In order to estimate the minimum and maximum grain diameters, as described in the methods section, the following averaged values for the grain area and the aspect ratio were extracted from the EBSD data plots of the grain area and the aspect ratio, both in dependence of the cumulative area fraction: $A_{50\%} = 1303 \mu\text{m}^2$ and $AR_{50\%} = 0.22$. By inserting these values in Eqs. 3 and 4, the mean diameters amount to $d_{\min} = 19.2 \mu\text{m}$ and $d_{\max} = 86.5 \mu\text{m}$, respectively. Basically, coarse grains often contribute to brittle failure of steels because of the higher ductile-brittle transition temperatures [16]. The calculated values for d_{\min} and d_{\max} are

Fig. 4b depicts the same scan but as a map of the grain orientation spread (GOS). This illustration shows the orientation of grains through the angle β relative to the horizontal axis. It can be seen that the majority of the grains is depicted in red and orange and these grains are therefore oriented almost parallel to the build direction. Hence, a strong epitaxial grain orientation is obvious. These epitaxial structures can be explained by the nature of the AM process [19].

In terms of cracking, no correlation between grain orientation and crack propagation was found as the failure occurred in a transcrystalline manner. Due to the relatively coarse grain structures, which were found using EBSD,

a significant contribution to cracking is possible. In order to avoid a coarsening during LPBF, Zhang et al. [20] investigated the influence of different *VEDs* on the grain structure of commercially pure titanium. This approach could also result in significant grain refinement and thus in a possible improvement of crack resistance of the investigated Fe-CoMo alloy. The change of *VED* may also alter the porosity of the produced material, as too low levels would generate lack-of-fusion while too high levels can induce keyhole porosity. The control of laser power profile temporally and spatially may provide further flexibility [21–23].

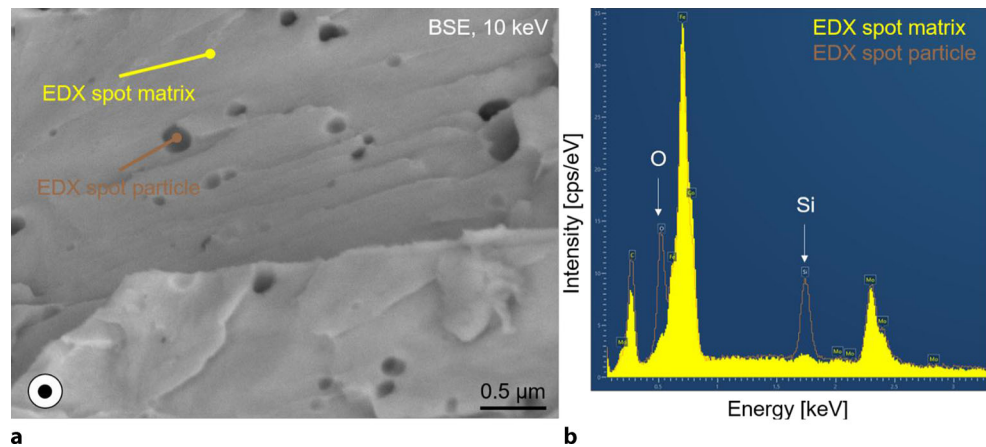
Fig. 5: **a** BSE SEM fractograph with corresponding **b** qualitative EDX spot spectra of matrix and particle composition. The latter can be clearly assigned to silicon oxide. The *white symbol* in **a** marks the building direction

Fig. 5a shows a high resolution BSE SEM fractograph, in which a transcrystalline cleavage failure can be seen (cf. Fig. 2d). The presence of dark spherically shaped phases with dimensions below 300 nm is obvious. As darker depicted structures in the BSE mode comprise lighter elements, the presence of oxides was assumed. Evidence of their presence on the crack surface is given by the EDX spot measurements depicted in Fig. 5b. A comparison of the matrix spot and the particle spot clearly assigns these non-metallic inclusions as silicon oxides.

These Si-rich inclusions probably formed due to the presence of residual oxygen during atomization or in the Argon gas atmosphere of the LPBF process. This assumption is in accordance with an investigation of a LPBF 316L steel published by Zhong et al. [25]. In order to reduce the risk of cracking due to such Si-rich non-metallic inclusions, a promising approach would be to atomize a powder without Si additions as this element is not mandatory for the mechanical performance (i.e. hardness level) of the investigated alloy.

Out of the potential cracking reasons discussed above, the presence of silicon oxides on the crack surface is the one with the highest probability of causing the failure of the investigated FeCoMo alloy. As a further potential cracking

The occurrence of non-metallic inclusions was determined as the most probable cause for cracking. EDX spot measurements clearly revealed that these inclusions comprise Si and O. Because a further reduction of O contamination during atomization and LPBF is hard to realize, a promising approach to avoid the formation of these silicon oxides is to remove Si from the powder. The latter is not mandatory for the mechanical performance of the investigated FeCoMo alloy.
