*Proceedings
of the*
5th International Conference

The Façade and the Rose-Window of Troia Cathedral (Apulia, Italy)

Domenico Liberatore, Giuseppe Spera and Marco Mucciarelli

ABSTRACT: The façade of Troia Cathedral is tilted around a horizontal hinge, of seismic origin and passing through the rose-window. As a consequence, the rose-window is heavily damaged and deformed out-of-plane. In this paper, cognitive and diagnostic investigations are presented on the materials and the elements of the rose-window (GPR, thermography, sonic and ultrasonic tests, ambient vibration survey), together with a structural diagnosis.

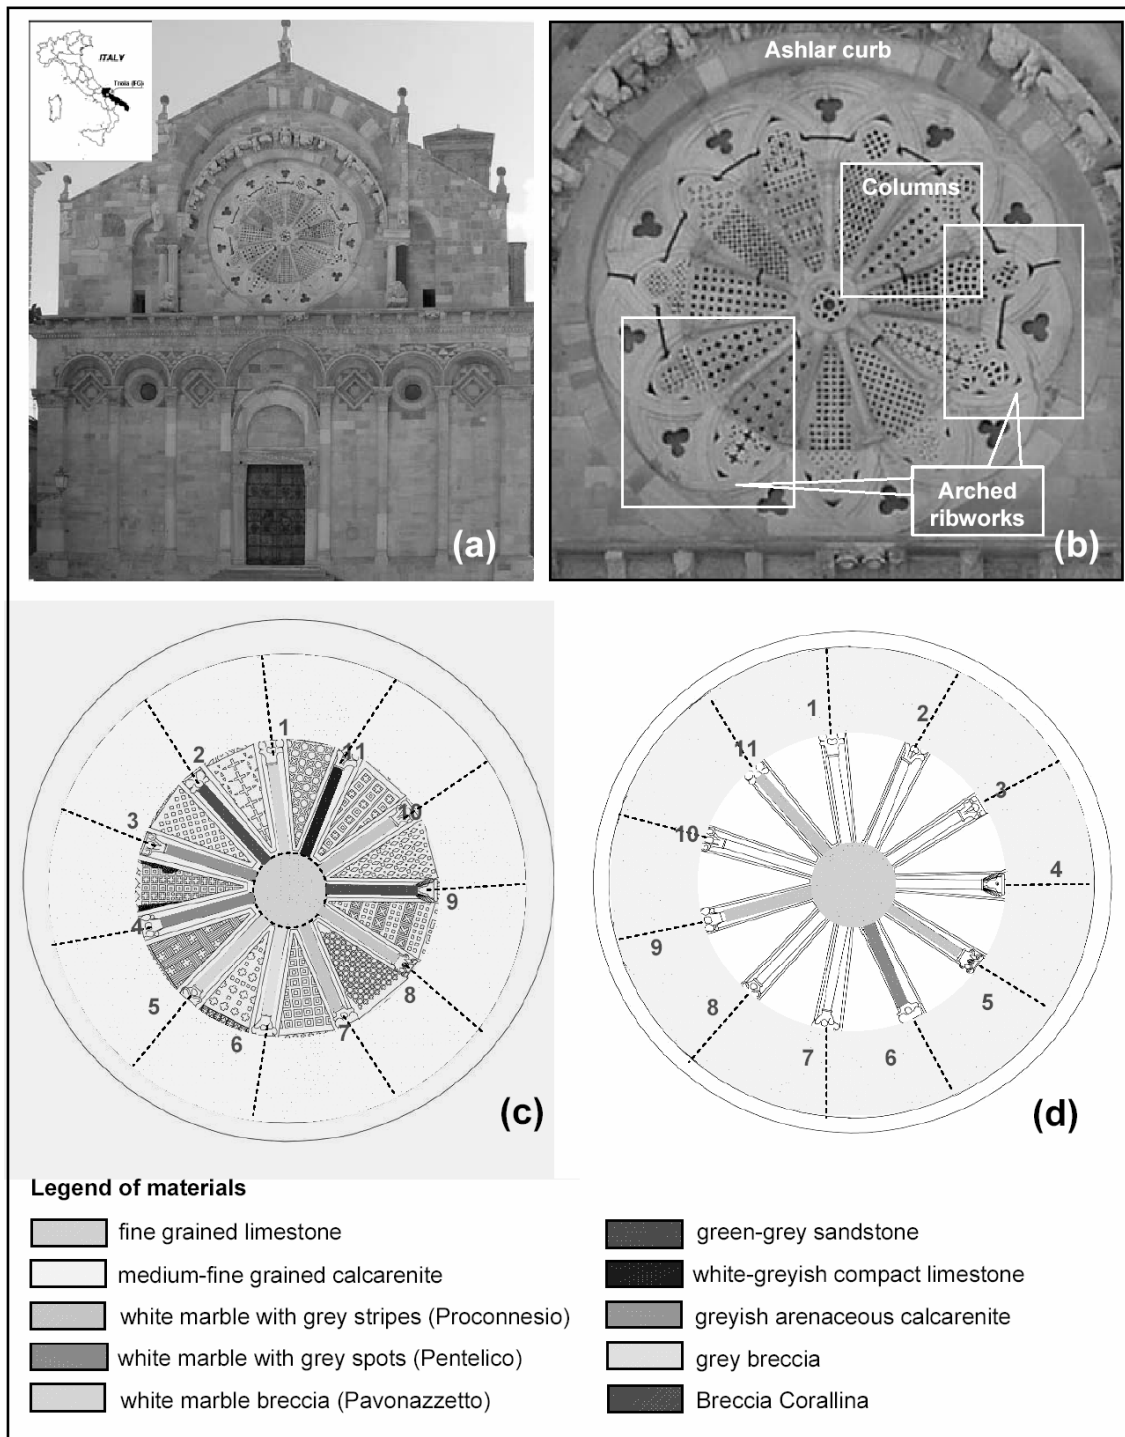
Figure 1 : Façade and rose-window of Troia Cathedral

The main damage of the façade consists of a rotation around a horizontal “hinge”, approximately 9.50 m above the base. The top of the façade is nearly 30 cm out of plumb. The origin of the rotation is clearly seismic, even though it was not possible to determine the date and the intensity of the event.

The rotation of the façade induced heavy deformations and damages in the rose-window, which is displaced outwards in the upper part, and inwards at the centre. Disconnections and rotations of the capitals, as well as compression failures of the columns may be observed. Relative displacements, up to 1 cm, may also be observed at the joints between the arched ribworks. An out-of-plane restraint was set up, presumably in the nineteenth century, consisting of two horizontal tubes, anchored to the ashlar and connected to some columns and arched ribworks through metal elements.

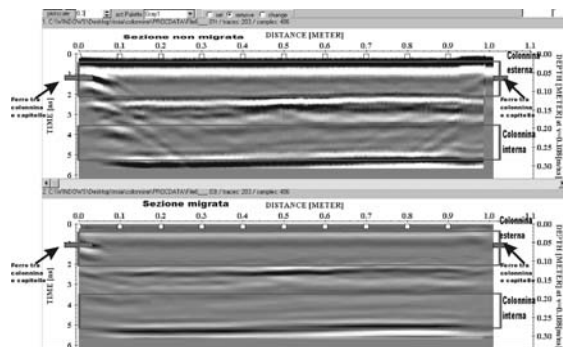
In this paper we discuss the results obtained on the most significant architectural elements. Fig. 2 shows the unmigrated (top) and migrated radargrams (bottom) relating to column 6, for which a velocity of 0.108 m/ns was estimated. Three reflections at 2, 3.4 and 5.4 ns are referable to interfaces between the different materials. In particular, a 3 to 5 cm thick layer of inhomogeneous material separates internal and external columns. In this space the carved panels are joined together by rubble and mortar. Thus, the total thickness of the three-layers medium (external column - inhomogeneous material - internal column) is about 26 cm.

Moreover, two semi-hyperbolas with apex at 0.05 m and 1.2 ns, on the two ends of the external column, could be associated to the edge of an iron anchor bolt linking the column with the capital. The anchor bolt penetrates in the column for about 5 cm, as marked in the migrated section.

Figure 2 : Top: unmigrated radargram of column n. 6. Bottom: migrated radargram with estimated velocity of em waves 0.108 m/ns.

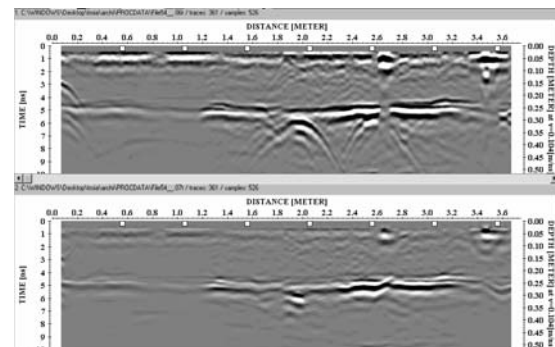
Fig. 3 is relating to the intersecting arched ribworks between columns 5 and 3. The radargram shows two different responses to the electromagnetic wave: the former between the abscissas 0-1.84 m, the latter between 1.84-3.68 m. This fact denotes the presence of two different materials. Moreover, diffraction hyperbolas at both ends reveal the presence of anchor bolts of about 10 cm linking the intersecting arched ribworks with the capital.

Figure 3 : Top: unmigrated radargram of the arched ribwork between columns n. 5 and n. 3. Bottom: migrated radargram with estimated velocity of em waves 0.104 m/ns.

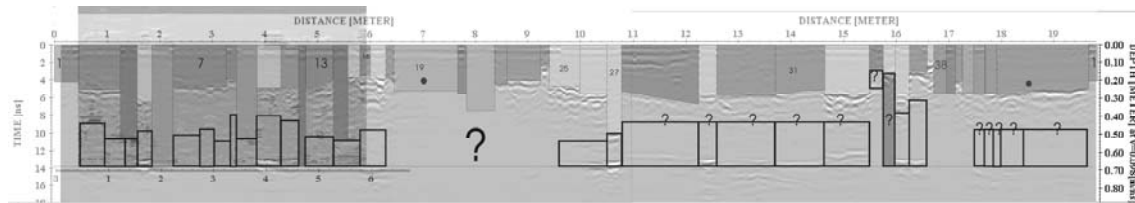
Fig. 4 shows the interpreted curb structure superimposed on the composite radargram obtained merging the topmost halves of the migrated sections from the external and the internal side.

In summary, the curb structure is a sandwich composed by two external rows of ashlars and an heterogeneous intermediate layer in the masonry core, probably composed by rubble. The two external rows are joined by a large number of diatons, especially in the lower part of the rose-window.

Figure 4 : GPR results on the circular ashlar curb: interpreted curb structure superimposed on the composite migrated section from both sides, outlining the ashlar's geometry and materials, and highlighting a more heterogeneous masonry core.

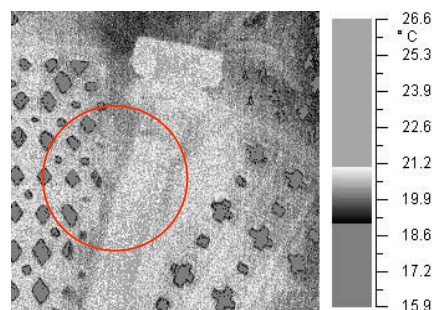
- cracks on the columns;
- surface cracks not visible;
- conservation treatments composed by mortar near the joints between the columns and the oeil-de-boeuf;
- superficial iron elements which join capitals to intersecting arched shape ribworks or to columns (Fig. 5).

Figure 5 : Thermal variation induced by a metal element connecting column and capital.

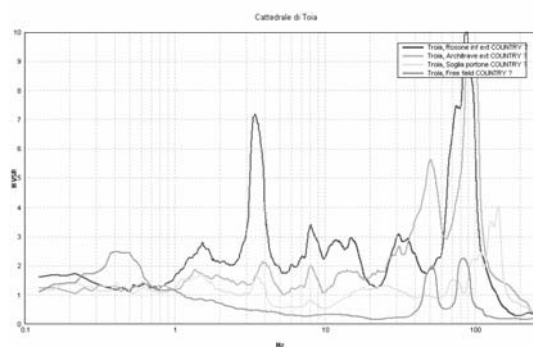
The measurements on the façade and the rose-window were performed with a digital tromometer (Micromed Tromino), that hosts in a single, small case 3 seismometers, a 24-bit digitizer and the data storage unit. For all the measurement points, 6 recording were acquired, lasting 1 min each. The sampling frequency was 512 Hz. The signals were detrended and filtered in the range 0.1-256 Hz. After the transform in the frequency domain, the ratio between the horizontal and the vertical component was calculated in order to estimate the fundamental frequencies. The HVRS analysis identified separate fundamental frequency for the two orthogonal directions (in-plane and out-of-plane). On the façade, two frequencies were identified, at 3.2 and 8.0 Hz, with amplitude increasing with height, as expected for the fundamental mode (Fig. 6).

Figure 6 : HVSR of the façade at different heights.

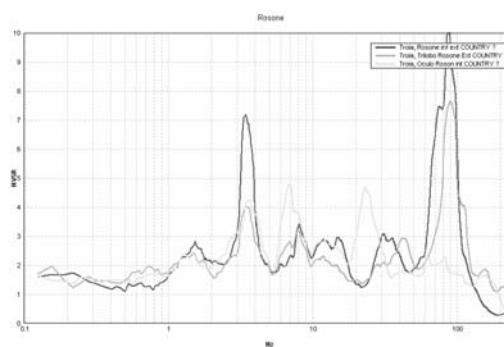
The measurements carried out on the rose-window (oeil-de-boeuf, arched ribworks and connection with the façade) show a different eigenfrequency (Fig. 7). While the façade frequencies are still visible, a separate frequency emerges at 22 Hz. This mode has greater amplitude at the center of the rose-window and decreases towards the connection with the façade, as expected for a 2D plate fundamental mode.

Figure 7 : HVSR of the rose-window.
