# Static monitoring of a masonry arch bridge: Evaluating the effects of changing environment

P. Borlenghi & C. Gentile

**ABSTRACT:** The paper presents selected results obtained in the continuous monitoring of the *Candia* bridge – a historical masonry arch bridge crossing the Sesia River in the north of Italy – to detect scour-induced effects. Generally speaking, hydraulic processes are the main cause of bridge failure, and masonry arch bridges are particularly vulnerable to scour-induced settlements. Consequently, the early detection of anomalies associated to scour is of outmost importance to ensure the safe operation of river bridges. In the present study, measurements of the piers rotation are performed using tiltmeters; in addition, environmental parameters, such as temperature, water level and riverbed changes, are measured to check possible correlation with the monitored rotations. The results from the first two years of monitoring highlight anomalous changes in the rotation-temperature correlation of various piers.

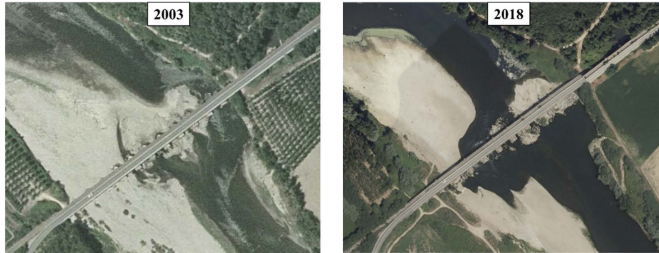
Armoring intervention of the riverbed were carried out on several occasions to stabilize the sediments around the foundations. To the authors' knowledge, the last intervention of riverbed stabilization - before the installation of the monitoring system - was performed after 2003 around the most eroded piers at the left side of the channel, where flow concentrates in normal condition. This operation, however, simply modified the local morphology of the riverbed, deviating the main flux - and therefore the scour process - from the left to the central-channel piers. Figure 2 shows a representation of this mechanism.

Figure 2. Satellite images of the Sesia River before and after the armorment intervention.

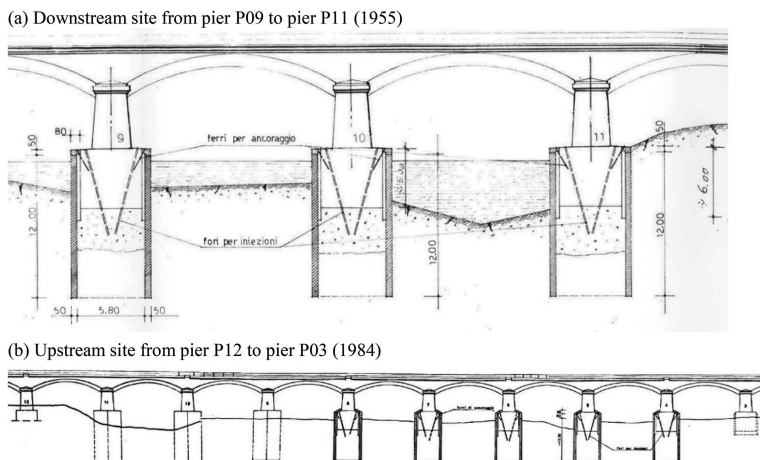
Between 1954 and 1955 the 9th arch – included among P08 and P09 – was reconstructed and the foundations of piers from P09 to P11 were strengthened a deepening of the foundation level (Figure 3a) up to 12 m below the riverbed. The reason of the heavy damage of the arch is still unknown but most likely it was connected to soil settlements. Subsequently, during the 1980s, a similar intervention on the foundations of piers P04-P08 was performed (Figure 3b), together with the strengthening of arches from 1 to 5.

Figure 3. Historical drawings of different strengthening interventions on the piers: (a) 1955 intervention on piers P09, P10 and P11; (b) 1984 intervention on piers from P04 to P08.

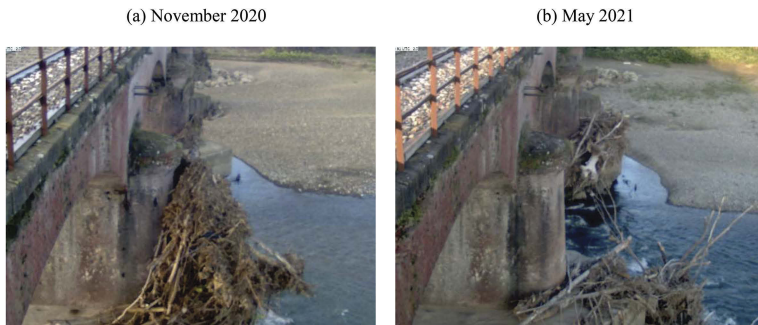
Regarding the analysis of debris accumulation Figure 5a shows the important wood debris accumulated over the concrete foundation basement of pier P05 after the flooding of October 2020 (estimated water level reach during the event equal to 105 m asl). After six months an event with a water level of 100 m asl occurred in May 2021 and a substantial variation in the debris accumulation is visible from Figure 5b.

Figure 5. Pictures from the permanently installed cameras: (a) debris accumulation on P05 in November 2020 resulting from the important event of October 2020; (b) debris accumulation on P05 and P04 after the event of May 2021.

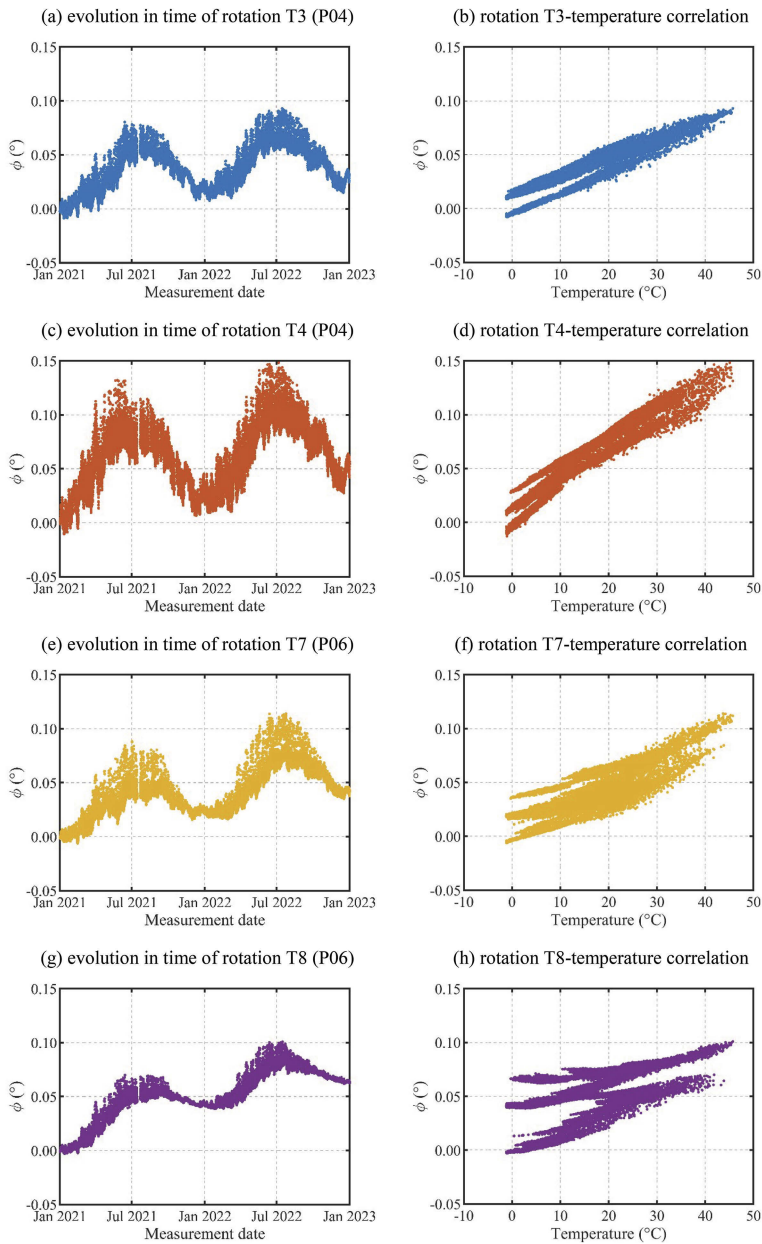
Figure 7. Time variation of rotations and rotation-temperature correlation of sensors T3 (P04), T4 (P04), T7 (P06) and T8 (P06).

Firstly, the qualitative comparison of Figures 7a, c, e, g and Figure 6a suggest that the fluctuations of the measured pier rotations approximately follow the temperature variations with a direct correlation: the rotations increase with the increase of temperature. However, the inspection of the time evolution of measured rotations (Figure 7a, c, e, g) reveals that between January 2021 and January 2023 – periods in which temperatures are similar – there is a clear accumulation of rotation, ranging from  $+0.02^\circ$  for T3 to  $+0.06^\circ$  for T8. In addition, as shown in Figures 7b, d, f, h, the rotation-temperature correlation exhibits various changes during the monitoring period, highlighting the presence of different anomalies.

- The tiltmeters of *Candia* bridge experienced an accumulation of rotation in the direction of the river flow; therefore, the phenomenon that caused the residual rotations should be related to a soil settlement of the downstream side. It is worth considering that the distribution of vertical loads is not symmetric: the railway track – decommissioned in 2010 – is on the upstream side while the roadway is on the downstream side, causing an asymmetric distribution of service loads.

- According to the blueprints of the different interventions (Figure 3) the foundations depth for all the piers should be equal to approximately 12 m (measured from the extrados of the foundation plinth). During an onsite survey a local measure of the scour hole depth on the upstream side of pier P05 was equal to 5.5 m. Consequently, the system should record the negative rotation residuals only if new important hydraulic events will occur.
