G. Cardani\* and G.E. Massetti\*\*

\* Department of Civil and Environmental Engineering, Politecnico di Milano  
e-mails: giuliana.cardani@polimi.it

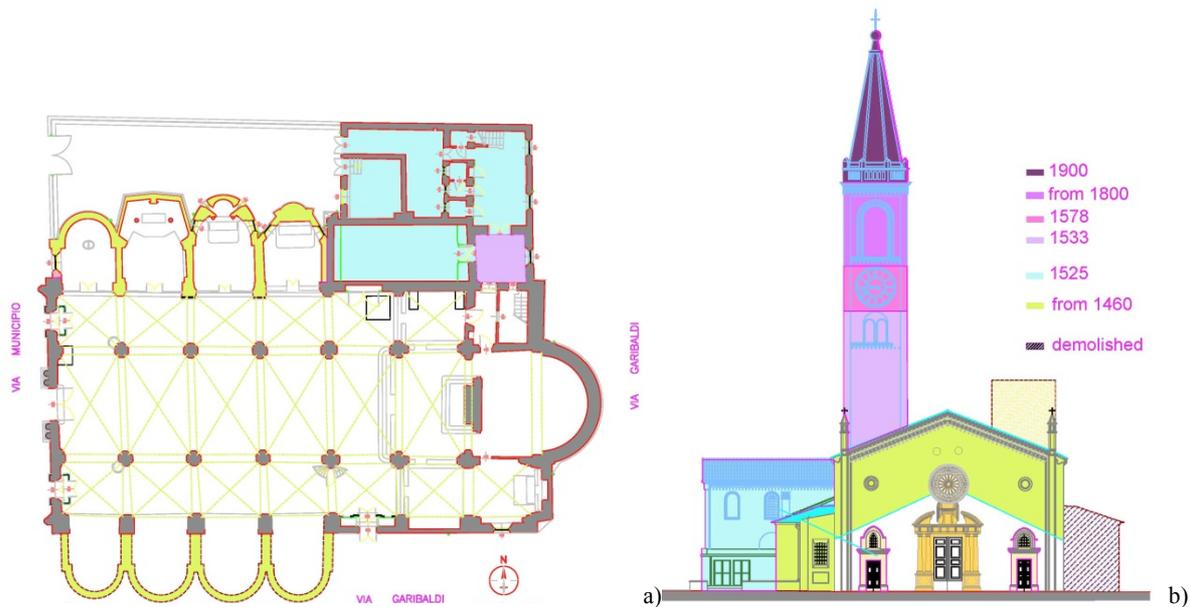
Figure 2: Historical evolution of the St. Bassiano church: a) plan and b) West facade view.

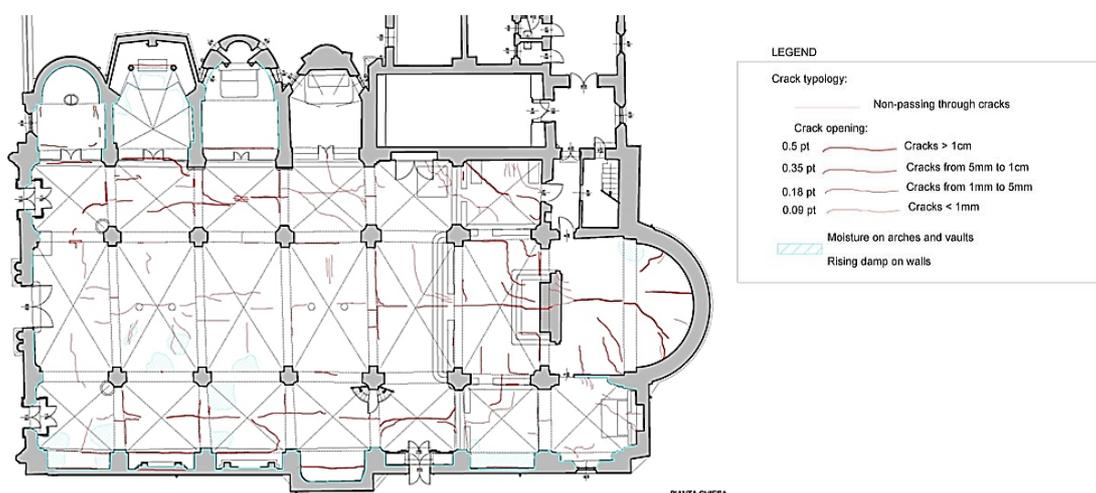
Figure 3: Crack pattern survey of the vaults of St. Bassiano church.

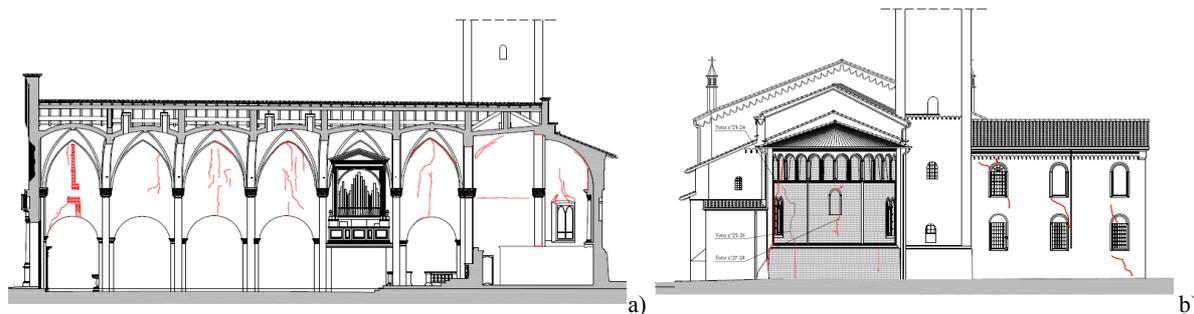
Figure 4: Crack pattern survey of St. Bassiano church: a) central nave longitudinal section and b) external view of the East side.

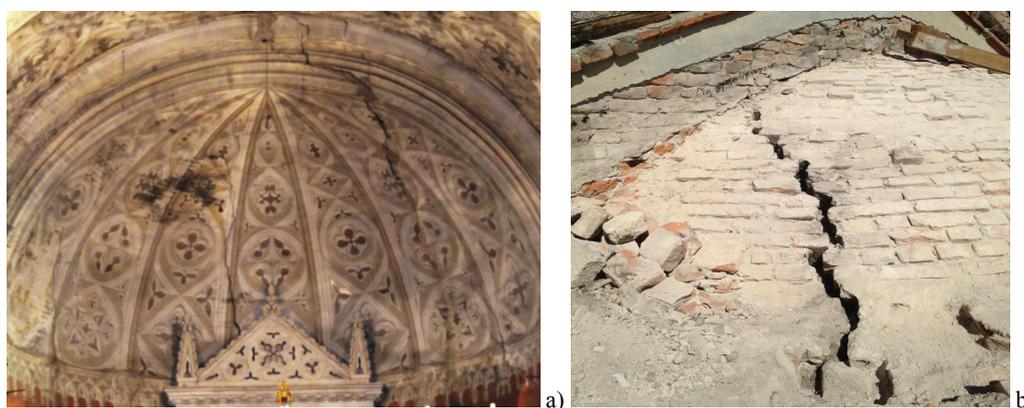
Figure 5: Crack pattern of St. Bassiano apse: a) internal and b) external view under the roof.

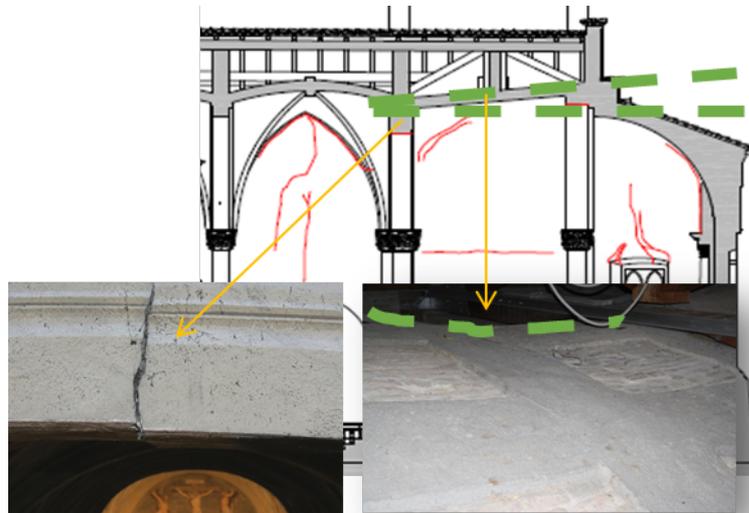
Figure 6: Crack pattern of St. Bassiano apse: the sliding of the main arch between apse and nave, on the left, and the curved profile of the barrel vault after the half-dome on the right.

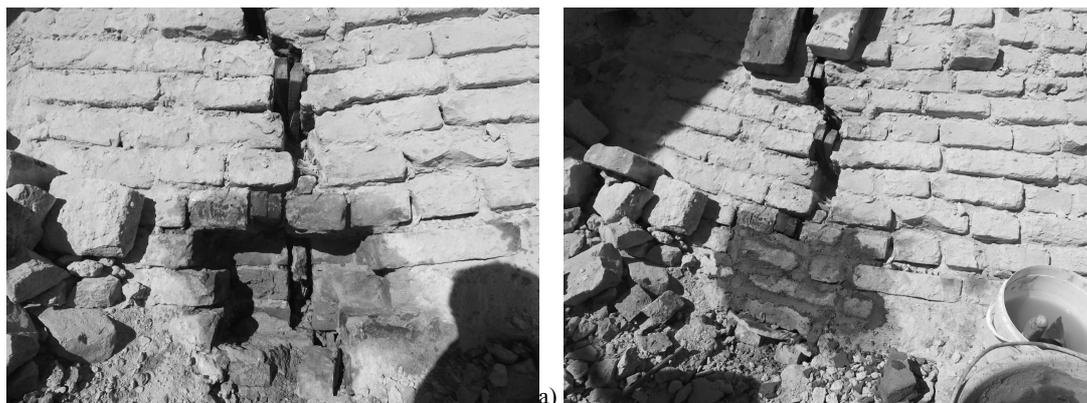
Figure 9: St. Bassiano church apse: cracks repair with “scuci-cuci” technique (literally, a technique of unstitching/stitching the damage masonry); before (a) and during (b) reparation

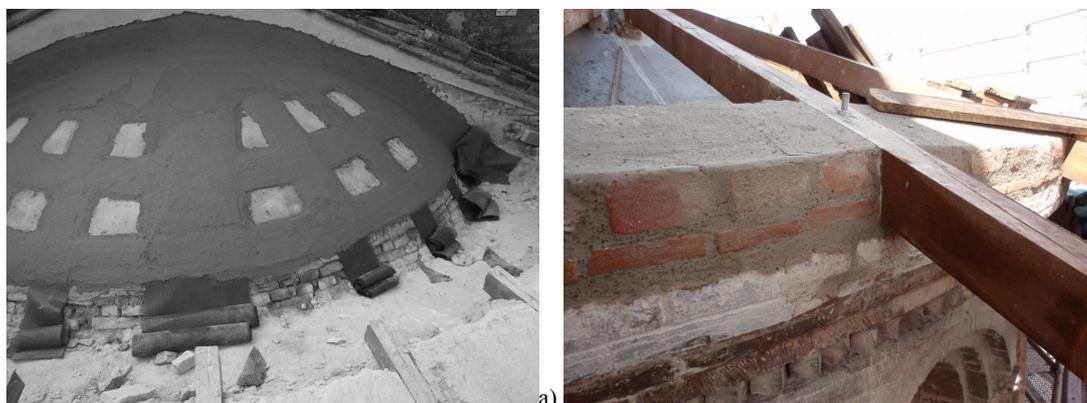
Figure 10: St. Bassiano church apse: a) FRCM matrix application and b) timber beams fixing

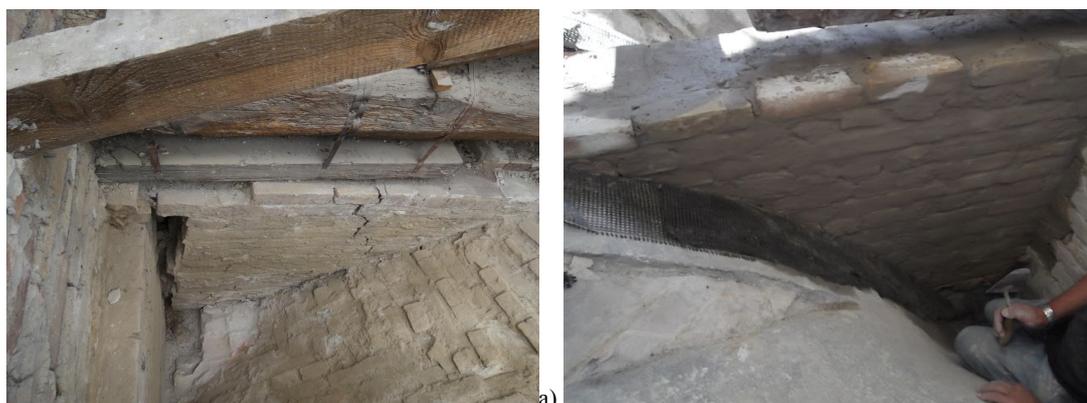
Figure 11: St. Bassiano church nave: a) damaged ribbed wall above a masonry vault and b) repaired ribbed wall and interlocked with the lateral walls

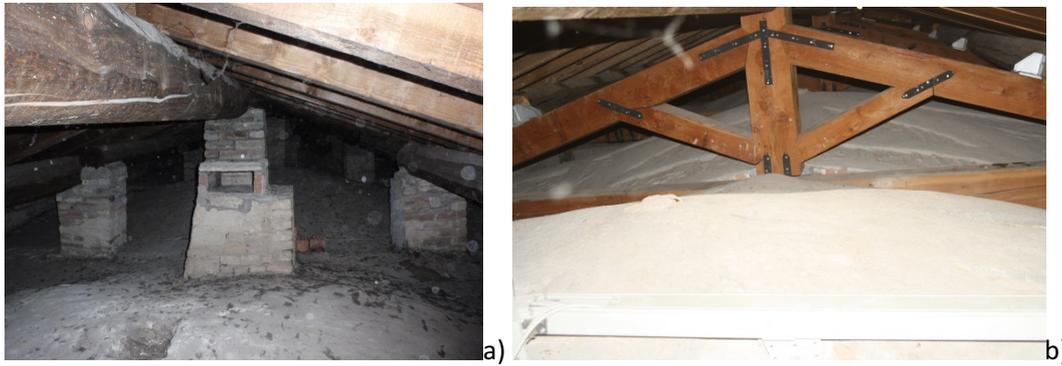
Figure 12: St. Bassiano church nave: a) old wood roof structure loading the masonry vaults and b) new wood roof structure with trusses

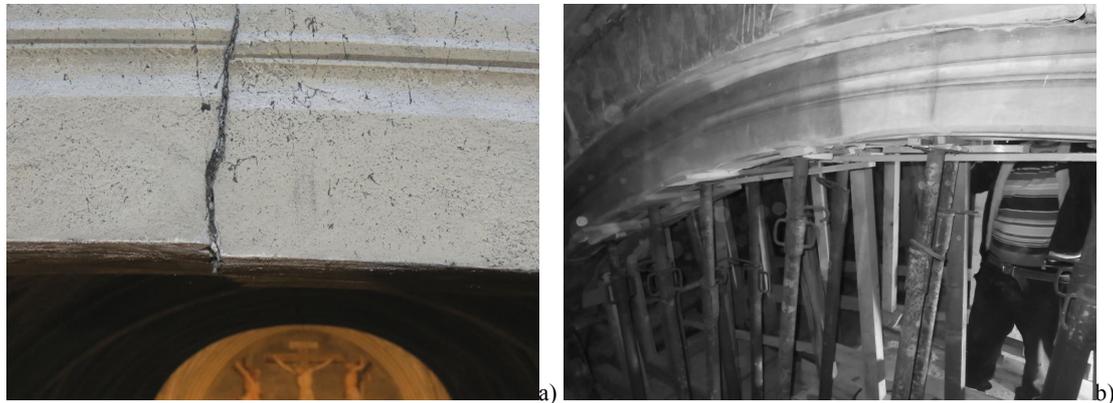
Figure 13: St. Bassiano church main arch between the nave and the apse: a) vertical sliding in the key before intervention and b) displacement in the original position with props

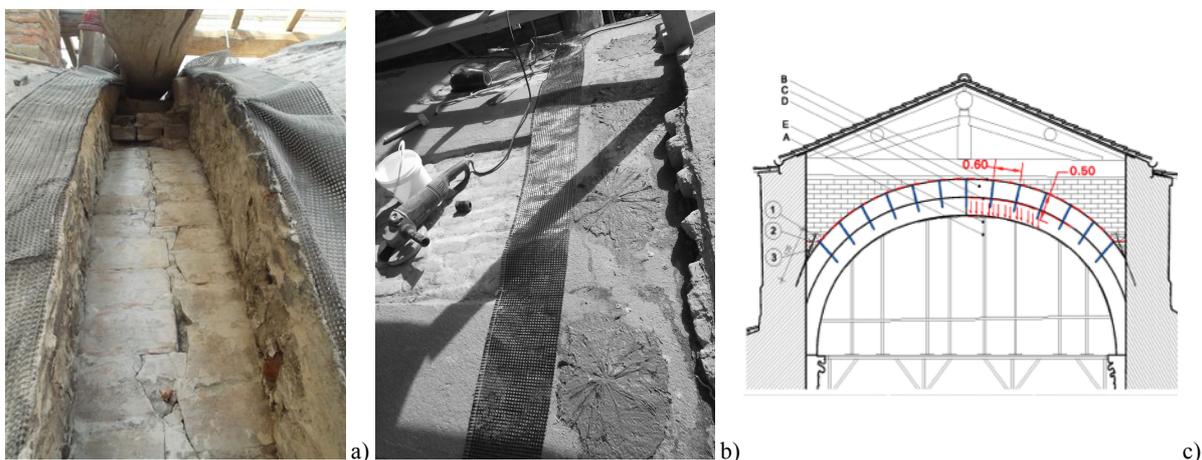
Figure 14: St. Bassiano church main arch between the nave and the apse: a) reinforcement with FRCM; b) and c) connection joints with masonry arch and lateral walls

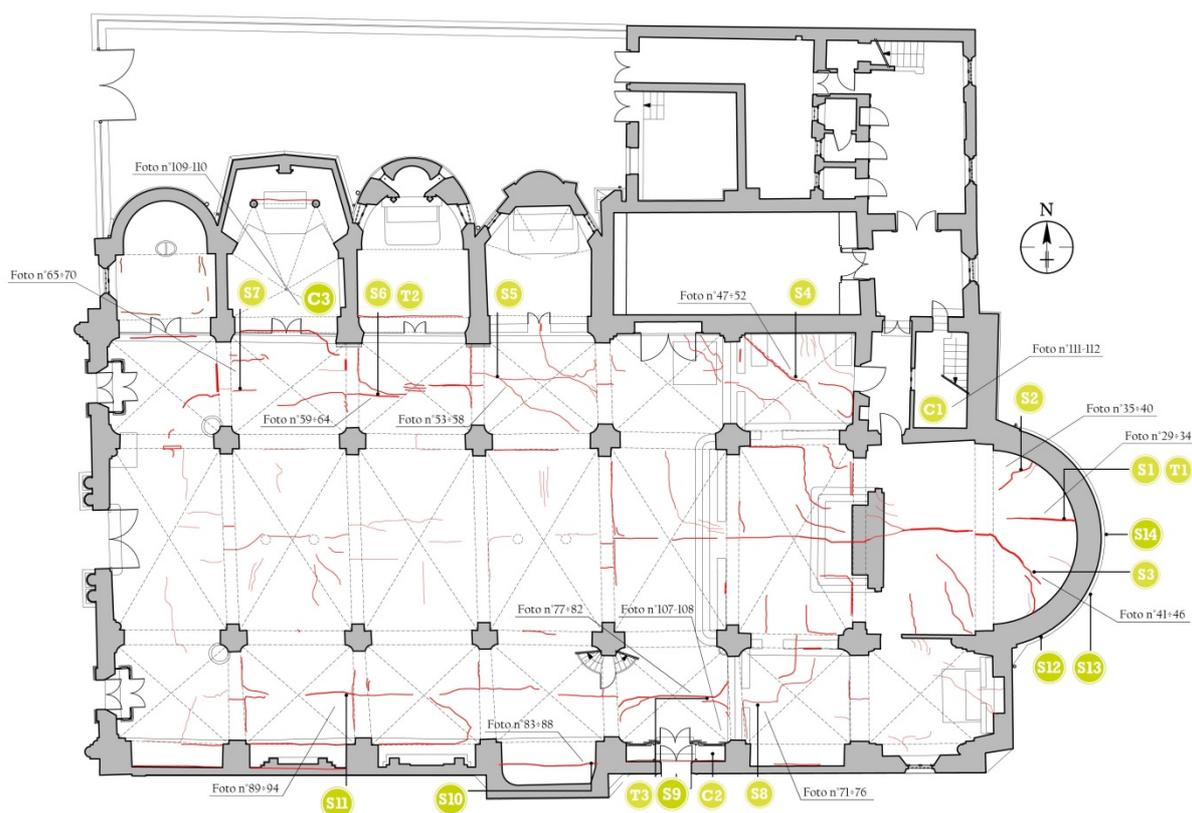
Figure 15: ST. Bassiano church: localization of the sensors on selected cracks of the aisles groin vaults and of the apse.

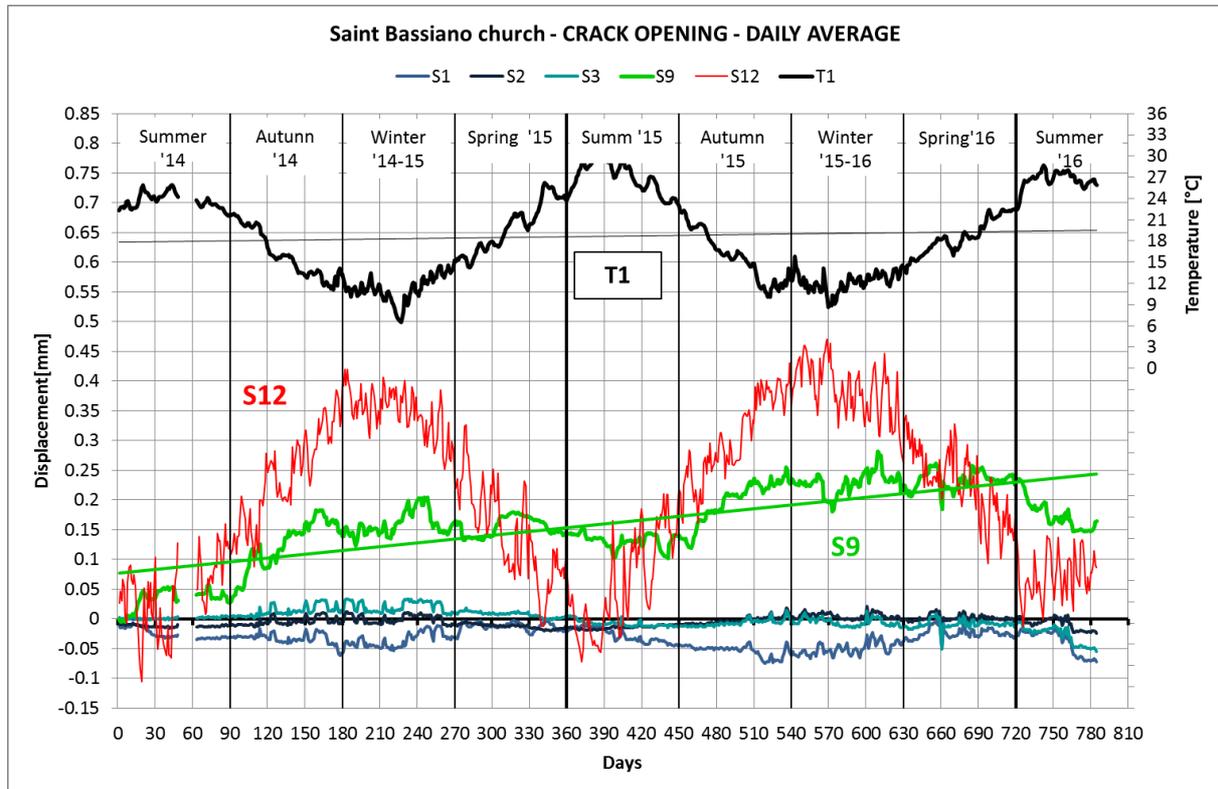
Figure 16: St. Bassiano church: plot of the 2-year crack monitoring, after the strengthening intervention of the nave vaults and roof. After two years, all cracks in the apse (S1, S2, S3 internally) and (S12 externally) are stable, whereas only one crack in the South aisle (S9) shows continuous opening.
