Probabilistic evaluation of concrete durability subject to accelerated decay by salt crystallization

Keywords: concrete durability, crystallization tests, laser profilometer, probabilistic model

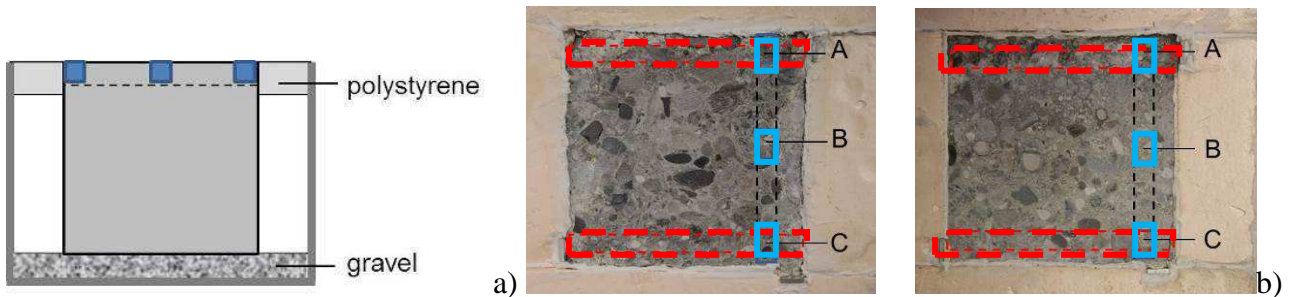
Fig. 1 a) Scheme of the specimen for crystallization test; b) scheme the profile measurements of the specimens 1R8 and 2R7 assumed for probabilistic analysis and of the samples for MIP (red and blue areas).

This type of laser profilometer was used to monitor the damage (Fig. 1b) [15]. The laser profilometer allows quantifying the loss of material on the exposed surface, by comparing the measurements from the start (T_0) to the end of the cycles (T_{24}) with a 0.5mm resolution.

The deterioration process of the specimen 1R8 was analyzed along the two strips in Fig. 1b.

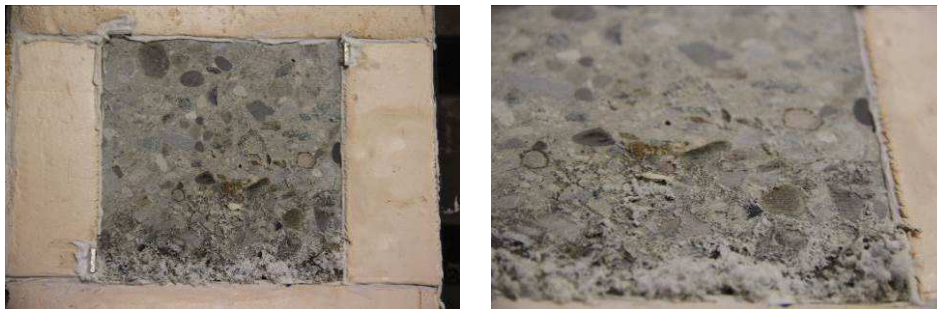
Fig. 2 Distribution of the salt crystallization on the top of the specimens 2R7.

- the salts crystallized only on the edges of the specimen, while in the center of the specimens there was no visible salt crystallization. The salt crystallized around aggregates (Fig. 2) and it caused their detachment.

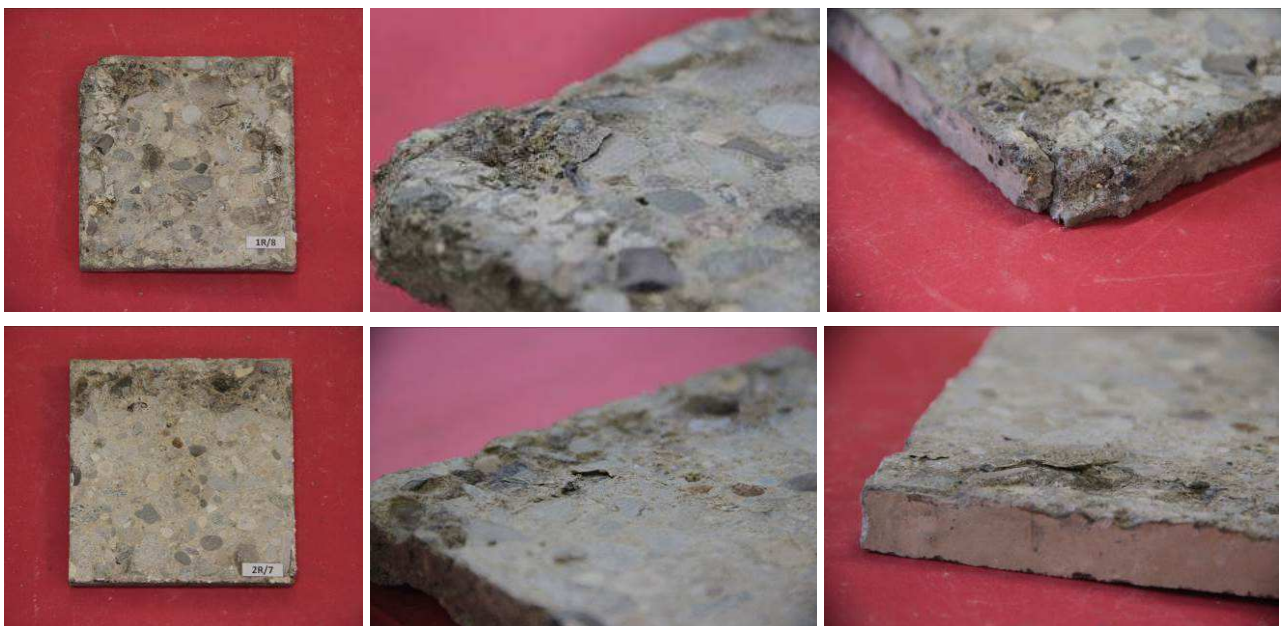
Fig. 3 Surface of the specimens 1R8 e 2R7 after 24 month cycles

- at the end of the crystallization test (T_{24}) the specimen 1R8 is more damaged than specimen 2R7. The decay of the specimen 1R8 develops on all surfaces exposed to the aggressive environmental conditions. The specimen 2R7 is damaged along the edges and in a limited area, from the top of the concrete casting to about 35mm of depth (Fig. 3).

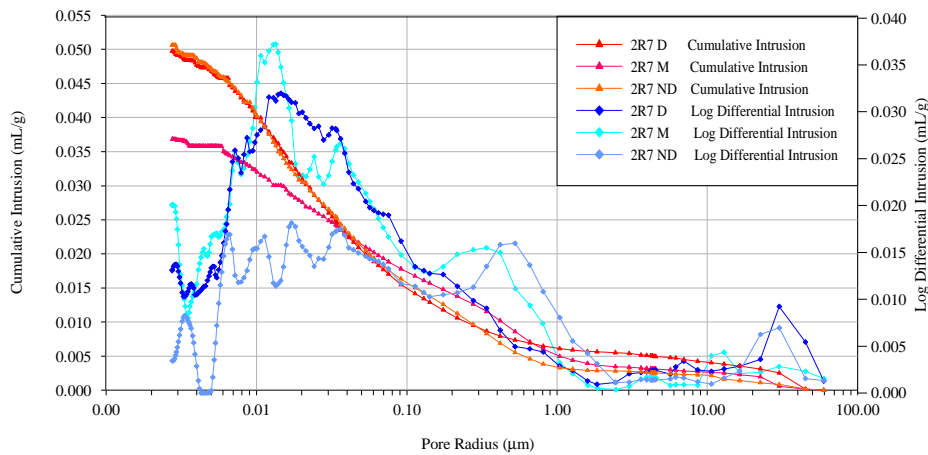
Fig. 4 Cumulative and Log Differential Intrusion (mL/g) pore radius distribution in 1R8 concrete sample taken from the most damage area (D), in the middle area (M) and in the less damage area (ND) after the crystallization test.

chamber to force mercury to intrude into the voids in a porous substrate. As pressure is applied, mercury fills the larger pores first. As pressure increases, the filling proceeds to smaller and smaller pores. A measuring pressure from 1.5 to 33000 psia was applied to the concrete samples, of dimensions 15mmx15mmx20mm. Figure 4 e 5 shows the values of the porosity.

Considering the percentage value of the porosity: the most damaged area (A) of the samples 1R8 and 2R7 has higher porosity (10.07-11.63%) than the middle damaged area (B) of the same samples (7.44-9.07%). Considering the porosity values of the single specimens: the porosity in the middle of the specimens 1R8 is similar to the less damaged area; while the porosity in the middle of the specimens 2R7 is similar to the most damaged area, probably this behavior depends on the aggregate distribution and the crystallized salts that occluded the macro pores.

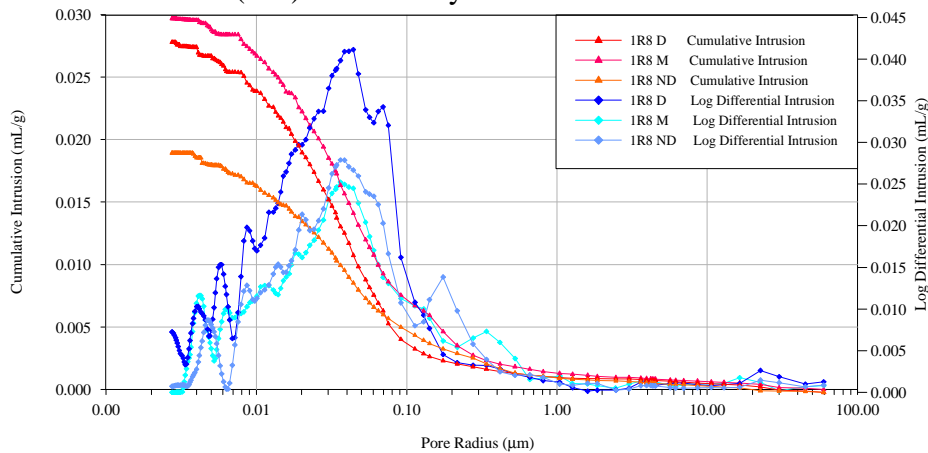
Fig 5 Cumulative and Log Differential Intrusion (mL/g) pore radius distribution in 1R8 concrete sample taken from the most damage area (D), in the middle area (M) and in the less damage area (ND) after the crystallization test.

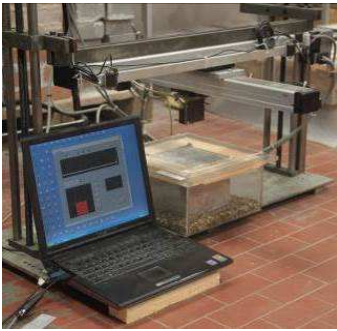
Fig. 6. Laser profilometer.

A laser triangulation CMOS-CCD profilometer (Fig. 6) was used to evaluate the decay of the specimen induced by salt crystallization tests. The profilometer had a biaxial system (X, Y) with linear axis controlled by servomotors, high precision movement (positioning, repeatability and guiding) with a maximum dimensions of the axis of 600mm x 600mm. It is an optoelectronic displacement measurement system with an integrated digital signal processor. This sensor measures position against almost any target without touching the specimen by means of a triangulation arrangement (measure range: 50mm; linearity: $\pm 0.2\%$; resolution static: $5\mu\text{m}$ and dynamic: $25\mu\text{m}$; measuring rate: 1KHz).

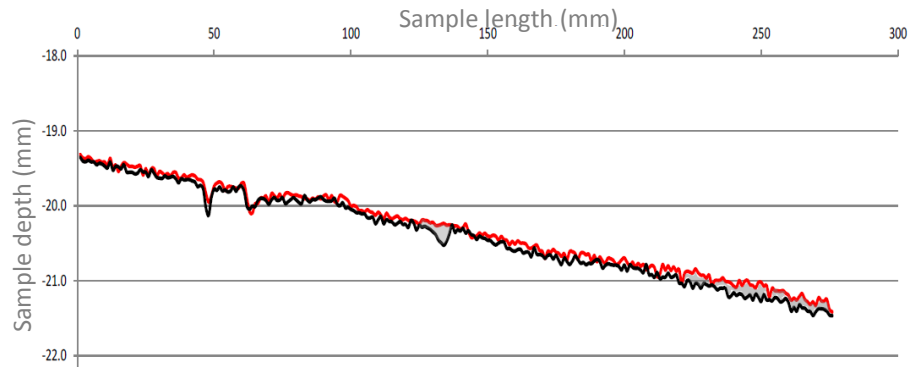
Fig. 7 Example of two contiguous profiles recorded with the profilometer.

Profiles recorded at the end of each salt crystallization cycle showed the changes of the surface over time due to the progress of decay. Therefore the loss of material was measured [16]. Figure 7 shows the loss of the material after 2 months from the beginning of the test.

Since each consequent profile was the measure of the loss of material during the previous cycle (4 weeks), the damage can be assumed as the loss of material itself and quantified as the area included between two contiguous profiles (an example is the grey area in Fig. 7). These results can be used for probabilistic modeling of the progressing damage [17] and for the life cycle assessment of the concrete specimens produced in different period and subjected to salt crystallization. The comparison was made both between damaged and undamaged specimen strips.

where \mathbf{A} is the area included between two consequent profiles (Fig 7, grey area). A simple linear interpolation of the experimental data provided a quite readable trend of the behavior of the loss a_i over time (Fig. 8, linear splines).

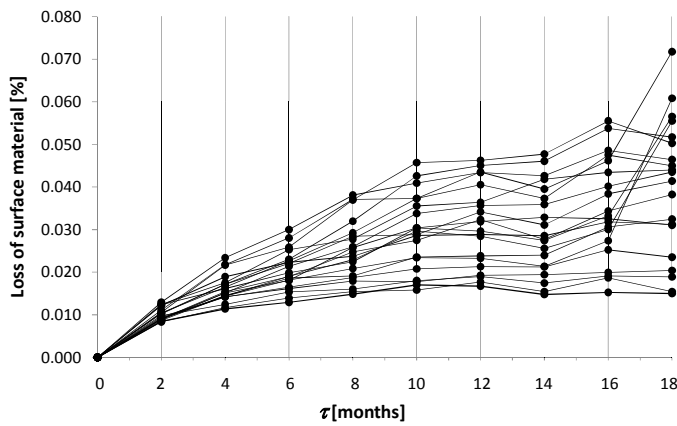
Fig. 8. Loss vs. time: example of behavior.

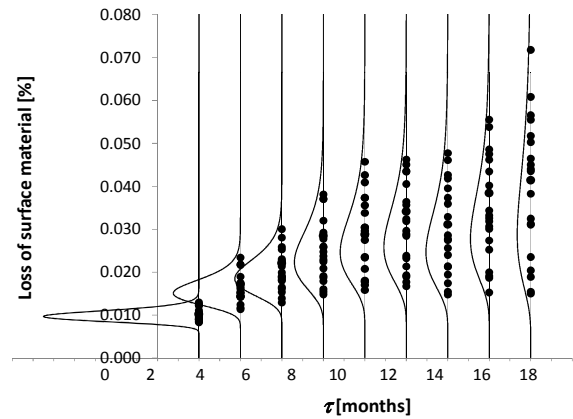
Fig. 9 Example of log-normal distribution of loss of material vs. time

During the laboratory tests, the measurements were made at every cycle (4 weeks), here referred to months τ . As expected, the measurements made at the same time on different profiles showed dispersion around the average value. Therefore, at each instant τ , the deterioration process was assumed as function of the r.v. a only. To model this behavior, the choice of an opportune distribution function was needed. This choice is not simple: it must be based on the knowledge of the modeled physical phenomenon and of the mathematical frame governing the behavior of tails distribution. In [16] this subject was largely explained and the conclusion was that a plausible probability density function (PDF), able to interpret the dispersion in the material loss cycle by cycle, is the Log-Normal distribution (Fig. 9).

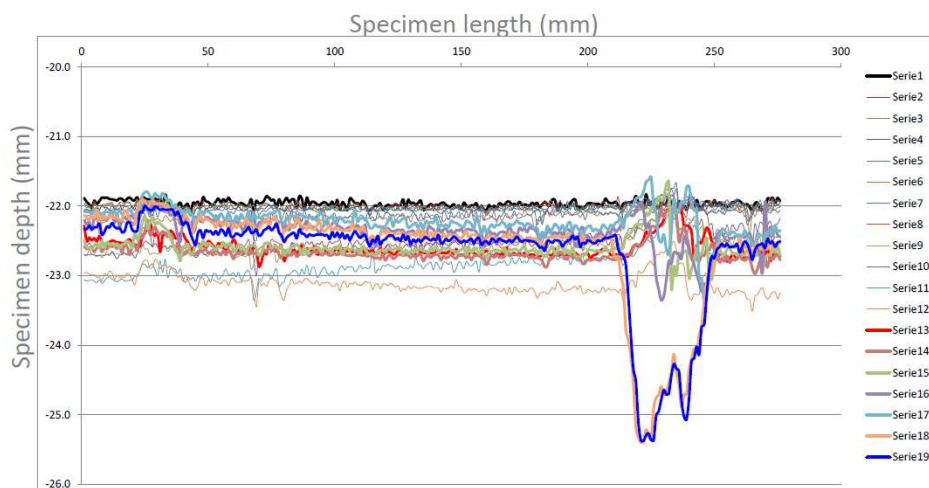
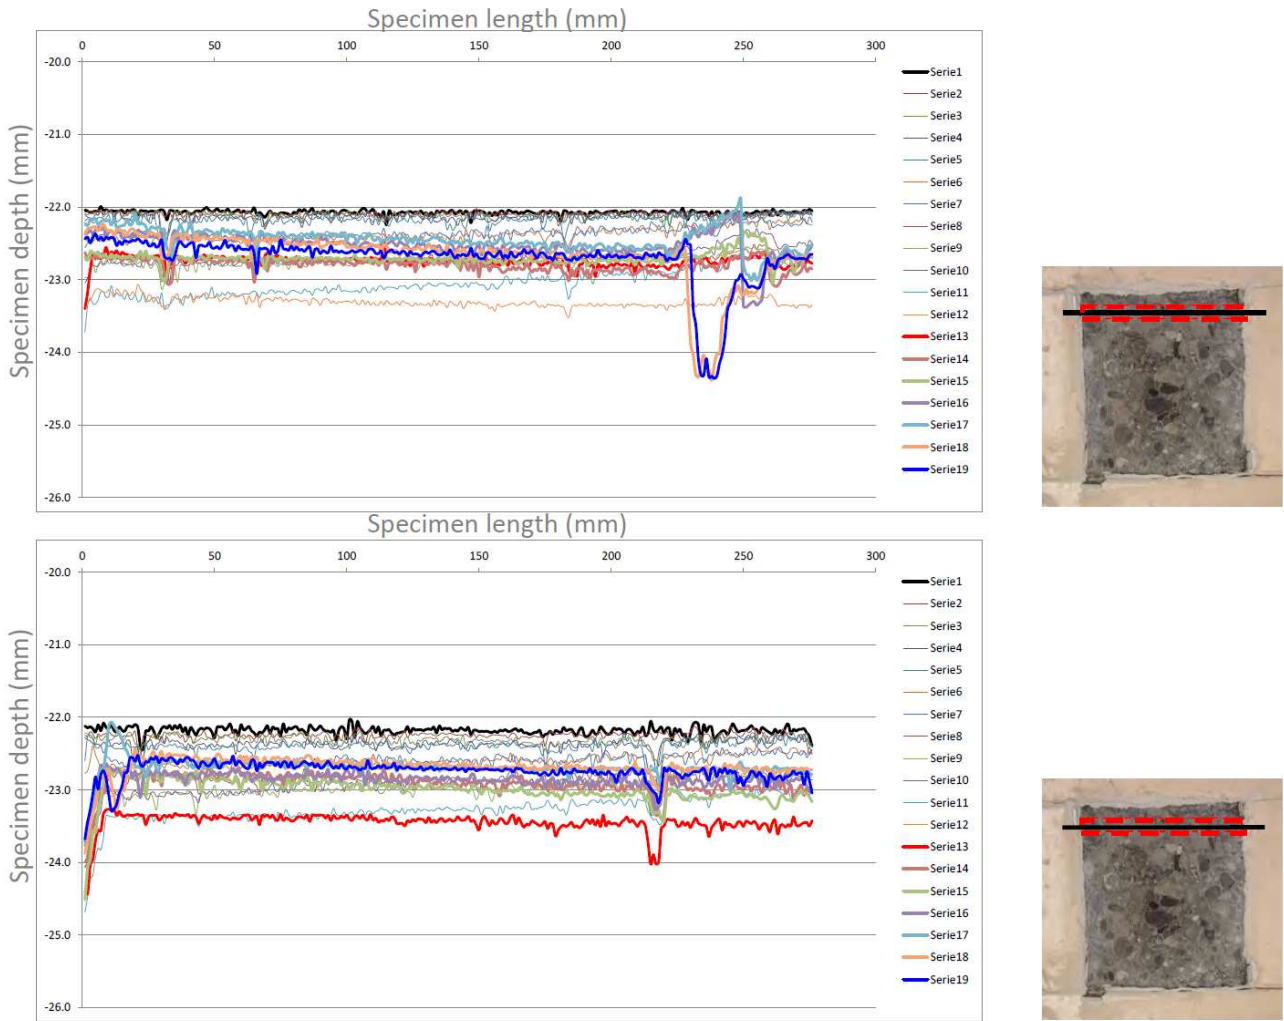
ig. 10 Profilometer reading for profile 30, 49 and 69 of the strip.

Profile measurements show how the lack of homogeneity of the conglomerate affects the damage. Fig. 10 shows the decay along three profiles on the investigate strip. The behavior between 30 and 40 profiles is characterized by an important swelling. It starts from twelfth month and it causes the detachment of some material up to the seventeenth month. Probably the detachment is due to expulsion of one aggregate with the consequent formation of a gap / isolated depression (Fig. 10).

Fig. 18 presents the exceeding probability, described by a single Weibull distribution which seems to be rather unreliable for the specimen 1R8. This is, probably, due to the formation of the depressions, evident in Fig. 10 and in Fig. 12, that distort the loss. Maybe a mixture distribution could lead towards a more reliable prediction, because a mixture could be able to be sensitive to the different behaviors before and after the bigger detachment. The modeling of the exceeding probability for the damaged strip of the specimen 2R7 where the loss is more regular cycle by cycle, is more reliable, even if the initial surface roughness is higher for this specimen than the surface roughness of the specimen 1R8. However a mixture distribution could be even better also to model the decay of this specimen.

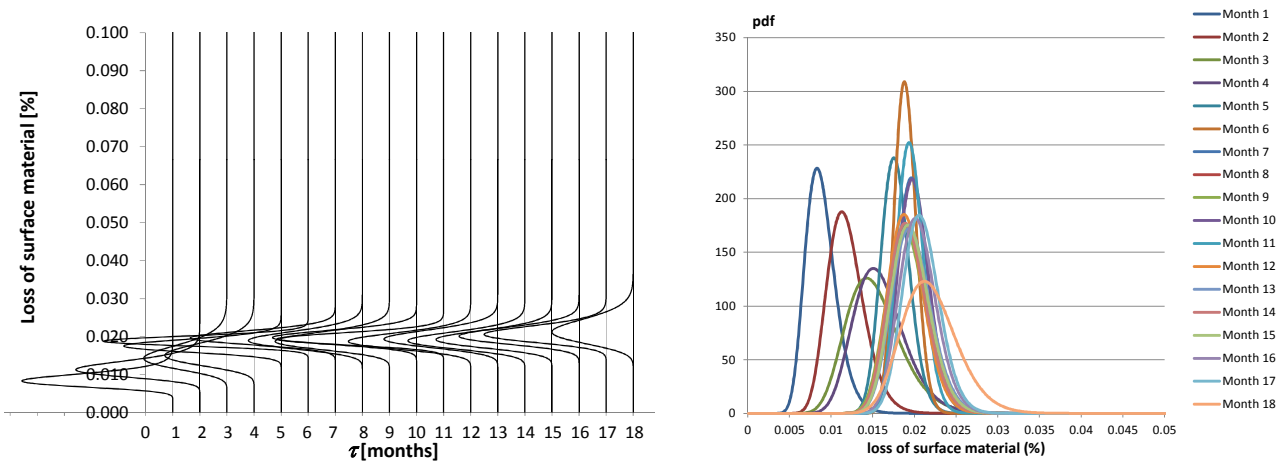
Fig. 11 Log-Normal probabilistic density modeling the damage cycle by cycle in two different way.

In addition the probabilistic model of the decay (Fig. 11) also shows this behavior.

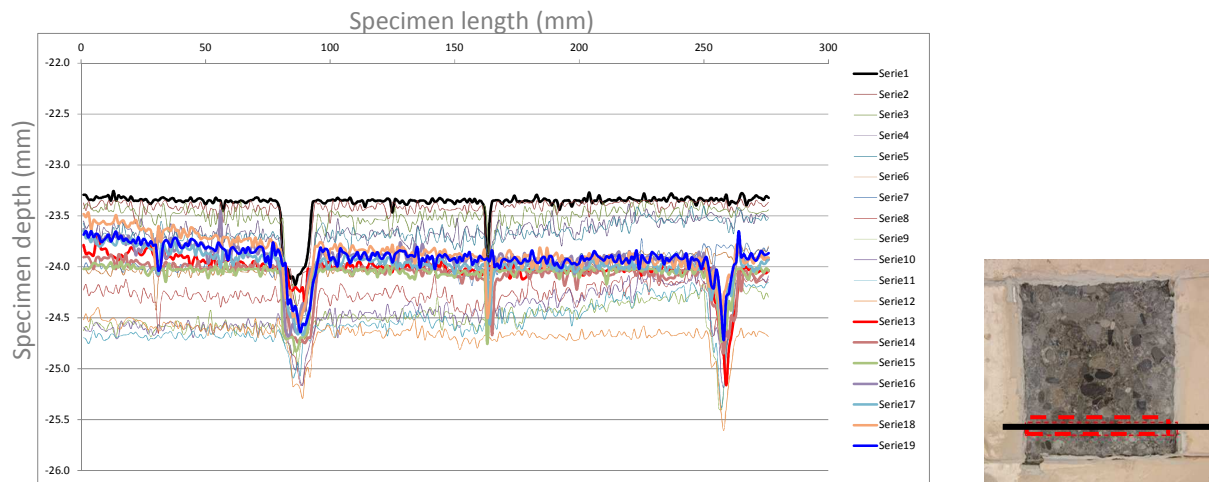
Fig. 12 Profilometer reading for profile, an example of the behavior shown.

The behavior during the cycles for undamaged strips is really different. The decay is widespread and there is a progressive swelling as from the twelfth month, but no detachment occurs until at T_{18} (Fig. 12).

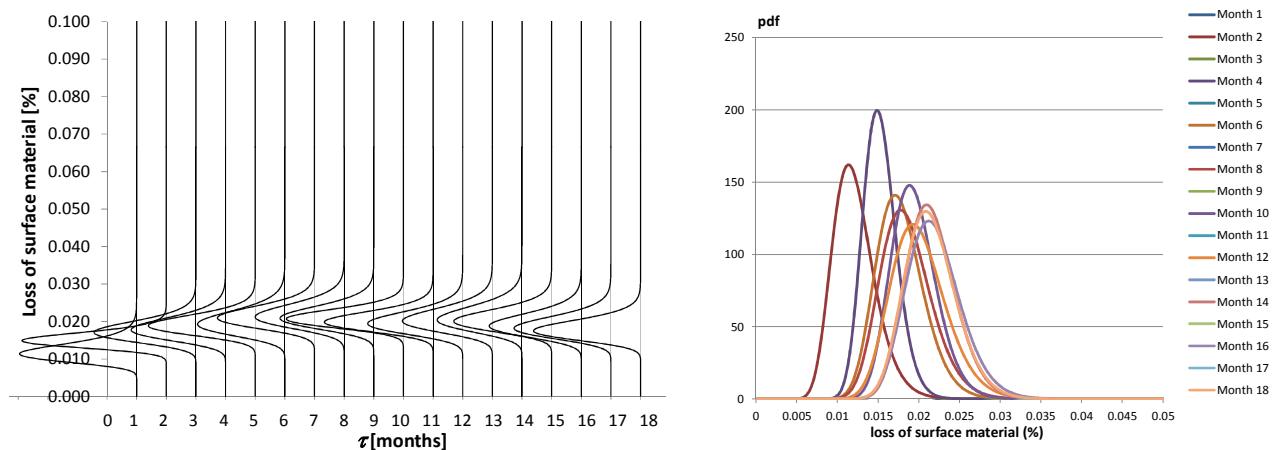
Fig. 13 Log-Normal probabilistic density modeling the damage cycle by cycle in two different way.

From T₇ onwards then there is a loss of material in correspondence of all profiles of the strip, but there is no swelling was visible before. This behavior is shown in Fig 13, which summarizes the probabilistic modeling of these phenomena.

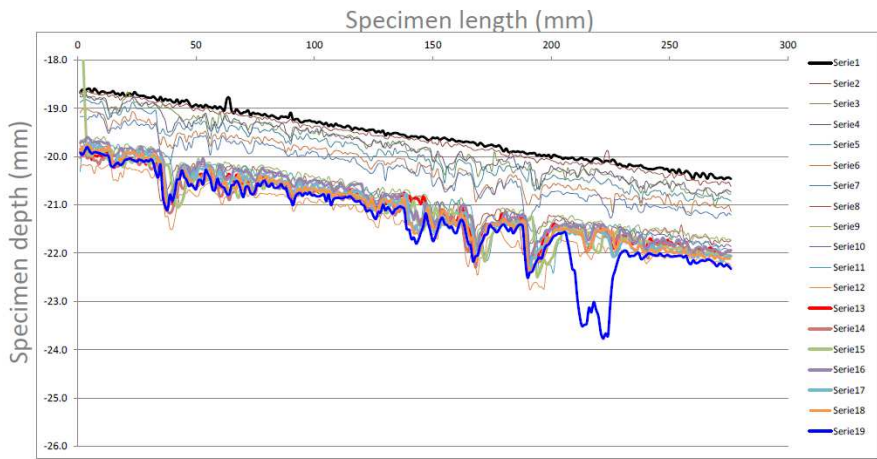
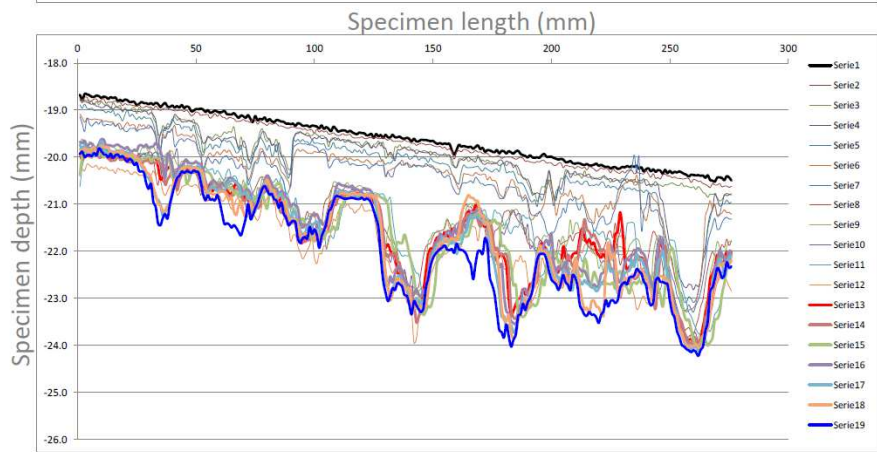
Fig. 14a Profilometer reading for profile number 1 and 15 of the border strip.

From profile number 1 to profile number 15 the surface decay is very discontinuous with detachments which were much larger when compared to the the detachments measured on the 1R8 specimen profiles (Fig. 14a).

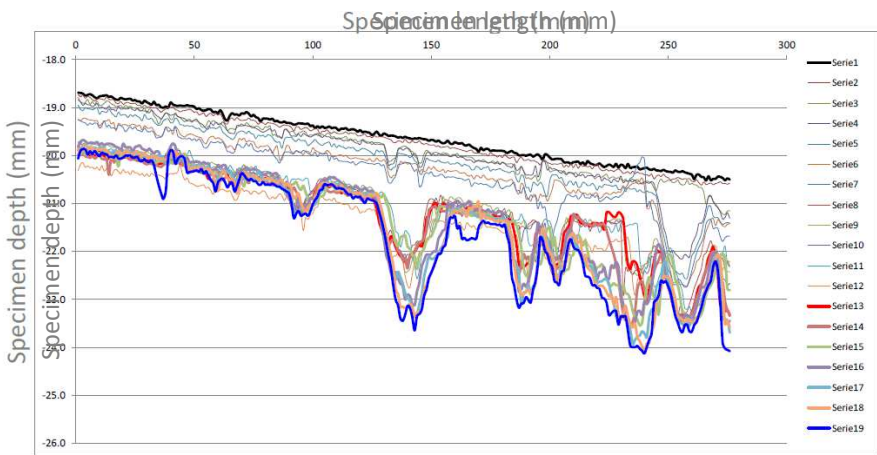
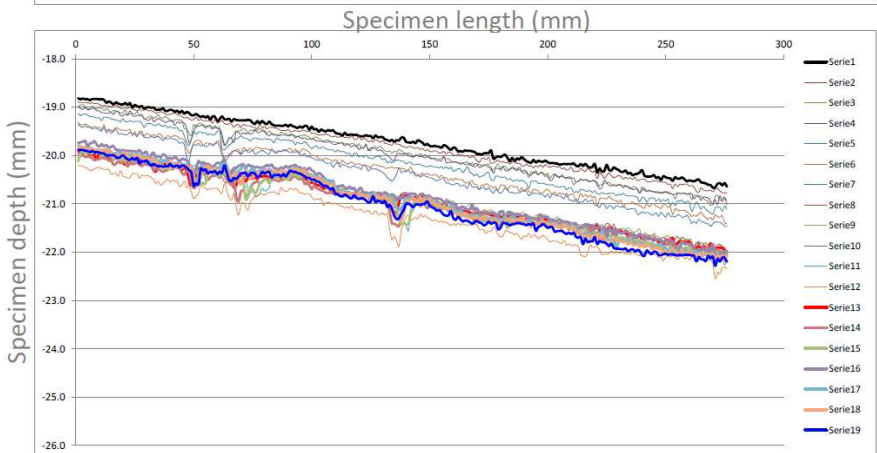
Fig. 14b Profilometer reading for profile number 20 and 40 of the border strip.

From profile number 20 and profile number 32 the decay is gradual. The detachment has developed on the entire surface. The same behavior was verified in the profiles from number 33 to number 40 (Fig. 14b).

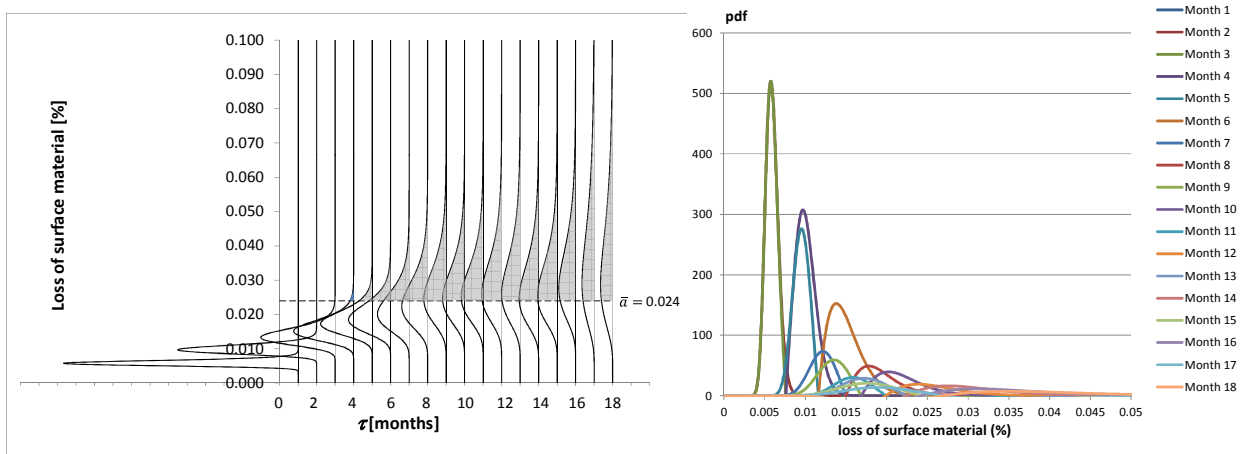
Fig. 15 Log-Normal probabilistic density modeling the damage cycle by cycle in two different way.

The high variation of deterioration along the 40 profiles of the strip is evident by the large dispersion present in distributions modelling the damage, cycle by cycle (Fig. 15).

A fragility curve describes the probability of reaching or exceeding a given damage \bar{a} over time (or for cycles). For a chosen damage level \bar{a} at a given cycle τ^* , the probability to reach \bar{a} can be seen as the area under the threshold \bar{a} and the probability of exceeding it can be seen as the area over the threshold \bar{a} (e.g.: in Fig. 15, shaded area, the exceeding probability for the threshold $\bar{a}=0.024$ is plotted).

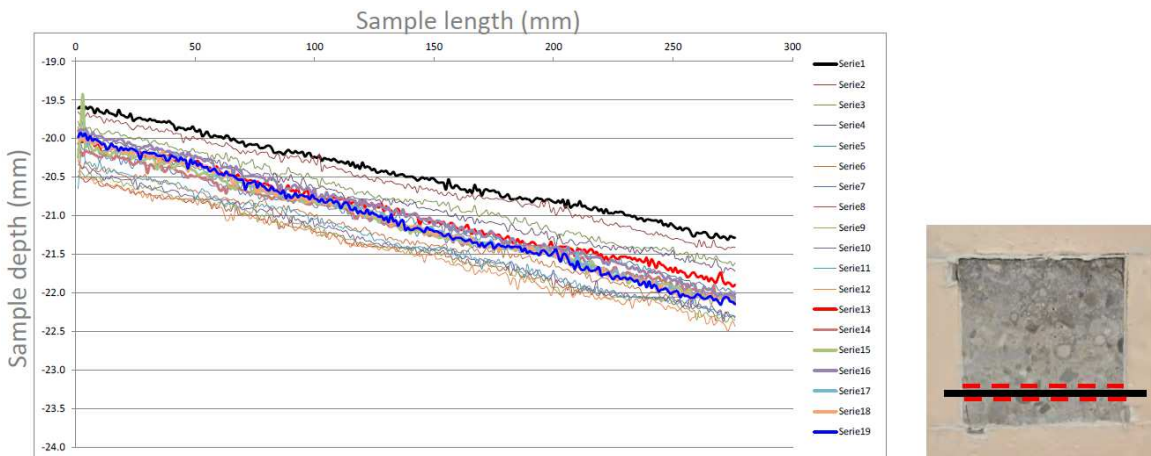
Fig. 16 Profilometer reading on a profile of the undamaged strip.

The decay of the 2R7 specimen is equal and very low for each profile analyzed for the undamaged area (Fig. 16).

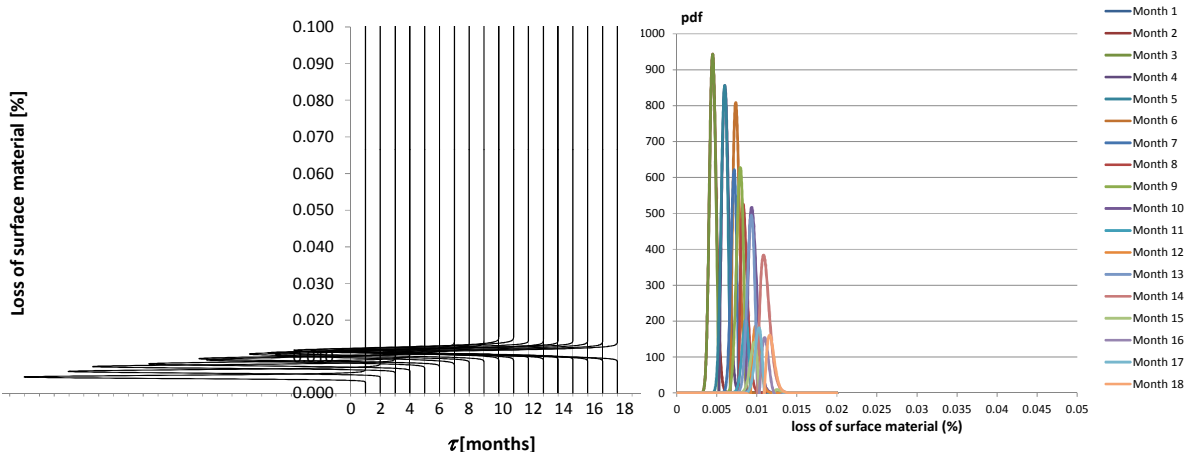
Fig. 17 Log-Normal probabilistic density modeling the damage cycle by cycle in two different way.

This result is confirmed by the probabilistic modelling of the damage. In Fig. 17 the probability distribution shows a very narrow distribution, which represents a low dispersions of the data collected.

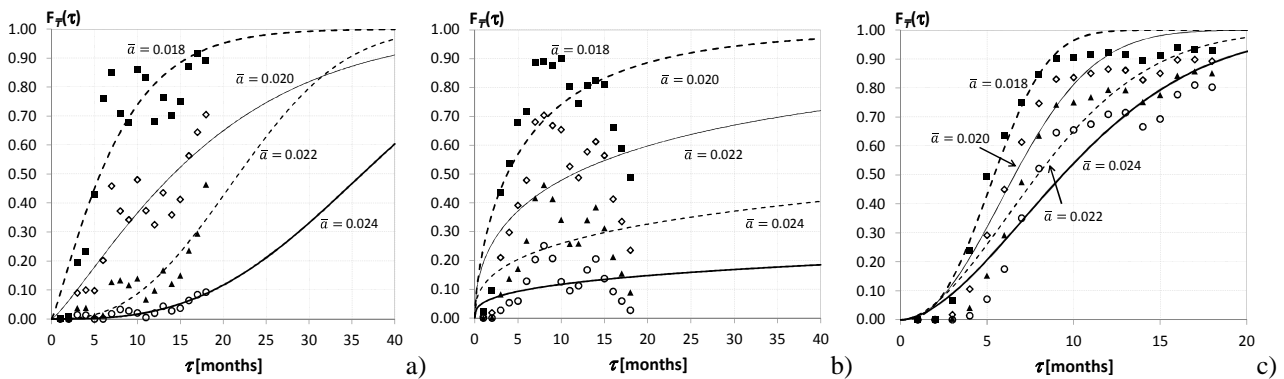
Fig. 18 Fragility curves for: a) 1R8_D b) 1R8_UD; c) 2R7_D. No damage was recorded in 18 months on specimen 2R7_UD for the thresholds chosen.

Fig. 18 shows the fragility curves plotted for the specimens analyzed and for the thresholds $\bar{a}=0.018$; $\bar{a}=0.020$; $\bar{a}=0.022$; $\bar{a}=0.024$.
