Continuous monitoring of a challenging heritage tower in Monza, Italy

Abstract

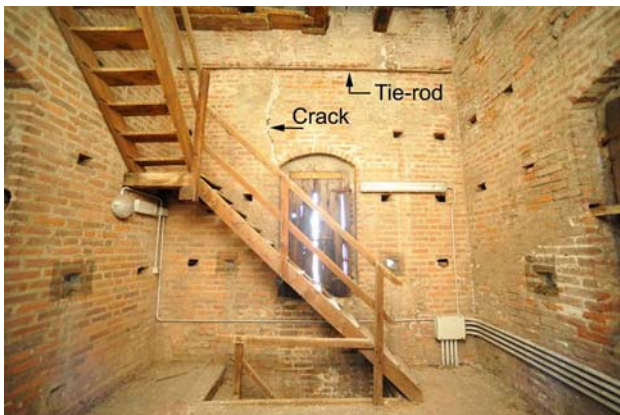
Fig. 4 Metallic tie-rod installed below the belfry (Level 2, West side)

As previously pointed out, one metallic tie-rod (Fig. 4) is placed above a main crack of the West side, which is surveyed by the transducer TL2_SOCH2 (Fig. 6b).

As it is exemplified in Figs. 7a and 8a, all the main cracks tend to close with increased temperature, with the exception of the one denoted as TL2_SOCH2: Fig. 8b shows that the crack opening exhibits significant daily variation, with the displacement envelope closely following the evolution of indoor/outdoor temperature. This unusual trend is conceivably dependent on the structural effect exerted by the metallic tie-rod (Figs. 4, 6b) installed

above the crack and connecting the North and South load-bearing walls: as the temperature increases, the loss of tension in the tie-rod induces the opening of the cracks.

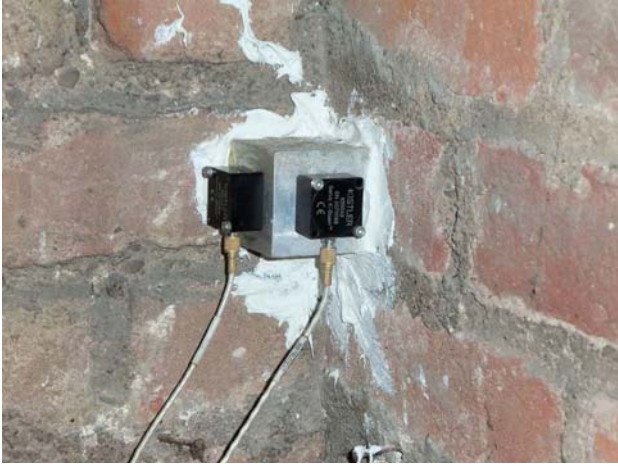
Fig. 11 MEMS accelerometers (Kistler, model 8330A3) adopted in the continuous monitoring

The continuous dynamic monitoring system is now active since 22 October 2015. The devices installed inside the bell-tower consisted of 4 MEMS accelerometers (Fig. 11), one Ethernet carrier with NI 9234 data acquisition module and one local PC for the management of the continuous acquisition and the data storage. Data are recorded at 200 Hz and stored on the local PC in separate files of 60 min.

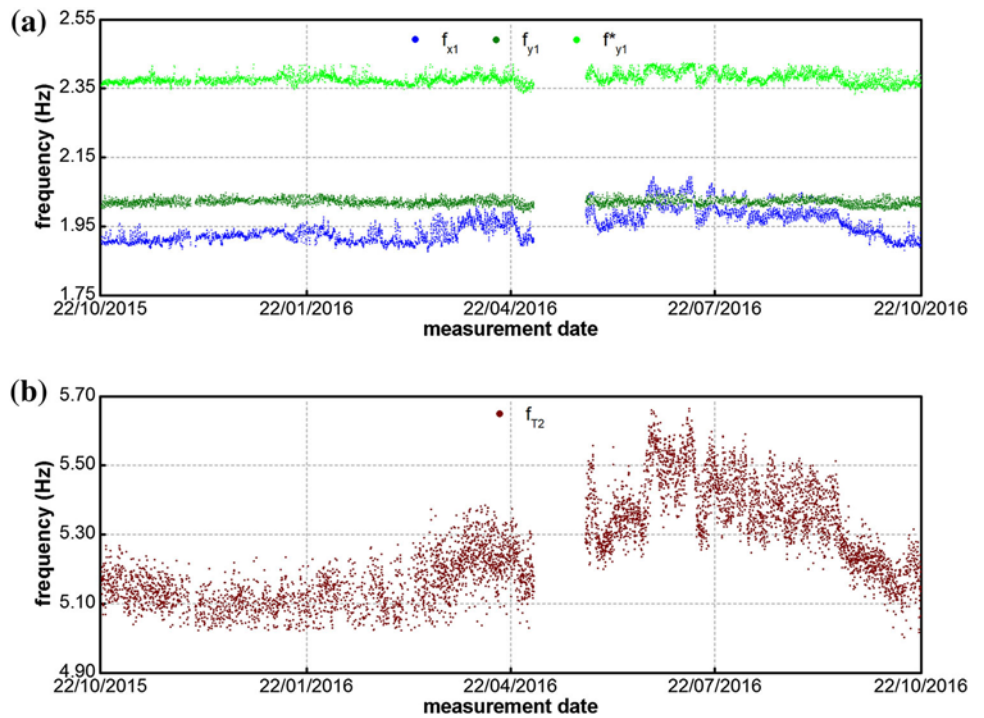
Fig. 12 Automatically identified natural frequencies of the bell-tower versus time: **a** modes f_{x1} , f_{y1} and f_{y1}^* ; **b** mode f_{T2}

Figure 12 presents the evolution of the identified modal frequencies, whereas the relevant statistics are summarized in Table 2 through the mean value (f_{ave}), the standard deviation (σ_f), and the extreme values (f_{min} , f_{max}) of each natural frequency.

1. Notwithstanding the low level of the ambient excitation, four normal modes were identified with high occurrence and accuracy.
2. The identification rate is higher for the lower 3 modes, ranging from 86.0% for mode f_{y1} to 99.3% for mode f_{y1}^* , and decreases to 77.6% for torsion mode f_{T2} .

3. The natural frequency of modes f_{x1} and f_{T2} (Fig. 12) exhibits significant increase in Spring and Summer period. This trend suggests that these modal frequencies are strongly affected by the temperature and—as it had to be expected from previous studies [8–14] on masonry towers—increase with increased temperature.

4. On the contrary, the natural frequency of modes f_{y1} and f_{y1}^* exhibits very limited variation, with the standard deviation being equal to 0.009 and 0.015 Hz, respectively. For those modes, the trend of modal frequency to increase with increased temperature is conceivably balanced by the loss of tension in the metallic tie-rod placed on the West side and connecting the North and South load-bearing walls of the bell-tower (Figs. 4, 6b). The loss of tension in the tie-rod, in turn, is also confirmed by the time evolution of the observed

- As shown in Fig. 12, the natural frequencies of the two lower modes f_{x1} and f_{y1} exhibit crossing in Summer months. To the authors' knowledge, such a crossing phenomenon has not been observed before on masonry towers and clearly depends on the different effect exerted by the temperature on the natural frequency of the two lower modes. In addition, the mode shape of both modes f_{x1} and f_{y1} tends to hybridize when crossing occurs: in other words, the two modes—which are usually associated with pure bending in orthogonal planes, as illustrated in Figs. 10a, b—tend to involve biaxial bending in both the main E–W and N–S directions when the natural frequencies become very close to each other. It is further noticed that this hybridization, suggesting the occurrence of something similar to mode veering (see e.g. [26, 27]), is more significantly detected for mode f_{y1} .

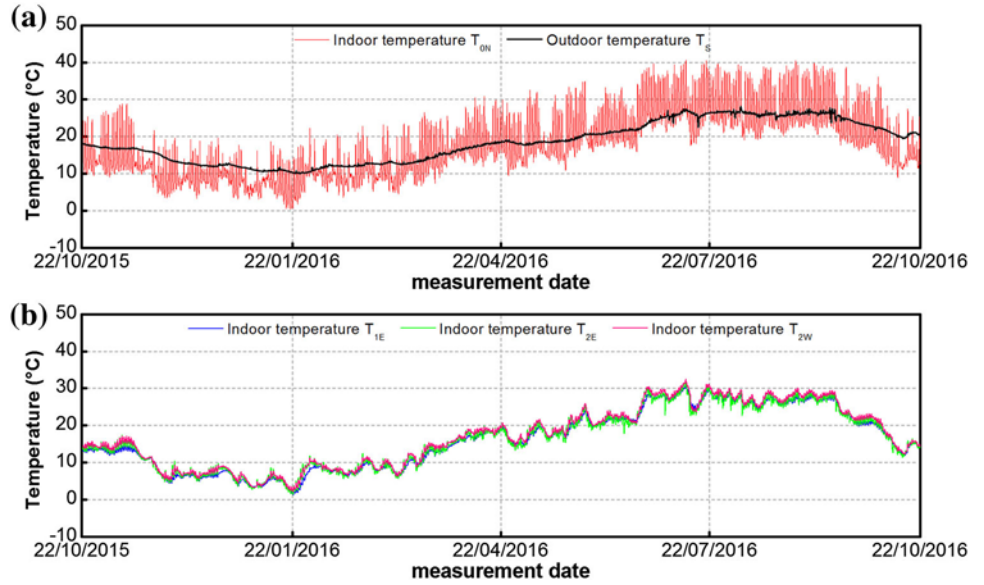
Fig. 13 Variation in time of measured temperatures: **a** T_{0N} and T_S ; **b** T_{1E} , T_{2E} and T_{2W}

In order to better investigate the effects of changing temperature on the natural frequencies, Fig. 13 shows the hourly averaged value of the measured temperatures in the monitoring period from 22 October 2015 to 21 October 2016. Table 3 summarizes the correlation coefficients [18] between the environmental data during the same period.

Both Fig. 13 and Table 3 indicate that a large degree of correlation exists between all temperature data, with the measurements T_{1E} , T_{2E} and T_{2W} being almost perfectly correlated and characterized by correlation coefficients very close to unity. Hence, using only one of those
