# When and how reducing moisture content for the conservation of historic building. A problem solving view or monitoring approach?

Elisabetta Rosina

Politecnico di Milano, ABC Department, Piazza Lenardo da Vinci 32, Milano, Italy

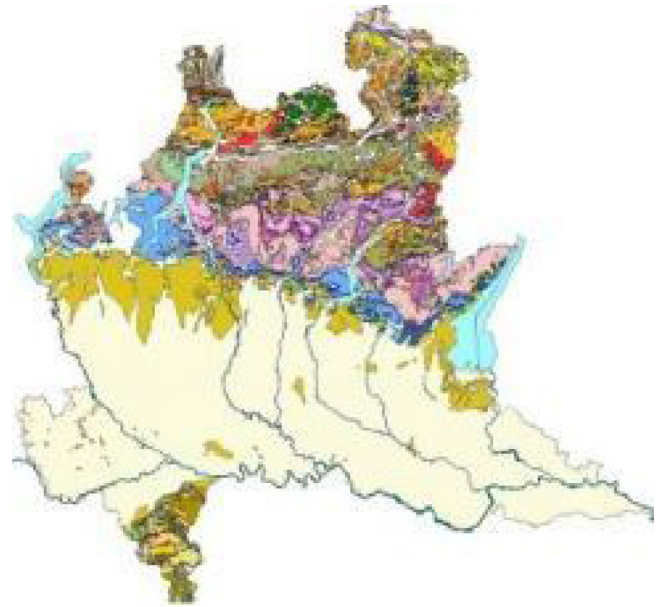
Fig. 1. Geological map of Lombardy: the different colors refer to different formations. The green color shows the debris component of soil, the white indicates the presence of clay.

In some cases, the draining nature of the soil prevents any swelling due to the foreseen variation of the water content and could prevent the damage of structures. The nature of soil can be different in close regions, as it happens in the Po Valley. In the southern part of Lombardy, the clay component is higher than in the northern part with a variability of the distribution that is influenced by the presence of past/preset riverbeds, the use of the soil (agriculture, animal stock, industry, urban life, etc.) and the stratification of the debris for natural geological cycles of rocks (Fig. 1).

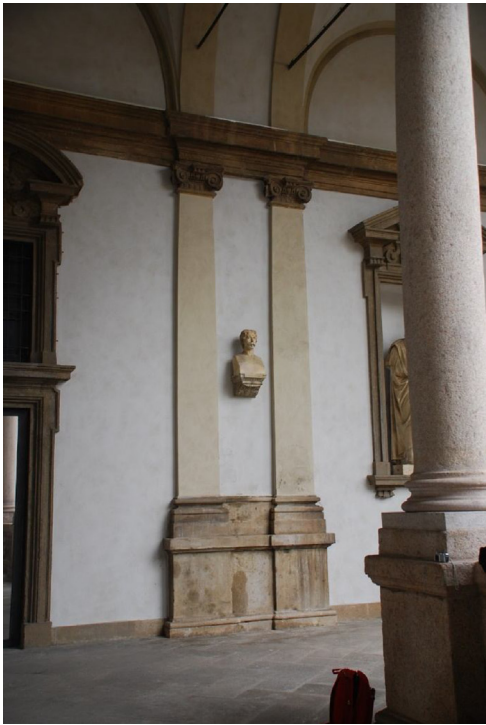
**Figs. 3 and 4.** Brera Palace, Milan, western side of the loggia, second level, mosaic of thermograms, exterior wall of room 24, June 8th, 2011; Emissivity 0.92, air  $T=22^{\circ}\text{C}$ ; RH% = 70%.

sufficient to contain and drain the hydrometeors. An example is Brera Palace, Milan (Fig. 3), and the consequences of the exceptional rainfall occurred in the beginning of June 2011. The exceptional storms with wind speed of 40 km/h and more, caused very heavy rains. The partial obstruction of one of the downspout due to leaves and timbers transported by wind in the eaves gutter (Fig. 5), the partial refurbishment of the system due to the new plant of climatization and the fast accumulation of a large amount of water inside the downspout caused its breakage and of the masonry around (see the mosaic of thermograms in Fig. 4; the recapture after few hours shows the large extension of the water infiltration from the vault along the downspout in the masonry, although the surface does not appear damaged yet, apart from the detachment of the decorative pillar that permitted to the accumulated water to flow out of the dead space between the downspout and the masonry).

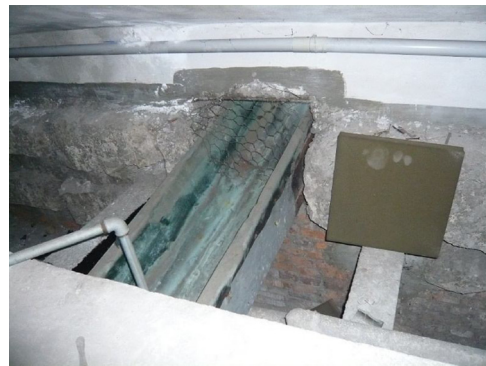
**Fig. 5.** Brera Palace, Milan. The connection of the water duct from the eave gutter to the downspouts. A metal grid protects the obstruction of big objects.
