Influence of aging in the temperature range 250-350°C on the tribological performance of a WC-CoCr coating produced by HVOF

L. Rovatti¹, N.Lecis¹, D. Dellasega², V. Russo², E. Gariboldi¹

¹Politecnico di Milano, Dipartimento di Meccanica, Milan, Italy

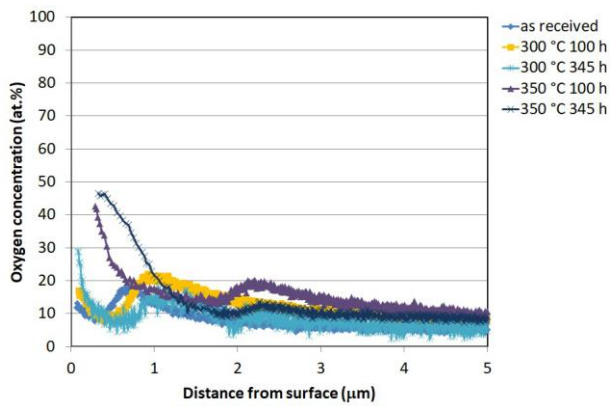
Fig: 4a

Figure 4. GDOES profiles of the oxygen and carbon concentration at increasing distance from the external coating surface after different aging treatments (a,b).

Considering a slight influence of the heat treatments on microhardness, only aging conditions for temperatures higher than 250°C were more deeply analysed, expecting a more significant oxidation effect in this case. The GDOES profiles related to the oxygen and to the carbon concentrations are represented respectively in figure 4a and 4b.

A rise in the oxygen content in the first microns was detected in the long-term treated coatings. Correspondingly, a carbon depletion was measured at the top surface of the same samples. The results confirm that an oxidized layer was grown on the HVOF coatings during the long aging treatments. Oxidation degree is related both to aging temperature and time. But it is possible to see that temperatures higher than 350°C induce a faster oxidation and carbon depletion dynamics respect to 300°C.

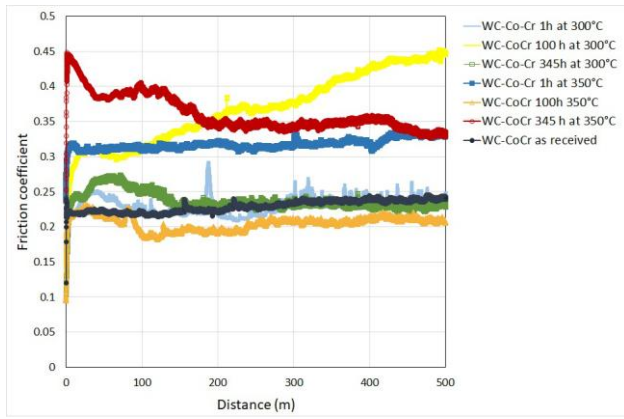
Fig: 8a

Figure 8. COF behaviour in function of the sliding distance during the pin-on-disk test for the analysed WC-Co-Cr coatings (a) and summary of the wear rate after the pin-on-disk sliding test (b).

The aging effect on the friction coefficient in function of distance is represented in Fig. 8a. It is possible to observe that the COF has not a clear increasing trend with the aging time and temperature. In particular, an irregular behaviour can be underlined for the short-term aging treatments at the two analysed temperatures. This aspect will be discussed later on considering the Raman analysis on the worn tracks. However, a significant increase of the friction coefficient was measured for the conditions exposed to the longest times. In fact, if the COF value in the steady state condition is 0.23 for the as received WC-CoCr material, it reaches immediately values above 0.4 for the coating aged 345 h at 350°C.
