## **A feasibility analysis on the application of eddy current testing to the detection of the most detrimental defects in historical metallic tie-rods**

M. Bellanova, M. Carboni, R. Felicetti

**A FEASIBILITY ANALYSIS ON THE APPLICATION OF EDDY  
CURRENT TESTING TO THE DETECTION OF THE MOST DETRIMENTAL  
DEFECTS IN HISTORICAL METALLIC TIE-RODS<sup>1</sup>**

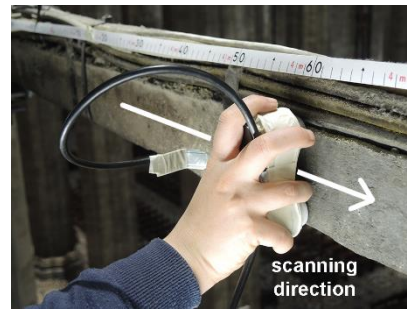
Figure 2: The horseshoe eddy current probe (a) prototype; (b) application on site

For the sake of brevity, the final configuration of the probe prototype, whose rationale is described and discussed in the remaining part of this Section, is first anticipated. Particularly, all the mentioned requirements were fulfilled by adopting a horseshoe scheme consisting of two copper coils wound on a ferromagnetic and electrically conductive U-shaped metallic core. The most effective number of coils turns was found to be equal to 2000 (1000 for each pole of the probe). The ferromagnetic and electrically conductive metal of the U-shaped core is characterized by a relative magnetic permeability and an electrical conductivity equal to 1000 and  $1.45 \cdot 10^6$  S/m, respectively. The optimized operational frequency was determined numerically and resulted to be equal to 500 Hz. Figure 2a show the final version of the prototype. The poles are provided with screwed interchangeable polyethylene caps as a protection against wear.

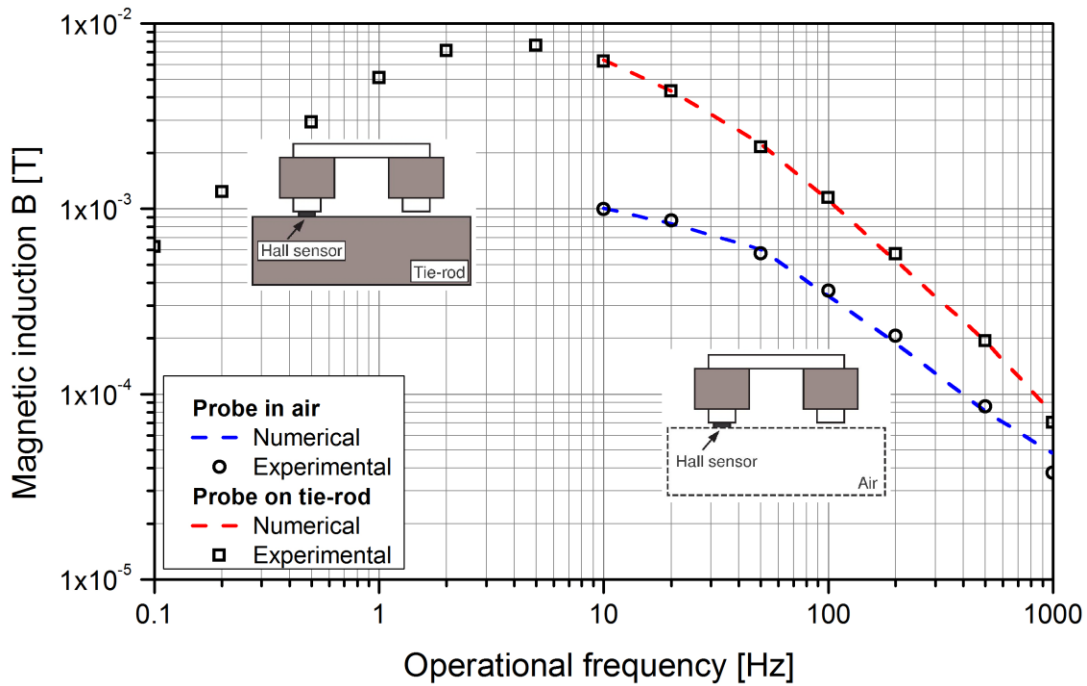
Figure 3: Validation of the numerical model by experimental acquisitions of magnetic induction on T01 tie-rod.

The described prototype of the probe and its application to heterogeneous ferromagnetic tie-rods define a complex electro-magnetic system that has no simple analytical solutions, at least to the authors' knowledge. For this reason, the design study was carried out by means of 3D ET numerical models implemented in the CIVA<sup>nde</sup> dedicated software package v. 2017 [16]. In particular, the final prototype of the probe was modelled implementing its geometry and operational parameters, while the tie-rod was modelled as a smooth prism (without defects) characterized by the electromagnetic properties derived experimentally (see Section 2). The experimental validation of the numerical model was carried out by acquiring the trend of magnetic induction as a function of the operational frequency. To this aim, a Hall sensor (Honeywell SS94A1F), having a sensitivity equal to 25 mV/Gauss, was positioned in the center of one pole. The probe was kept either in air (frequency range 10-1000 Hz) or coupled to a chunk of T01 tie-rod (frequency range 0.1-1000 Hz). The same two configurations were then simulated by the numerical model (frequency range between 10 Hz and 1000 Hz) and the results compared to the experimental evidences. In Figure 3, the obtained experimental results are compared with the numerical ones showing the good fit of the model.

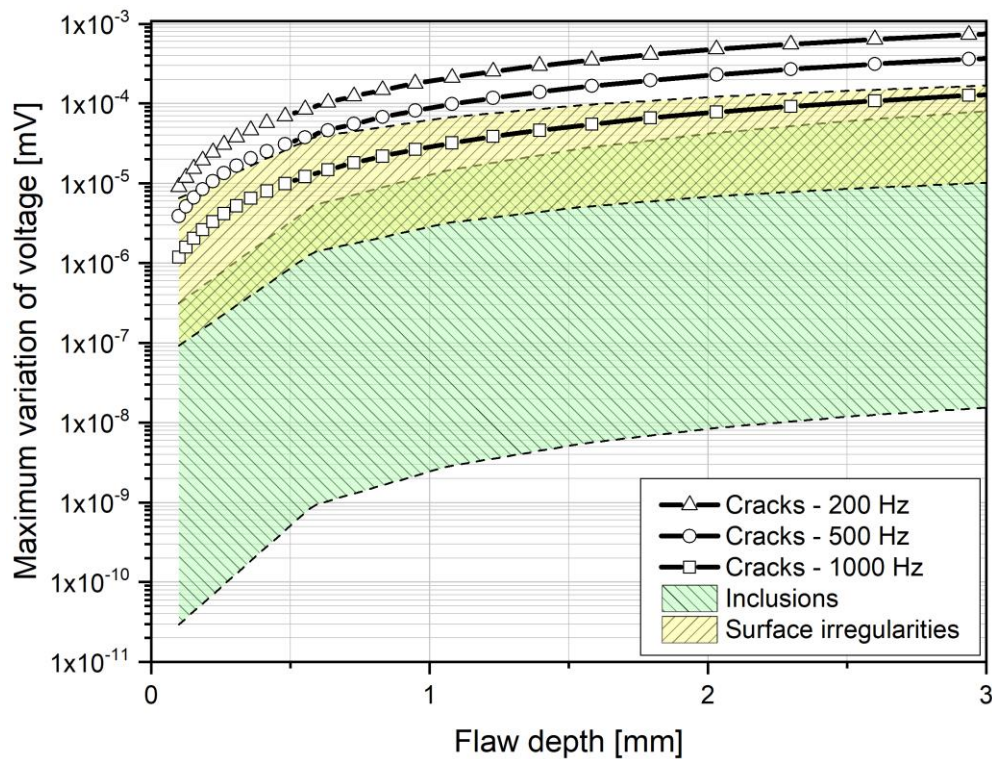
Figure 5: Numerical sensitivity analysis, about the operative frequency, based on flaws of different nature, shape and dimensions.

shape and dimensions. In particular, three frequency values (200 Hz, 500 Hz and 1000 Hz) and the following flaws were considered (Figure 5).

Figure 5 shows the results of the full factorial plan in terms of the maximum variation of voltage, through the two coils, versus the depth of the considered flaws. As expected, increasing the depth of the flaws, the signal responses tend to saturation, likely due to the limits of penetration of eddy currents. On the other hand, a comparative discussion on sensitivity is more interesting. The reported shaded areas represent the regions of the plane covered by all the ET responses of inclusions and surface irregularities: such areas partially overlap, but a tendency to a higher detectability (i.e. higher values of the variation of voltage) is observed for the case of surface irregularities. Nevertheless, inclusions and surface irregularities are disturbing elements for the present application, where the most detrimental flaws, i.e. crack-like straight scarf forged welds, are the main inspection target. Superposing

the responses due to cracks to the shaded areas, it is possible to highlight an operational frequency equal to 1000 Hz falls inside the region of surface irregularities, so setting some uncertainty on a clear detectability of the cracks themselves. On the contrary, an operational frequency equal to 200 Hz seems to outdo the job. An optimized value of the operational frequency is, then, equal to 500 Hz, whose trend is located just above the upper bound of the shaded areas. This frequency value was finally chosen to operate the probe prototype.

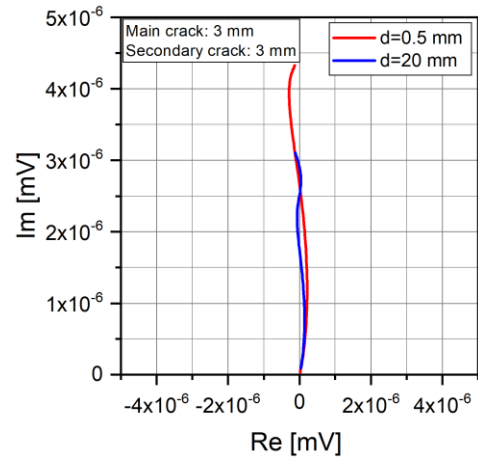
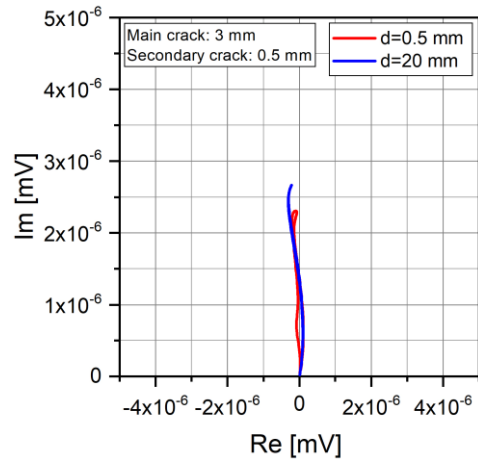
Figure 6: Results of spatial resolution for two exemplificative cases: a) a main 3 mm deep crack versus a secondary 3 mm deep crack; b) polar plot of case (a); c) a main 3 mm deep crack versus a secondary 0.5 mm deep crack; d) polar plot of case (c).

Figure 6 summarizes the results, for two exemplificative cases, in terms of polar plots of the maximum variation of voltage through the coils: a main 3 mm deep crack versus a secondary 3 mm deep crack (Figure 6a) and a main 3 mm deep crack versus a secondary 0.5 mm deep crack (Figure 6c). Unfortunately, it was quite difficult to get significant information on spatial resolution from these polar plots because both the phases and the magnitudes are very similar for all cases. More insight, instead, could be achieved analyzing separately the real and imaginary parts of the polar plots in terms of the instantaneous position of the probe during the simulated inspection (Figure 7).

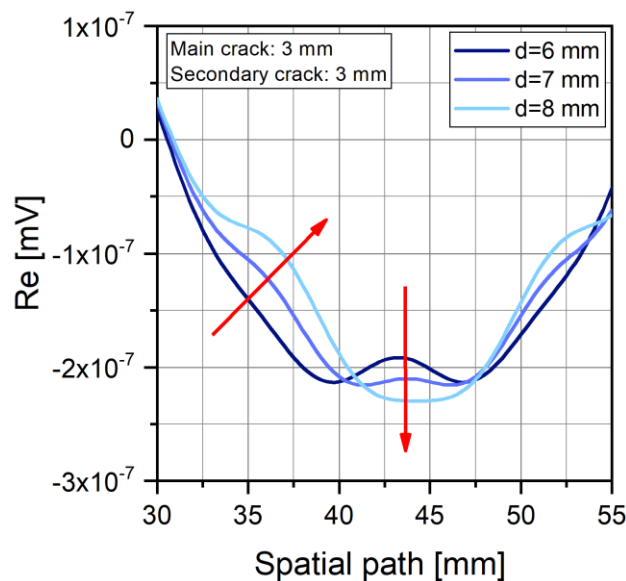
Figure 8: Quantification of the spatial resolution of the prototype.

The distance equal to 8 mm is the smallest one at which a significant separation of two local maxima, and the disappearance of the single one, begins to be appreciated. The same value could be determined by analyzing all the other configurations of the full factorial plan,

so it represents the spatial resolution of the prototype, which is considered low enough for the present application.

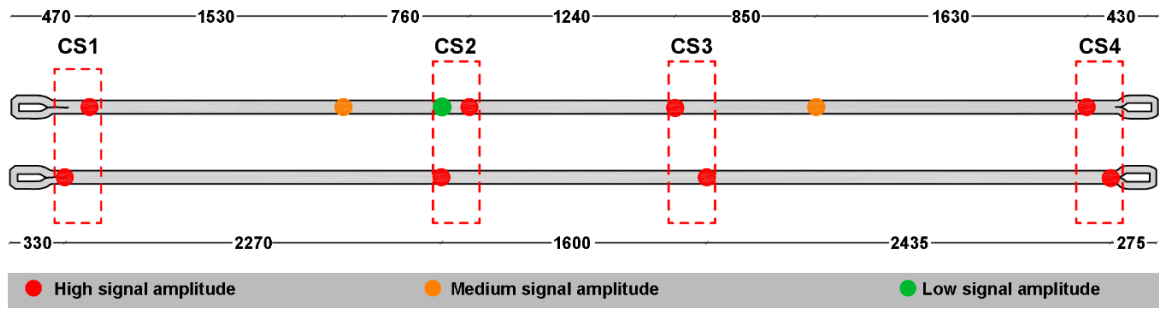
Figure 9: Pattern survey of the indications achieved by the horseshoe probe prototype.

The designed ET probe was finally verified experimentally by inspecting the two opposite larger sides (depth) of T02 tie-rod by the probe prototype. The resulting pattern survey is shown in Figure 9: as can be seen, all indications corresponding to forged welds, and highlighted by MT, were detected, while almost all the other ones, clearly detected by off-the-shelf probes, were neglected and not recognized. Moreover, the total inspection time lasted just one hour. It can be concluded that the developed ET inspection technique is actually effective in detecting just the most detrimental defects in historical metallic tie-rods. Moreover, the customized method is not time consuming and, hence, it can be reasonably used for a more extensive on-site campaign.
