# The Domus of Octavius Quartio in Pompeii: Damage Diagnosis of the Masonries and Frescoed Surfaces

Article in *International Journal of Conservation Science* · November 2016

*Domus of Octavius Quartio occupies the entire insula 2 of Region II in Pompeii, representing one of the most important village of this archaeological site. An interdisciplinary approach has been adopted in order to plan conservative, preventive and restoration actions aimed at the requalification of Pompeii within the frame of “Grande Progetto Pompei” program. 3D Laser scanner surveys and damage diagnosis following Fitzner’s method were carried out. The identification and description of weathering forms was carried out using ICOMOS-ISCS and NorMaL 1/88 recommendations, readapted and reinterpreted also for frescoes. Ten different weathering forms were identified; the frescoed room and the fountain are mainly affected by fissures, convex deformations, lacuna, efflorescence, discoloration, moist areas and patinas; the surrounding wall shows back weathering due to the disaggregation of bedding mortars; moreover the blocks are interested by rounding and biological colonization (lichens). Mapping the areal distri

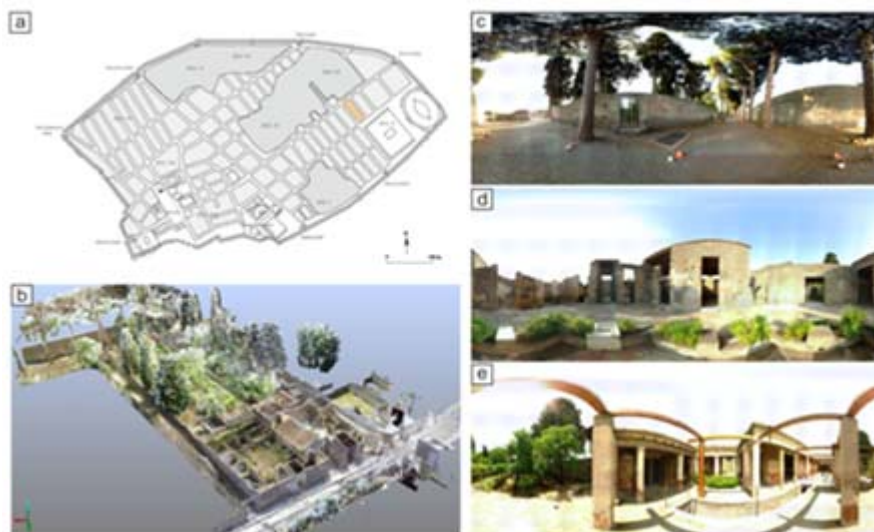
**Fig. 1.** The archaeological site of Pompeii and the *domus* of Octavius Quartio: a) location of the insula entirely occupied by the domus of Octavius Quartio (red filling); b) perspective view of the final point cloud 3D model of the entire insula; c) 360° panoramic view of the external wall close to the gym; d) 360° panoramic view of the peristyle; e) 360° panoramic view of the garden.

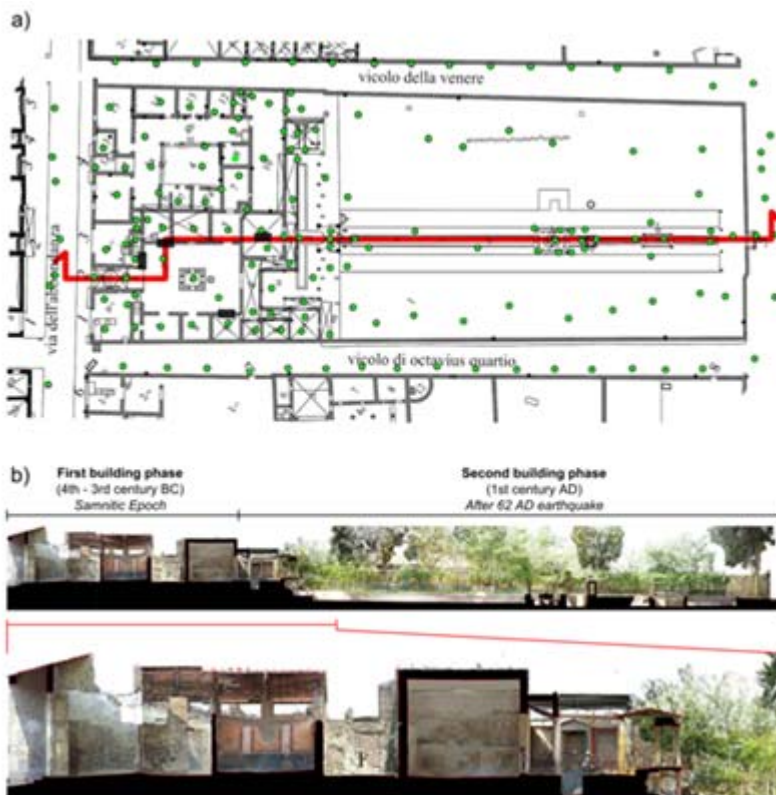
Fig. 2. The *domus* of Octavius Quartio: a) Plan view of the *domus* showing the scans station and the longitudinal section; b) longitudinal section reporting the two building phases of the *domus* with detailed zoom of a portion of the longitudinal section.

A three-dimensional survey of the *insula* was performed by means of a phase-shift technology laser scanner (Faro Focus3D-X Series) with integrated camera. In order to avoid parallax errors, the integrated camera had the same nodal point of the laser emitter. This equipment has a field of data acquisition of more than 100m (range of 0.6 - 130m) and provides resolution and accuracy in the order of millimetres. Compactness and lightness of the instrument combined with the speed of acquisition of 3D points (the maximum is 976000 points/second) permitted quick campaign operations despite numerous scan stations were needed. In fact, in order to produce a detailed and reality-based 3D model of the entire *insula*, 177 scans were performed and about 60 scan stations were required for the survey of the external perimeter wall (Fig. 2a).

elevation sections (Fig. 2b, represents one of these); orthoimages of the external walls and frescoed walls of the interior. The orthoimages have been extracted from the coloured model points, selecting planes of projection parallel to the walls. Selected georeferenced orthoimages with millimeter resolution were used for distribution of geomaterials and weathering forms mapping.

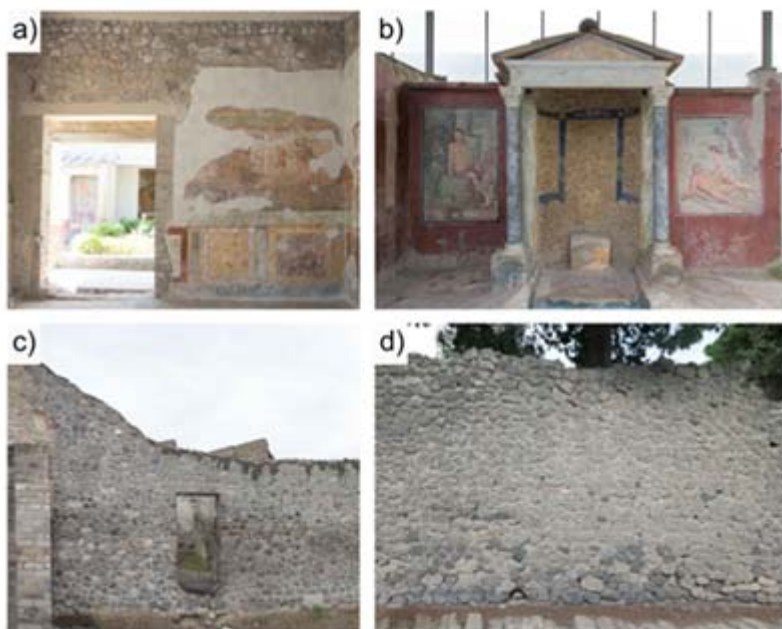
**Fig. 3.** Some portion of the investigated masonries by Fitzner and Heinrichs methods [14-16]; a) western wall of frescoed room h (*triclinium*); b) the aedicule with fountain; c) external wall, part 1; d) external wall, part 2.

On the basis of the type and distribution of building materials, three representative locations of the domus were selected for the implementation of the Fitzner's method: a frescoed room (Fig. 3a), selected for the extensive presence of mural paintings; the aedicule (Fig. 3b), where

more decorative elements appear; the surrounding wall on the west side of the *domus* (Fig. 3c and d). The external wall also shows all the structural elements from the Samnitic Epoch throughout the roman epoch until the modern restorations occur. Damage diagnosis of the masonries and frescoed surfaces of the *domus* of *Octavius Quartio* were carried out following the widely-accepted quantitative approach proposed by Fitzner and Heinrichs [14-16], also taking into account the presence of refined 4<sup>th</sup> style mural paints. For this purpose, an accurate mapping for a quantitative evaluation and distribution of geomaterials, weathering forms and damage categories was performed. Worth to note is that the method here proposed has never been carried out in the old town of Pompeii.

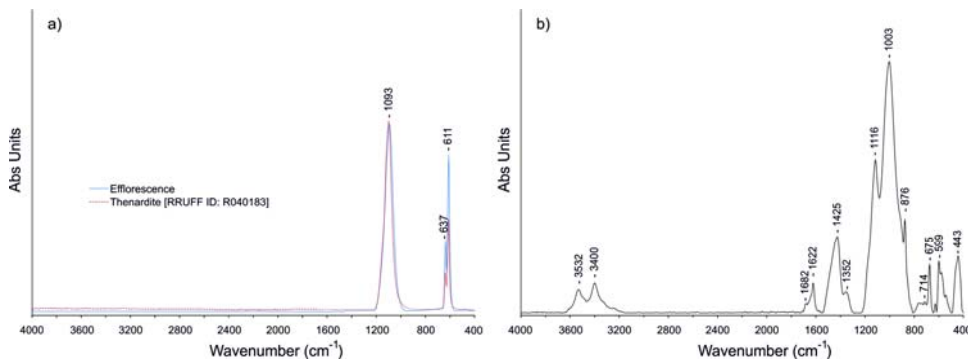
In situ ATR/FT-IR measurements (Fig. 4a) [32-33] demonstrated that the efflorescence was mainly constituted by thenardite (NaSO<sub>4</sub>). This saline compound represents, along with other magnesium and sodium sulphates, one of the most dangerous salts affecting the durability of building materials [12, 34]. Furthermore, frequent discoloration phenomena compromising the aesthetic value of frescoes were observed (Table 3; Fig. 4c).

Fig. 4. ATR/FT-IR spectrum of: a) efflorescence products of frescoed room compared to thenardite IR spectra; b) bedding mortar from the part 2 of the external wall.

A deeper disaggregation affecting the bedding mortar in another portion of the external wall (Table 3; Fig. 8b) defines a severe damage for this surface. In situ ATR/FTIR measurements performed on the products of granular disaggregation of bedding mortars showed the constant presence of calcite and silicate phases, as well as the presence of gypsum (Fig. 4b). Calcite was witnessed by the bands around  $1425\text{cm}^{-1}$  (asymmetric stretching of C-O) as well as by bands at  $876$  and  $713\text{cm}^{-1}$  (out-of-plane and in-plane vibrations) [37]. The bands at  $1003\text{cm}^{-1}$  and  $443\text{cm}^{-1}$  were related to bending and stretching in  $\text{SiO}_4$  tetrahedra of silicates. The bands at  $3532$ ,  $3400$ ,  $1682$ ,  $1622$ ,  $1116$ ,  $675$  and  $599\text{cm}^{-1}$  indicate the presence of gypsum [33, 37] likely due to sulfation phenomena [34, 37] justifying the friability of mortar in this sector of the wall.

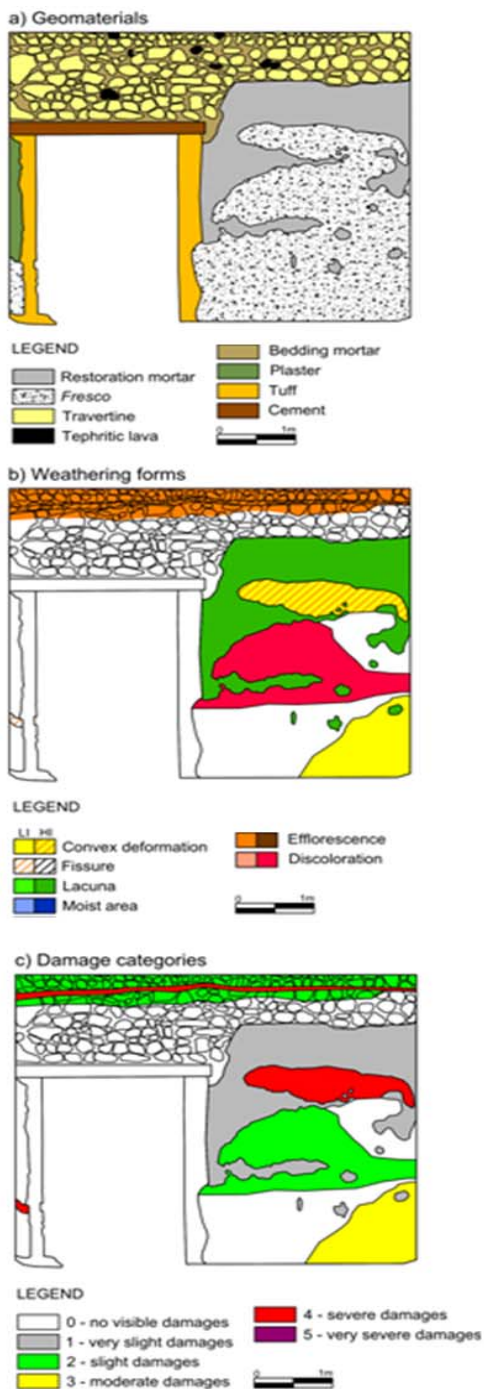
As far as the frescoed room is concerned (Fig. 3a - examined area: 74.4m<sup>2</sup>) it was almost entirely covered by frescoes mural painting and mortars from the restoration, except in southern and western walls (Table 2; Fig. 5a) where travertine and bedding mortar masonries could be observed.

In this room, six individual weathering forms were identified (Table 3; Fig. 5b). Being the walls originally frescoed, the gaps were considered as *lacunae*. This type of weathering form was the most representative for this room and reaching the higher intensity and extension on the northern wall (Table 3; Fig. 5b). Convex deformations and fissures were usually ascribed to rising damp of salt solutions as suggested by the presence of moist areas and efflorescence phenomena observed along the margins and at the base of the walls.

Data of damage categories (Table 4; Fig. 4c) generally highlighted a good state of conservation for the room h’, except for the eastern wall where damage indices reached 2.2 D<sub>lin</sub> and 2.5 D<sub>prog</sub> value, respectively.

**Fig. 5.** Damage diagnosis of the western wall of frescoed room h (*triclinium*): a) geomaterials (lithological mapping); b) weathering forms and related intensities (HI = High Intensity, LI = Low Intensity); c) damage categories and decay evaluation.

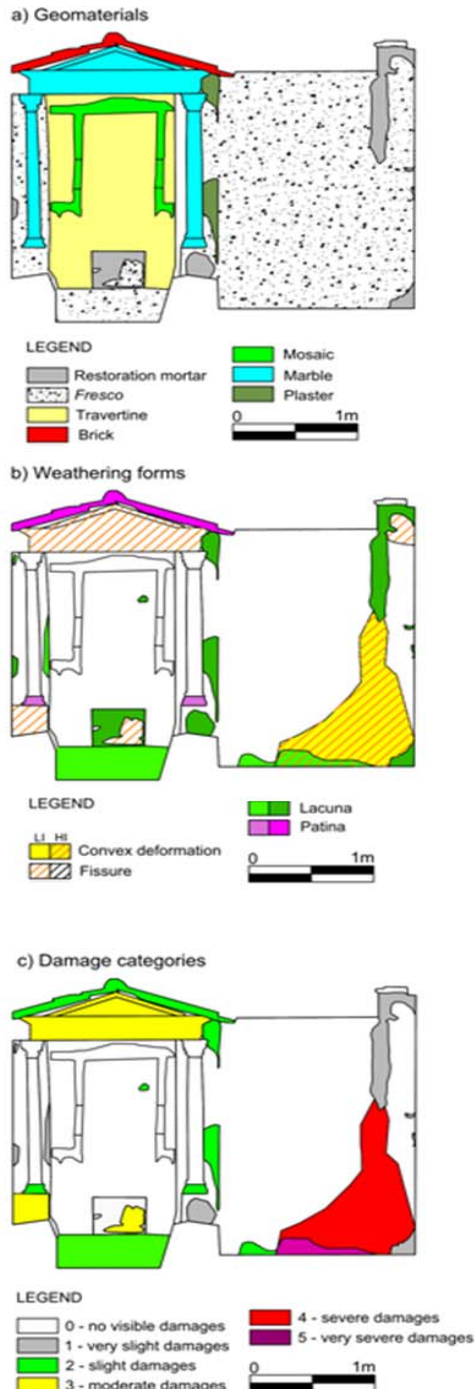
The *aedicule* with the fountain (Fig. 3b - examined area: 7.7m<sup>2</sup>) showed a wider and more selected variety of geomaterials (Table 2; Fig. 6a). The internal surface of the votive *aedicula* was covered by travertine fragments (with a diameter of about 10cm) and green/blue glass mosaic *tesserae*. Others geomaterials observed were white marble for the *capitella*, alabaster for tympanum, black marble for the columns and bricks on the top of the *aedicula*.

The weathering forms here observed were convex deformations, fissures and *lacunae* (Table 3; Fig. 6b), as well as minor *patinae* on the marbles. Although the overlapping of different weathering forms gave back some minor areas with damage categories 4 and 5 (Table 4; Fig. 6c), the damage indices were relatively low, 0.7  $D_{lin}$  and 1.5  $D_{prog}$ , respectively. Nevertheless, the discrepancy between the two indices is due to the fact that  $D_{prog}$  emphasises the weight of higher damage categories in the calculation [16].

**Fig. 6.** Damage diagnosis of the aedicule with fountain: a) geomaterials (lithological mapping); b) weathering forms and related intensities (HI = High Intensity, LI = Low Intensity); c) damage categories and decay evaluation.

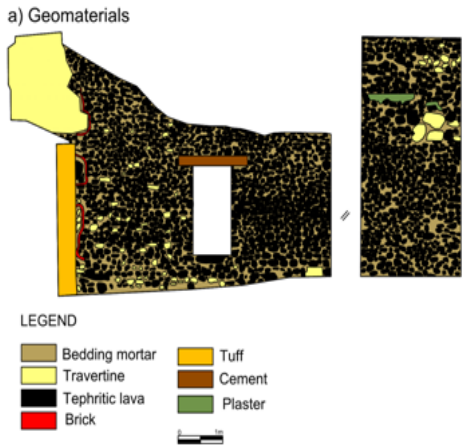
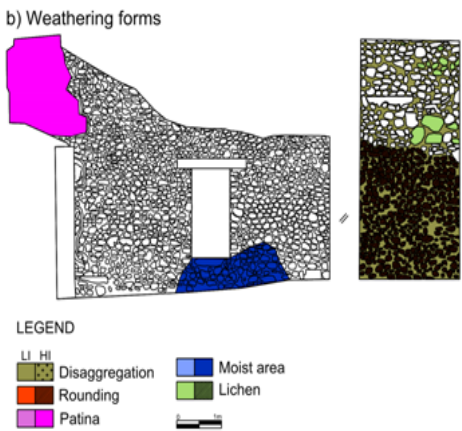
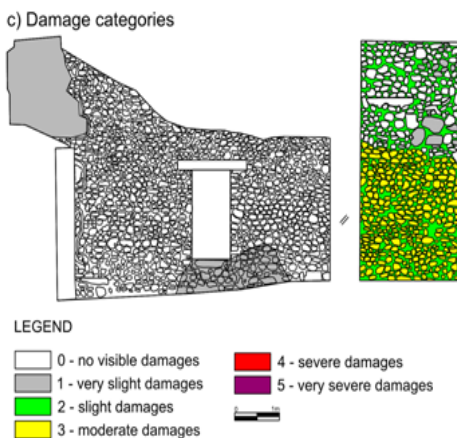
Travertine and tephritic lava blocks jointed with mortar formed the external wall (Figs. 3c and d - examined area: 266.5 m<sup>2</sup>). However, the distribution of geomaterials (Table 2; Figs. 7a and 8a) and the textural properties of the bedding mortars [35] allowed distinguishing two different parts of the wall. In the first part (alongside the rooms a<sub>1</sub>, b<sub>1</sub>, 4, a, b, d, e, f, m; Fig. 2a) the masonry was formed mainly by leucite-bearing tephritic lava blocks jointed by cohesive grey mortar made with abundant volcanic and cocchiopesto aggregates. On the other hand, in the second part of the wall the travertine was prevalent and the bedding mortars were yellowish, friable and frequent unmixed white lumps occurred [24, 36].

These lumps are usually referred in literature as defects in the preparation of mortar and could suggest the presence of pozzolanic raw materials that reduce the setting time of mortar hindering a complete mixing of the components [24]. In the entire external wall, minor amount of bricks and tuff (original and modern), as well as some beams of modern cement, were found within relict portions of plasters (Table 2; Fig. 7a).

Fig. 7. Damage diagnosis of external wall, part 1: a) geomaterials (lithological mapping); b) weathering forms and related intensities (HI = High Intensity, LI = Low Intensity); c) damage categories and decay evaluation.

The different types of geomaterials and their different distribution in the two parts of the external wall unavoidably influenced the conservation state of the masonry. In fact, in a portion of the external wall, a slight and localised concave-parallel back weathering of bedding mortar was noted probably due to a granular disaggregation (Table 3; Fig 7b). This pathology was accompanied by a rounding of tephritic lava blocks, as well as other less extended and less intense weathering forms, such as: patinae on travertine, biological colonisations (lichens) and moist areas (Table 3; Fig 7b).

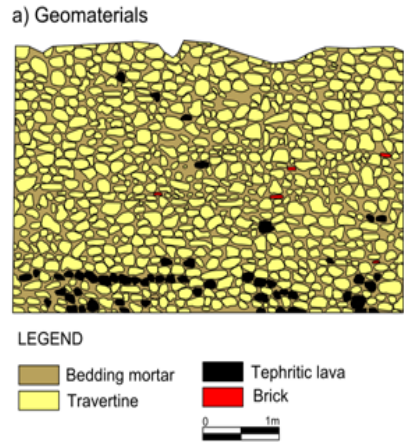
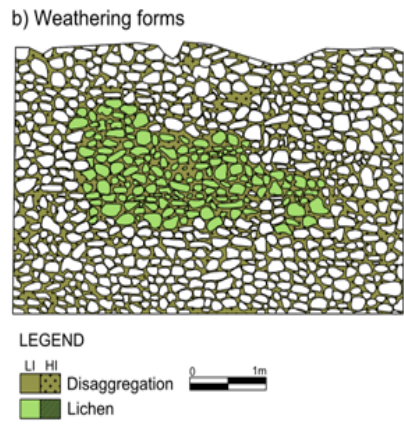
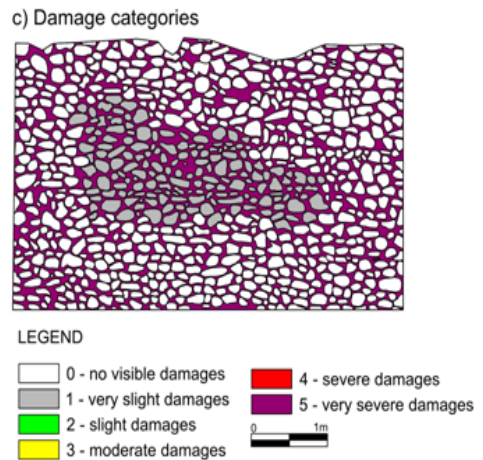
Fig. 8. Damage diagnosis of external wall, part 2: a) geomaterials (lithological mapping); b) weathering forms and related intensities (HI = High Intensity, LI = Low Intensity); c) damage categories and decay evaluation.

Taking into the account the structural role of bedding mortar in a masonry, this weathering form has been precautionary classified as a damage category 5 (Table 4; Fig. 8c) thus, the high value of damage indices ( $1.9 D_{\text{lin}}$  and  $3.0 D_{\text{prog}}$ ) infer a urgent intervention.
