Forensic Analysis of Levee Failures: The Breitenhagen Case

ABSTRACT: *Forensic analysis of past failures is valuable to improve our understanding of levee behavior. In this article a new systematic approach of forensic analysis for levee failures is proposed and applied to the Breitenhagen levee breach that occurred along the river Saale in Germany in 2013. The purpose of this study is to identify the cause of the breach based on the proposed approach, even though limited data is available. Based on the information prior, during and after the breach of the levee, a slope stability model is developed for the entire event. First, results from this model are obtained based on the expected values of the uncertain parameters and the best estimates of the situation. Uncertainty of the model is included in the calculation subsequently by defining possible failure scenarios. The most likely failure scenarios are derived from the data and included into the model so that it is possible to eliminate or validate all possible causes by means of a sensitivity calculation. It is concluded that the levee breach is likely caused by locally weak soil conditions, unexpected high water pressures due

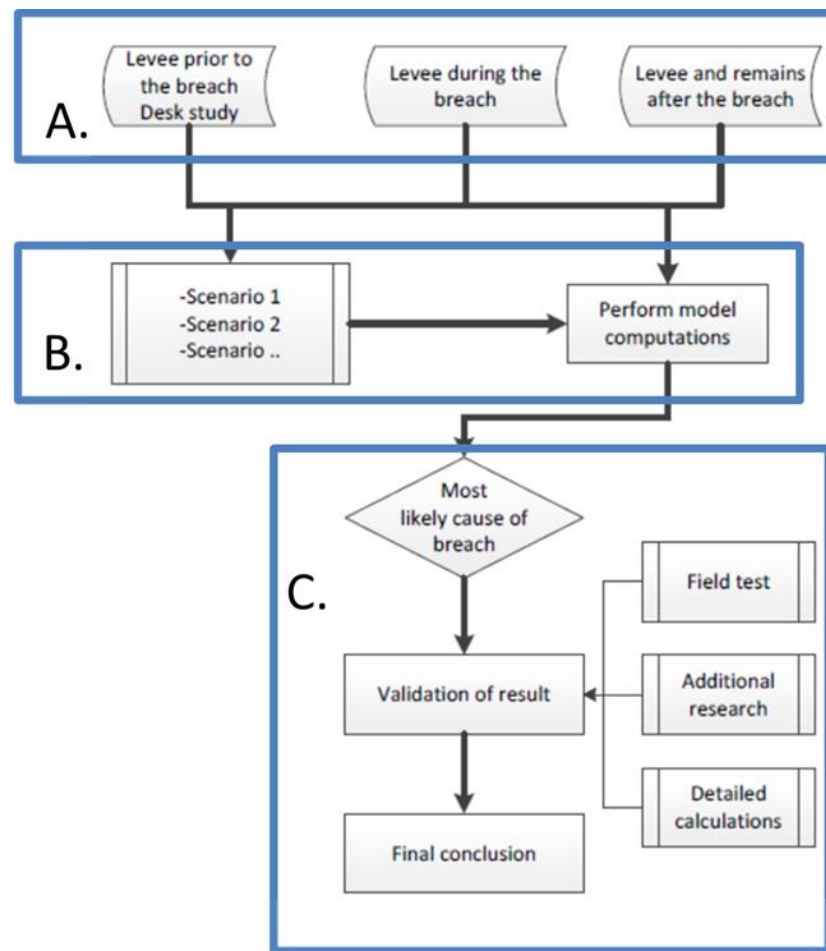
Figure 8. Generic approach for levee forensic analysis based on Borsje, et al. (2014) Step A.: Collecting information for exploring possible scenarios; Step B.: Evaluate with a computational model; Step C.: When results do not identify the cause, additional information can be gathered.

To identify the most likely cause of a levee failure, a systematic approach for forensic analysis of levee failures is suggested. In order to make the generic forensic analysis approach more applicable to levee failures, the standard three steps of forensic engineering as proposed by TNO (see section 3.1) are adapted into three more specific steps for levees (A, B and C, see Figure 8).

In step A, the collected data that are typically relevant for levee breaches, are sorted in three ways, i.e. data collected prior, during and after the failure as shown in Figure 8. This provides a clear overview of which data are relevant in terms of factors that are of influence on the performance behavior and a first impression on the performance behavior of the levee during extreme circumstances. A distinction is made between input parameters (which are considered as possible causes e.g. pore water pressures and shear strength of the soil) and model choices (e.g. LEM and (un)drained soil behavior). With the data during and after the failure, possible failure scenarios are determined and the behavior of a levee is studied.

In step B, a sensitivity analysis is used to validate or eliminate possible causes contributing to the levee failure (hindcasting) (Figure 8). Using the data and additional literature, the best estimate scenario and expected values for the input parameters are modelled (further referred to as "base model"). During the process of developing a "base model", all the individual uncertainties are identified and introduced as scenarios (in terms of input parameter and modelling choices). During the sensitivity analysis, the expected values of the still uncertain input parameters are replaced one by one by realistic upper and lower limit boundary values.
