# Monitoring as strategy for planned conservation: the case of Sant'Andrea in Mantova (Mantua)

### The diagnostics plan for the basilica di Sant’Andrea

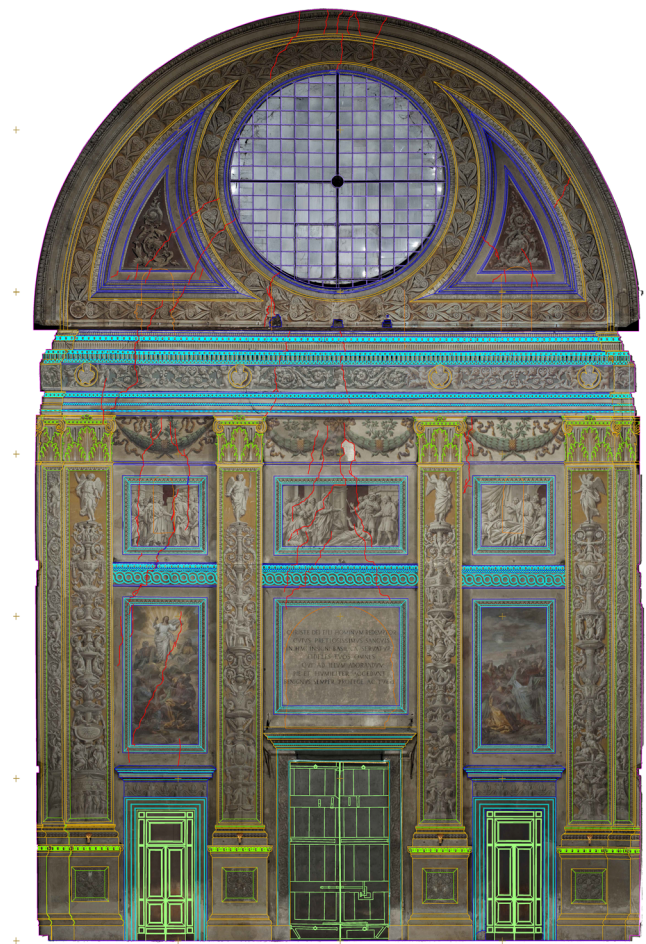
Fig. 1 The orthophoto of the counter-facade of the Basilica with vector drawing overlay and crack detection

Out of the totality of these first elaborations, the orthophoto of the counter-façade of the Basilica was produced (Fig. 1)

enabling us to read the complexity and gravity of the map cracking underway (Chiarini et al. 2014). Thereafter, a careful analysis of the structural picture began with targeted interventions.

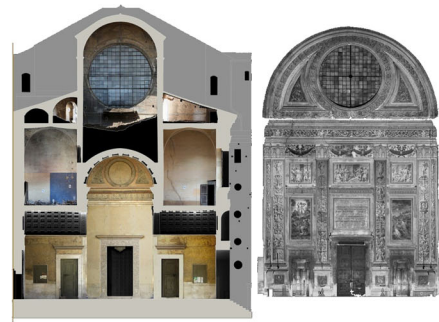
Fig. 4 The façade and counter-façade of the Basilica

cracks, envisioning a static acquisition system with six acquisition sensors placed in the most suitable positions (left of Fig. 4) deemed appropriate by the structural technician.

- Probe 01: +0.20 mm enlargement;
- Probe 02: +0.05 mm enlargement;
- Probe 03: -0.02 mm narrowing;
- Probe 04: +0.01 mm enlargement;
- Probe 05: +0.08 mm enlargement;
- Probe 06: +0.00 mm (zero) variation.

We noticed a stability of the map cracking with a significant opening as regards the probe placed above the architrave of the entrance door to the Basilica (bottom right of Fig. 4).
