# Masonry Texture Reconstruction through High Frequency 3D GPR

## Survey for Building Seismic Assessment

Federico Lombardi (\*), Maurizio Lualdi and Elsa Garavaglia

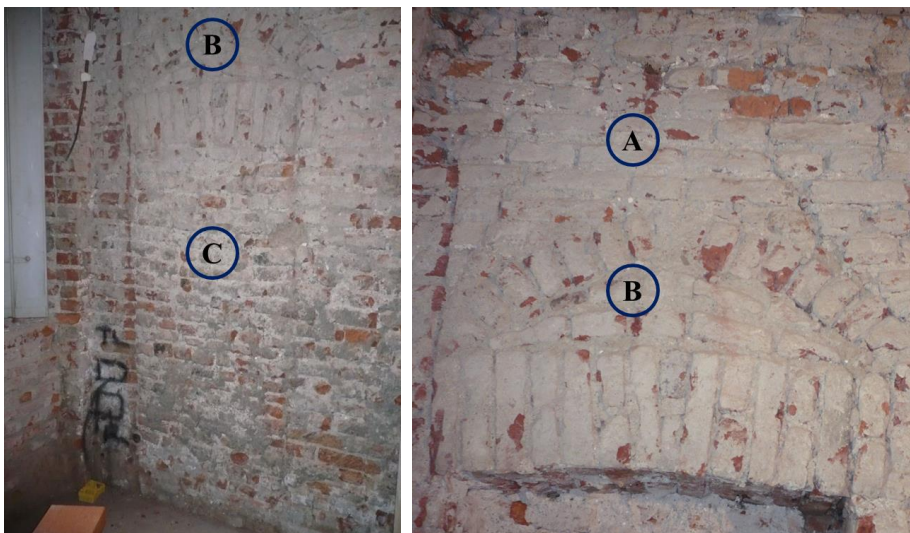
118  
119 **Figure 1: Experimental area.**

114 For the purpose of the study, a recently covered wall has been selected to evaluate the GPR potential in  
22  
115 reconstructing the morphology of masonry buildings. The site has been chosen as it presents several critical  
24  
116 aspects in terms of masonry design, constituent elements distribution, size and geometry, as can be seen in

117 Fig 1.

120 From the photographs prior to the restructuring, it can be seen that the selected site is composed of three main  
53  
121 areas: a first sector exhibiting a geometrically regular brickwork (marked A in Fig. 1) on top of a segmental  
55  
122 arch (marked B in Fig. 1), i.e. an arch whose intrados is circular but less than a semicircle, a sign of a former  
57  
123 aperture within the masonry wall, visible with its correspondent jack arch in the lower part of Fig. 1 (marked

124 C in Fig. 1). This represents the typical relieving arch design, built over a lintel or a jack arch to divert loads  
1  
125 and hence relieving the lower member from excessive loading.

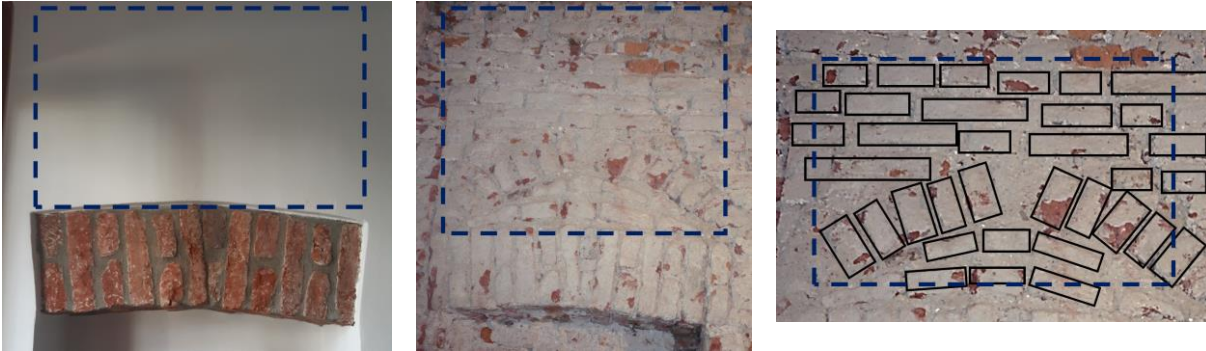
228  
22  
229 **Figure 2: survey area details.**

126 An area of 70-by100 cm has been surveyed (Fig. 2a), covering the first two previously described areas, as  
6  
127 shown in Fig. 2b.

230 Within these (Fig. 2c), the portion of the upper area that has been acquired consists of 3 rows of bricks each of  
27  
281 them including 5 to 6 elements, unevenly distributed, as well as inhomogeneous mortar joint thickness, while  
29  
302 the underlying segmented arch includes 9 voussoirs (an additional element straddles the acquisition  
31  
323 boundaries) with a maximum skewback angle of 35 degrees with respect to the arch keystone, and a core of  
33  
344 brickwork between the underside of the arch and the top of the lintel.

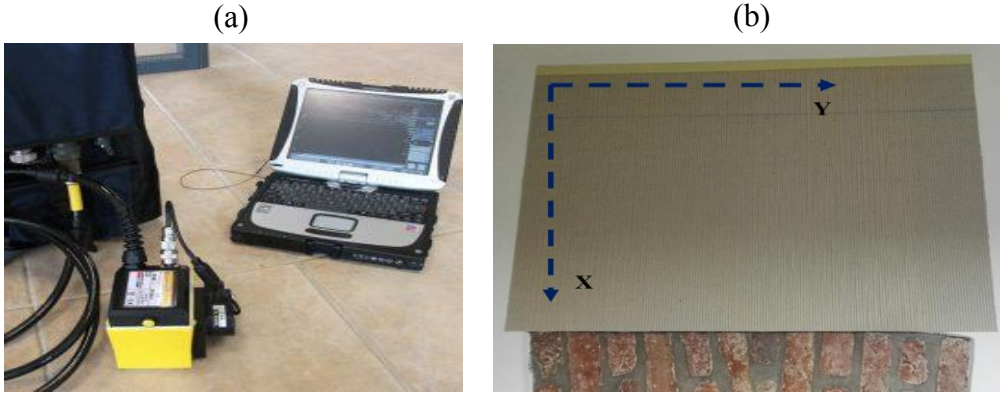
**Figure 3: (a) employed GPR platform and (b) survey geometry.**

35  
36  
37  
38 GPR data were acquired using an IDS Georadar TR-SHF radar, a ground coupled impulse system with a  
39  
406 central frequency and a bandwidth of 3 GHz. The device carries two bow-tie antennas spaced 6 cm and  
41  
427 oriented perpendicular to the survey line (Fig. 3a). The sensor head, which is essentially a passive component  
43  
4438 weighting approximately 2 kg and with a size of 6 by 12 cm, is connected to a central unit responsible for the  
45  
4639 generation, transmission and reception of the signal. The required dense and regular 3D acquisition grid has  
47  
48  
4940 been obtained by directly placing a cardboard variant of the PSG (Pad System for Georadar, [41]) over the  
50  
5141 wall (Fig. 3b), ensuring parallelism between adjacent profiles, while the inline sampling was controlled  
52  
5342 through an odometric wheel directly connected to the sensor head.

In this case, data were acquired along the ceilings to the floor direction. However, as logistic constraints might necessitate different acquisition geometries compared to the chosen one, two orthogonal volumes have been acquired to assess eventual differences in the imaging results. The choice of the orthogonal direction derived from the fact that, despite not expected to exhibit a strong polarimetric response, the regular geometry of a brickwork, particularly the vertical and horizontal mortar joints, might impact the magnitude of the scattering response [42]. Moreover, in case of structural metallic reinforcement elements such scheme will ensure a full detection, as a consequence of the well-known sensitivity to polarisation of highly conductive linear targets [43]. Precise correspondence among the acquired samples has been ensured by rotating the system with respect to the reflection centre of the antennas, while maintaining the same acquisition geometry.

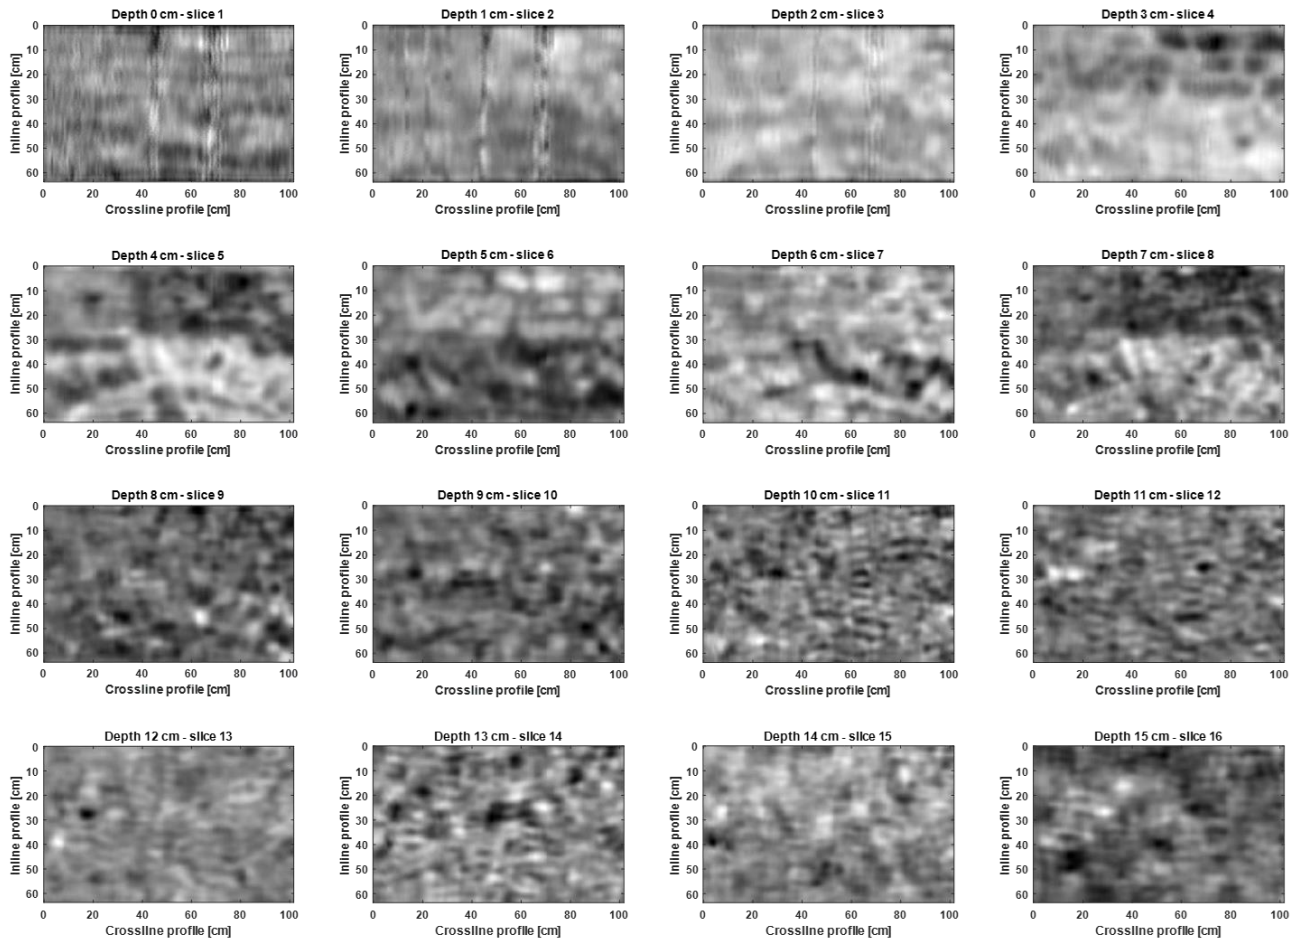
**Figure 9: GPR results, migrated horizontally oriented depth slices.**

20  
21  
22  
249 To solve the challenge of quantitatively reconstruct the masonry wall, i.e. determine the number and actual  
23  
24  
250 location of each element, migrated data are presented for each acquisition scheme, starting from the  
25  
26  
251 horizontally oriented volume (Fig. 9). As described in Table II, a limited aperture value has been selected to  
28  
252 further improve the resolution of the produced images and to avoid the introduction of processing artefacts.

As expected, the additional processing step has the benefit of accurately reconstructing each scattering element and the relative boundaries, at the same time sharpening the image, as can be clearly seen in the depth slices ensemble. In agreement with the predicted plaster thickness and brick thickness, masonry layer appears at a depth of 3 cm, and its scattering contributions vanishes with depths greater than 11 cm. What can be also noticed is that the signature of the arch appears slightly deeper, meaning either a locally increased covering thickness or an underestimated velocity value. The close correspondence with the existent masonry texture is particularly evident for the geometrically regular brickwork (slice 4 in Fig. 9).

A very similar level of detection and reconstruction performance can be defined, following what has been commented from the analysis of Fig 9. The better delineation of vertical elements that emerged from the analysis of the unmigrated data results in a clearer definition of the brickwork core under the arch, as assessed in Fig. 12 and Table VII, respectively. The geometrical characterisation from the vertically oriented acquisition required approximately 2 to 3 slices, in agreement with the values obtained from the horizontal one.

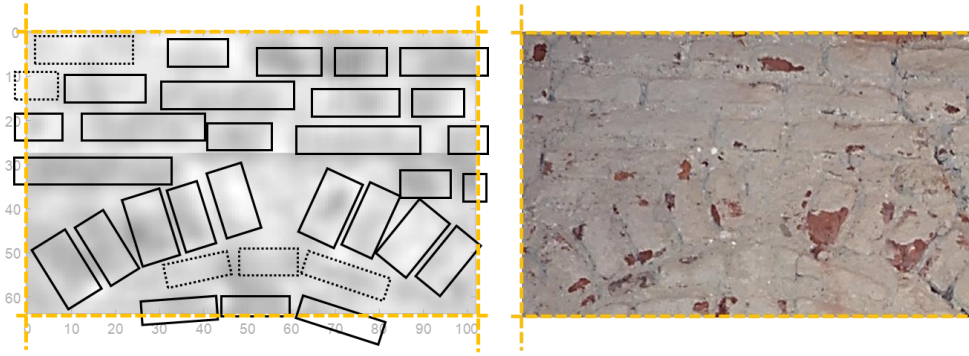
**Figure 10: Reconstruction performance, migrated horizontally oriented depth slices.**

The additional advantage of analysing migrated data over unmigrated ones is that it requires a significantly reduced number of radar slices to properly reconstruct the masonry morphology, 2 to 3 images, thus mitigating as well the effects of the user familiarity in interpreting the data. Detection performance are sketched in Fig. 10.

The texture is clearly identifiable, and the actual number of elements and their size can be guessed, with a remarkable level of accuracy and detail. Only the smallest and less regularly organised elements still represent a challenge, even if their presence can be supposed considering the texture of the surrounding neighbourhood. As a figure of merit, Table VI describes the obtained accuracy in determining the size of brick examples compared to the actual values.
