Continuous Monitoring of Masonry Arch Bridges to Evaluate the Scour Action

Keywords: Masonry bridge · Scour action · Structural health monitoring · Static monitoring · Hydraulics

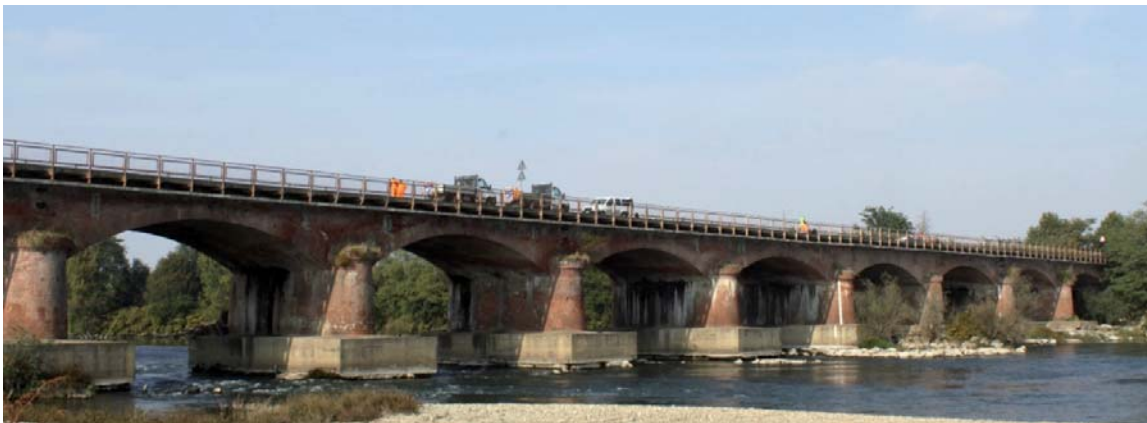
Fig. 1. The *Candia* bridge: view from the downstream of Sesia River.

The paper illustrates the application of the SHM strategy for multi-span masonry arch bridges subjected to scour actions on one of the selected structures: the *Candia* bridge (Fig. 1). The *Candia* bridge, crossing the Sesia River, is a masonry bridge built in the second half of the 19th century. The inspection on the structure revealed that all pier footings resting on the riverbed underwent strengthening interventions, highlighting the vulnerability to scour actions. Consequently, the permanent monitoring system was designed to investigate the flood-induced scour risk acquiring data from both the structure, the river, and the riverbed with a heterogeneous sensor network. The preliminary results show a promise toward the possibility to perform the early detection of scour-induced damages.

The *Candia* bridge (Fig. 1) is an historical multi-span masonry arch bridge crossing the Sesia River in the neighborhood of the small town of Candia Lomellina. The structure is

Regarding the interaction with the Sesia River, the bridge crosses the river 5 km upstream of the confluence with Po River. Flow regime is rather torrential, with flow discharges ranging between 70 m³/s and 5000 m³/s. In case of a 200-year flood event, water can reach an elevation of about 105 m above sea level (asl) and 1 m above the skewback of the bridge arches. Moreover, the river is close enough to the Po River as to feel its backwater effect. Consequently, different hydraulic scenarios may occur at the bridge section. In other words, multiple flow rates and velocities can correspond to a given water depth. The Sesia River has a meandering channel pattern, which appears planimetrically stable from aerial images observation since 1954. On the other hand, the river has showed bed elevation changes, inducing a scour process at the base of the pier footings. Scour can develop at different space and time scales. At large scales, the altimetric profile of Sesia River suffered a general degradation of several meters in the last century. In particular, along the period 1960–2000, the river generally eroded for 2–3 m. This process led to threat to the stability of the bridge pier foundations. For this reason, all pier footings resting on the riverbed underwent strengthening interventions (see, e.g., the piers in Fig. 1).

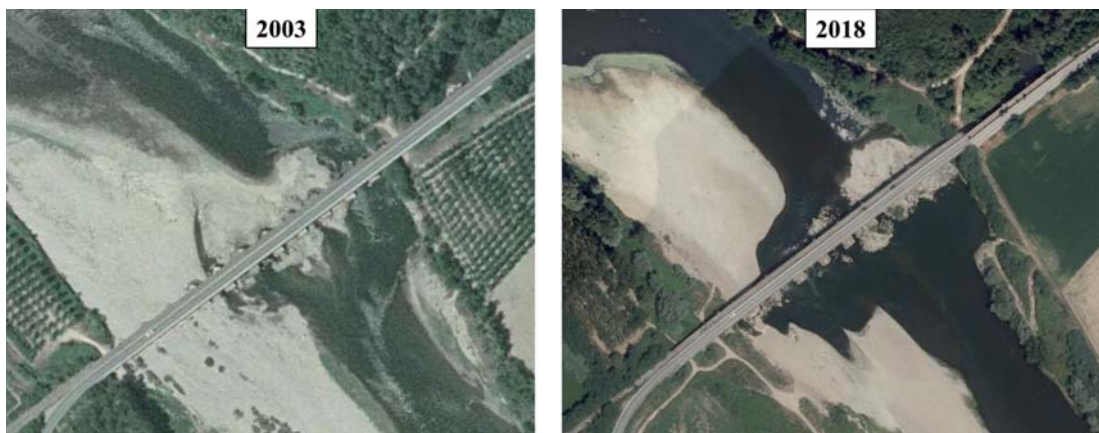
Fig. 2. Satellite images of the Sesia River before and after the armoring intervention.

Armoring intervention of the riverbed were carried out on several occasions to stabilize the sediments around the foundations. To the authors' knowledge, the last intervention of riverbed stabilization was performed after 2003 around the most eroded piers at the left side of the channel, where flow concentrates in normal condition. This operation, however, simply modified the local morphology of the riverbed, deviating the main flux - and therefore the scour process - from the left to the central-channel piers. Figure 2 shows a representation of this mechanism. Scour can further develop locally during a single flood event, due to the local acceleration of the flow around the piers. The presence of debris, which easily accumulates in front of the piers during a flood event, can further intensify the local scour process.

Figure 6 shows the time evolution of measured rotations of two selected piers (i.e., P4 and P6). It is worth mentioning that both piers are located in the area that – after 2003, see Fig. 2 – has been affected by scouring and, therefore are monitored with two tiltmeters each. The inspection of Figs. 5(b) and Fig. 6 firstly suggests that the fluctuations of the measured pier rotations follow the temperature variation. In order to further demonstrate the temperature dependence, Fig. 7 shows the correlation of the measured rotations at pier 4 and pier 6: all the selected pier rotations exhibit an almost linear correlation with temperature. The main difference between the tiltmeter measurements at piers 4 and piers 6 is a sharp permanent shift in the rotation-temperature relationship starting from the 31/03/2021. Particularly, the variation of the linear correlation is demonstrated by the changes in the R^2 coefficient (Table 1). The tiltmeters T3 and T4 (pier 4) exhibit a high value of R^2 – close to 0.9 – for the entire monitoring period. Conversely, the tiltmeters T7 and T8 (pier 6) exhibit a clear drop in R^2 coefficient after the 31/03/2021.

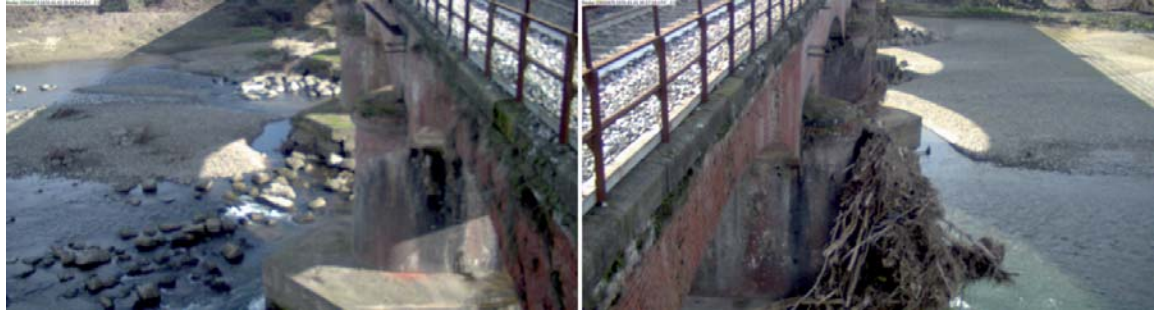
Fig. 4. Pictures of the upstream side from the permanently installed cameras.

3598 1-h dataset were collected and analysed. In addition, the upstream side pictures – taken with the permanent cameras in the daylight – were used to realise a time-laps video showing the evolution of debris accumulation. In Fig. 4 two images of the upstream side of the bridge are reported, showing the impressive debris accumulation on pier 5 after the last flooding in the beginning of October 2020.

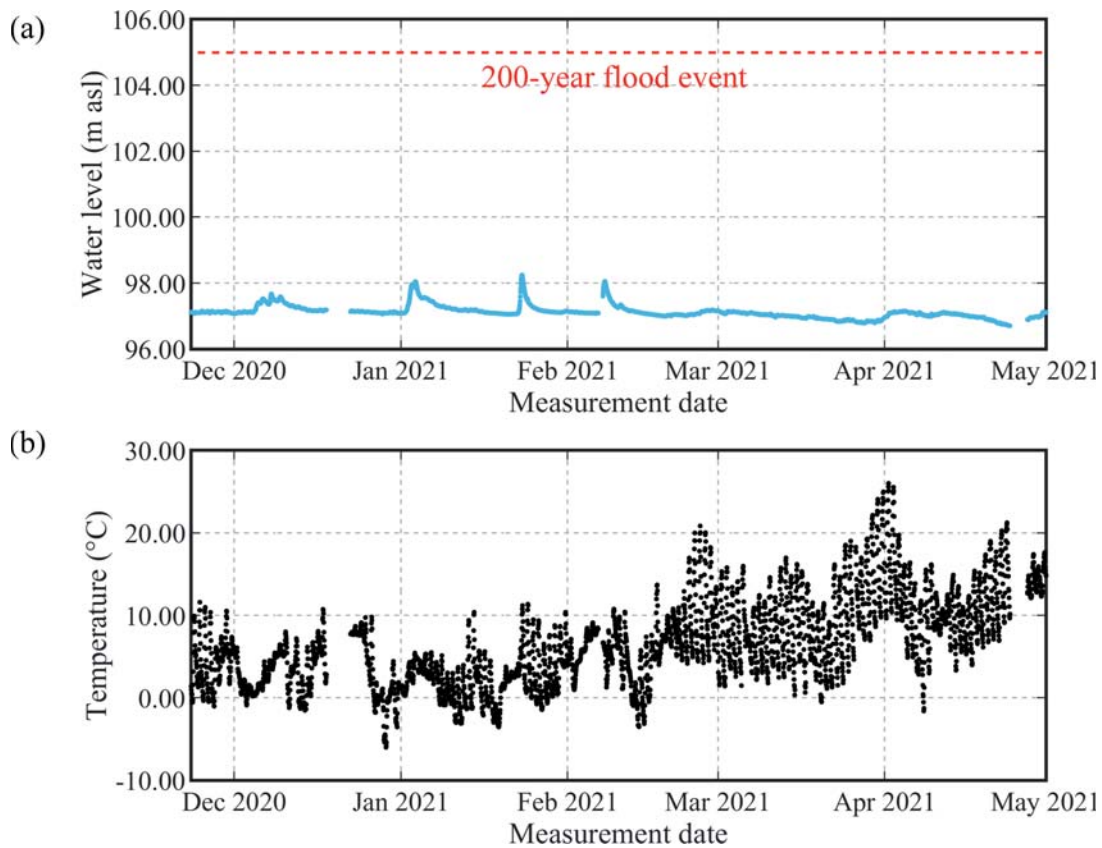
Fig. 5. Variation in time of measured water level (a) and temperature (b).

Regarding the measure of the environmental parameters, Fig. 5(a) presents the evolution of the river (water) level measured with the hydrometer in terms of elevation above the sea level (m asl). The inspection of Fig. 5(a) reveals that the water elevation changed about 1.5 m during the monitoring period. It is worth considering that during the expected 200-year event, water can reach an elevation of about 105 m also, namely, rising about 8 m from the minimum measured water level. Therefore, the detected variations in the water level are negligible in respect to the expected rare events and so that only negligible scour values should be expected under such conditions. To further confirm this assumption, the recorded pier rotations have no correlation with hydrometer measurements. Figure 5(b) illustrates the evolution of the outdoor temperature measured with the weather station installed on the bridge. The maximum and minimum recorded temperatures in the selected period are equal to 26 °C and –6 °C, respectively.

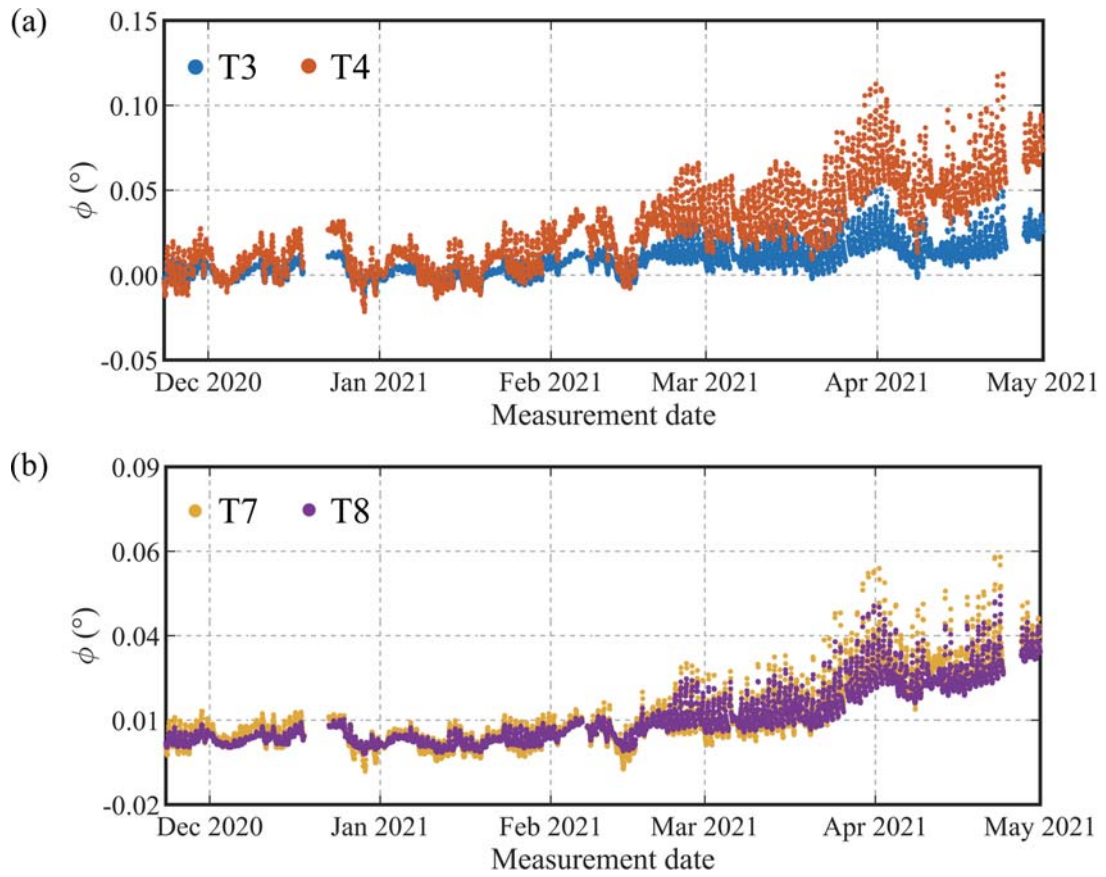
Fig. 6. Time variation of rotations: (a) tiltmeters T3 and T4 at pier 4, and (b) tiltmeters T7 and T8 at pier 6.
